Transport Accident
Investigation
Commission

Final Report

***Marine Inquiry MO-2018-202
Accommodation fire on board
Fishing trawler Dong Won 701
Timaru
9 April 2018***

December 2019

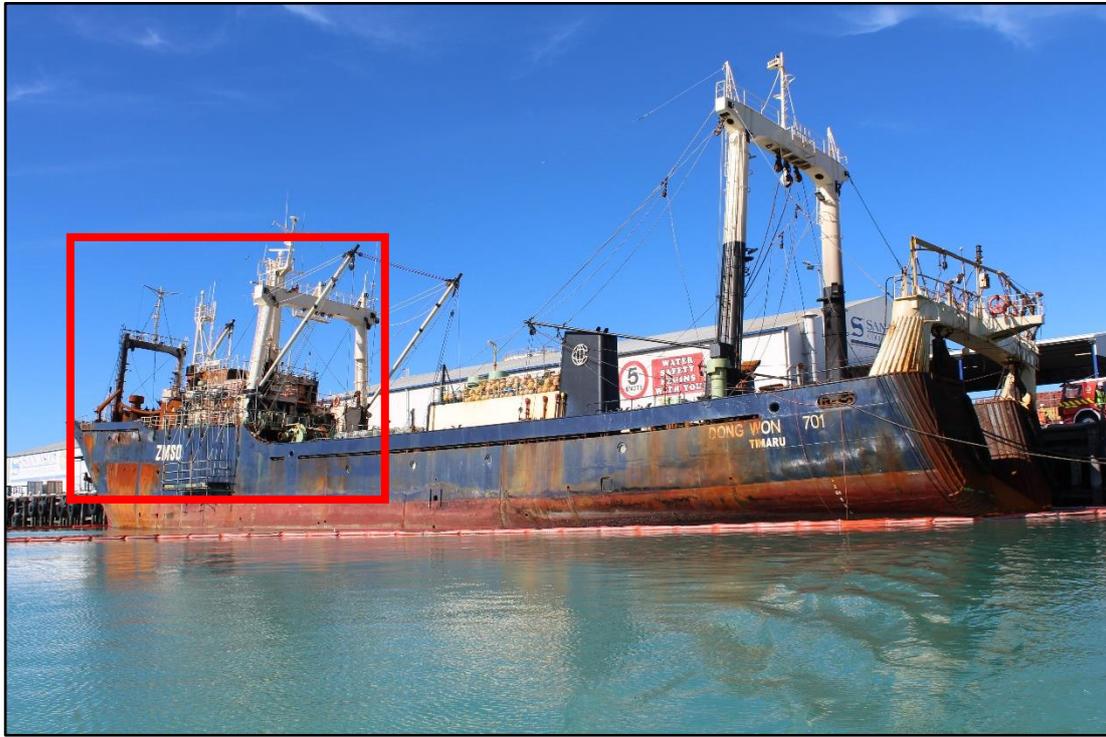
Figure 6: Area affected by fire marked in red

2.25. The following is an overview of the damage caused by the fire. A FENZ fire investigation report in Appendix 1 provides a more detailed description of the damage. The vessel suffered fire and heat damage to areas forward of the main winches on the upper deck, as shown in Figure 6.

2.26. The accommodation superstructure and area forward of the superstructure suffered severe heat damage and buckled in several areas. The rear of the superstructure was less affected: the protective paint was still relatively intact and there was no buckling of the upper deck.

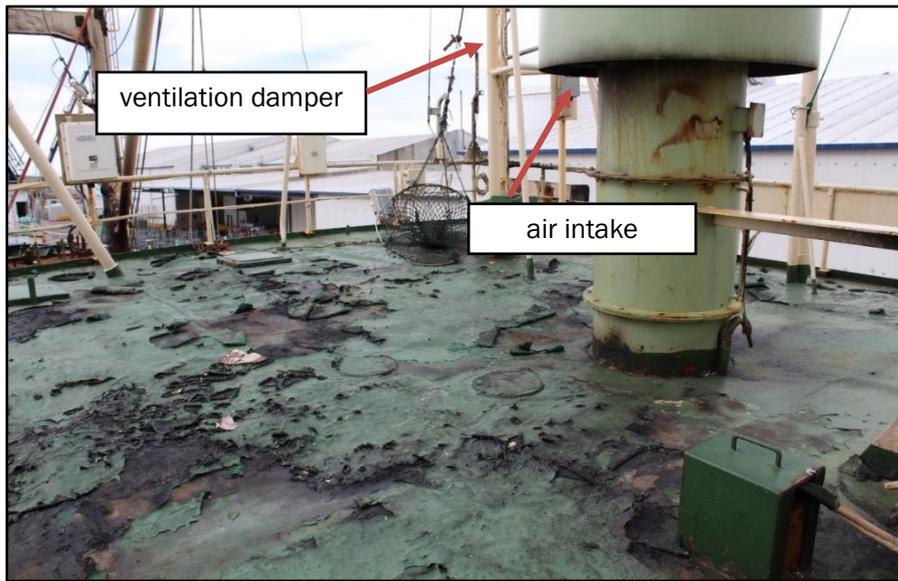
Figure 7: Ventilation damper on top of the bridge

2.27. A ventilation damper¹⁰ located above the bridge was found in the open position.

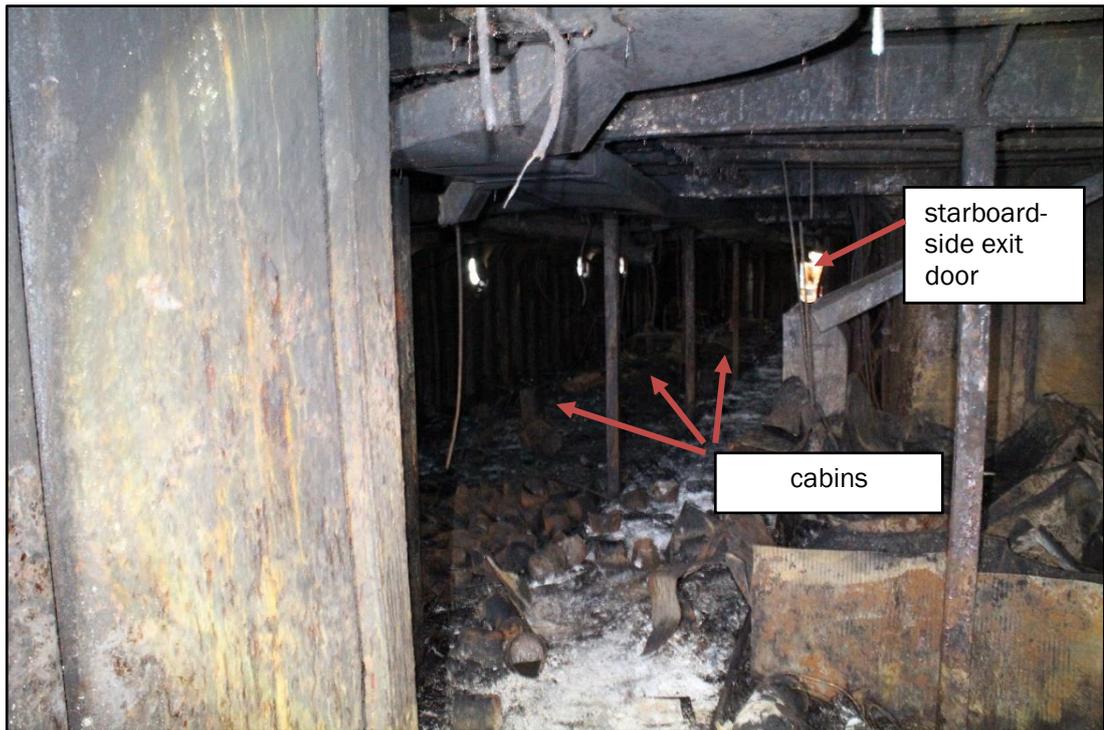
Figure 8: Fire damage to cabins on the officers' deck

2.28. All cabins located on the port and starboard sides of the officers' deck were destroyed by the fire (see Figure 8 and Figure 9). The first engineer's cabin suffered the most fire damage. The severity of the damage reduced with the distance away from the first engineer's cabin.

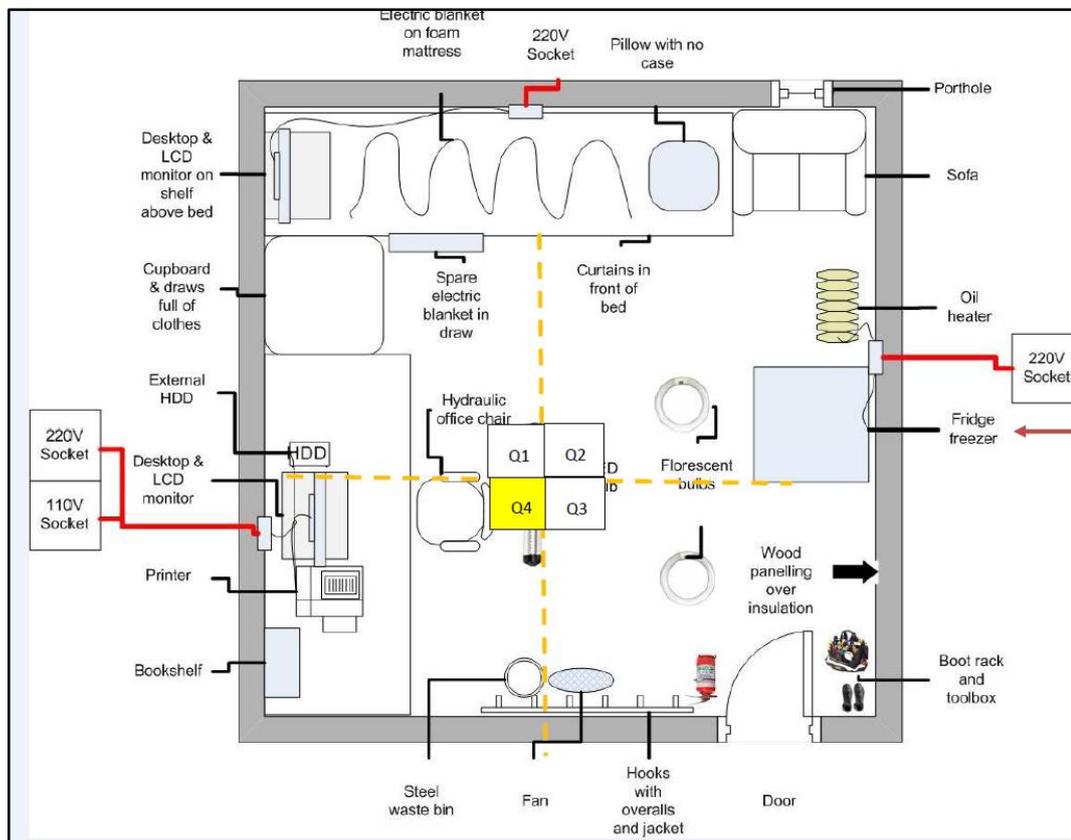
Figure 11: Plan layout drawing of first engineer's cabin

- 3.7. The point of origin was considered to be at or just above the floor level beside the rubbish bin, next to the first officer's desk. The burn patterns on the ceiling and the warping of the steel plate where the cabin bulkheads¹³ were fastened supported this conclusion, as did the accounts of those who entered the cabin during the initial firefighting effort.

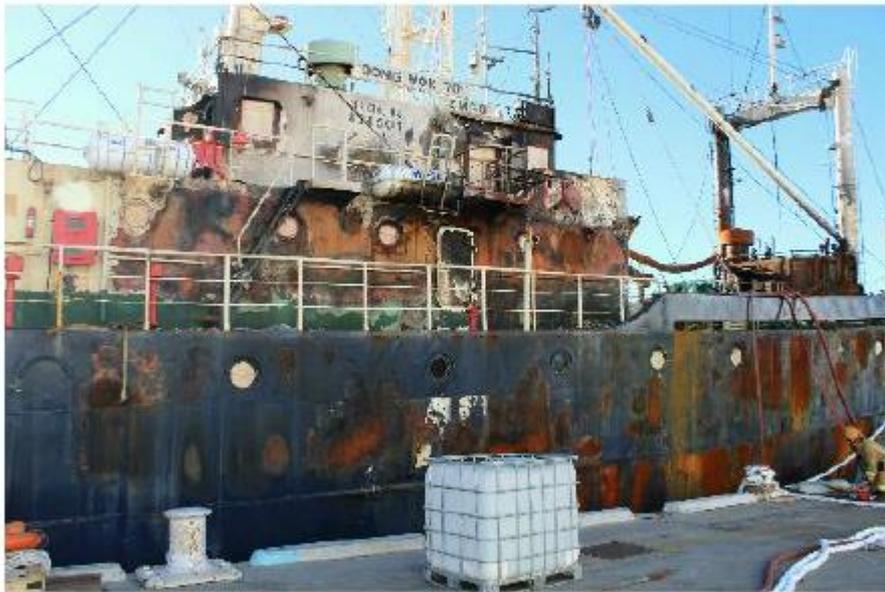
An external examination of the vessel was carried out which revealed obvious signs of fire and heat damage to almost the entire front half. Oxidization of the steel hull on both port and starboard sides was proof of this. (Refer to photo 4).

Photo 4: Shows the oxidisation on the superstructure and hull that is a result of excessive heat.

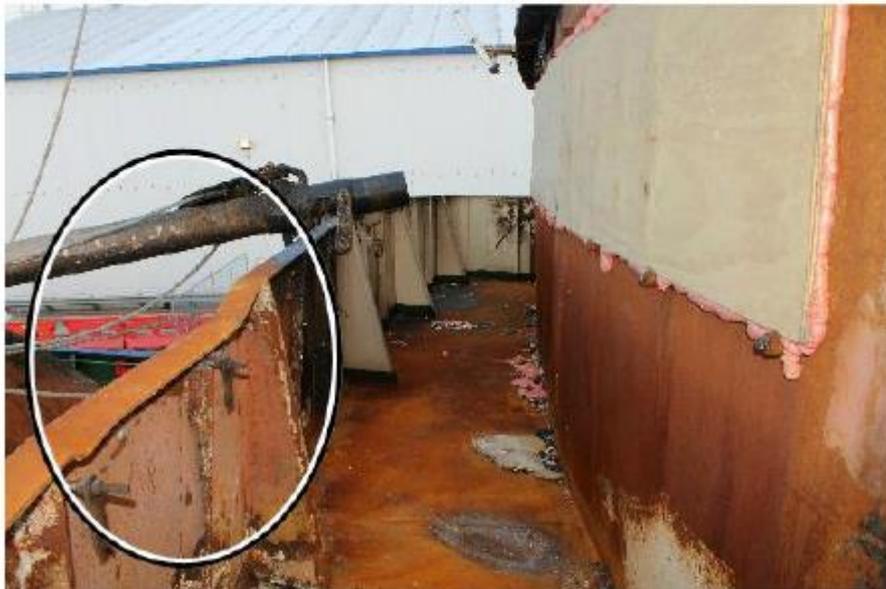
burning and oxidization of the steel around the windows at the front of the area to have less fire debris left on the port side compared with the starboard side. This aligned to the warping of the gunnel in front of the bridge. There was a large rectangle hole in the floor that had obviously been engineered into the floor. It was more to the port side of the area and was the ladder that provided access between levels. I did not identify anything in the debris that could have been a door or hatch to shut the ladder off from the lower level. (Refer photo 7). The rear starboard corner of the Bridge was less damaged than the rest of the area. I noticed parts of the wooden flooring were still in place along with timber framing that lined the steel structure and polystyrene that was used as cladding between the hardboard walls and the steel structure. (Refer to photo 8).

Photo 6: The circle indicates the warping of the gunnel in front of the bridge windows. Note: this is all on the port side of the bridge.

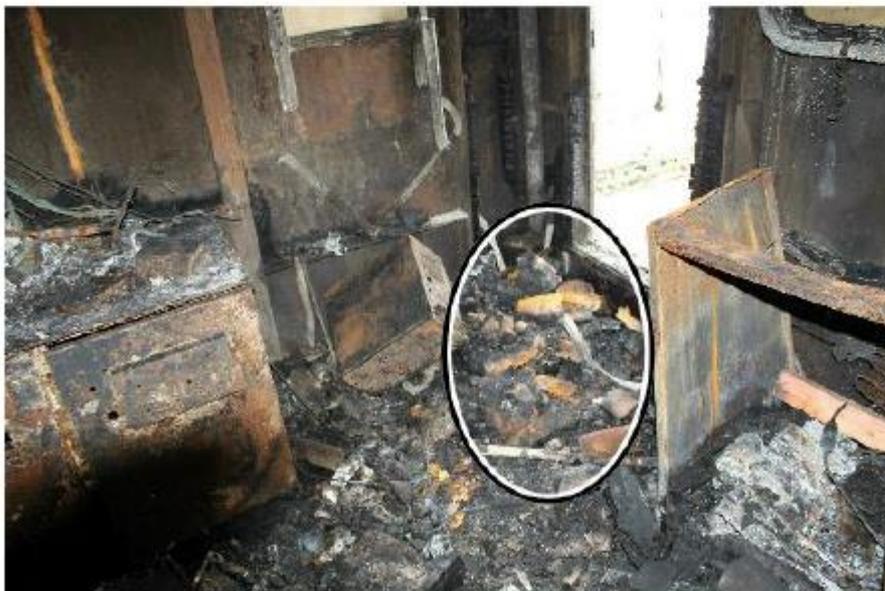
Photo 8: The circle shows the wall cladding and remaining floor at the rear entrance on the starboard side of the bridge.

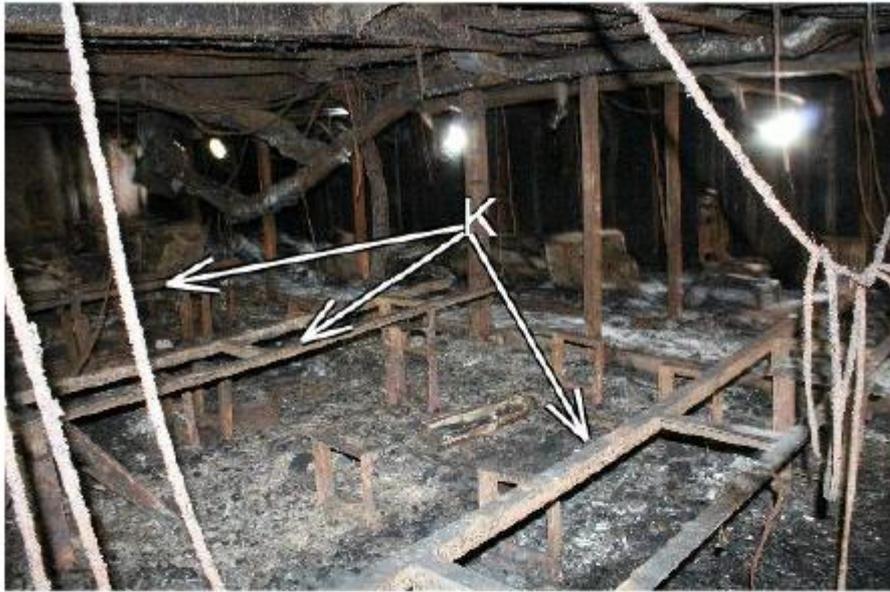
I entered this area through the galley door at the rear on the port side. I noticed a chair in the galley that was only partially burnt. Galley appliances such as a wok and deep fryer were also only partially damaged. I noticed the ceiling lining was hanging from the roof at the rear of the galley. I then inspected the dining area and found all wall, floor and ceiling linings were gone. The dining tables were steel frames. I could clearly make out the passageway due to the lack of debris and identified the steel plate that protruded vertically from the floor where the internal wall was fastened too. (Refer to photo 9).

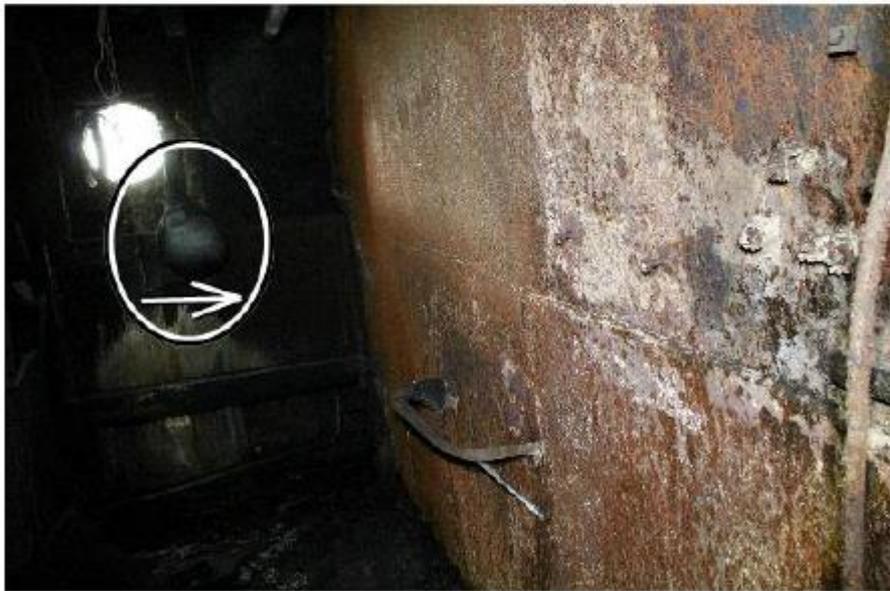
I inspected the two cabins on the port side as I moved toward the front of the ship. Both had similar damage with the exception of the forward-facing steel wall in the second cabin. This wall had been subjected to intense heat. This was indicated by the oxidization of a section of wall. The rest of the room still had the remains of wall linings attached to the walls. There was a cover hanging from the port hole that had moved toward the forward-facing wall due to this being the hottest area. (Refer to photo 10).

Photo 10: The circle identifies the cover over the port hole and the arrow shows the gravitation towards the heat.

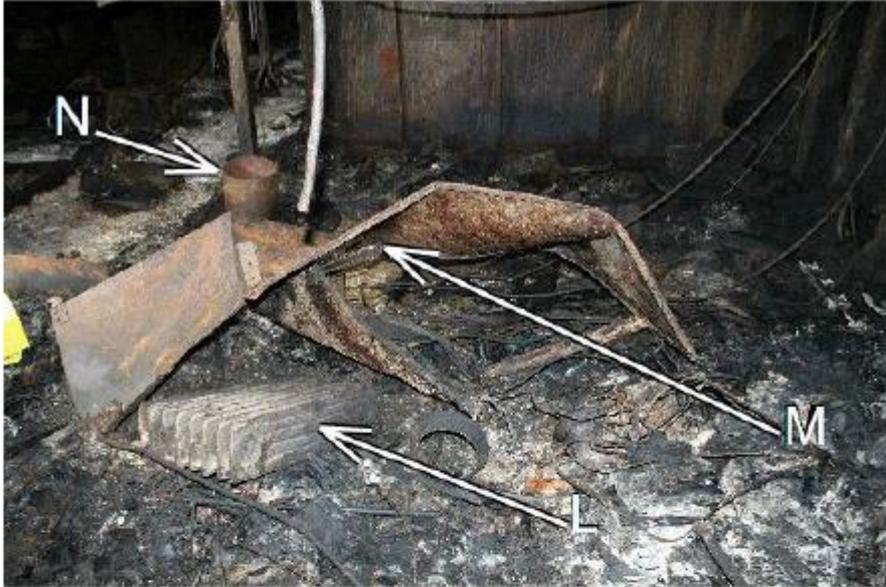
I returned to the First Engineer's cabin and examined the area. I found the remains of a fridge that had collapsed toward the starboard side of the room. Underneath this was an oil column heater. The fridge would have been positioned against the wall between the first engineer's cabin and cabin 1. (Refer photo 11). Working my way to the rear of the cabin from this point I identified a rubbish bin on the starboard side and the metal cover from an electric blower fan beside it. I noticed the steel plate that protruded vertically from the floor where the hardboard wall had warped extensively due to heat at this point. (Refer to photo 12).

Photo 11: Shows the first engineer's cabin looking to the rear of it. 'M' identifies the fridge. Note the way it has collapsed. 'L' identifies the oil column heater. 'N' identifies the rubbish bin.

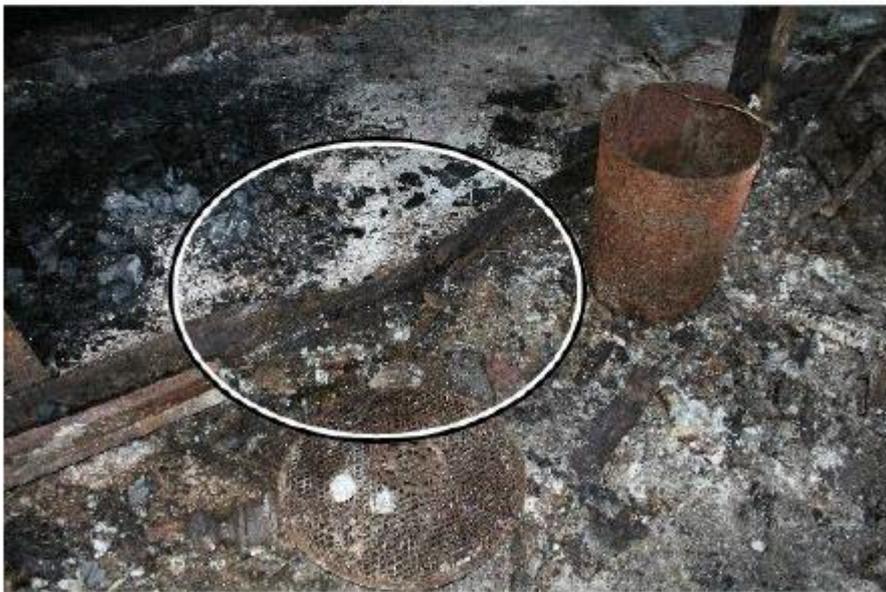
Photo 12: The circle shows the warped steel plate.

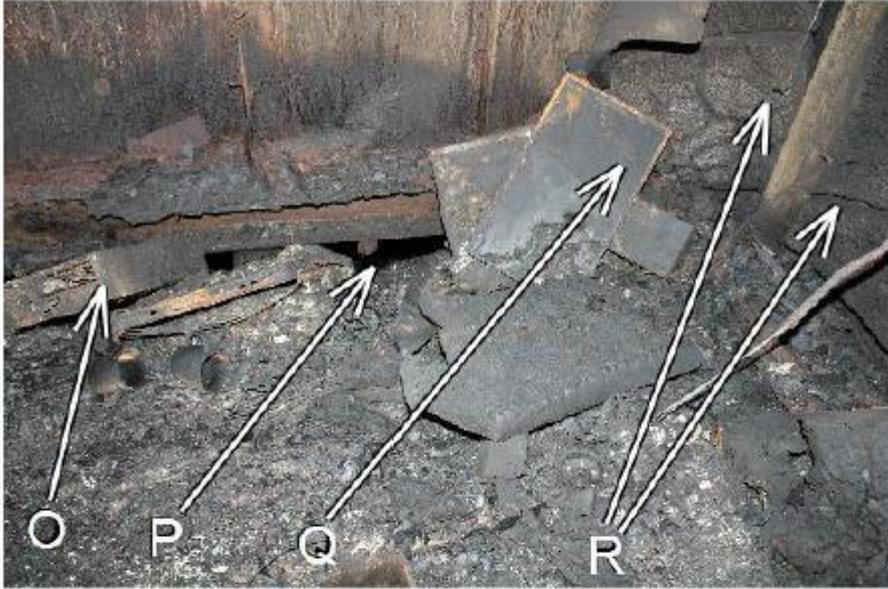
I moved to the rear of the cabin and found the remains of a computer, printer and monitor on the floor against the rear wall. I noticed a hole in the floor where it had separated from the wall. It was approximately two metres long and 150 mm wide at its widest point. (Refer photo 13). The bottom section of the wall and the floor that joined it were extremely rusted and corroded. I noticed there was polystyrene insulation along the port side wall and the burn patterns on the steel were not as pronounced as those on the rear wall and the roof.

Photo 13: 'O' identifies the computer. 'P' identifies the hole at the bottom of the rear wall. 'Q' identifies the computer monitor and 'R' shows the remaining cladding on the port side wall.

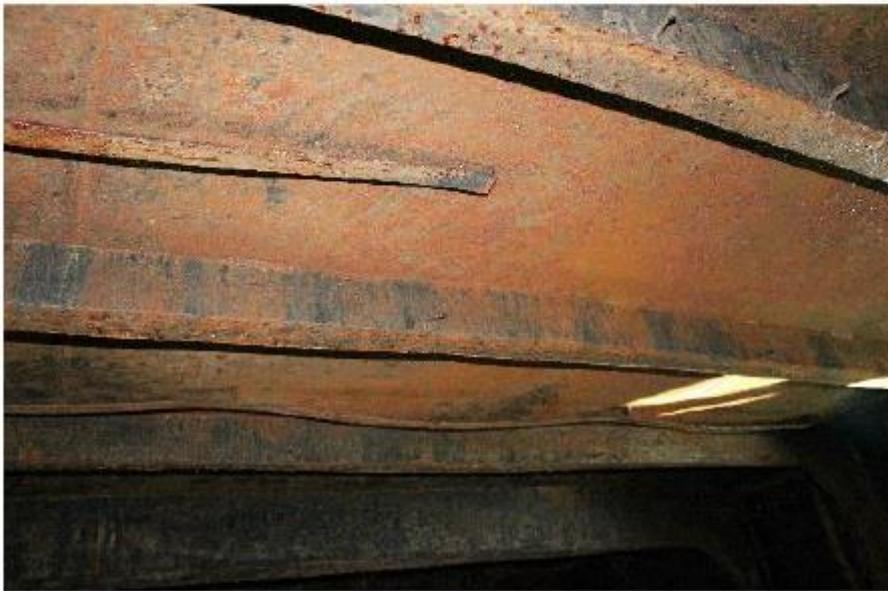
The burn patterns that showed the area that sustained the most intense heat were those on the ceiling. (Refer to photo 14). They were more intense in a strip across the cabin (port to starboard) in a line between the port hole and rubbish bin. I identified a number of green glass bottles on the floor against the port side wall. The tops of the bottles had distorted and were pointing toward the direction of the most heat. They were indicating across the cabin toward where the rubbish bin was positioned.

Photo 14: Shows the burn pattern on the ceiling in a line between the porthole and the rubbish bin.

The point of origin was considered to be at or just above floor level beside the rubbish bin. Indications of this were the burn patterns on the ceiling, the position of the of the fridge, the warping of the steel plate that had the cabin wall fastened to it and the witness statement that identified fire in the wall just above floor level.

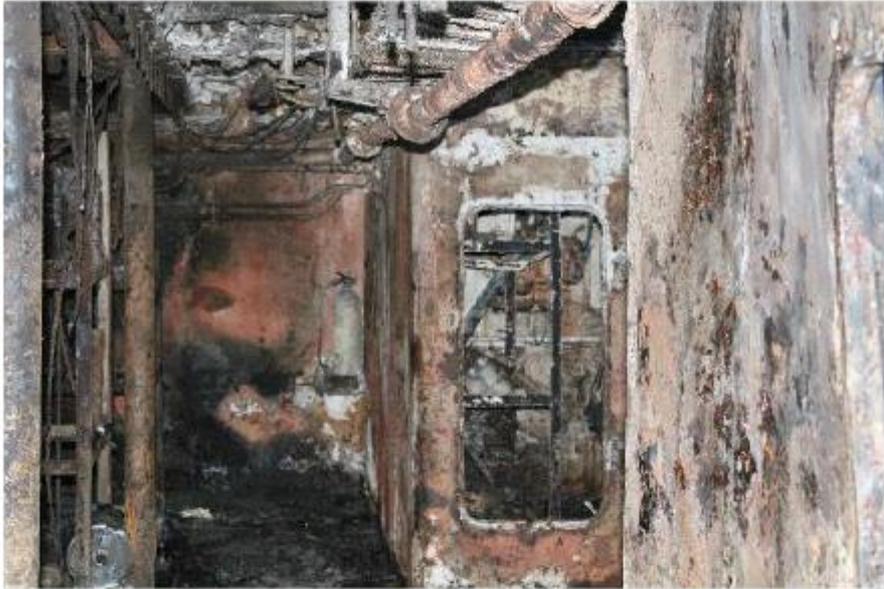
While the walls, floors and ceiling linings of the cabins in this area were destroyed there was clearly less fire intensity. Indicators that identified this were even burn patterns with no obvious fire travel indicators as found on other levels and a considerable amount of cladding and paint remaining on the walls. (Refer to photo 15).

Photo 15: Shows the remaining paint on the walls of the Seamen's Living Quarters.

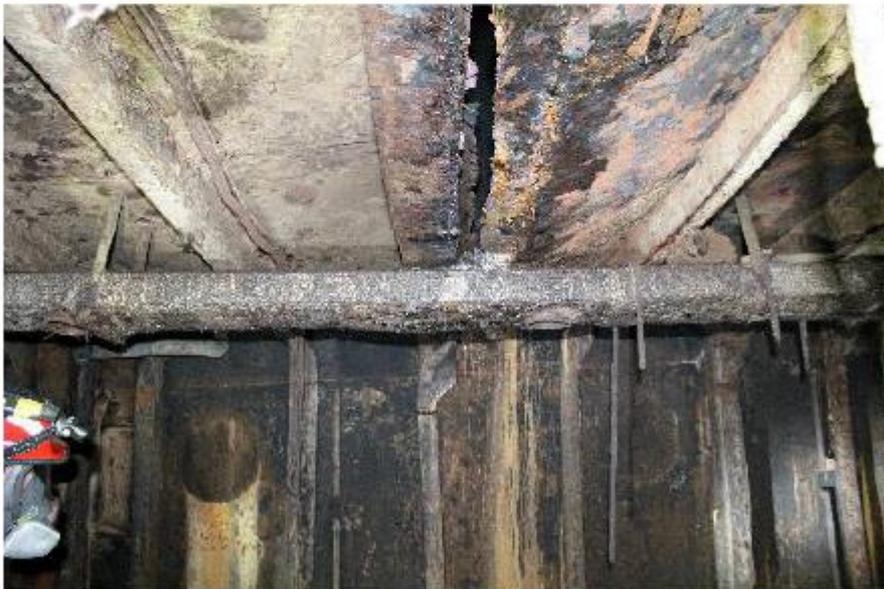
I examined the area below the First Engineer's cabin. While the ceiling below this cabin showed more indication it had sustained heating for longer than the rest of the area it was not to the degree of the patterns on the ceiling in the First Engineer's cabin. I then examined the separation in the ceiling. As above, in the First Engineer's cabin I observed excessive rust and corrosion. I did not consider this to show any indication of fire travel between levels. (Refer to photo 16).

Photo 16: Shows the corrosion around the separation between the wall and ceiling in the Seamen's Living Quarters.
