## **Cargo shift and damage to vehicles on ferry *European Causeway* North Channel, between Scotland and Northern Ireland 18 December 2018**

### **SUMMARY**

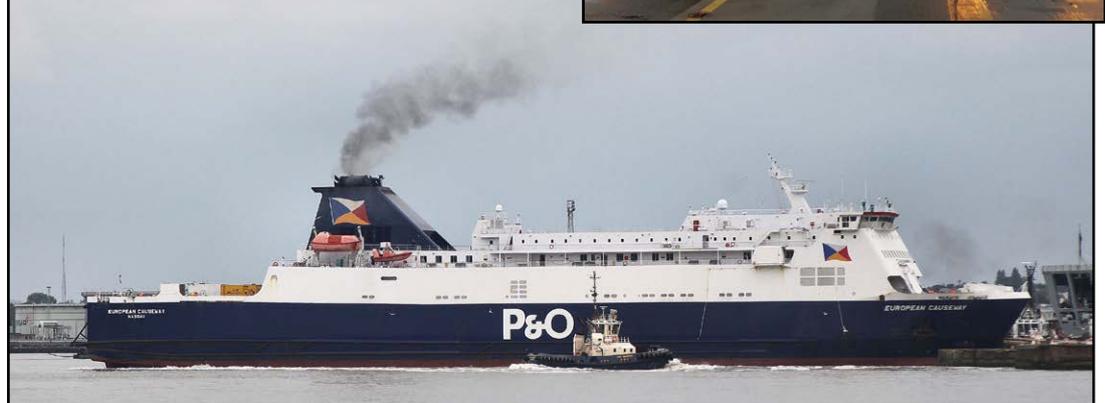
**Figure 1: *European Causeway***

At 0633 on Tuesday 18 December 2018, the roll-on/roll-off (ro-ro) passenger ferry *European Causeway* (Figure 1) rolled heavily in very rough seas and very high winds during its voyage from Larne, Northern Ireland to Cairnryan, Scotland. The violent motion caused several freight vehicles to shift and nine to topple over. This resulted in damage to 22 vehicles, some damaged severely (Figure 1 inset).

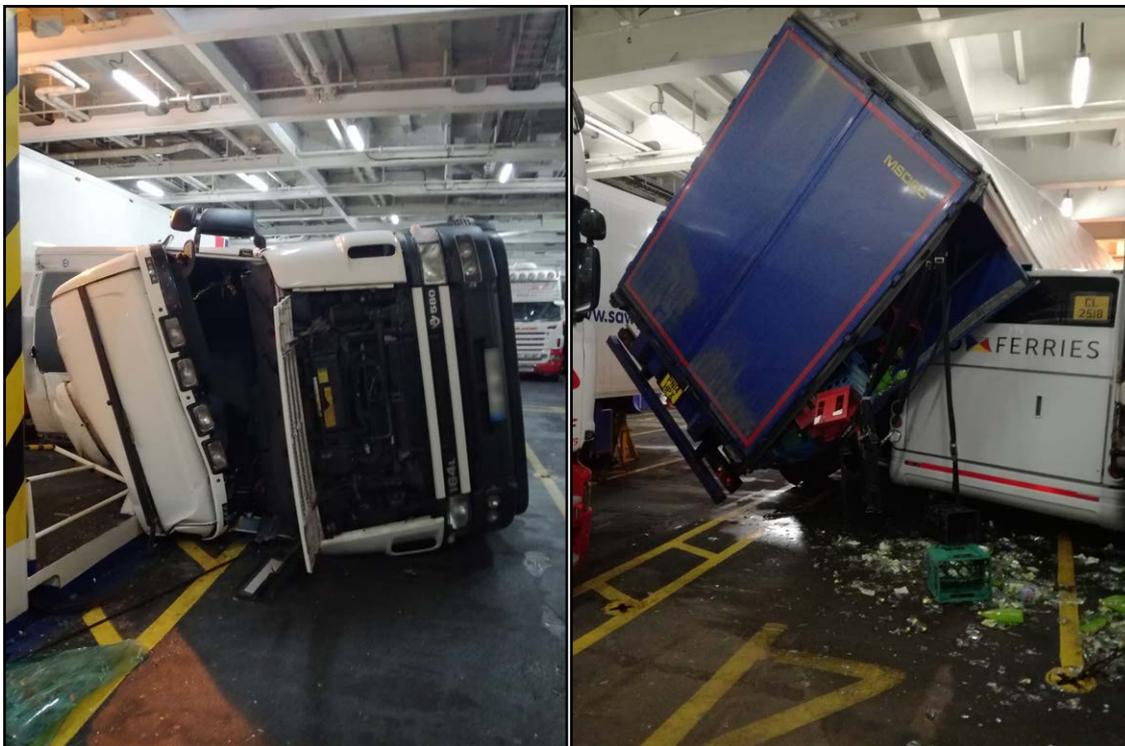
At 0629 the OOW altered course to starboard and brought the ship onto a course of 060°. About 4 minutes later, *European Causeway* rolled 20° to starboard, then yawed violently to starboard, achieving a rate of turn in excess of 100° per minute. The ship then took a larger roll to port of just over 30°. During the 30° roll several of the freight vehicles and unaccompanied semi-trailers on the vehicle decks moved and some toppled over (**Figure 2**). At the same time, unsecured objects on the bridge, in the master's cabin and around the ship, were thrown to the deck. In the engine room, a lubricating oil low level trip activated on one of the ship's four main engines, causing it to shut down.

**Figure 2:** Damaged vehicles

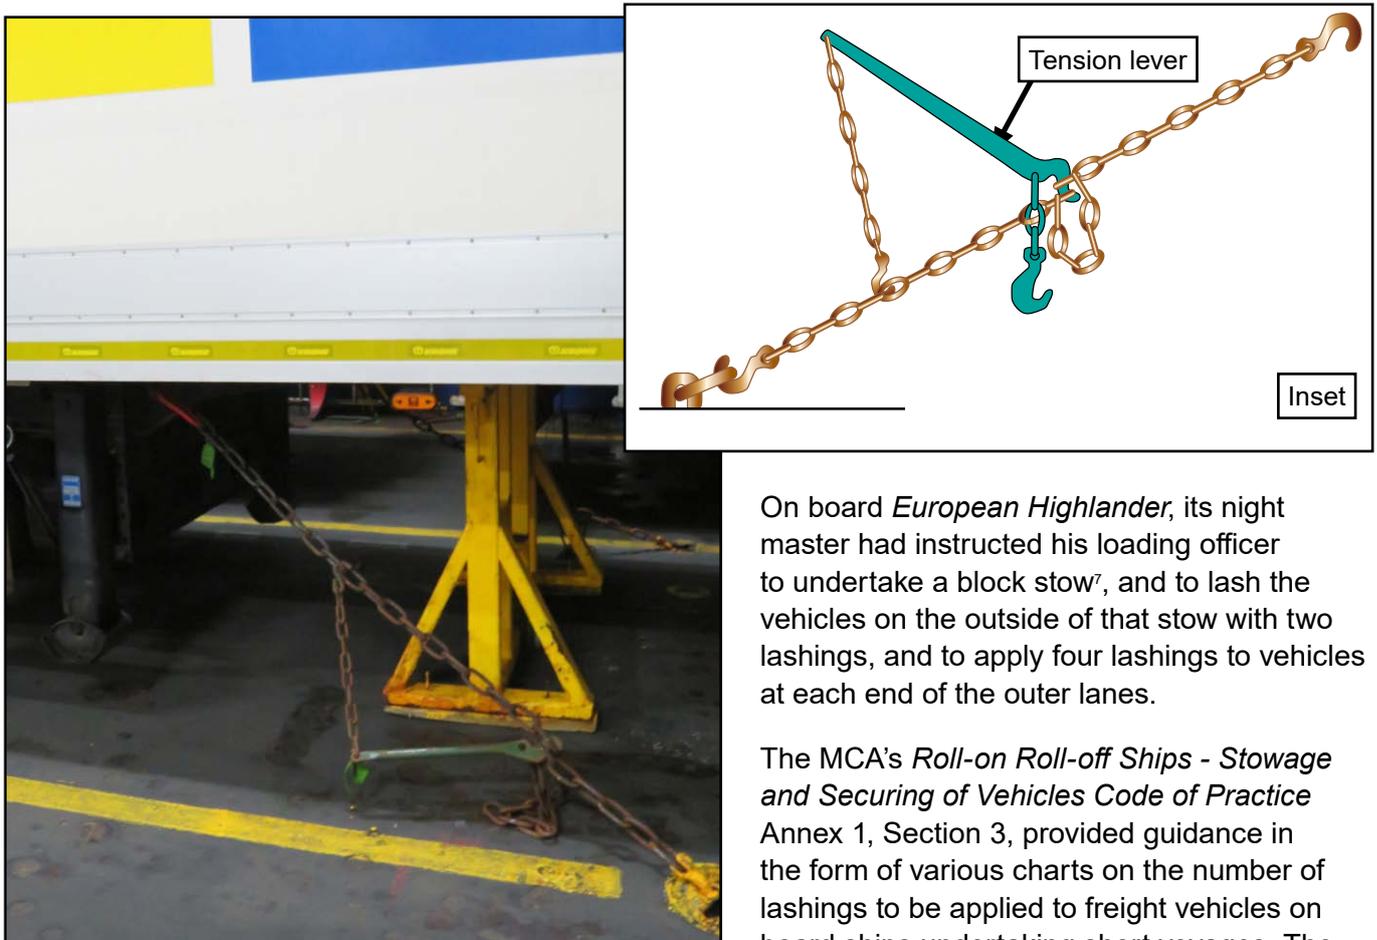
The lashings used on *European Causeway* were steel chain with a rated Safe Working Load of 10t and were connected to the vehicle by means of a tension lever system (**Figure 3**).

**Figure 3:** Lashing applied on board *European Causeway*  
(inset: Tension lever lashing system)

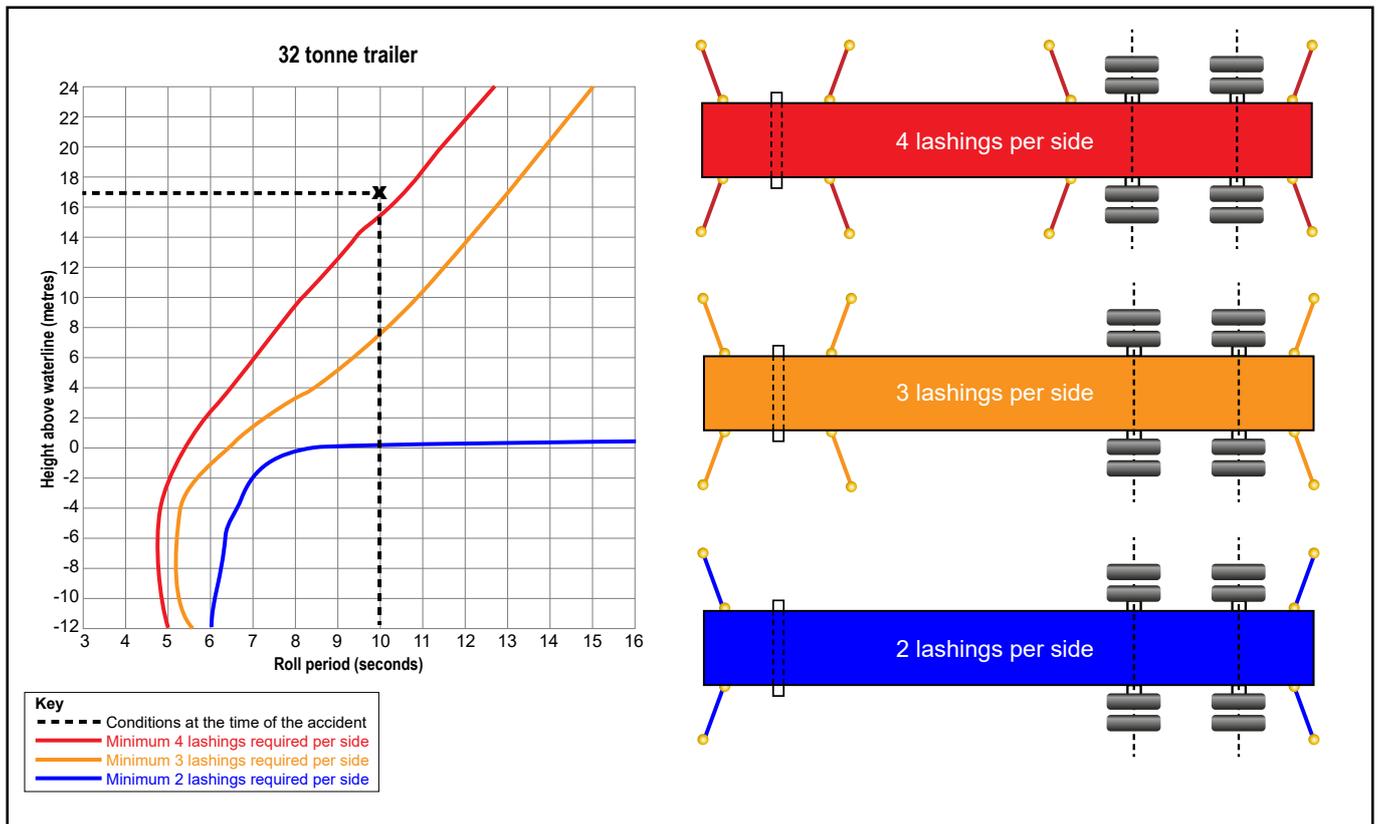
The MCA's *Roll-on Roll-off Ships - Stowage and Securing of Vehicles Code of Practice* Annex 1, Section 3, provided guidance in the form of various charts on the number of lashings to be applied to freight vehicles on board ships undertaking short voyages. The charts were based on a defined case of a ship undergoing a cyclic roll angle of 20° in combination with a pitch of 5° (**Figure 4**).

**Figure 4:** Illustration based on MCA's guide table

Most of the articulated freight vehicles had a semi-trailer weight of about 32t and were stowed on the upper deck, which was approximately 17m above the waterline. *European Causeway* was experiencing a roll period of approximately 10 seconds. The MCA guide table indicated that these should have been lashed with four lashings per side, i.e. eight lashings in total.
