# WORLD BORA & RABA

Marine accident report on collision

19 FEBRUARY 2019

**MARINE ACCIDENT REPORT ON COLLISION WITH  
WORLD BORA AND RABA ON 19 FEBRUARY 2019**

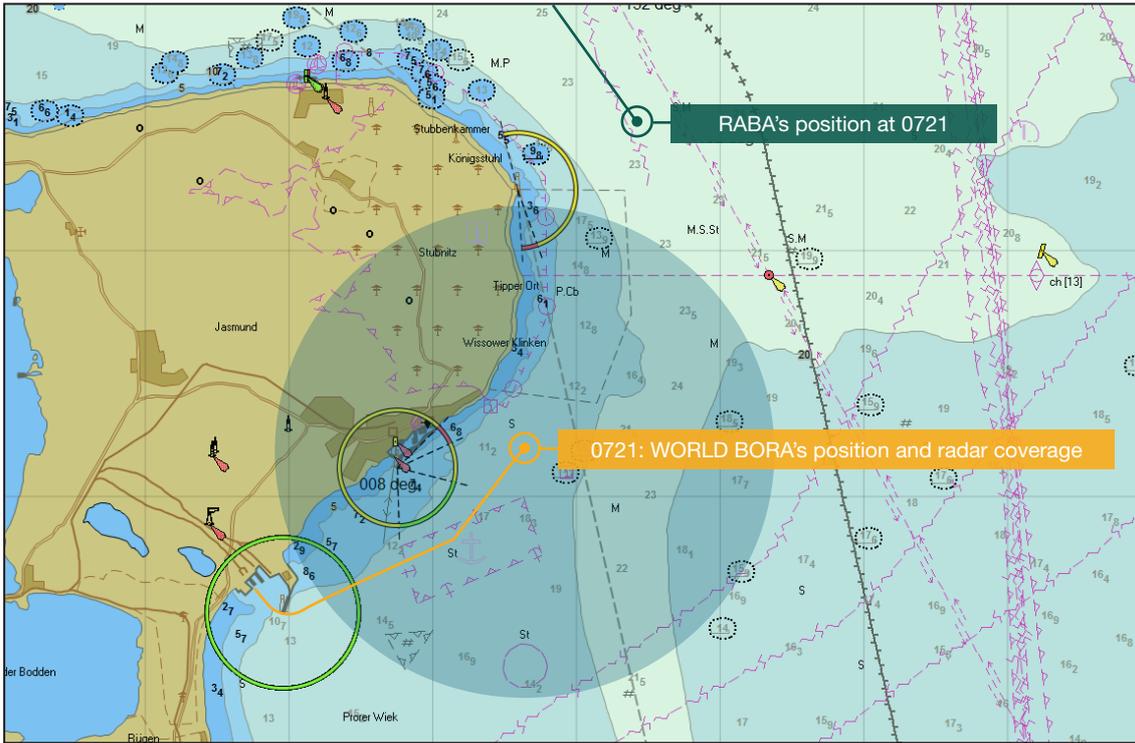
15 minutes after WORLD BORA's departure from Mukran at 0701 am, the chief officer left the bridge, and the master was alone navigating the ship and keeping lookout. At 0719 am, the master made a course alteration, looked at the radar and did not identify any object which posed a risk of collision. WORLD BORA was still situated close to shore, and the radar was therefore set to a radius of 3 nm. Based on an analysis of the sequence of events, a conservative estimate for when the master could have looked at the radar before the collision was 0721 am. At 0721 am, RABA was at a distance greater than 3 nm and hence was not within WORLD BORA's radar coverage (figure 6, next page).

Figure 6: RABA outside WORLD BORA's radar coverage at 0721 am.  
 Source: © Made Smart Group BV 2019; © C-map Norway AS 2019/DMAIB

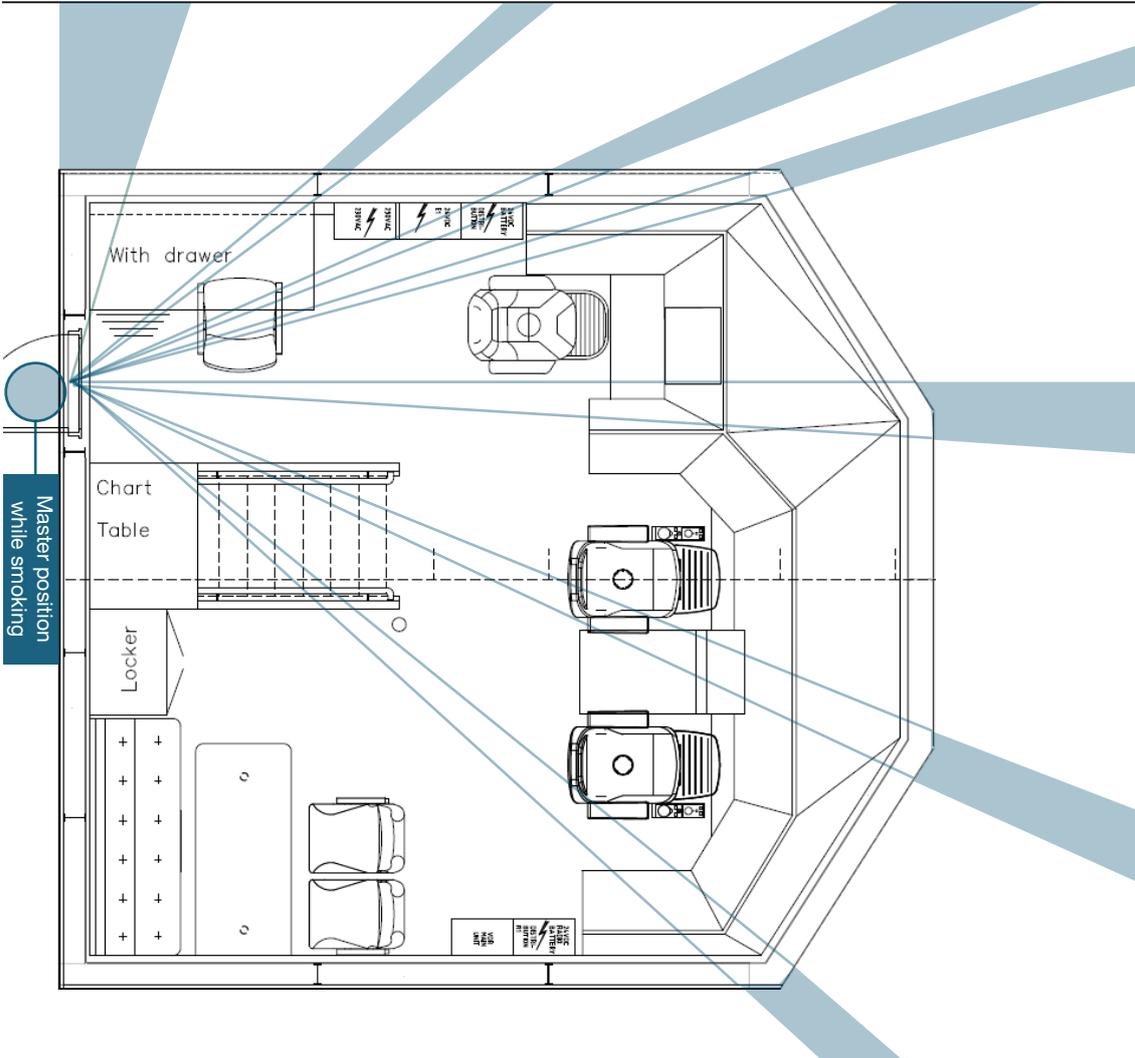
However, from the master's stationary position by the door, RABA could remain hidden behind a window bar (figure 7, next page).

Figure 7: Blind angles on the bridge from the master's stationary position while he was smoking.  
 Source: World Marine Offshore/DMAIB

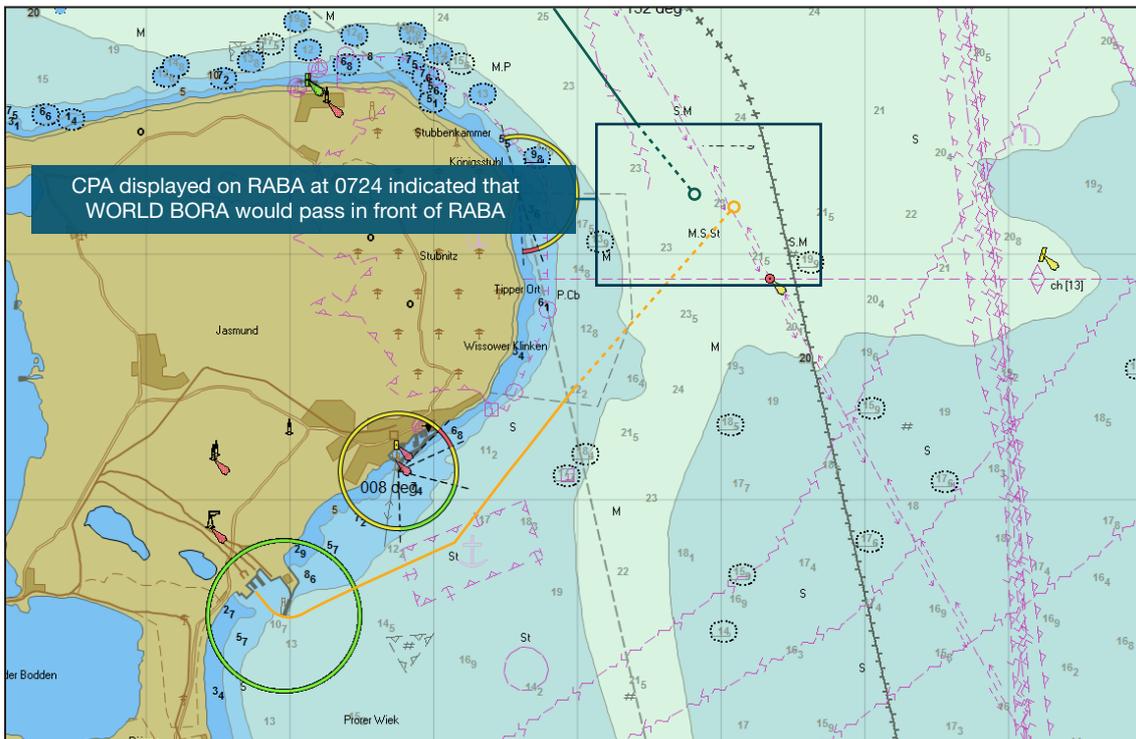
On RABA, the master identified WORLD BORA on the radar at 0724 am with a CPA of 0.6 nm. According to the CPA, WORLD BORA would pass in front of RABA and hence the master did not consider RABA to be on collision course with WORLD BORA (figure 9).

Figure 9: CPA of 0.6 nm displayed at 0724 (reconstruction).  
 Source: © Made Smart Group BV 2019; © C-map Norway AS 2019 /DMAIB

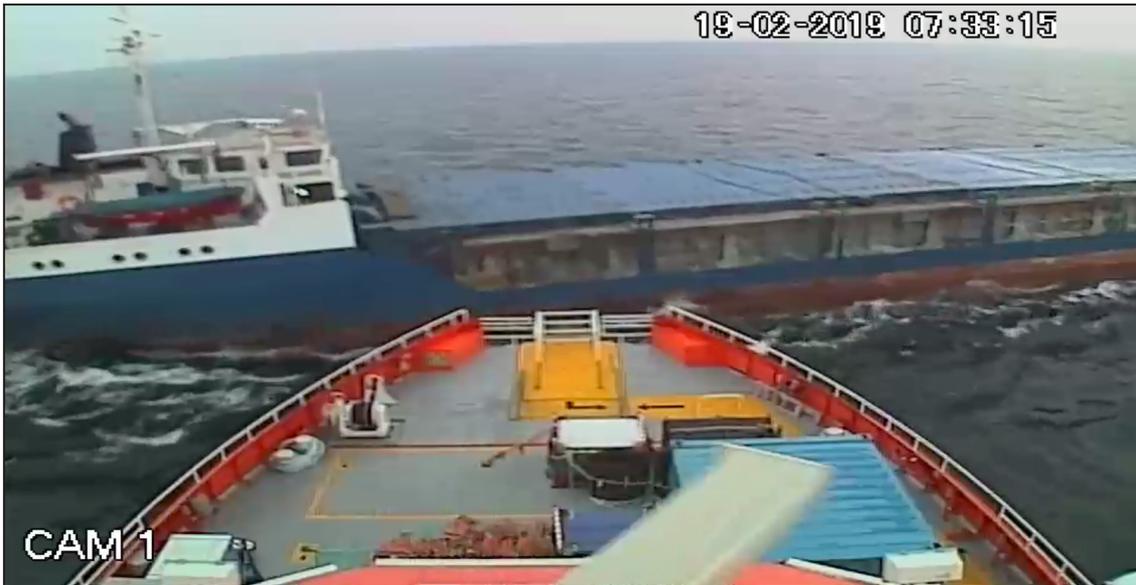
Figure 12: Angle of impact seen from WORLD BORA.  
Source: World Offshore Marine

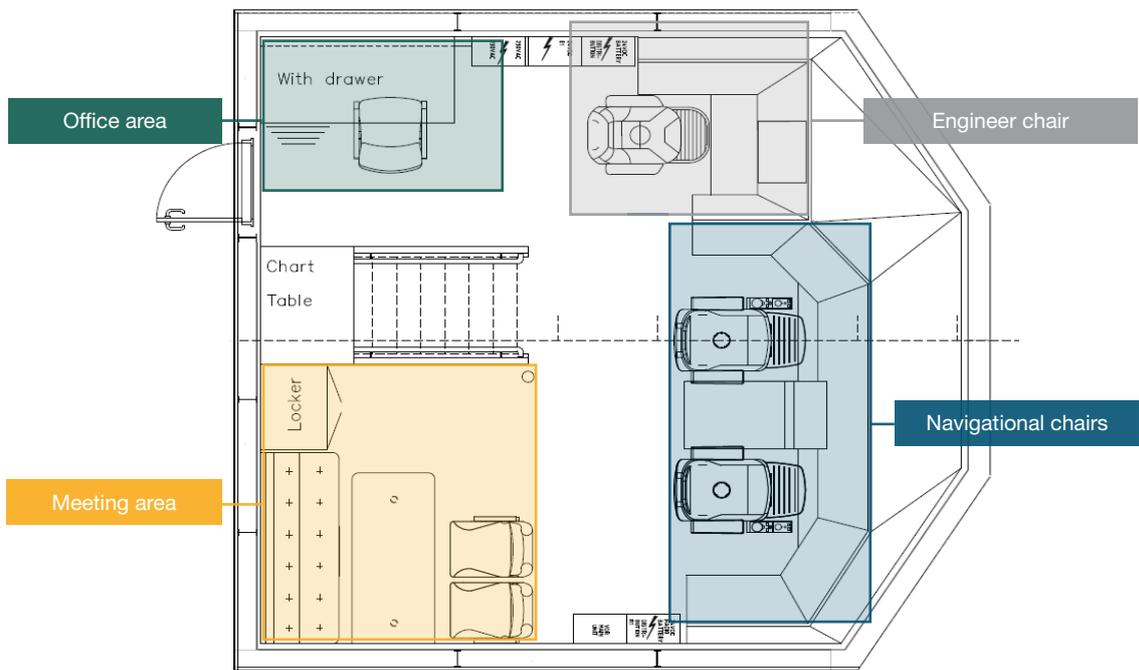
Figure 14: Bridge layout on WORLD BORA.  
Source: World Marine Offshore/DMAIB

The bridge layout on WORLD BORA comprised an office area, telephone and a meeting area. This layout introduced the possibility for distractions and encouraged the bridge crew to take on work other than navigation during the voyage. In this respect, the bridge was not sanitised from disturbances as prescribed in the HSC requirements to the operating compartment.

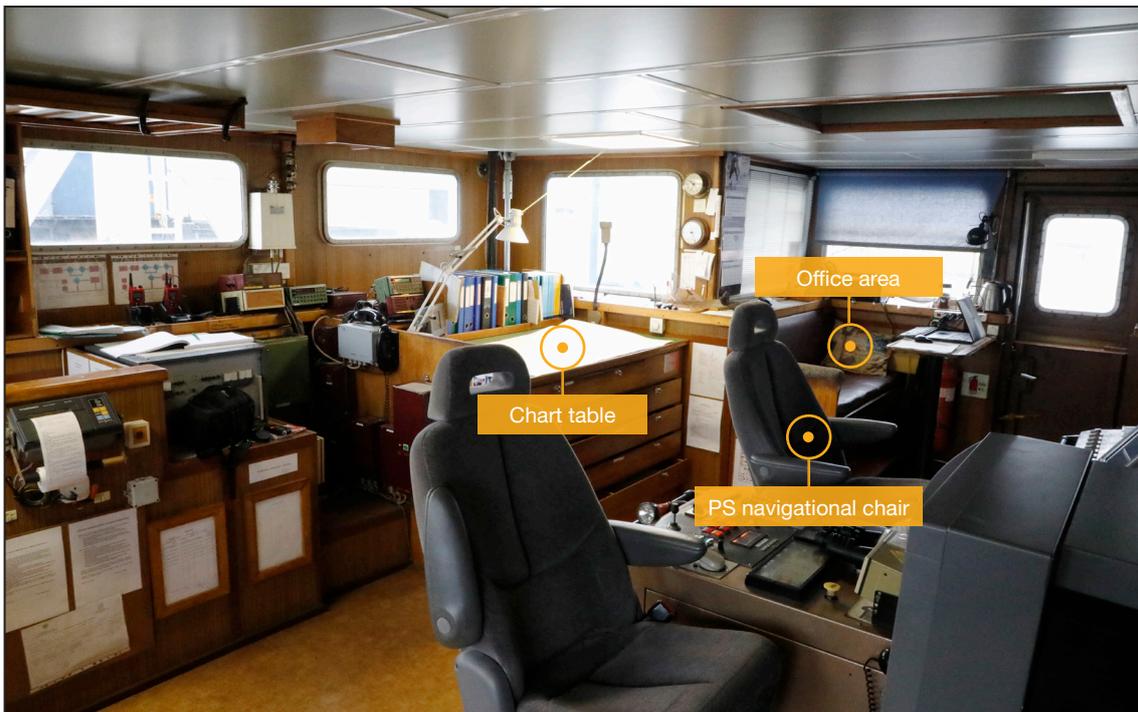
Figure 15: Bridge on RABA  
Source: DMAIB

- The chart table, which was the only available working table on the bridge, was positioned in such a way that the navigational officer faced aft and was not be able to monitor the oncoming traffic while working at the table. The table was used for plotting the ship's position, making entries into the logbook and doing various paper work.

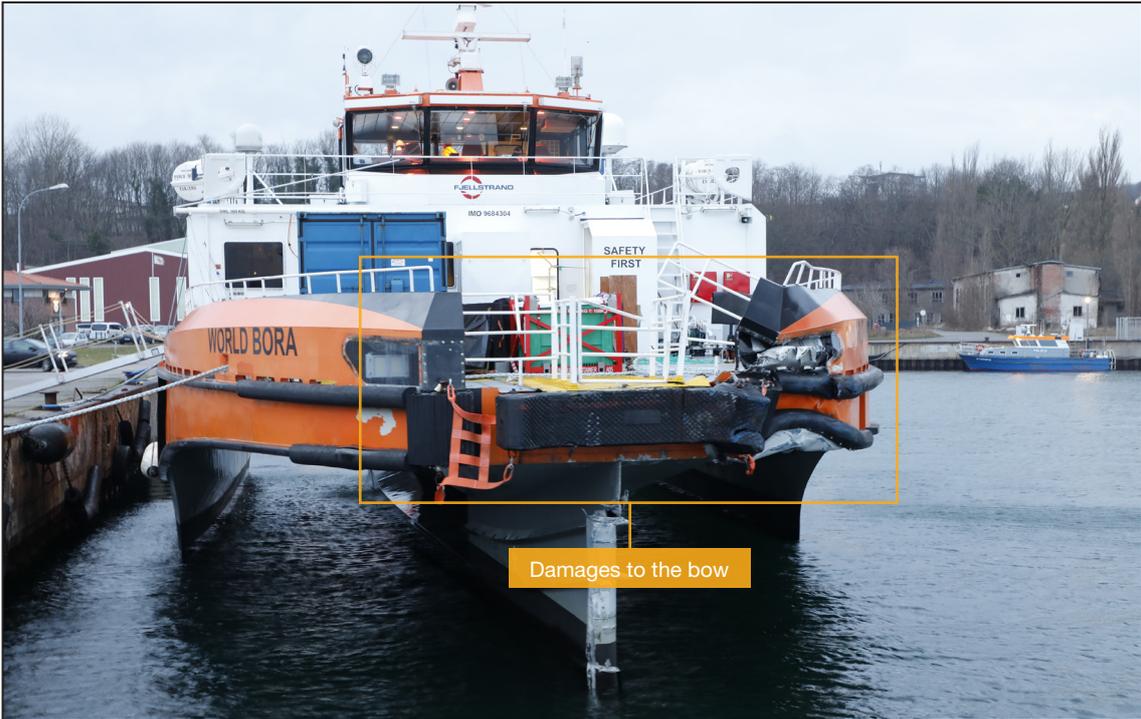
The structural damage to WORLD BORA's hull was limited, as the hydraulic soft bow absorbed the impact energy (figure 15). However, this absorption led to an abrupt and forceful de-acceleration from approx. 18 knots to a halt in less than 0.5 meters. The de-acceleration caused loose objects to be tossed about at high speed, while fastened objects were deformed and torn from the bulkhead, and fixtures dislocated.

Figure 15: Damages to the bow  
Source: DMAIB

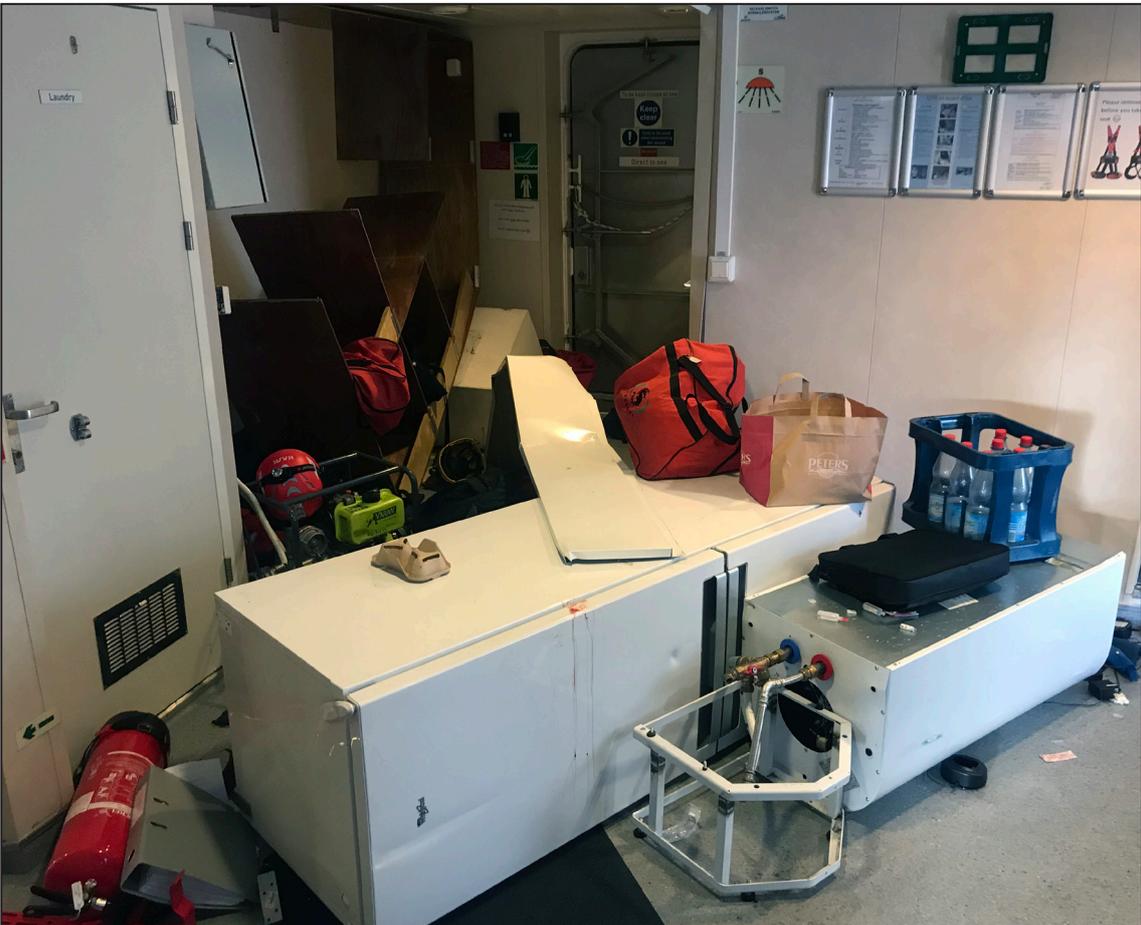
Both crew members and industrial personnel suffered secondary impact traumas such as spinal fractures, broken legs and head injuries. Three crew members suffered the most severe injuries. They were engaged in various activities on the ship, such as working in the engine room or preparing food in the galley, and were therefore not sitting in the seats wearing seat belts designed for collision impact. The industrial personnel suffered head injuries from impacting with the back of the chair in front or the window board. Some suffered injuries to the legs, because they sat by the emergency exit and were hurled a greater distance towards the front seat.

Figure 16: Damage to WORLD BORA's interior  
Source: DMAIB

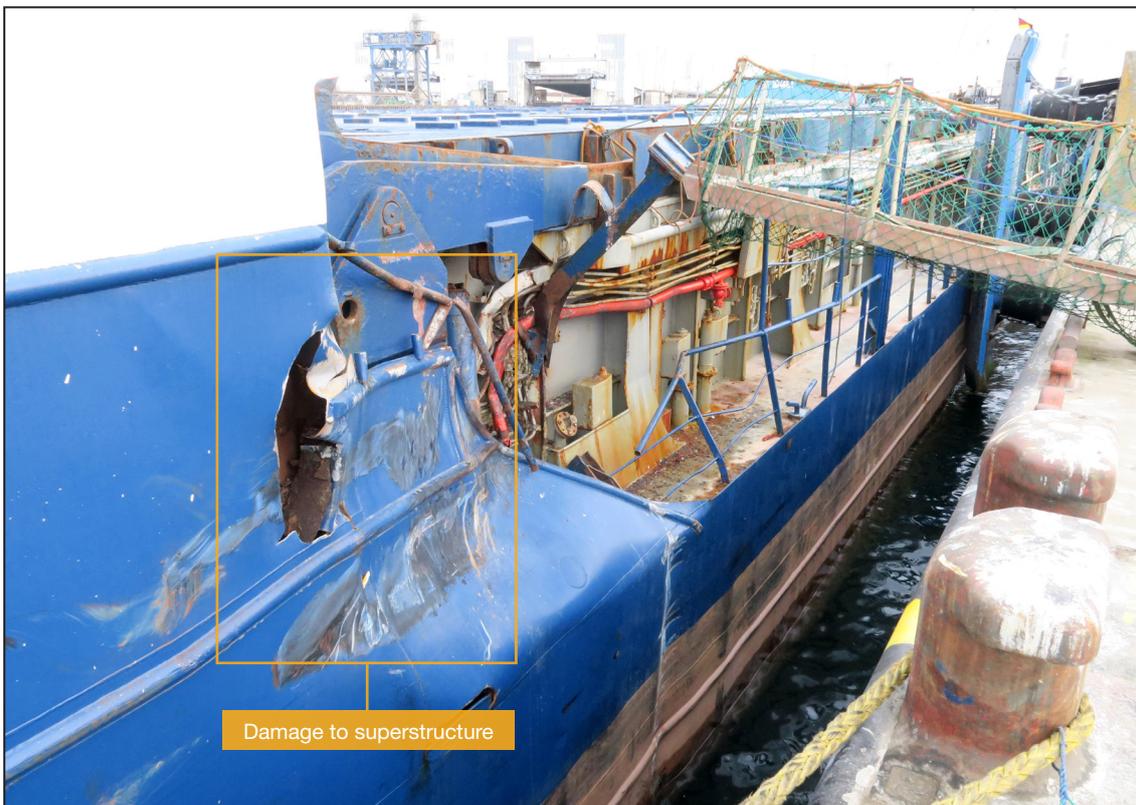
RABA suffered minor structural damages to the starboard quarter, which resulted in indentations on the shell plating in the area of the bulwark and the cargo hold. The impact also crushed and damaged several cables that ran along the coaming. In addition, a column used as a platform when stowing containers buckled, and the thrust bearing of a hydraulic cylinder was torn off.

Figure 17: Damages on RABA
