National Transportation Safety Board

Marine Accident Brief

Flooding and Sinking of Towing Vessel *Tom Bussler*

Accident type	Flooding	No. DCA19FM013
Vessel name	<i>Tom Bussler</i>	
Location	Tennessee River, mile 15, near Calvert City, Kentucky 37°03.62' N, 088°22.63' W	
Date	January 7, 2019	
Time	2030 central standard time (coordinated universal time – 6 hours)	
Injuries	2 minor	
Property damage	\$297,368 est.	
Environmental damage	Approx. 25 gallons diesel released and oil sheen on water	
Weather	Visibility 10 miles, cloudy skies, winds southwest 5 knots, gusts 10 knots; air temperature 60°F, water temperature about 45°F, sunset 1653, evening twilight ended 1721	
Waterway information	The Tennessee River at mile 21.1 (near the Interstate 24 bridge) was at watch phase with a strong current of +4.6 miles per hour (mph). The channel had a depth about 41.5 feet.

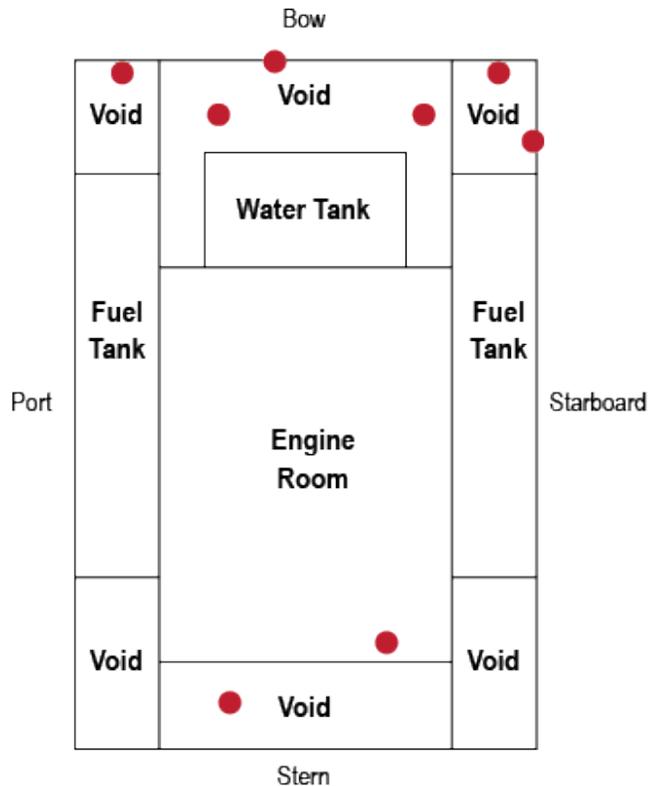
On January 19 the vessel was drydocked, and a marine surveyor inspected the vessel for damages and noted several fractures at multiple points in the hull that appeared to "pre-exist the incident." The upper 12 inches of the port bow corner plating contained an approximate total of 30 inches of fractures, and the starboard bow corner plating contained an 18-inch fracture, all open to a width of 0.25 inch. On the inboard sides of both the port and starboard towknees, the forward extreme of the bow deck plating of each contained a 12-inch transfer fracture open to 0.25 inch. There were also fractures at the base of the headlog plating just starboard of centerline, in the hull bottom plating at a point adjacent to the inboard side of the starboard inboard fair water angle, and in the hull bottom plating inboard from the inboard leg of the port strut. The surveyor also noted that "the lower [5 feet] of the shredded tire bumper on the starboard towknee was adrift and partially missing." The estimated cost to repair the vessel was \$297,368, and the company decided to scrap the vessel.

Both the captain and deckhand stated that the bow centerline void had a pre-existing crack slightly above the waterline. The vessel was equipped with two portable sump pumps: one was placed at the bow to dewater the forward voids, and a second pump was placed on the stern to dewater the aft voids. Three voids (centerline forward, port stern and starboard stern) were pumped out daily. Both electric pumps were capable of pumping 43 gallons per minute. They were operated by placing them through a main deck hatch to the void.

Simplified layout of the *Tom Bussler's* voids and fuel tanks. Pre-existing damage is marked with red circles.

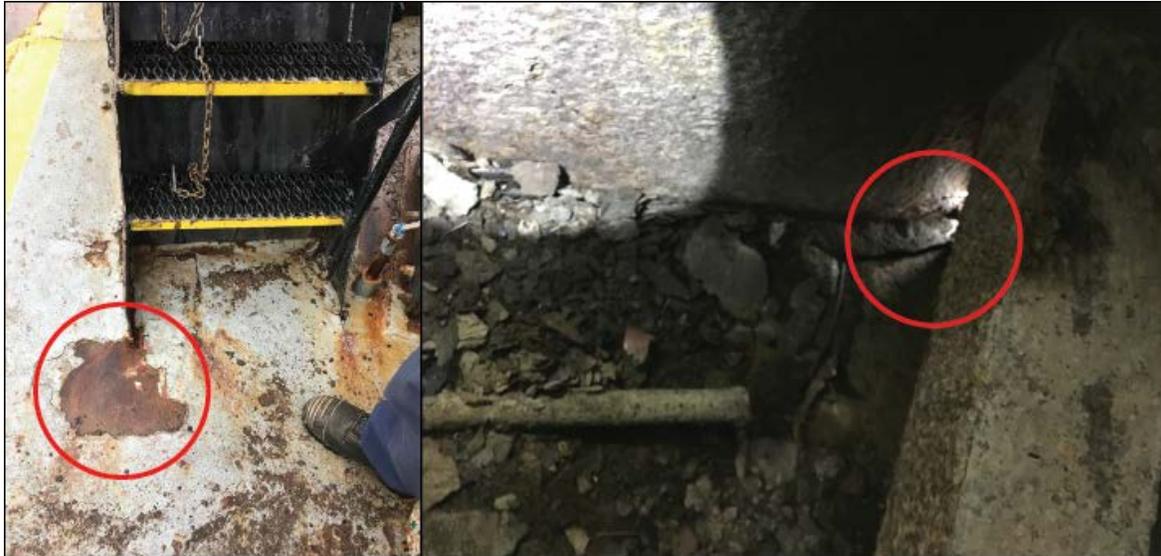
Pre-existing damage on the *Tom Bussler*. Left: severely corroded deck on the bow inboard of the port towknee. Right: corroded hole in the hull from within the bow void.

Based on the numerous cracks in the *Tom Bussler*'s hull found during the postaccident survey, and the documented reports from the crew of water leaking into voids, investigators attempted to determine how long the watertight integrity issues had existed and what actions, if any, had been taken to mitigate them. The vessel had last been drydocked in January 2018, about a year before the accident. No hull repairs related to watertight integrity were scheduled or completed. Throughout 2018, multiple issues with the hull were reported by crewmembers. However, attempts to find the leaks were unsuccessful, and the reported issues were not resolved. Instead, portable pumps were used to control the water ingress. The postaccident survey showed seven pre-existing hull fractures that compromised the integrity of the bow voids, the centerline aft void, and the engine room.

Intermittent flooding of the bow voids likely began as water from the bow wave entered fractures in the forward part of the hull. As the vessel's forward draft increased (from the flooding), fractures in the hull near the bow were submerged, allowing water to enter into the voids at a higher rate. Additionally, water that went over the bow and onto the main deck flooded the bow voids through fractures and leaking hatches, until the vessel lost stability, capsized, and sank, bow first.

The National Transportation Safety Board determines that the probable cause of the flooding and sinking of the tugboat *Tom Bussler* was the company's lack of an effective hull maintenance and repair program, which resulted in flooding into the bow voids and engine room through fractures in the hull.

To protect vessels and the environment, it is good marine practice for owners to conduct regular oversight and maintenance of hulls, including between drydock periods. Regardless of inspection requirements, owners are obligated to ensure vessels are properly maintained, equipped, and operated in a safe condition. Issues with watertight integrity and wastage should be addressed immediately.
