Report on the investigation of
the collision between the ro-ro passenger ferry

Red Falcon

Greylag

in Cowes Harbour, Isle of Wight

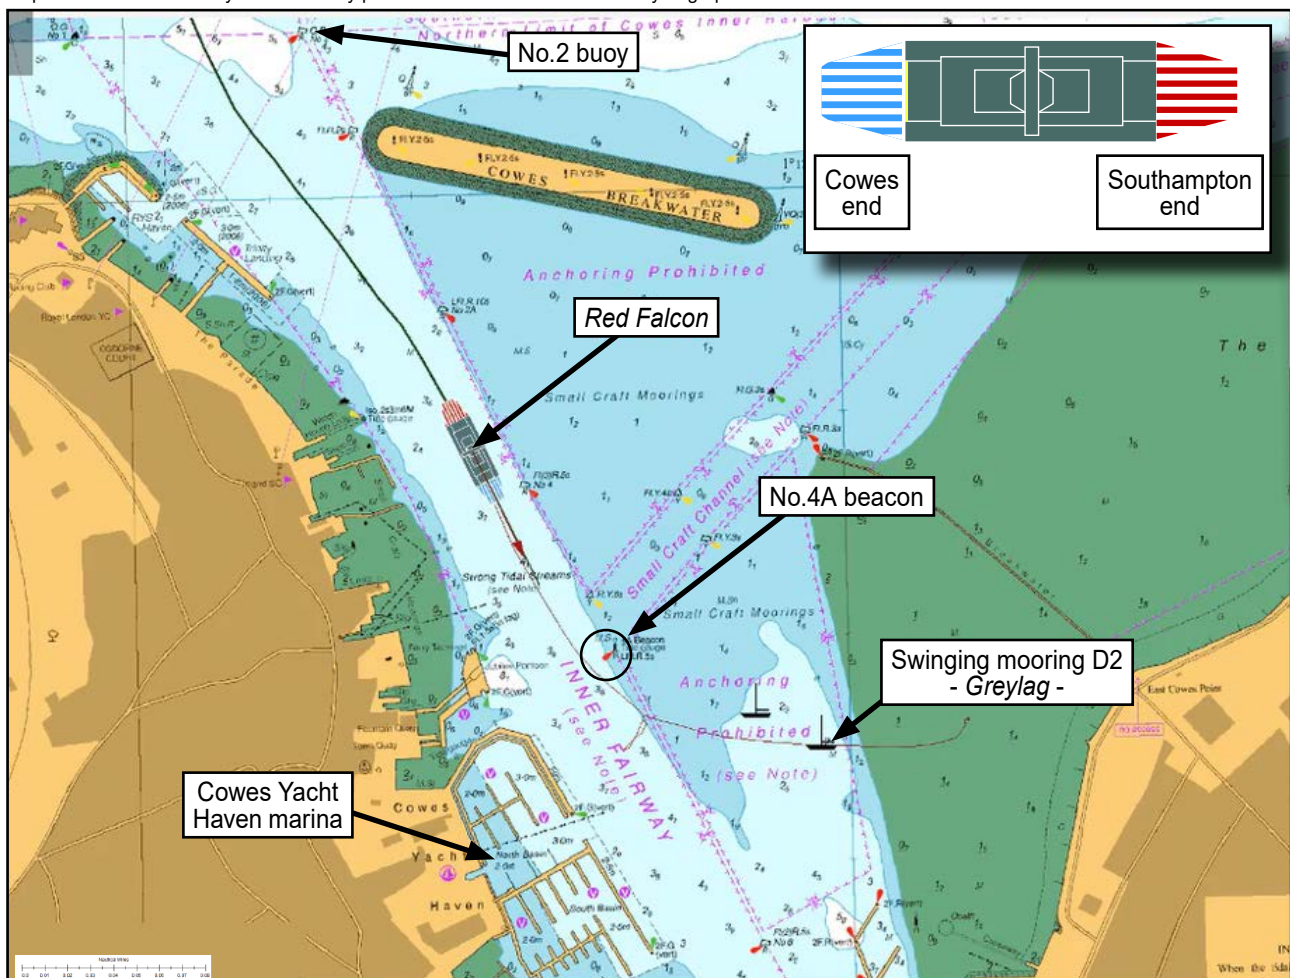
Figure 4: Red Falcon passage track into Cowes Harbour

In anticipation of a small east to west cross-stream near to the inner fairway's No.4 buoy, the master ordered a course to steer that took the ferry to the east of the channel centre line, close to the port hand channel buoys. At 0807, as *Red Falcon* approached No.4 buoy, the deck lookout called the bridge on his hand-held Ultra High Frequency (UHF) radio and reported that the vessel was close to the buoy (**Figure 4**), and that it needed to be brought to starboard.

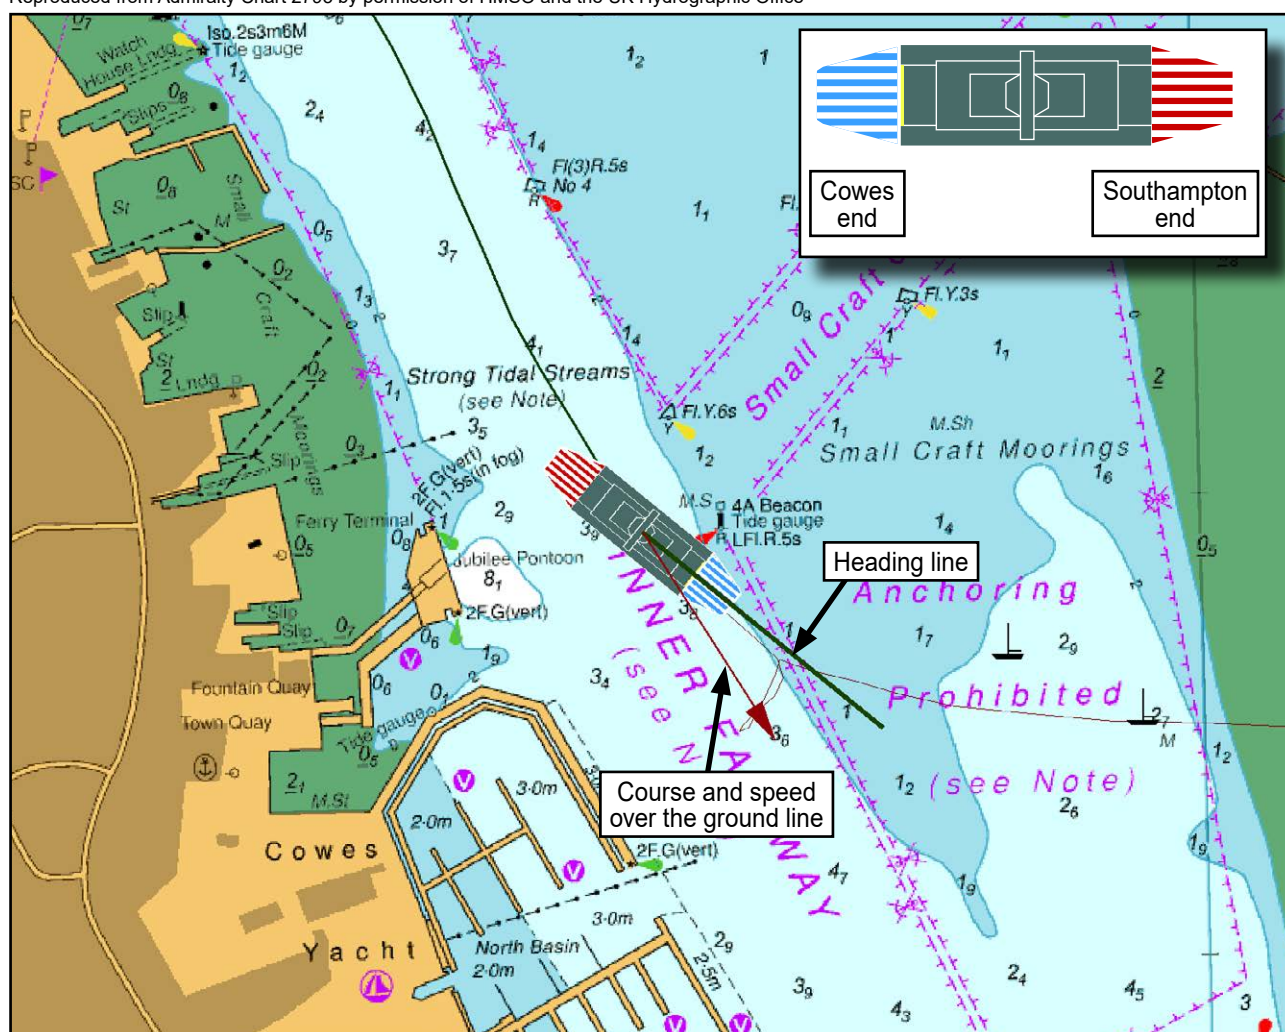
Figure 6: Red Falcon starting to swing out of the channel

The master managed to arrest the vessel's swing briefly but, at 0808:30, *Red Falcon* started to swing to port once again as it passed close to No.4a beacon (**Figure 6**). The master attempted to stop the vessel's swing, but as the Cowes end of the ferry left the inner fairway to the east, just missing the No.4a beacon, the Southampton end spun round quickly. At this point the visibility closed in even further and the bridge team were no longer able to visually identify the shoreline or navigation marks. The C/O continued to provide the master with his own observations and updates from the deck lookout.

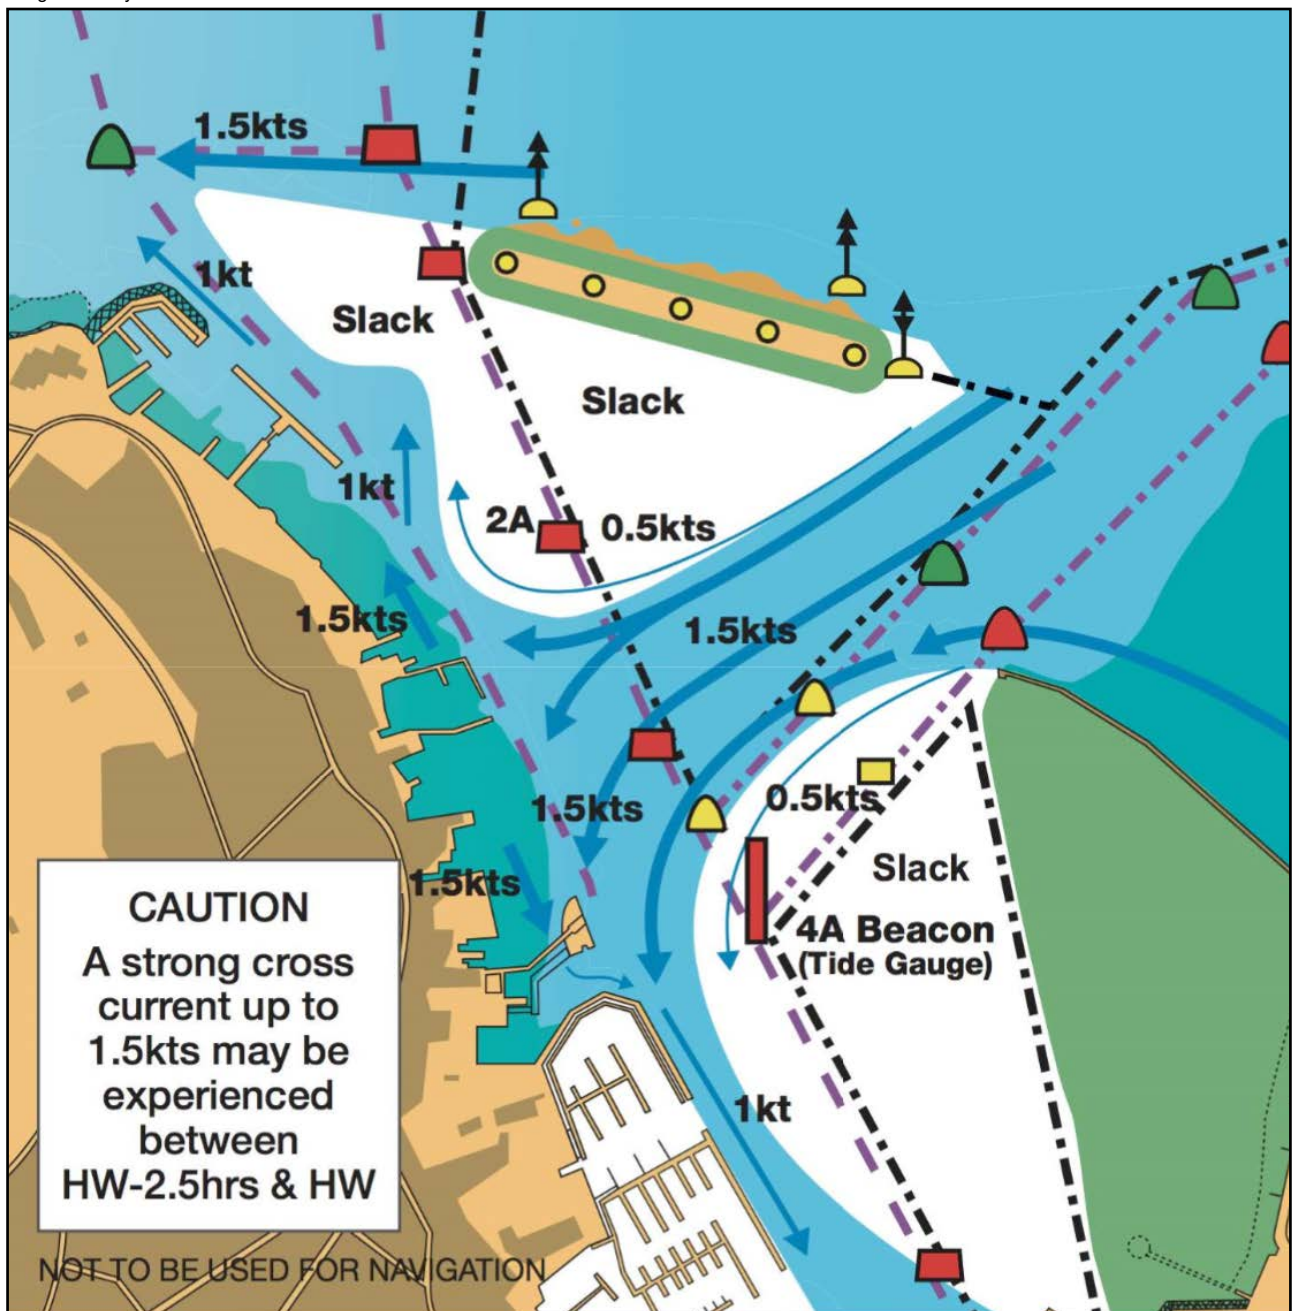
Figure 11: Current flow in Cowes Harbour

At the start of the buoyed channel, into Cowes Harbour, the tidal stream flows toward the east until about 2½ hours before high water, when it changes rapidly to flow to the west. During the 2½ hour period before high water the flood tide into Cowes Harbour and the Medina river flows from east to west in way of the small boat channel, and across into the main channel, where it splits, with the main flow into the Medina (**Figure 11**). The effects of the cross-currents are more apparent during spring tides.

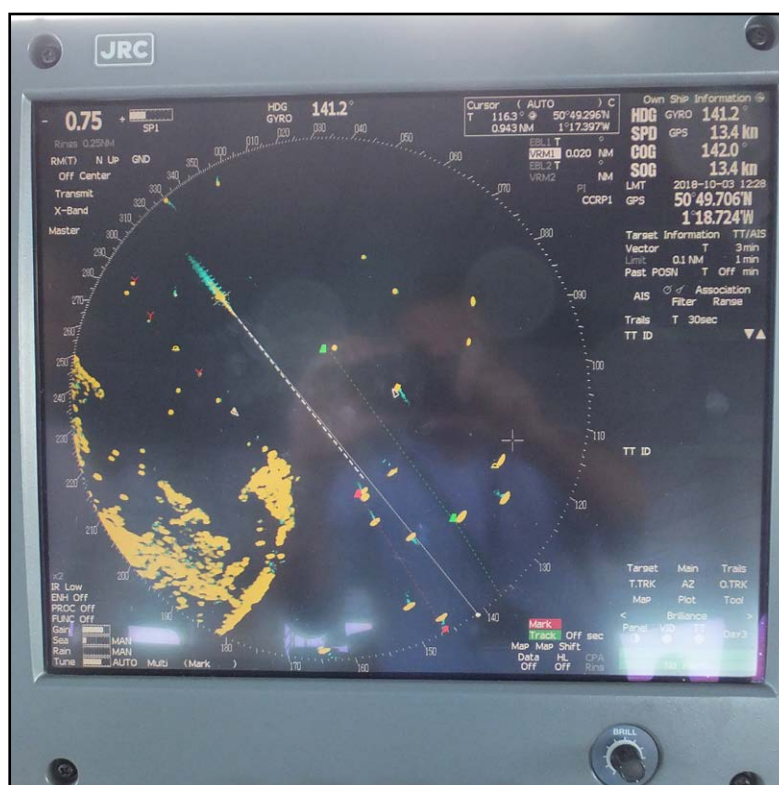
Figure 15: Radar picture offset (approaching Calshot Spit, not in Cowes Harbour)

On the passage to Cowes, the aft radar display operated by the C/O was offset to the north-west. Just before *Red Falcon* entered Cowes, the C/O reduced the range scale in use from 1.5 to 0.75nm, but the radar picture remained offset to the north-west, and was not reset until after the accident (**Figure 15**).
