# National Transportation Safety Board

## Marine Accident Brief

### Flooding and Sinking of Fishing Vessel *Pacific 1*

<b>Accident type</b>	Flooding	<b>No.</b> DCA19FM019
<b>Vessel name</b>	<i>Pacific 1</i>	
<b>Location</b>	Kashega Bay, Unalaska Island, Alaska 53°31.30' N, 167°15.74' W	
<b>Date</b>	February 15, 2019	
<b>Time</b>	About 0330 Alaska standard time (coordinated universal time – 9 hours)	
<b>Injuries</b>	0	
<b>Damage</b>	\$720,000 est. (total constructive loss)	
<b>Environmental damage</b>	Oil sheen reported	
<b>Weather</b>	Overcast skies with scattered showers and southwest winds at 20 knots, gusting to 25 knots; seas 10-12 feet; air temperature 45°F; water temperature 39°F	
<b>Waterway information</b>	Kashega Bay is located on the northwest coast of Unalaska Island, Alaska.

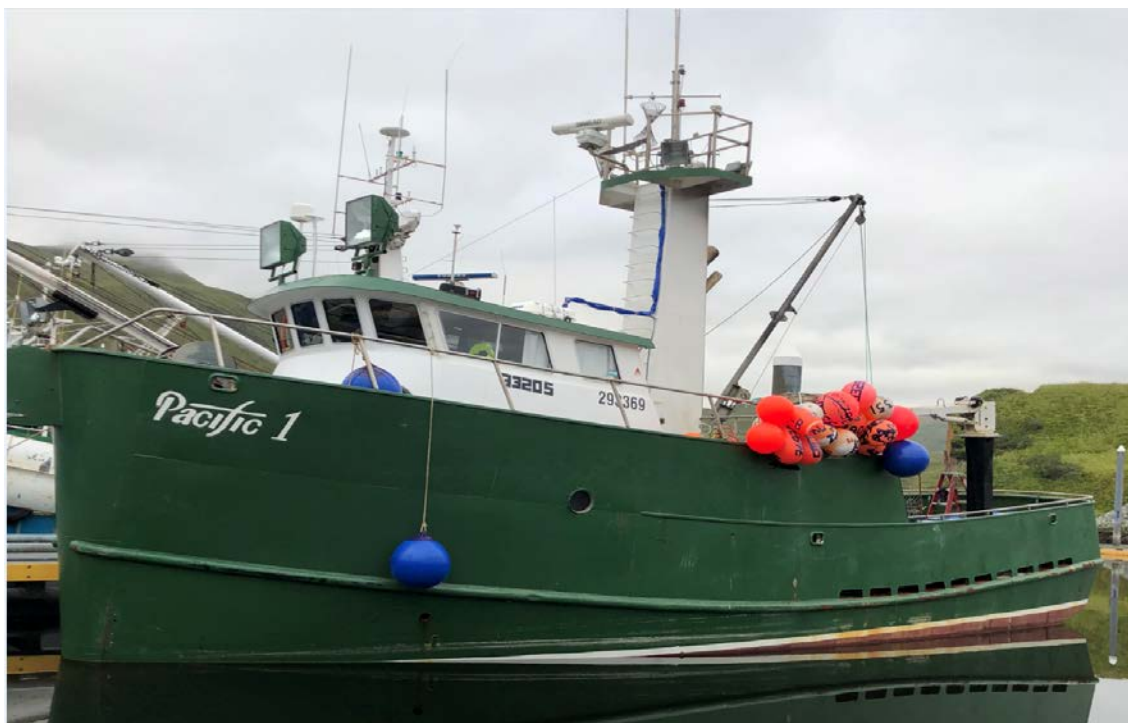
The fishing vessel *Pacific 1* before the accident. (Source: *Pacific 1* owner)

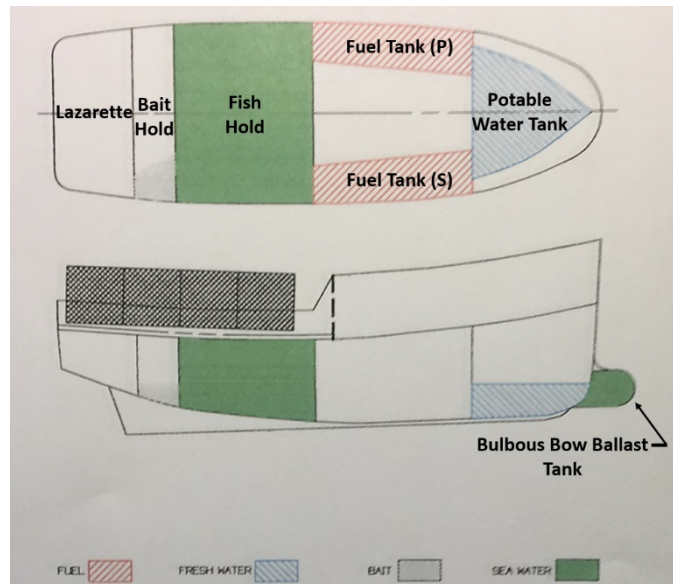
**The *Pacific 1* top and starboard-side profile view of compartments and tank locations. Although the stability booklet shows the bulbous bow ballast tank filled with sea water, at the time of the accident, this tank was pressed with fresh water. (Background source: *Pacific 1* Stability Booklet)**
