MARINE ACCIDENT
INVESTIGATION BRANCH

SAFETY DIGEST

**Lessons from Marine
Accident Reports
1/2020**

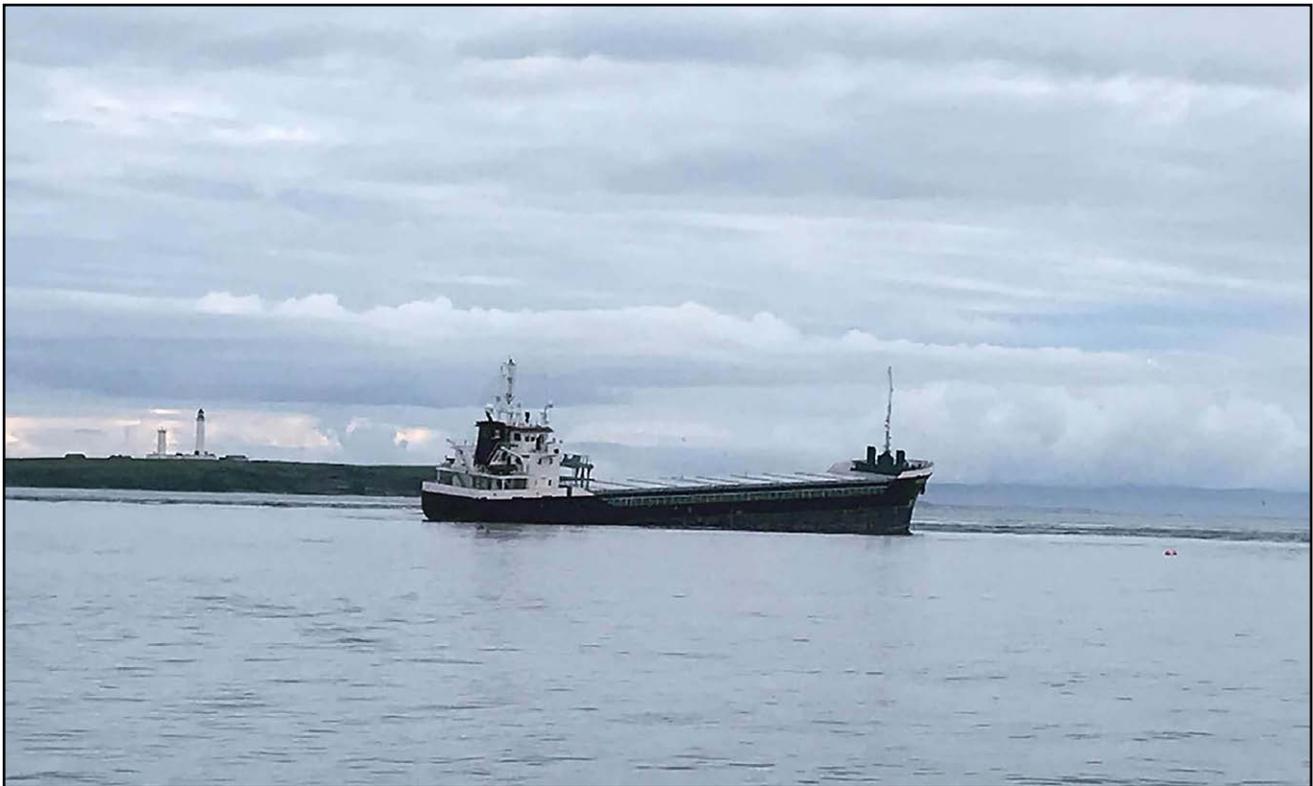
A small cargo vessel was on sea passage and heading towards the coastline of the country of its next port of call. The OOW had taken over at 0200 and soon thereafter had started watching music videos on his mobile phone. Between about 0230 and 0430 the vessel was slowly set off the planned track by the tidal stream in the area. This resulted in the vessel heading towards some outlying, uninhabited rocky islands, marked by a lighthouse. However, the risk of grounding had not been observed by the OOW.

The vessel was badly damaged by the accident and remained aground for several days until the cargo had been removed and sufficient tugs were available to haul it off the rocks.

Figure: The cargo vessel aground with the lighthouse visible in the background

1. The accident happened primarily because the OOW was distracted from navigation by the use of a mobile phone. This is a hazard that must be guarded against by appropriate policies for the use of mobile phones at sea.
2. Fatigue was also a potential causal factor. It was the middle of the night and the OOW was alone and bored on a warm bridge. These were conditions that induced a high risk of falling asleep - and he might have done so from time to time.

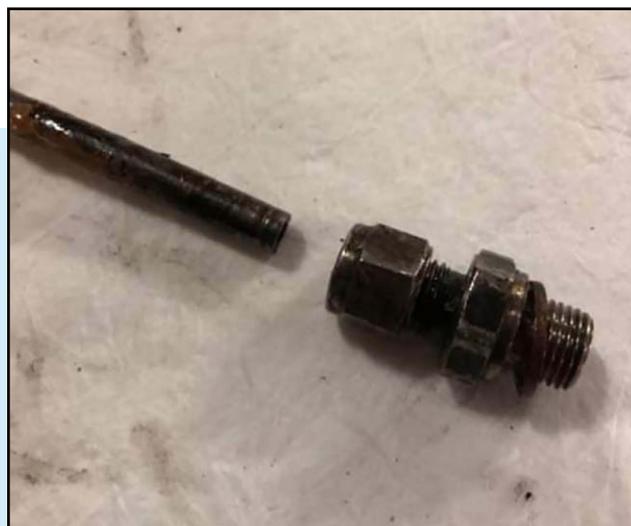
1. Post-accident analysis established that the source of the fire was from fuel that had sprayed onto the port engine from a failed compression joint (figure) on small bore pipework to a fuel supply pressure gauge. This stainless steel fitting had failed because it had been sealed with a brass olive (or compression ring). In metal compression fittings, the pipework should be a 'softer' metal than the olive. In this case, the brass olive was 'softer' than the steel pipework and it had deformed and failed, rather than compress and seal the pipework, which would have been the case had a 'harder' stainless steel olive been used.
2. The chief engineer's response to the fire was both rapid and effective. These actions contained the fire, bringing the situation

Figure: The failed compression fitting (olive not shown)

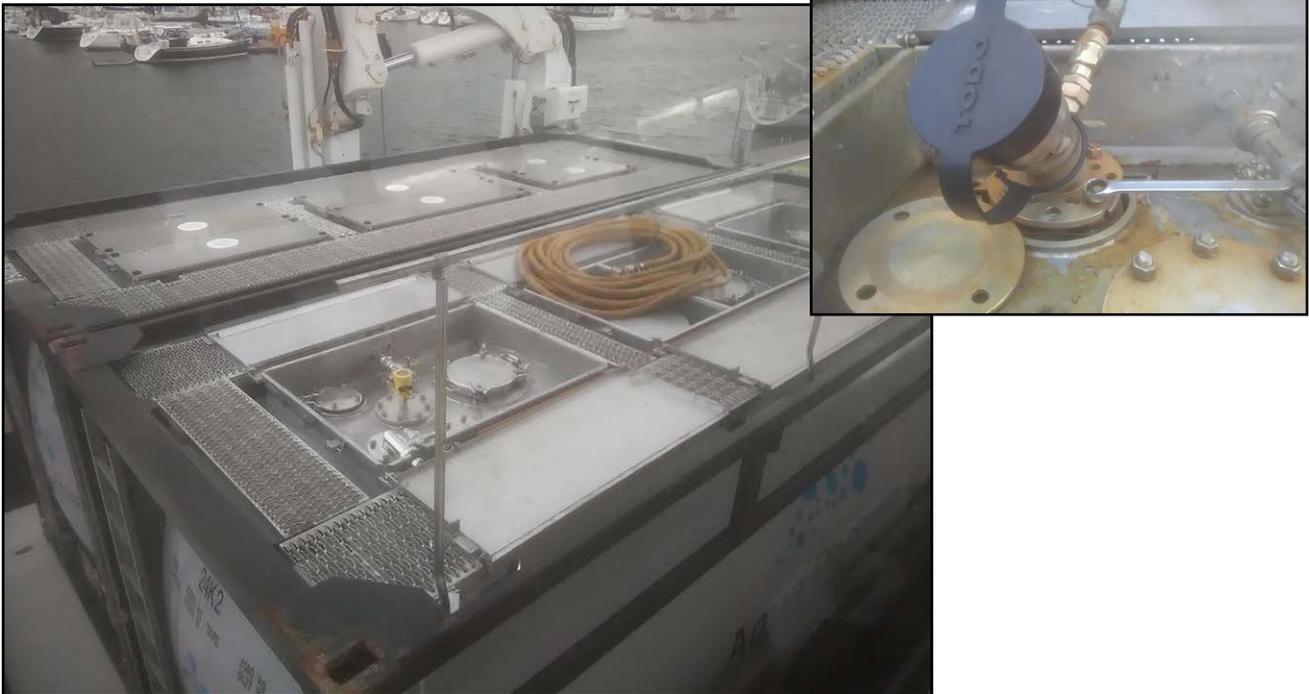
the release of pressurised hydrogen peroxide, spraying onto the contractor. The crew doused the contractor with fresh water to rinse off the hydrogen peroxide and he was treated by paramedics then taken to hospital. Fortunately, the contractor did not suffer any long-term injuries.

Figure: The hydrogen peroxide tanks as seen from the wheelhouse (inset: the valve being removed)

1. Whatever the size and nature of a vessel, all installation or maintenance work must be risk assessed and undertaken in accordance with an agreed plan. After the accident, it was discovered that the contractor thought that the tanks were empty and was, therefore, unaware of the hazard he faced in undoing the securing bolts of the valve. Had a risk assessment been undertaken and a 'toolbox talk' get together happened at the start of the day, it is highly likely that this risk would have been avoided.
2. The crew's response of dousing the casualty with fresh water was quick and appropriate, and it is highly likely that these prompt actions saved the contractor from serious injury.

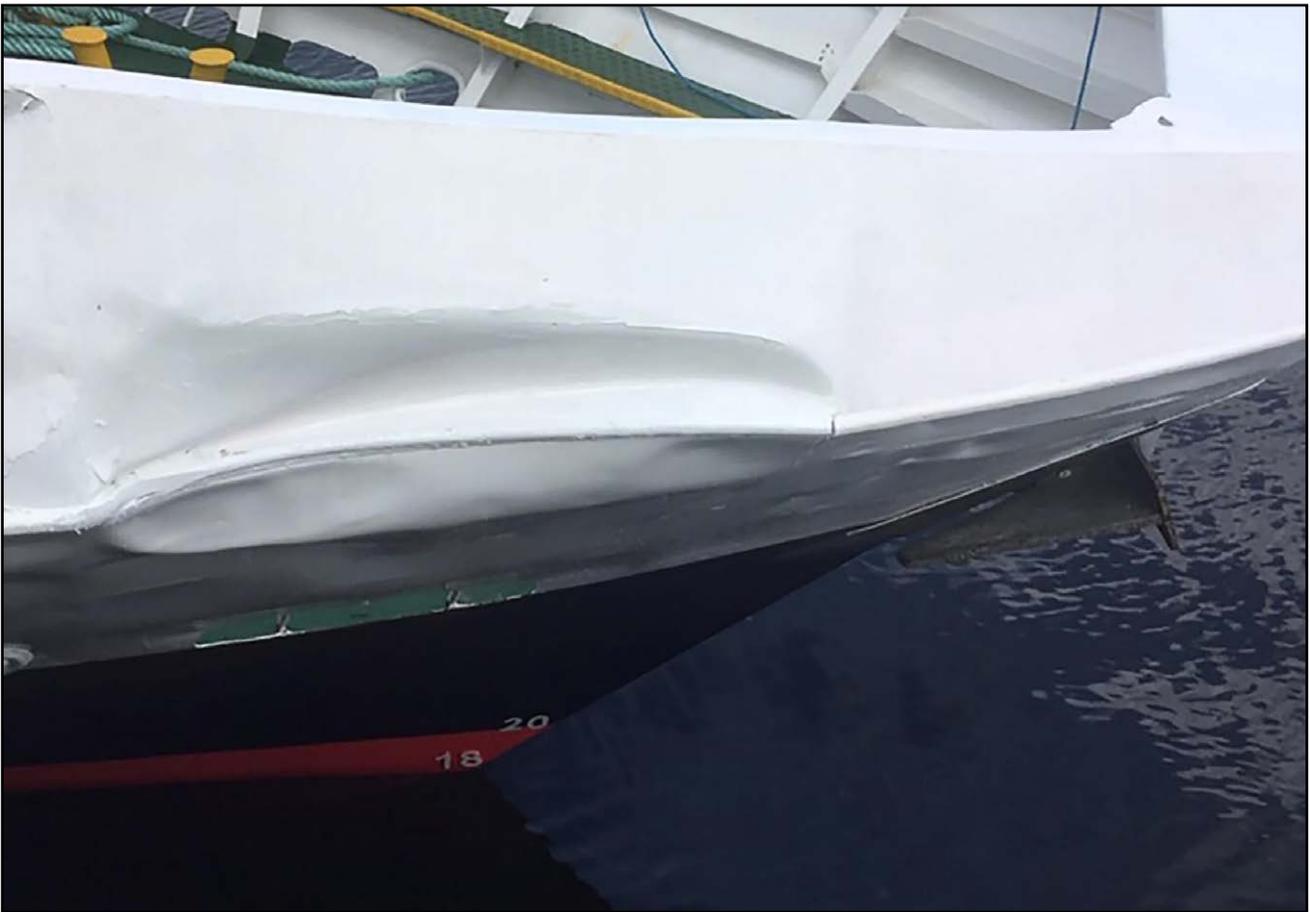
A commuter passenger ferry was approaching the berth when control was lost due to a combination of the local tidal effect and a strong wind. The ferry's starboard bow was damaged after making heavy contact with the quay (figure); thankfully none of the 42 passengers was injured.

Figure: Structural damage to the ferry's starboard bow after the impact

This case is a good illustration that accidents rarely have a single causal factor. Instead, there is often a chain of events that can set the conditions for something to go wrong. In this case, the unusual berth, the relief master's lack of familiarity with the environment, the tidal stream and the breezy conditions all added up to create a potentially hazardous situation.

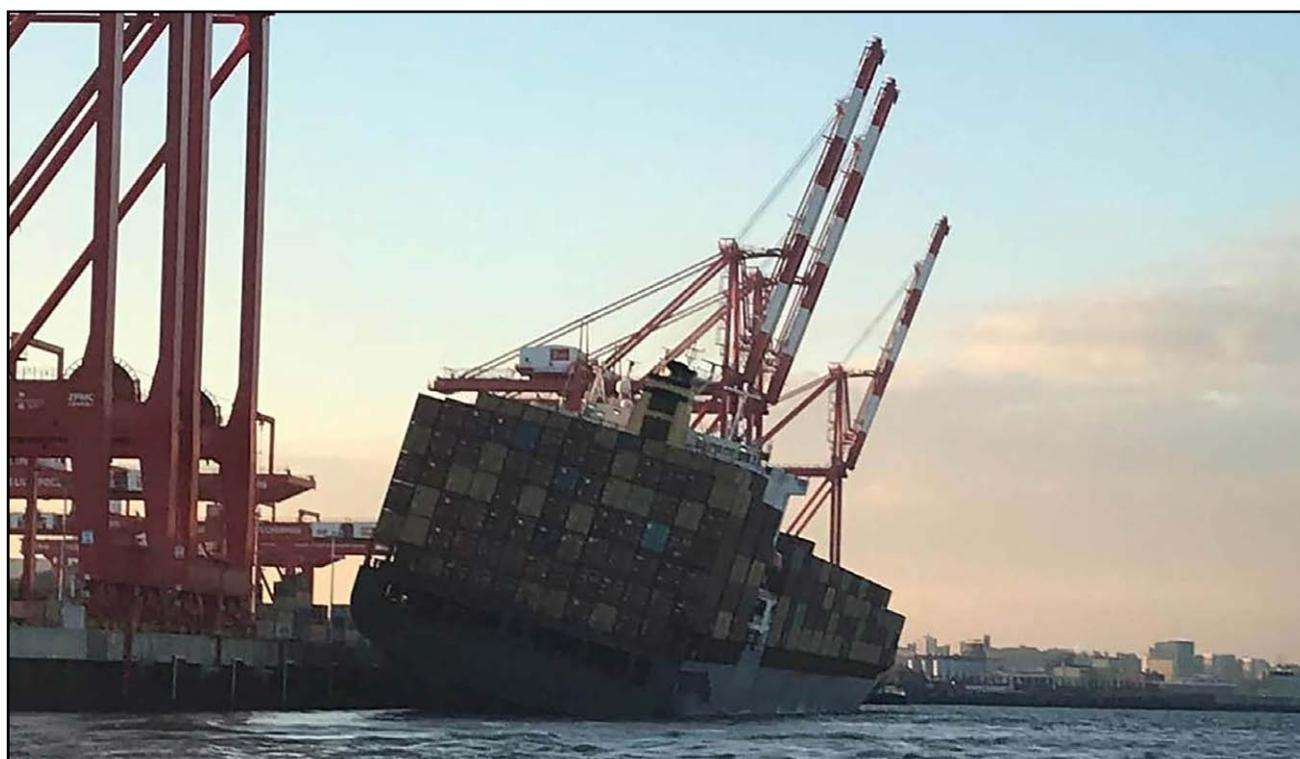
As the volume of water in the starboard tanks increased, the vessel started to list heavily to starboard (figure). As the situation deteriorated, all the crew evacuated ashore.

After the incident, manual soundings were taken, which showed that one of the port ballast tanks' gauges had been reading full when the tank was actually empty, and the fault was almost certainly an airlock in the gauge system.

Figure: The container vessel listing alongside

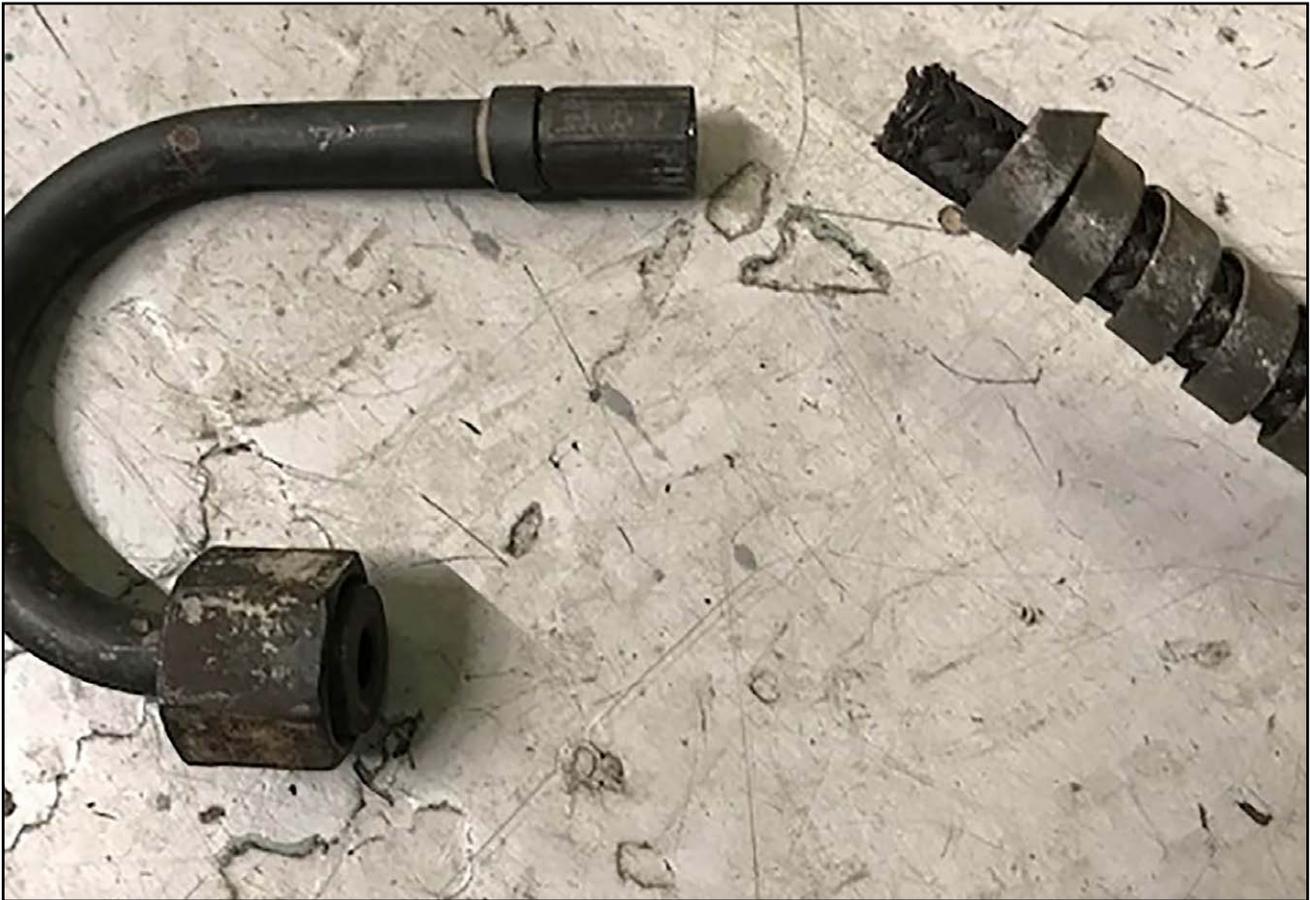
1. Post-accident investigation established that the fire started when an oil feed pipe for the port engine turbocharger failed (Figure 1), causing pressurised oil to spray onto the hot engine and ignite. Further technical assessment suggested that the pipe might have been vulnerable to fracture due to heat-related hardening. Regular inspection of oil pipework, particularly joints, connections and brackets is vital to maintain system integrity.

Figure 1: The failed turbocharger oil feed pipe

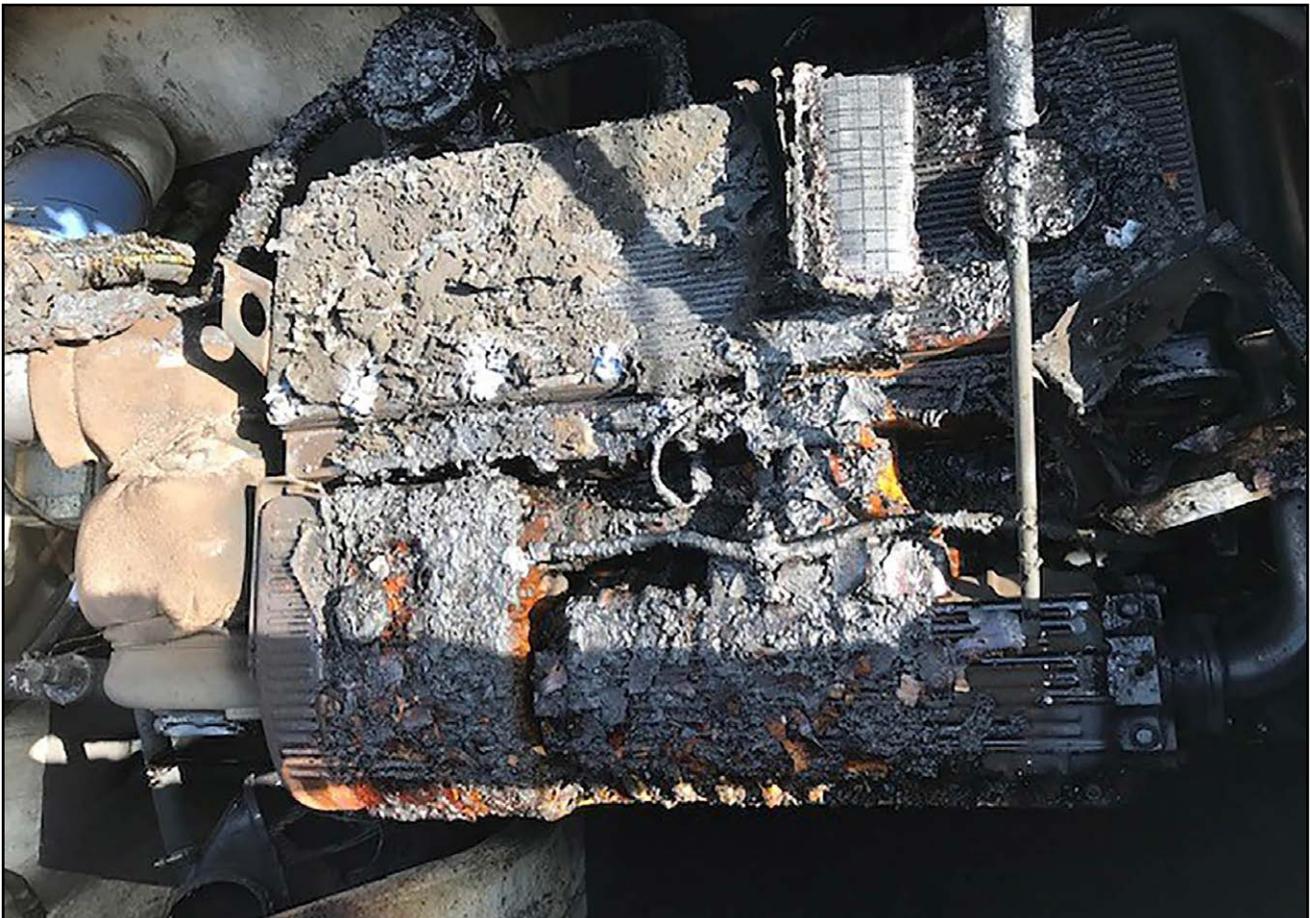
2. The engine and its compartment were extensively damaged (Figure 2). This included soundproofing material melting onto the engine and damage to the fiberglass structure. Even though the fixed fire suppression system was activated, the fire carried on smouldering for about an hour. This happened because the compartment ventilation flaps did not seal correctly, allowing air to feed the fire and smoke to escape.

Figure 2: Fire damage to the port main engine and its compartment

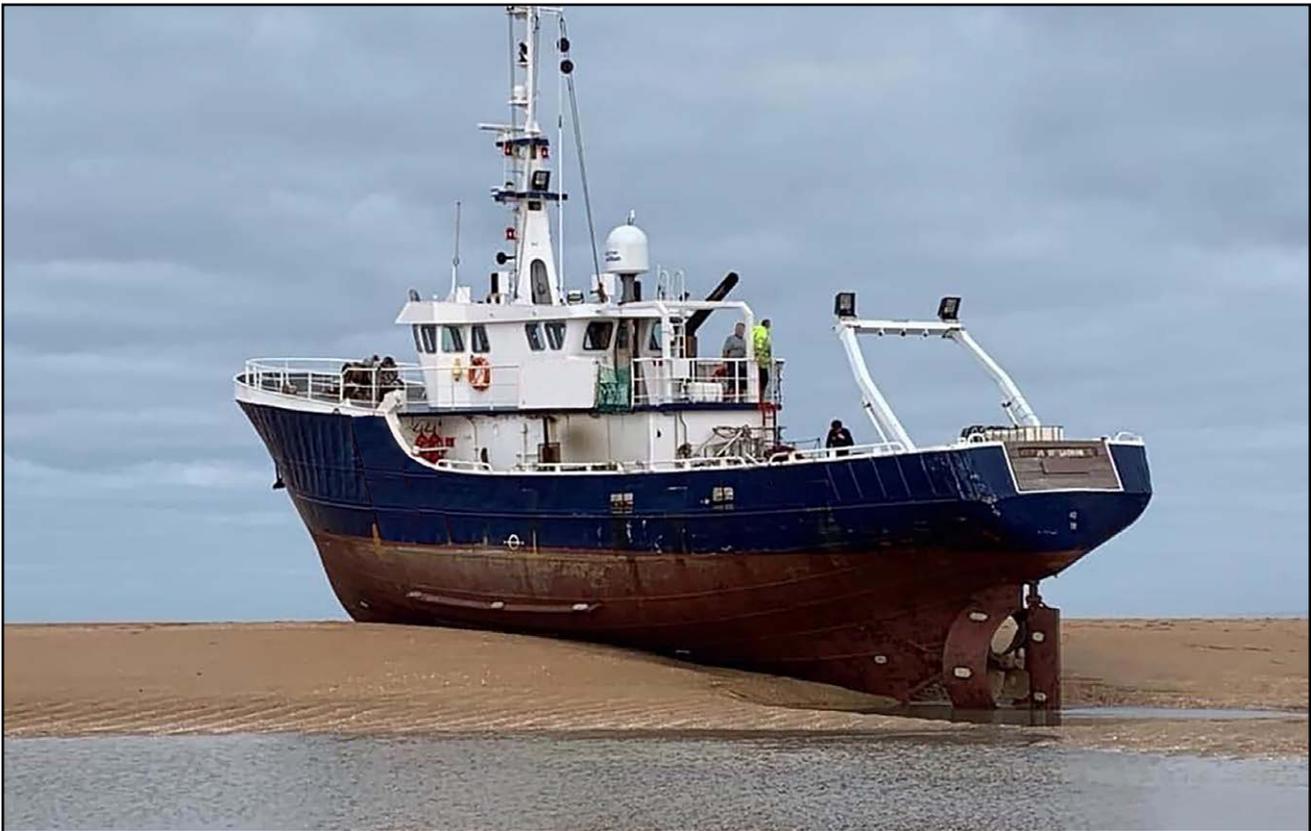
The skipper was woken by the grounding and came to the wheelhouse and tried to free the vessel, but this was unsuccessful. The tide was falling, and at low water the workboat was high and dry (figure). There was no pollution, injury or damage and the workboat refloated without assistance at the next high water.

Figure: The workboat aground at low water

1. Fatigue is one of the most enduring causes of incidents and accidents, and must be guarded against. In this case, the mate was alone in the wheelhouse, in the early morning towards the end of a long watch. This was a time when there was probably a very high risk of him falling asleep. Repetitive work can also induce boredom, reducing stimulation and attention to the task in hand.

2. Alarms can provide a safety barrier to help prevent incidents. A BNWAS can help to combat this risk. However, the workboat's BNWAS was defective at the time of the accident, and there were no other alarms that were effective in waking the watchkeeper before the grounding.

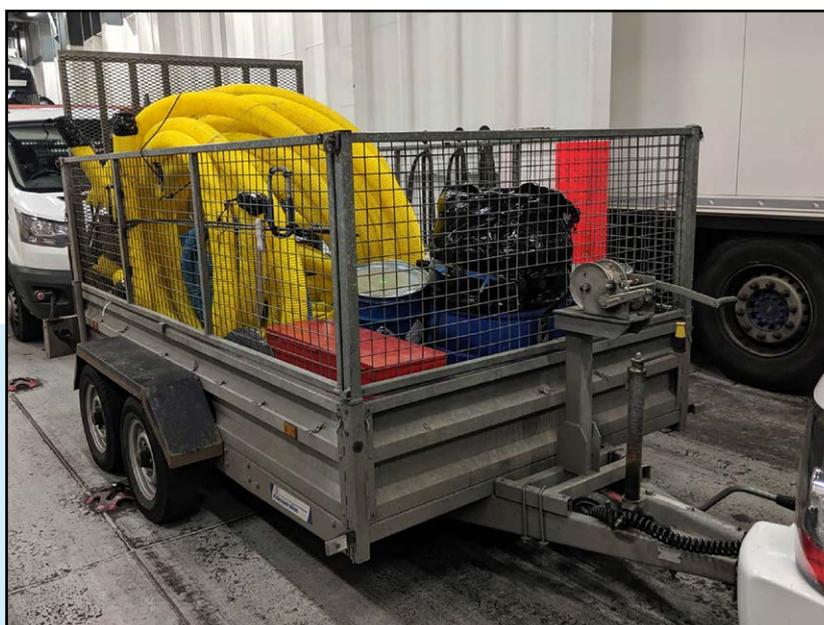
Figure: The trailer before the fire started, with the suspicious barrel

1. Post-accident analysis identified that the barrel contained a phosphine-based substance. Phosphines are widely used as fumigants in the agriculture industry. Phosphine gas is a colourless, toxic, flammable gas with a garlic odour. It is categorised as a hazardous cargo and should not have been carried on the ro-ro ferry.

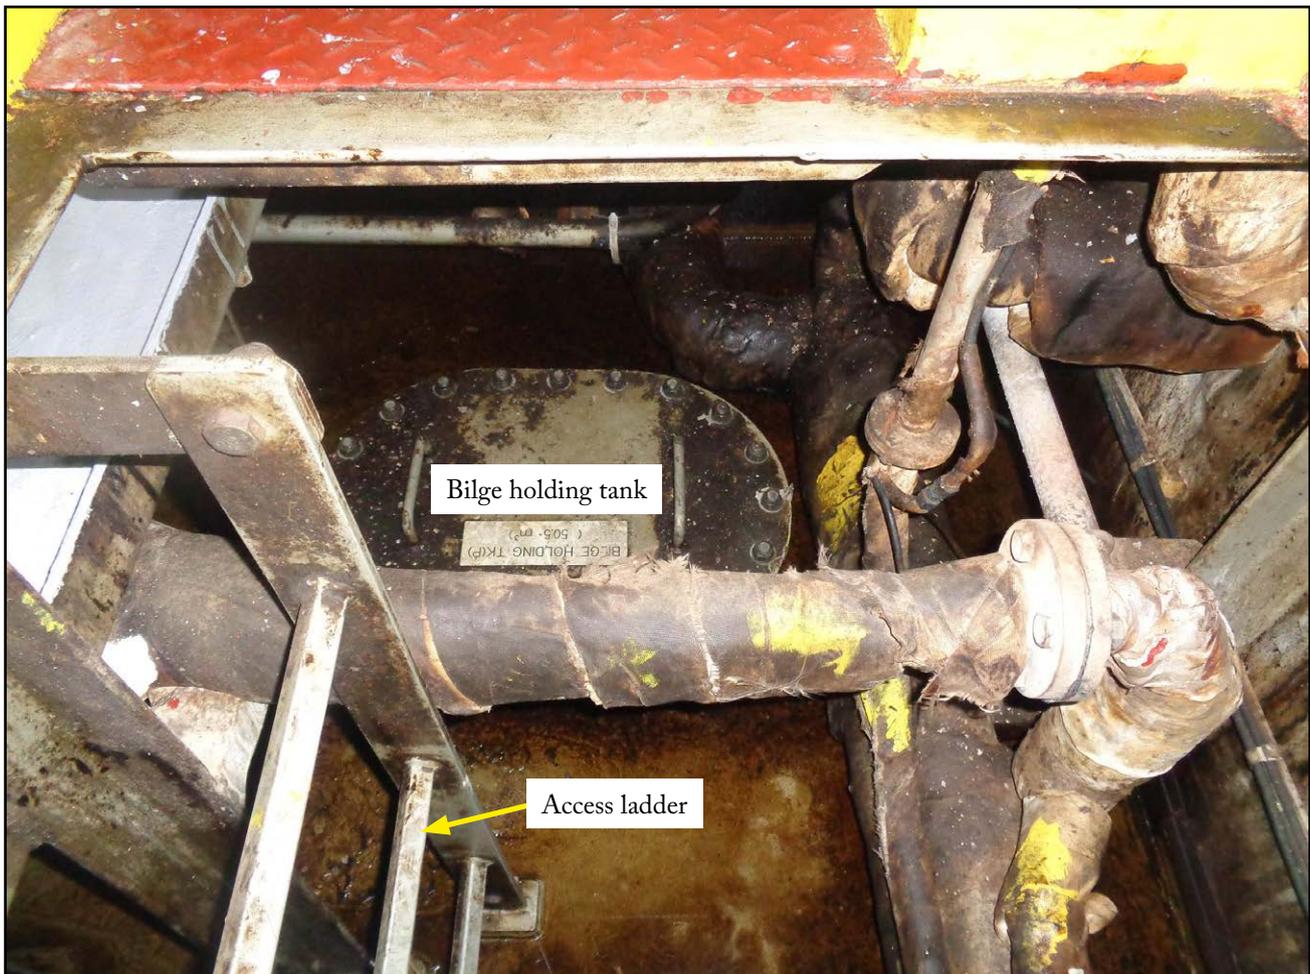
The engineer on watch coughed as he tried to make his way out of the bilges, but passed out near the bottom of the access ladder a short distance away from the open tank (Figure 1). He fell backwards onto an uninsulated steam pipe. He recovered shortly afterwards and though disorientated, made his way to the purifiers, where he was seen by another crew member. The crew member raised the alarm. The ship's medical team immediately arrived and carried out first-aid. The engineer was taken to hospital, where he was treated for gas inhalation and serious burns to his back. He was unable to return to work for a number of weeks.

Figure 1: Access to bilge holding tank manhole cover

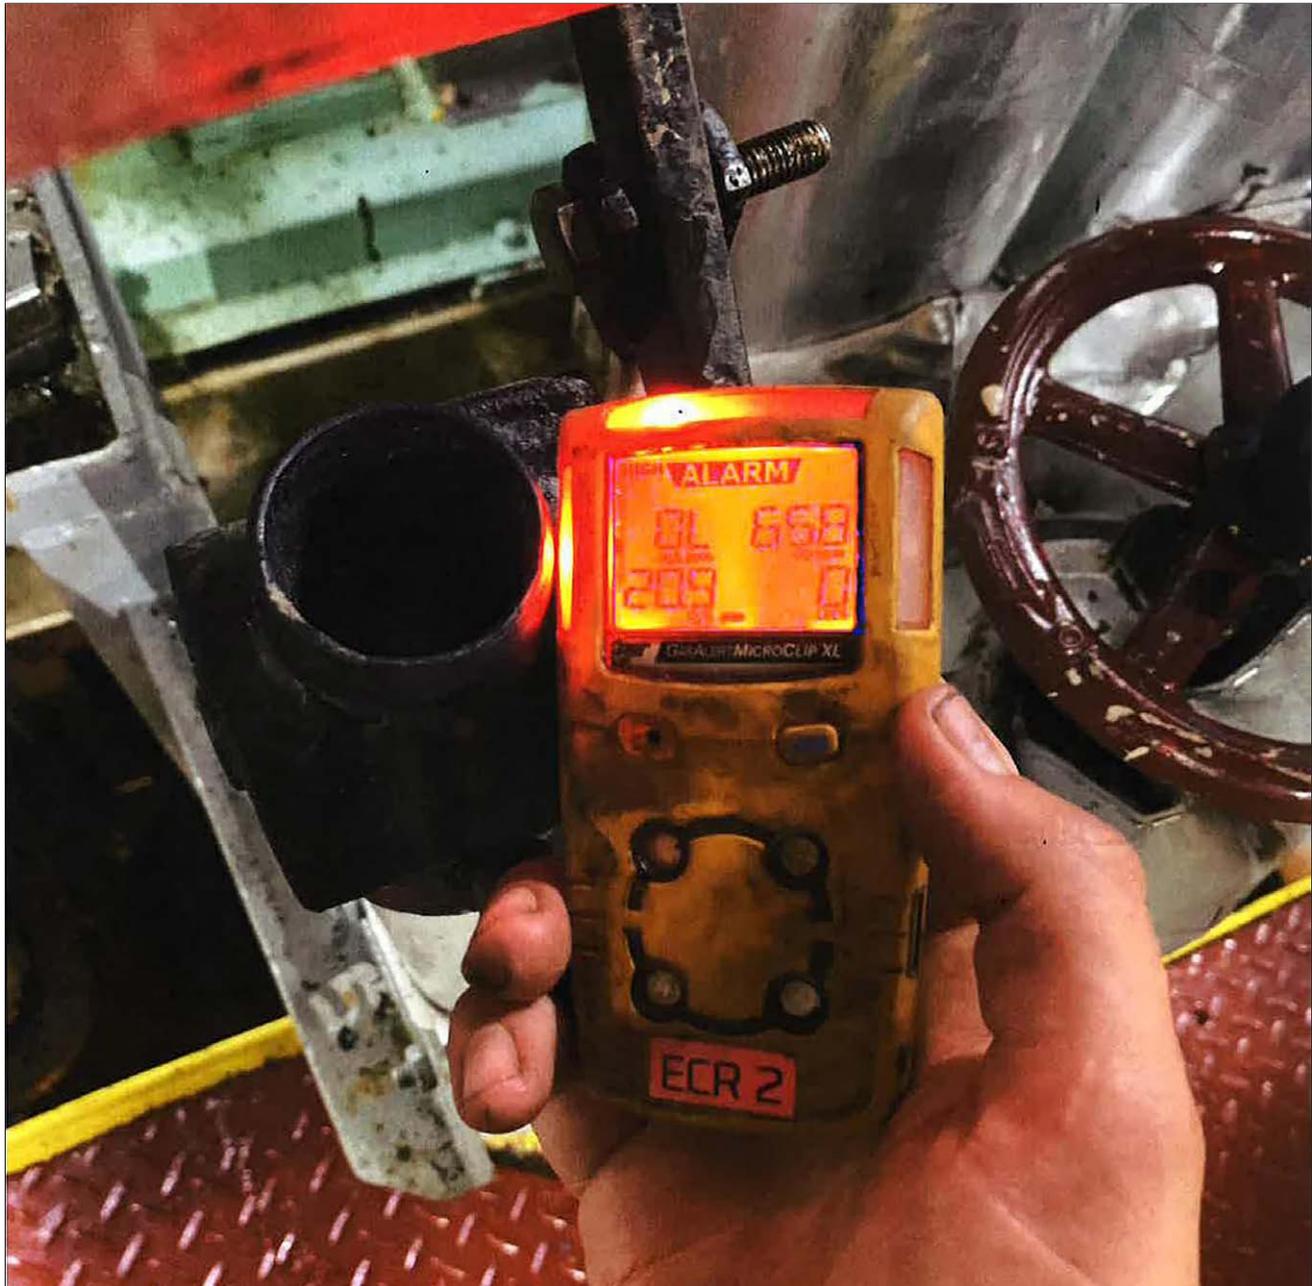
Immediately after the accident, the ship's crew sampled the atmosphere in the bilge holding tank at the mouth of the sounding pipe. The hydrogen sulphide (H₂S) content had crossed the upper limit of the instrument's measurement capability and the carbon monoxide content was 658 parts per million (ppm) (Figure 2).

Figure 2: Multi-gas meter readings immediately after the incident

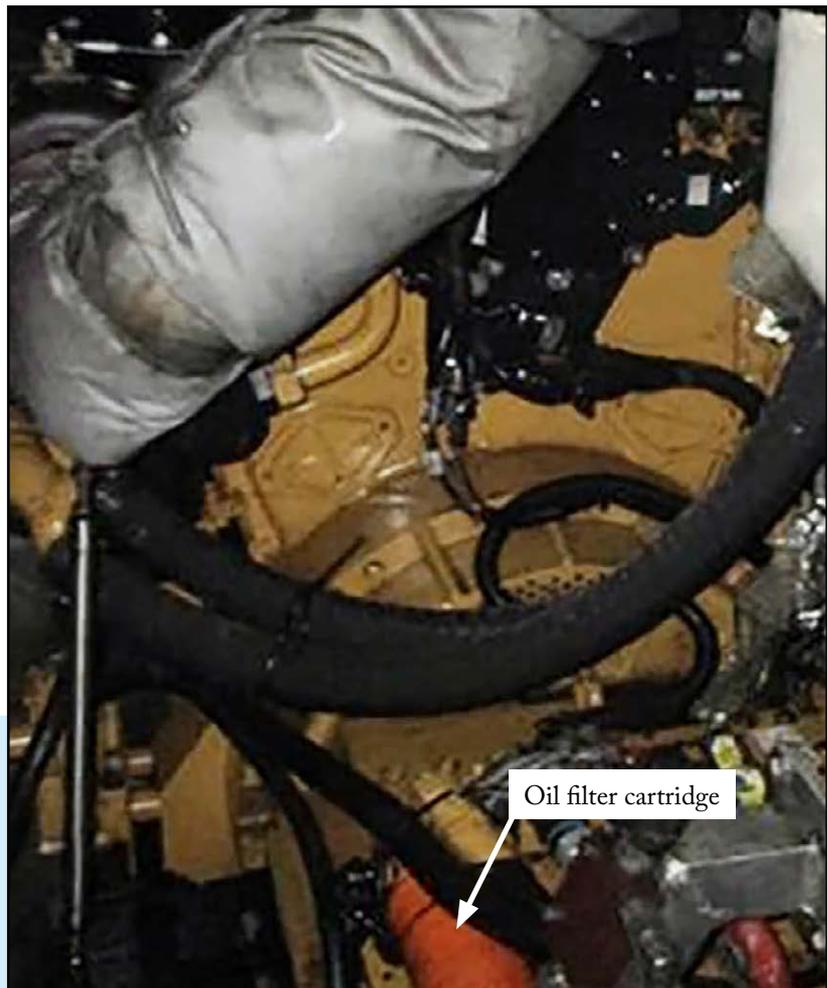
mechanism had worked itself loose (figure), allowing hydraulic oil at 25 bar pressure to spray onto the exhaust shielding of the engine. The oil then seeped through to the bare exhaust pipe and ignited, resulting in the fire.

Figure: Clutch hydraulic oil filter cartridge

1. Pressurised oil and fuel spraying onto a hot surface has caused a large number of engine room fires. No effort should be spared to ensure that leakages of oil and fuel are kept to a minimum.
2. Ensure that all fuel and oil fixtures and fittings are securely fastened and, in the event that they come loose, the release of their contents is protected and directed away from hot surfaces.
3. Excessive vibration can result in machinery components working loose or cracking. Ensure that the vibration levels are kept below acceptable limits.

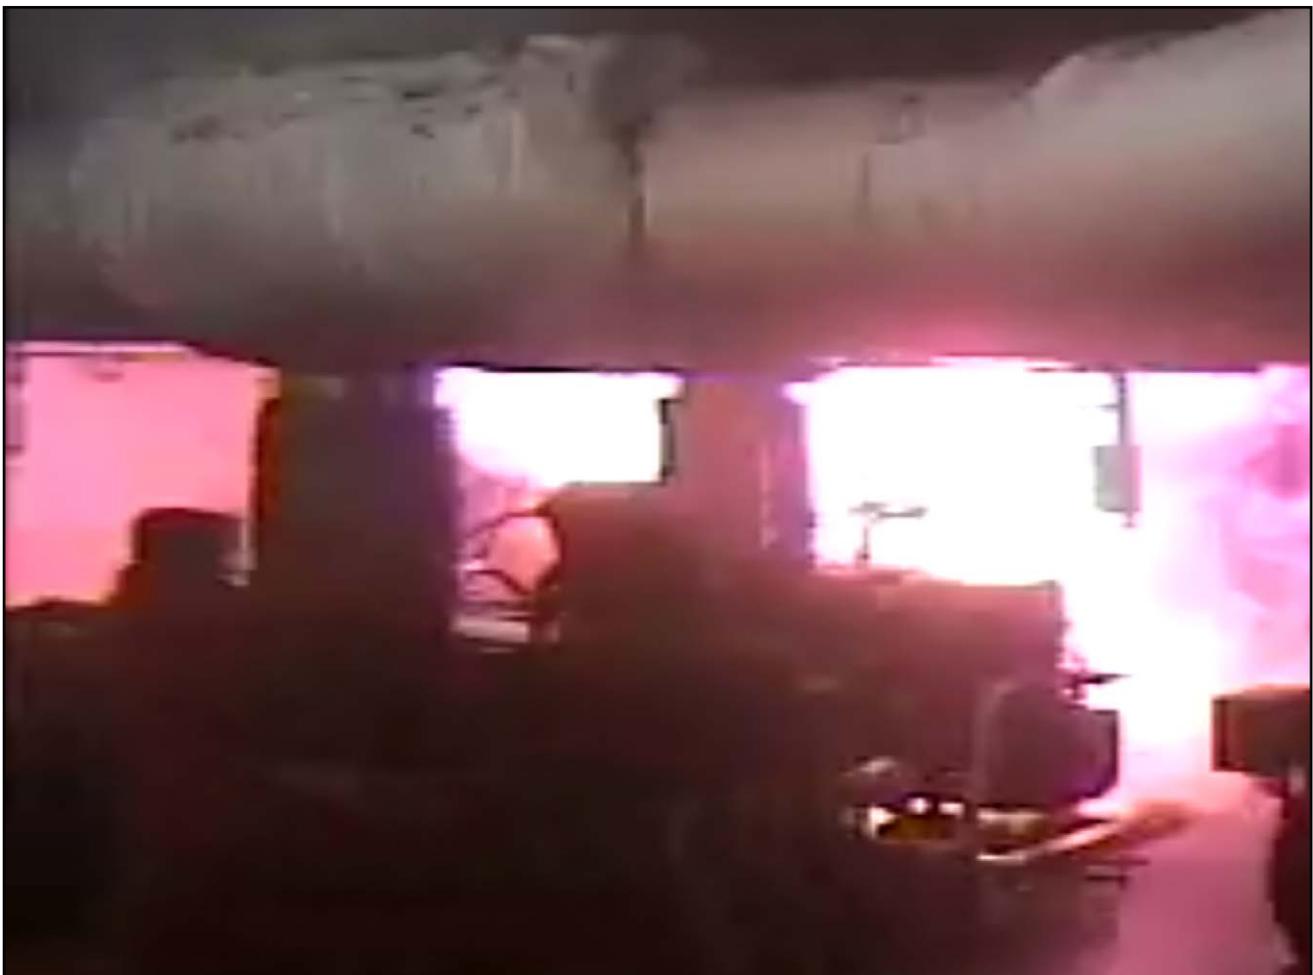
A ro-ro passenger ferry with 40 persons on board was approaching its berth when one of its four main propulsion engines exploded. The engine had been completely rebuilt and after 5 hours of operation failed. The vessel's engineer was standing next to the engine at the time and suffered serious burns to his hands and face. Fortunately, the engineer's cotton boiler suit protected the rest of his body from the blast.

Figure 1: Main propulsion engine explosion captured

The engine maker's investigation report suggested that the engine's failure was probably a result of dirt lodged between a main bearing and its journal. This caused the bearing shells to turn and block the oil supply to the adjoining big end bearing, which then seized. The most likely cause of this dirt ingress was through the oil channel on top of the engine block. This channel had been exposed during the transport and storage of the partly assembled engine block.

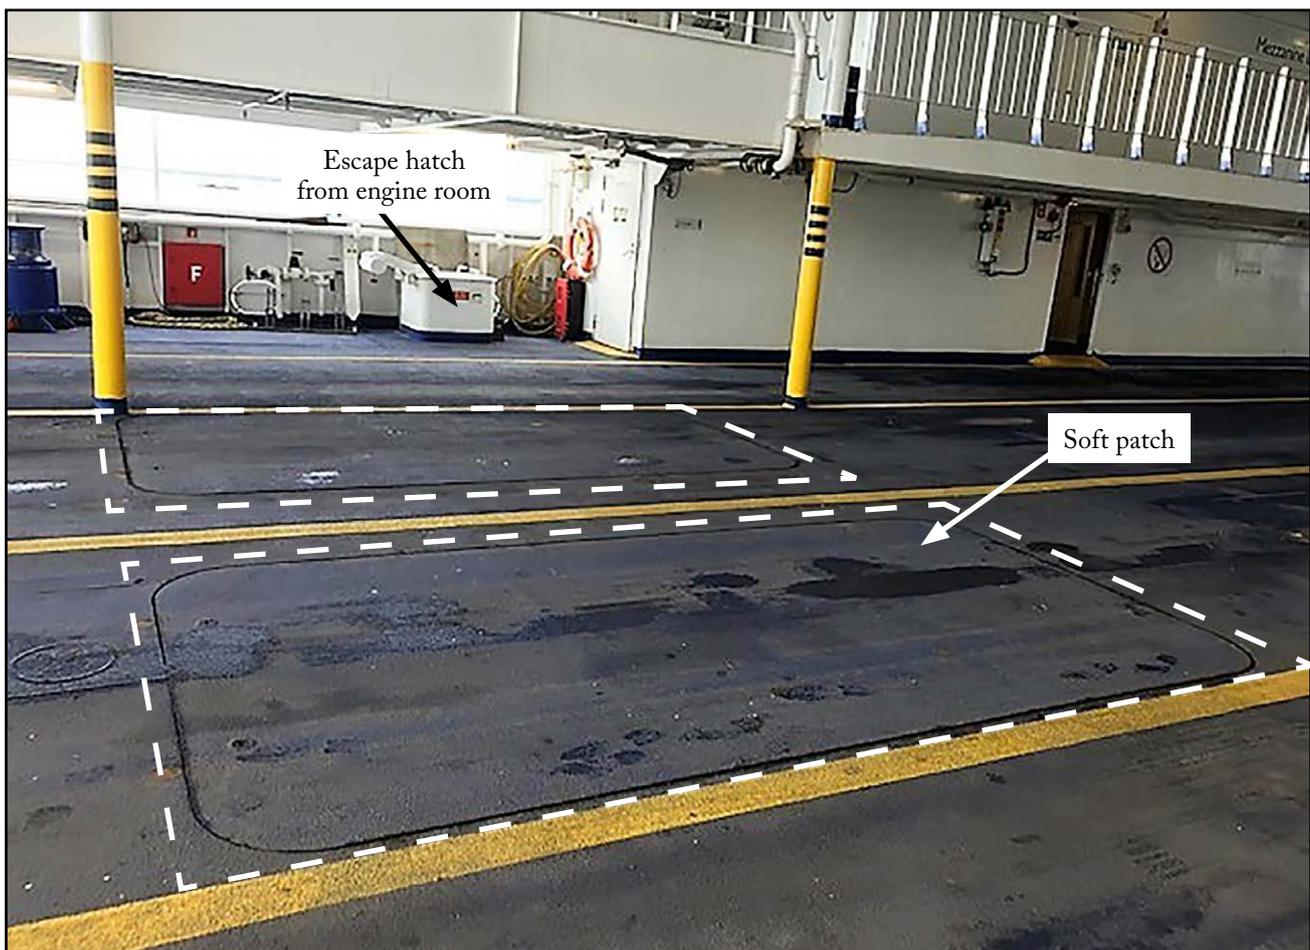
The vessel's engine room had a large soft patch that could be removed to allow complete engines to be lifted out and onto the vessel's car deck above (Figure 2). However, removal

of this soft patch was difficult because exhaust pipes and other large fittings had to be removed first. To save the time needed to remove the soft patch, the vessel's managers and service engineers had agreed that it would be easier to remove and replace engines by partially dismantling them so they could be shipped via a small emergency escape hatch from the engine room.

Figure 2: Soft patch and escape hatch

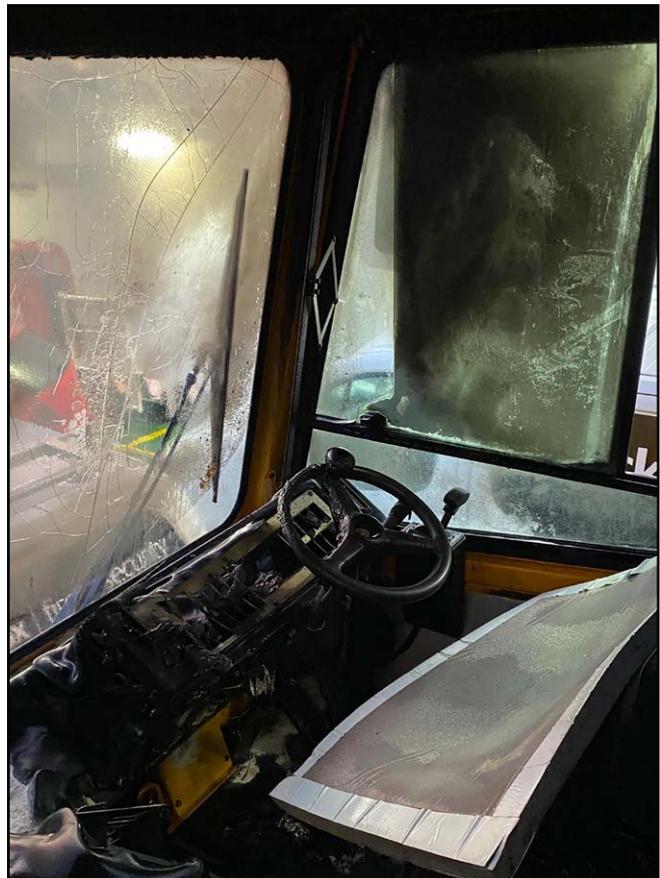
When the ferry arrived in port, the local fire service attended to assess the situation. The tug master unit was extensively fire damaged internally (Figure 2); however, there was no damage to the vessel and no passengers or crew were injured.

Figure 2: Fire damage to the cab of the tug master after the fire had been extinguished

1. Vehicle fires present a major hazard on board ferries, and every precaution should be taken to minimise the risk. Post-event analysis identified that the cause of this fire was almost certainly an electrical short-circuit; the cab driver's window had been left open, letting rainwater in; the key was in the ignition; and the battery isolator was not in use. This was not an appropriate condition for the cab to be left in, particularly on an open car deck in the rain. CCTV imagery also spotted that the tug master's headlights switched on prior to the smoke being sighted. Since the accident, the ferry operator has instructed tug master drivers to electrically isolate their cabs when unoccupied; a precaution that should be a consideration throughout the industry.

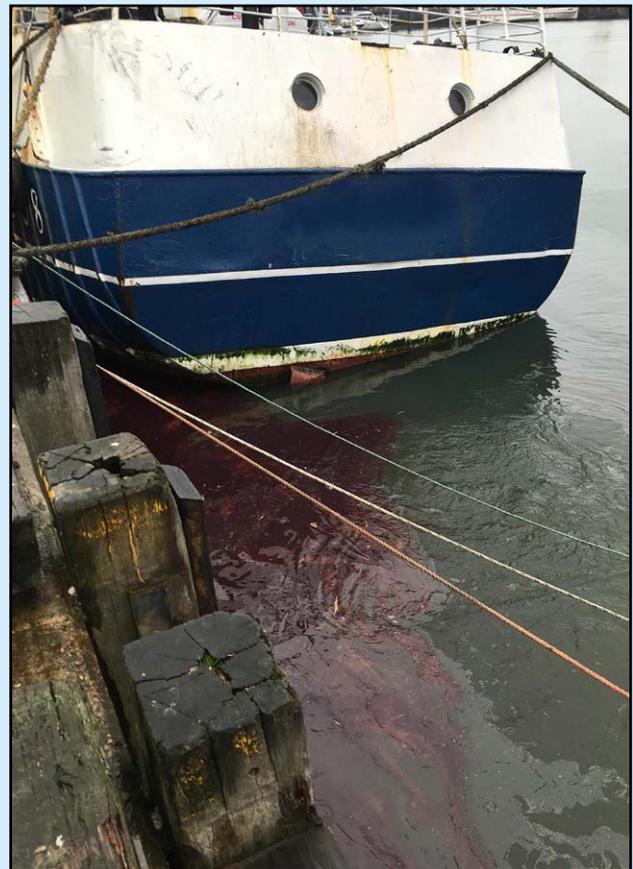
Figure: Pollution from the overflowing fuel tank

1. The transfer of fuel is a task that must be taken seriously, and it is a time when due diligence and care must be applied. Environmental damage caused by pollution is significant, especially if lower grade fuel is used, such as heavy fuel oil or lubricants. Furthermore, causing pollution is illegal and is a punishable offence. Those responsible can incur a heavy penalty, such as a hefty fine, or even imprisonment.
2. All fuel transfer operations must be constantly monitored by a competent and responsible member of the crew. Do not leave the operation unattended - even for a short time.
3. Those responsible for monitoring fuel transfer operations must understand the system well enough to ensure that they can react quickly and effectively during an emergency.

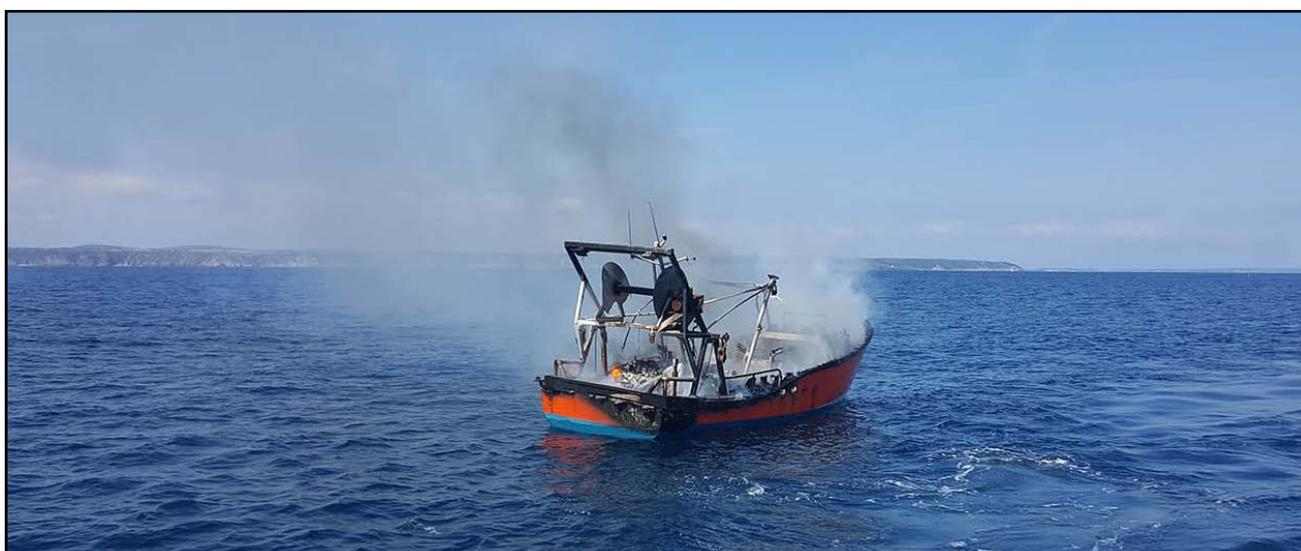
From the liferaft, the fishermen were able to raise the alarm as they had a good mobile phone signal. They were both rescued by an RNLI lifeboat soon after making the distress call and then taken safely to shore. The abandoned fishing boat (figure) eventually burnt out and sank.

Figure: Smouldering vessel prior to sinking

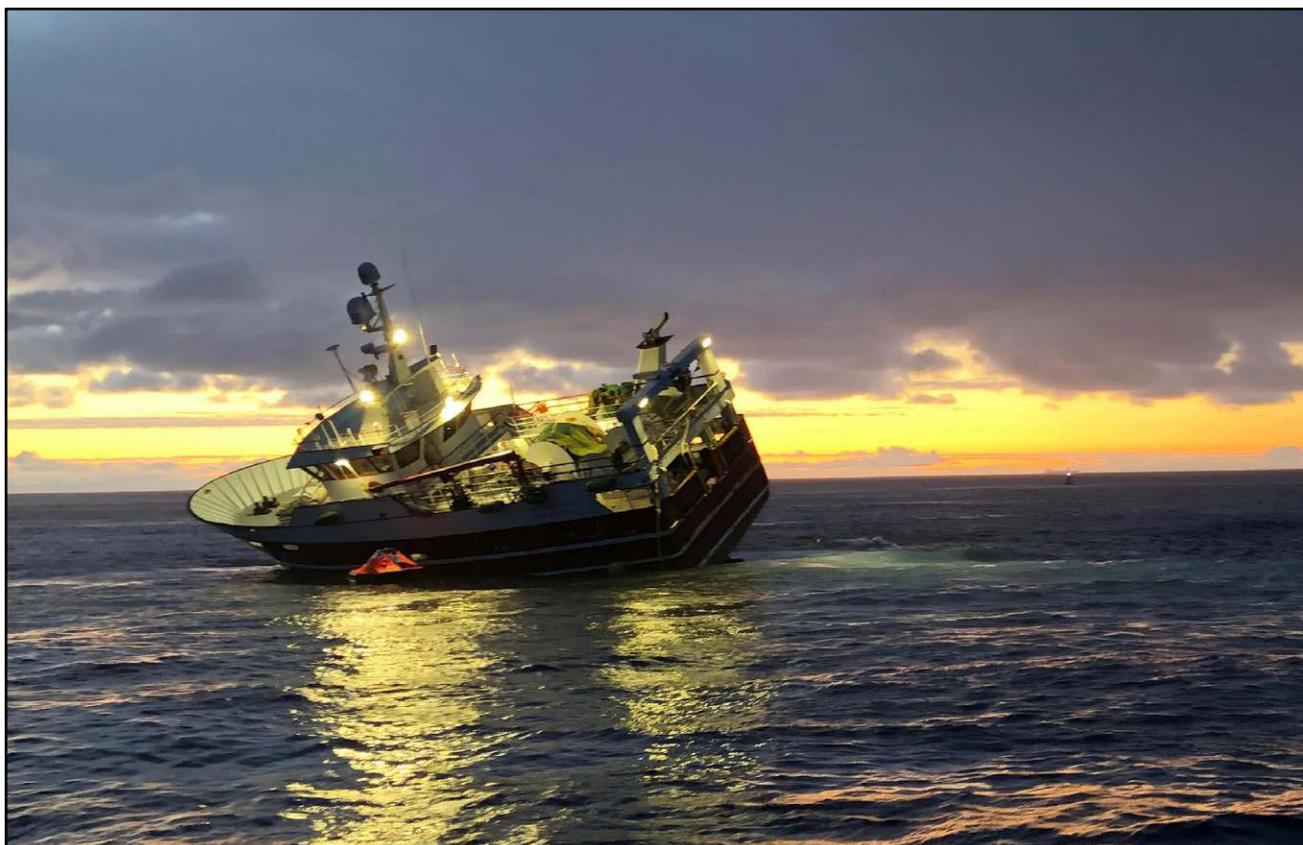
The following morning, both the vessel's skippers and the chief engineer returned on board with a team of salvage divers. Although the vessel had been damaged, water ingress was minimal and, at high water, the tug was able to haul the fishing boat free; it was then towed back to the harbour for repairs.

Figure: The fishing vessel hard aground with the inflated liferaft nearby

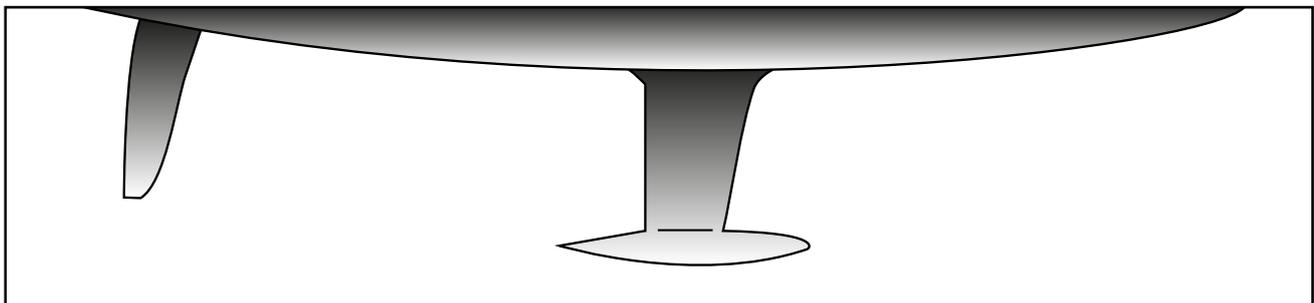
3. This was a serious grounding in which the yacht was subjected to significant stresses for a prolonged period. The keel was of a fin and bulb design commonly found on modern cruiser racers (figure). The owner followed good practice in commissioning a survey immediately afterwards. Fortunately, no serious damage was detected and the yacht was able to be put back into commission.

Figure: Modern keel and rudder arrangements are efficient but potentially vulnerable and should be professionally examined following a grounding

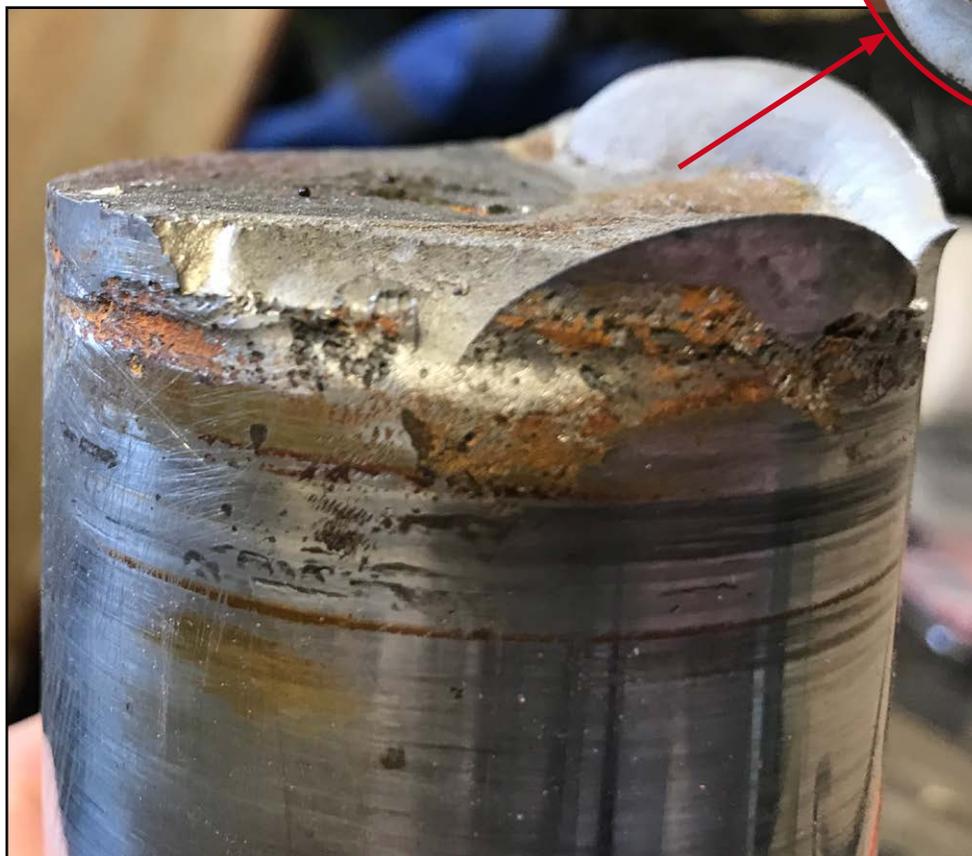
A technical investigation into the shearing of the rudder stock identified that it had failed as a result of weakening caused by crevice

Figure 1: The failed rudder stock showing the effects of crevice corrosion
