MARINE ACCIDENT
INVESTIGATION BRANCH

SAFETY DIGEST

**Lessons from Marine
Accident Reports
1/2020**

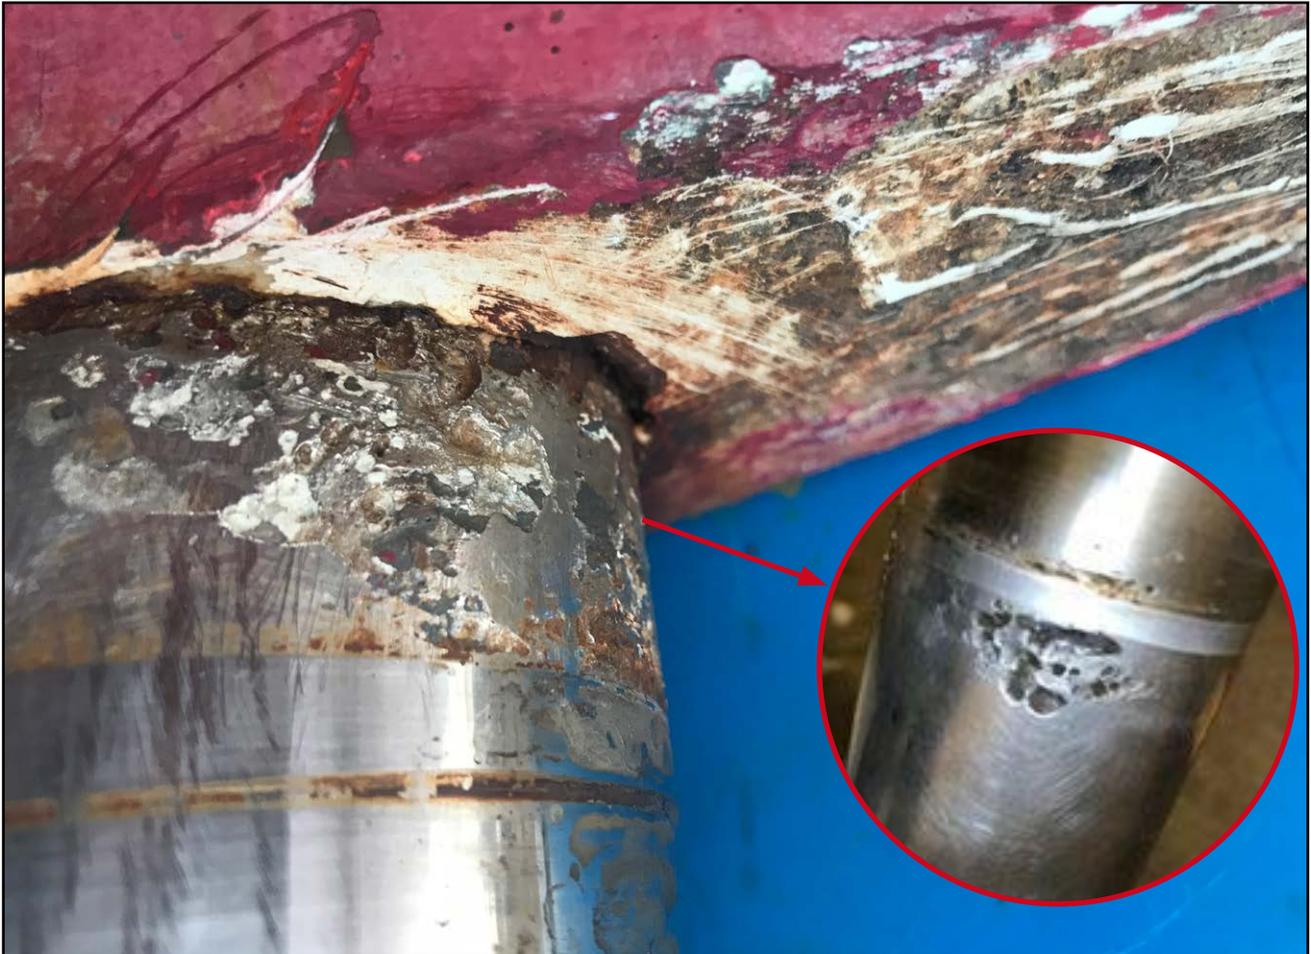
The sailing school that operated the boat decided to inspect its identical sister yacht, where evidence of pitting on the rudder stock was a clue to potentially similar corrosion (Figure 2). Both yachts were taken out of service until new rudders and stocks could be fitted and the yachts' manufacturer was notified.

Figure 2: The rudder stock of the sister yacht, showing pitting and evidence of corrosion
