National Transportation Safety Board

Marine Accident Brief

Engine Room Fire aboard Bulk Carrier *St. Clair*

Accident type	Fire/Explosion	No. DCA19FM020
Vessel name	<i>St. Clair</i>	
Location	CSX TORCO Iron Ore Terminal, Maumee River; Toledo, Ohio 41°41.54' N, 083°27.05' W	
Date	February 16, 2019	
Time	2010 eastern standard time (coordinated universal time – 5 hours)	
Injuries	None reported	
Property damage	>\$150 million	
Environmental damage	None	
Weather	Mostly cloudy, visibility 10 miles, winds east 12 mph, air temperature 28°F, water temperature 34°F ¹	
Waterway information	Maumee River flows from northeast Indiana, into northwest Ohio, and then into Lake Erie. The city of Toledo borders the river where it enters Lake Erie.

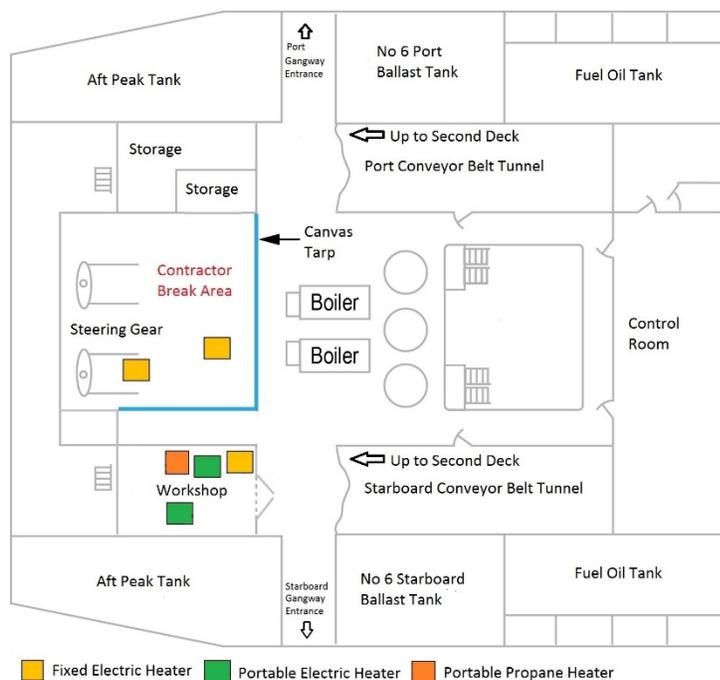
Drawing (not to scale) of third deck, showing location of heaters and tarp in the engine room.

There was a total of six heaters, five electronic and one propane, located in the area of the workshop and the steering gear. A red canvas tarp was hung around the steering gear to help keep the area heated while the workers were taking their breaks. The electronic heaters were routinely left on after the contractors departed the vessel at the end of the day to keep the space warm.

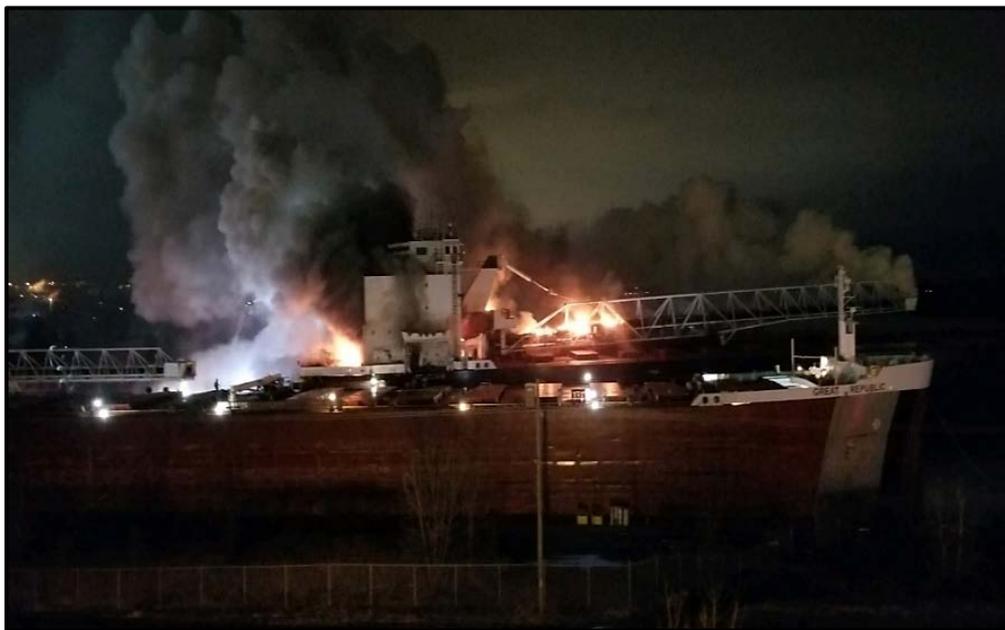
Vessel fire at 2209. Billowing smoke pours from the vessel as fire in the aft part of the deckhouse spreads up the conveyor belt on the boom. (Source: *Great Lakes Trader* Chief Engineer)

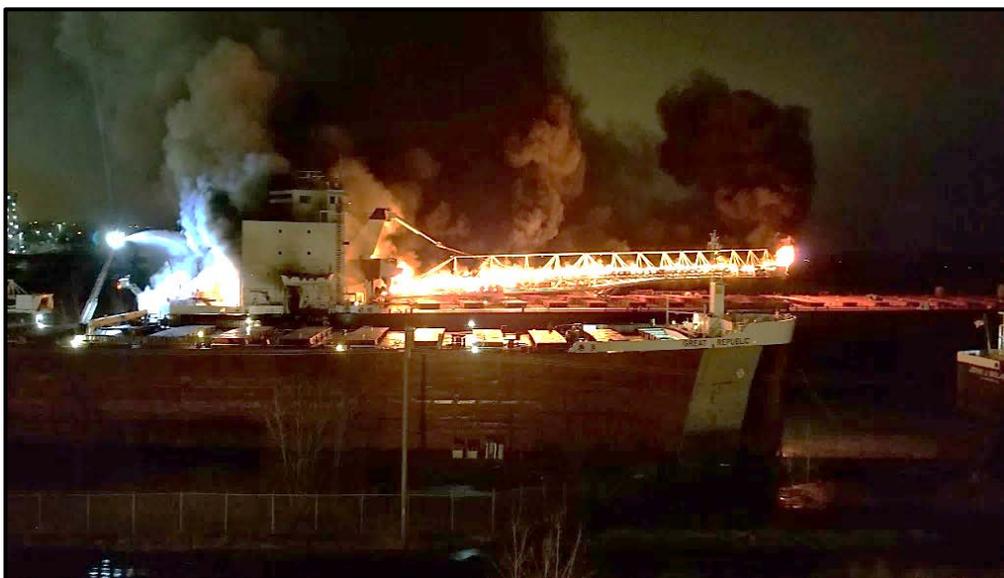
Vessel fire about 10 minutes later, at 2220. The cargo conveyor boom is completely engulfed in flames (Source: *Great Lakes Trader* chief engineer)

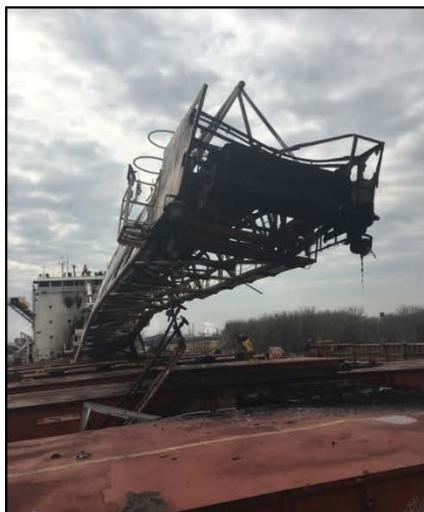
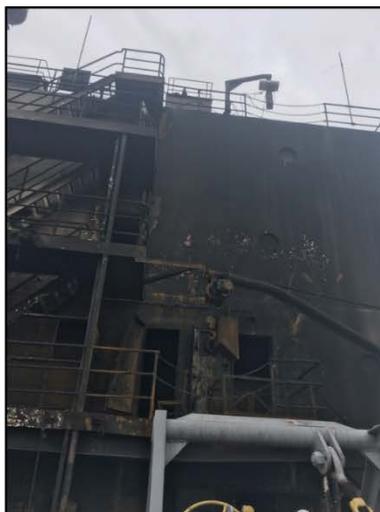
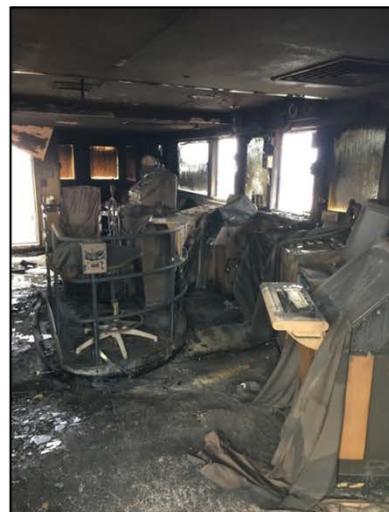
The fire burned within the engine room spaces, the entire superstructure, and the self-unloading belt throughout the port- and starboard-side conveyor tunnels to the bow, as well as onto the cargo conveyor boom belt above the main deck.

Fire damage to the vessel: (left) cargo conveyor boom, (center) stern of the deckhouse, and (right) the bridge.

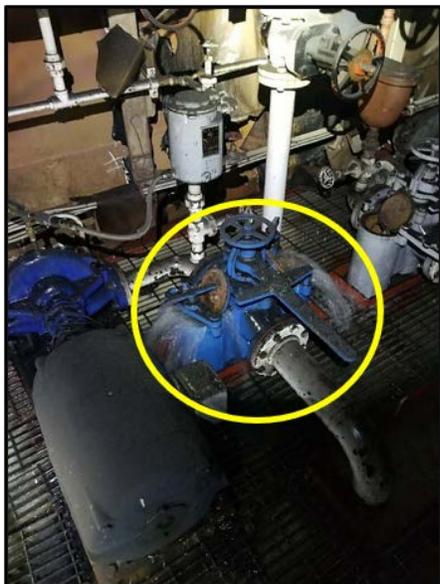
After the fire was extinguished, the vessel's engine room was found flooding from the emergency fire pump's strainers and sea chests, which were open for layup. The pump's sea valve was electrically controlled and designed to fail open during a loss of power. During the fire, the vessel lost shore power, which actuated the opening of the valve and thereby allowed a steady ingress of water through open strainers and sea chests. Eleven days passed before divers were able to temporarily plug the main sea chest and close internal valves to stop the flooding. The water that entered the vessel was removed with portable pumps.

As encircled, the seawater duplex strainer to the emergency fire pump in the lower level of the engine room leaking water. (Source: Coast Guard)

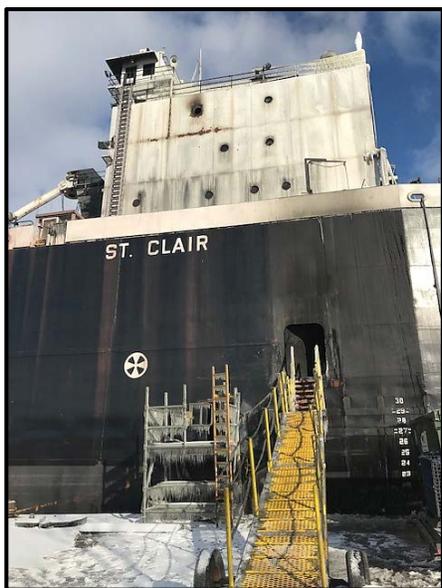
Portside gangway entrance following the extinguishing of the fire.

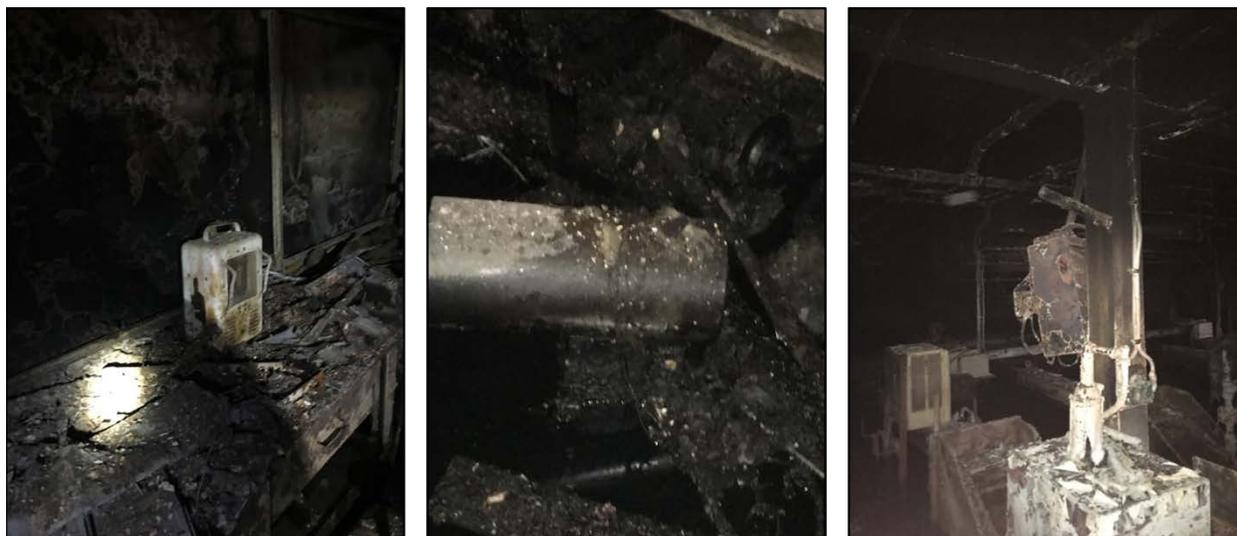
Space heaters located in the engine room break area following the fire: (left) an electric heater on the workshop bench, (center) a propane heater on the deck of the workshop, and (right) a fixed electric heater located forward of the steering gear.

The National Transportation Safety Board determines that the probable cause of the fire aboard the bulk carrier *St. Clair* was the ignition of combustible material in the vicinity of an engine room workshop likely due to the use of portable space heaters or smoldering smoking materials, which spread to other areas of the vessel. Contributing to the extent of the fire damage was the lack of operating procedures for continuous active monitoring of the vessel while in layup status.

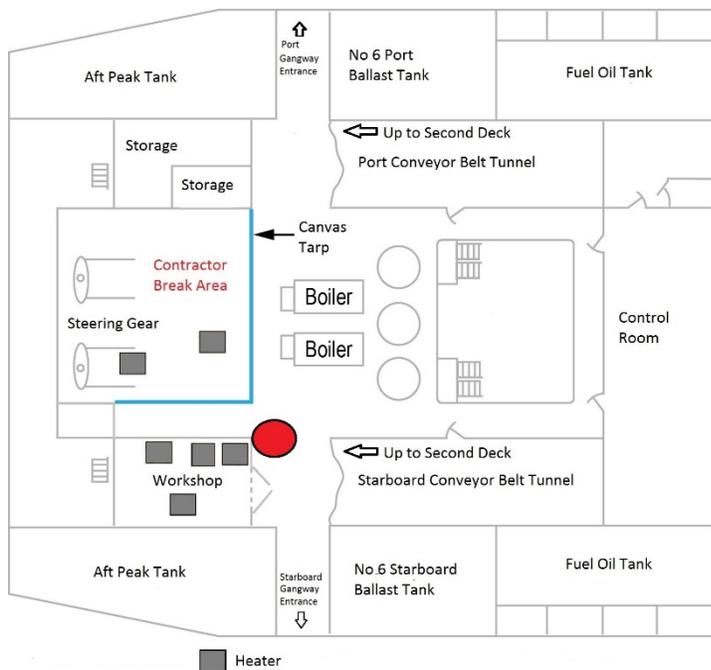
Fire Damage. The investigation into the fire identified a significant amount of damage within the vessel. The engine room, the second deck (where the port- and starboard-side tunnel conveyor belts, port- and starboard-side cross belts, and incline conveyor belt were located), and the entire deckhouse were severely damaged by fire. All the conveyor belts within the vessel were completely burned. Investigators noted that the smoke and fire damage was also located with the forward ladder trunk and all the cargo holds. The most extensive fire damage discovered were fractures in the overhead of the third deck, which was the second deck. These fractures were located just outside and above the workshop.

A red circle identifies the structural fire damage on the third deck (not drawn to scale).

Given the location of the hot work and based on the structural damage found during the investigation, the fire appeared to have originated just outside the workshop on the third deck on the starboard side of the engine room where the contractors regularly took their breaks. While numerous possible sources of ignition were identified in this area—including the propane heater, permanent (hardwired) and portable electric heaters, and heat lamps, as well as cigarette smoking in the break area—the exact source could not be determined. However, there was a lot of combustible material in this area, including wood and the lubricants used in the engine room. As the fire grew and became stronger, heat was transferred through the steel deck above and into the spaces on the second deck. At some point as the fire grew, the conveyor belt on the second deck was ignited. After the conveyor belt caught fire, it provided a path for the fire to expand forward to the bow and up into the deckhouse and onto the cargo boom.
