National Transportation Safety Board

Marine Accident Brief

Overpressurization and Rupture of Cargo Tank on Cargo Vessel *Fairchem Filly*

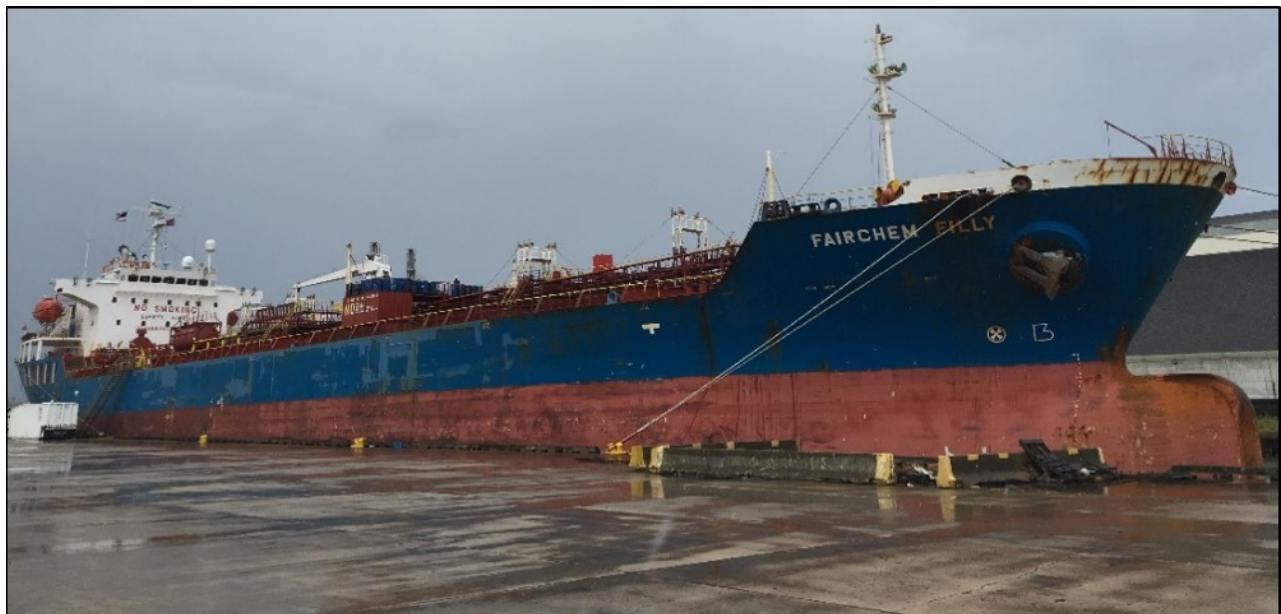
Chemical tanker *Fairchem Filly* after the accident in Galveston, Texas.

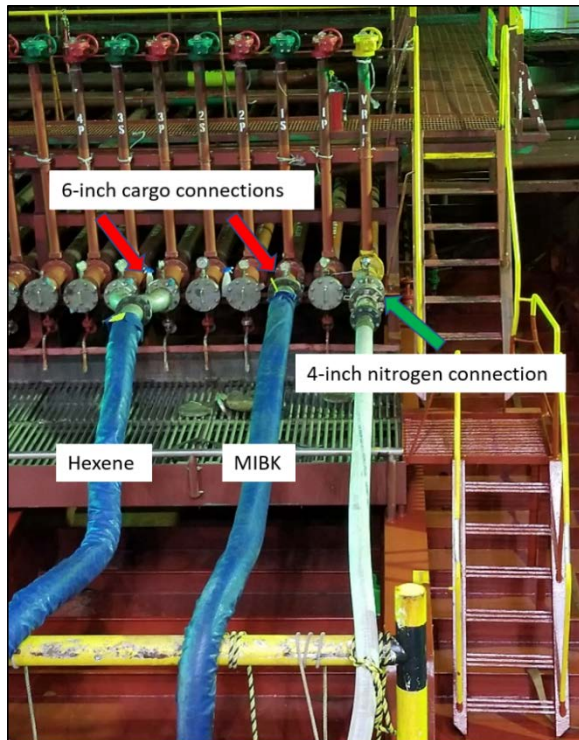
Cargo manifold configuration on board the *Fairchem Filly* at the time of the accident. (Source: Vopak)

Utilizing the shoreside crane, Vopak’s dockman and the *Fairchem Filly*’s pumpman began making hose connections. The 6-inch hexene and MIBK cargo discharge hoses were connected directly to flanges on board the vessel. A 4-inch nitrogen hose was connected via a reducer to the vessel’s 6-inch vapor recovery line. To control the flow of the nitrogen, the shore used a 4-inch gate valve, and the vessel used a 6-inch butterfly valve. The ship’s pumpman was assigned to operate the cargo manifold valves on the ship, including the nitrogen supply valve, and the Vopak PIC was responsible for the shore valves. All hoses were connected by 0540, and shortly afterward, the terminal completed a personnel shift change. The relieving dockman assumed the role of Vopak PIC from the dock supervisor and completed a handover with his counterpart. There was no requirement to inform the vessel of the shift change at that time, and no attempt was made. Over the next hour, terminal employees on the dock made physical checks of the cargo hoses and communicated with the terminal control room to verify that the terminal’s piping system was lined up correctly.

Although both the terminal and operator of the vessel had procedures and control measures in place that clearly outlined a nitrogen blanketing operation, the procedures were not followed on the day of the accident. The terminal’s crew had work instructions that required that a 2-inch nitrogen hose be used to transfer liquid cargo, and the ship’s QHSE manual required its crew to use a 1-inch hose or orifice. However, on the day of the accident, a 4-inch nitrogen hose was

connected to the vessel with no orifice, which removed engineered controls designed to limit the flow rate of nitrogen to the cargo tanks safely below their relief capacity. Additionally, the ship's QHSE guidelines included a "Nitrogen Handling Checklist," which outlined the flow rate and other information associated with a nitrogen operation, but the ship's crew did not complete this checklist on the day of the accident. Had the crew referenced this checklist, it is likely that they would have known that the potential flow rate of nitrogen would have exceeded the cargo tanks' PV valve relief capacity, and they may have reassessed and corrected the configuration by using the correct hose size or a reducing orifice.

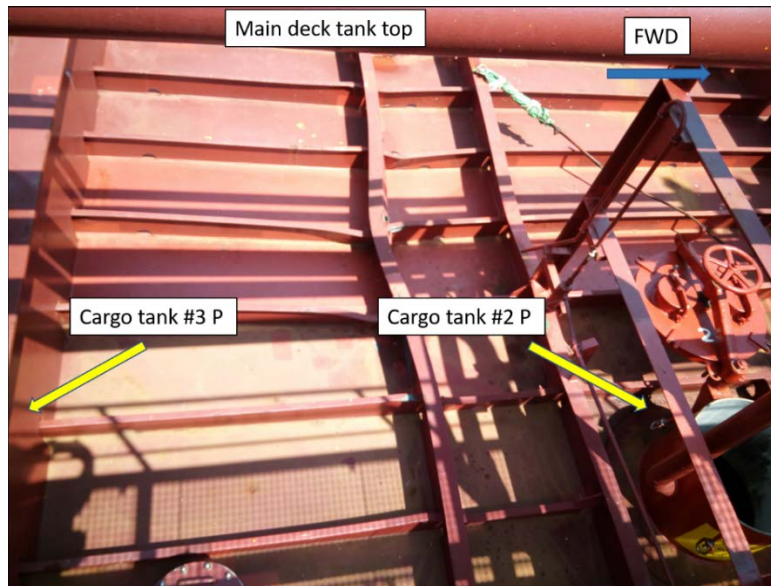
In addition to individual cargo tank pressure indicators in the cargo control room, the *Fairchem Filly* was equipped with an independent cargo vapor pressure-monitoring alarm and recording system, which automatically recorded and stored tank pressure data. After the accident, the system data showed a highest recorded pressure of 15.8 psi (109 kPa) in the 3P and 3S cargo tanks.

Main deck tank top deformation on the port side of *Fairchem Filly*.

Vessel. After the accident, the *Fairchem Filly* proceeded to shipyard for repairs. The overpressurization of the 3P cargo tank caused the transverse bulkhead between 2P and 3P to buckle and ruptured the tank's inner bottom plating. In addition, the tank rupture damaged the bulkhead between the 3P cargo tank and the numbers 2 and 3 port wing ballast tanks. The main deck plating, deck transverse section, and deck longitudinals adjacent to the ruptured cargo tank and damaged ballast tanks were also damaged. Repairs required that all affected steel be cropped out and repaired with new material.

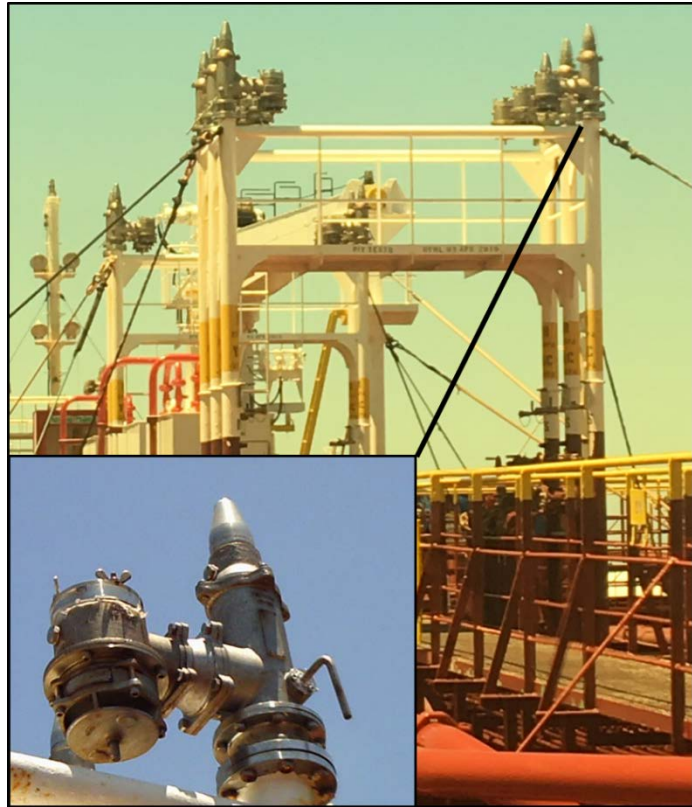
Each cargo tank on the *Fairchem Filly* was protected from low and high pressure by a single bullet-style pressure/vacuum valve (PV valve). The PV valves were set to open at a high pressure of 2.9 psi (20 kPa) or at a low pressure of -0.51 psi (-3.5 kPa). The pipe diameter where the PV valve connected to the tank had an inside diameter of 4 inches. The seat diameter for the pressure relief port was 3.35 inches, and the seat diameter for the vacuum relief port was 5.9 inches. All PV valves on board were successfully overhauled and pressure-tested in early April 2019. In addition, in accordance with the vessel's pre-arrival checks, all the ship's PV valves were manually operated and visually inspected 10 days prior to the accident, when they arrived in Galveston anchorage, with no deficiencies noted.

Pressure/Vacuum valves on board the main deck of the *Fairchem Filly*.

Relief valves are fitted to cargo tanks to protect the tanks from an overpressurization event. The ship’s PV valves were overhauled and pressure-tested in April 2019 and had been inspected 10 days prior to the accident, with no deficiencies noted. Therefore, it is likely that the PV valves performed as designed. The terminal had no recent history of terminal equipment failure.
