MARINE TRANSPORTATION SAFETY INVESTIGATION REPORT M17C0179

BOTTOM CONTACT AND SUBSEQUENT FLOODING

Passenger vessel *Island Queen III*
Kingston, Ontario
08 August 2017

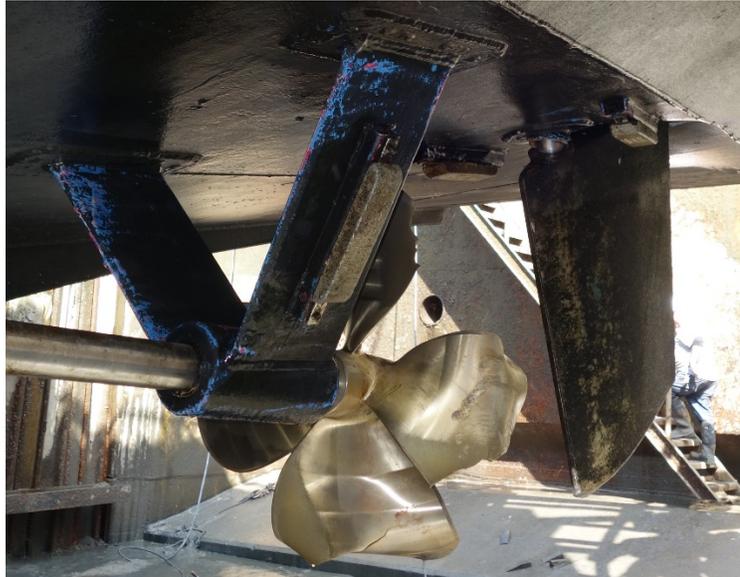
Figure 3. Damage to port propeller and rudder (Source: TSB)

The grounding deformed the vessel's keel from amidships to the stern, with tearing near amidships. The port propeller was damaged (Figure 3), as well as its tail shaft and shaft strut. The port rudder was pushed aft, bending the port rudder stock and deforming the hull surrounding the rudder stock. The top of the port rudder also punctured the hull at the steering compartment, creating an L-shaped opening measuring approximately 20 cm by 40 cm and pushing the shell plating upward approximately 15 cm (Figure 4). Nearby hull stiffeners and the bulkhead separating the steering compartment and stern storage were also damaged.

When the vessel made bottom contact, the port engine stalled. Once the engine was restarted, it was operated at a maximum of 900 rpm, as above 900 rpm significant vibration was felt throughout the ship. The engine's usual maximum is 1900 rpm.

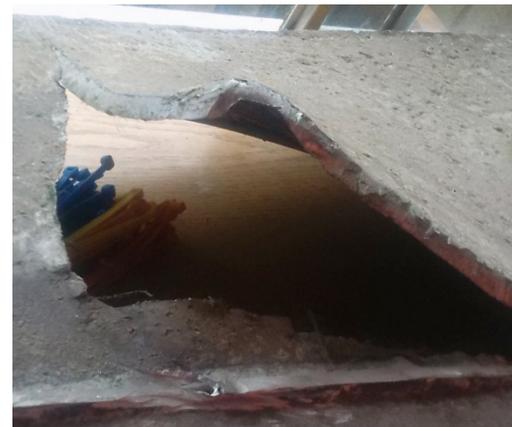
Figure 4. Section of bottom shell plate punctured by rudder (Source: TSB)

Once the master observed that the vessel was north of the planned route, he made a series of small corrections to return the vessel to the centre of the channel; however, there was limited time and distance to correct the vessel's course. When the master applied corrections to the vessel's course, they were not early enough or significant enough to return the vessel to its intended track. As the vessel's bow swung toward the centre of Whiskey Cut, the vessel's stern made contact with the bottom on the north side of Whiskey Cut, near Cartwright Point, puncturing the bottom shell plating.
