Marine Transportation Safety Investigation Report M19P0246

GIRDING AND SINKING

Tug *Sheena M* and barge *Seaspan 566*
Williamsons Landing, British Columbia
01 October 2019

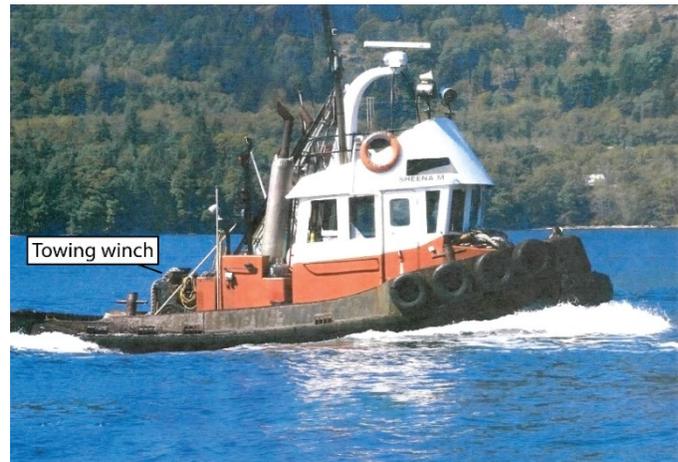
Figure 1. *Sheena M* (Source: Active Marine Towing Ltd., with TSB annotations)

The *Sheena M* was a twin-screw steel-hulled tug of 9.99 gross tonnage (GT) that was built in 1981 and owned by Active Marine Towing Ltd (Figure 1), which was also the authorized representative. It was powered by 2 diesel engines of 447 kW total power and had a towing winch located aft on the centreline. The *Sheena M* was normally used to tow log booms; it had also towed 500-series Seaspan barges on numerous occasions. The tug was crewed by a master and a deckhand.

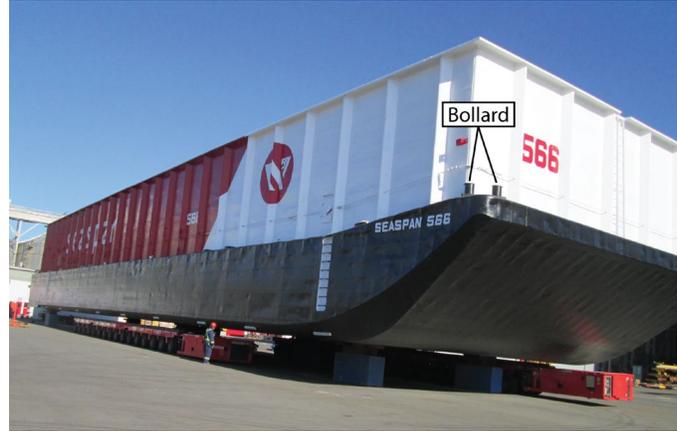
Figure 2. Seaspan 566 (Source: Seaspan ULC, with TSB annotations)

The *Seaspan 566* is a non-propelled unmanned steel barge of 883 GT with a cargo capacity of 2500 short tons (Figure 2). On the occurrence voyage, the barge was loaded with 2159 short tons of wood chips and had a draft of 2.25 m, an aft trim of approximately 20 cm, and a starboard list of approximately 3 cm.

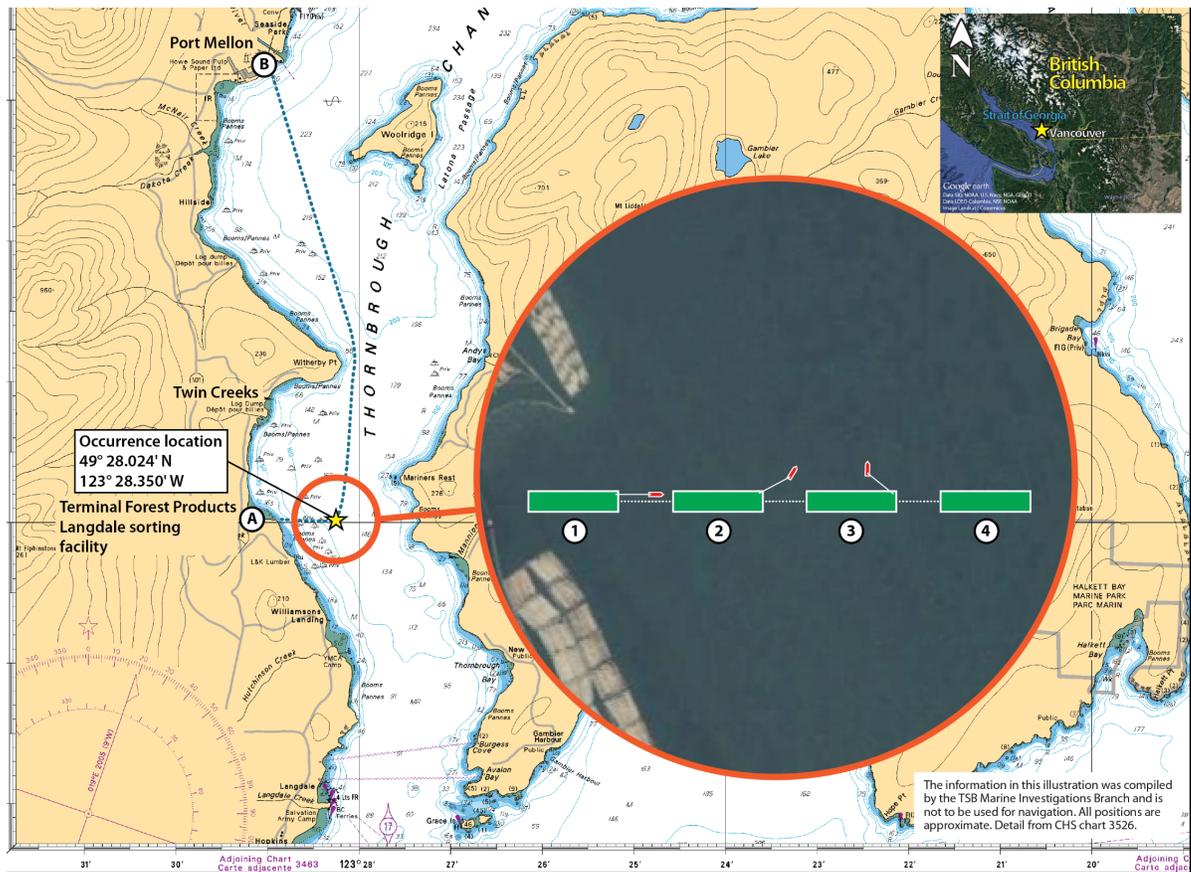
Figure 3. Area of the occurrence (Source: Canadian Hydrographic Service and Google Earth, with TSB annotations)

Soon after the master and deckhand escaped the capsized tug, the towline parted and the *Sheena M* sank at position 49°28.025' N, 123°28.350' W (Figure 3). After the towline parted, the barge drifted in the vicinity of the Terminal Forest Products facility. The deckhand swam to a nearby tied-up log boom, and the master swam to the barge *Seaspan 566* and climbed on board using a ladder attached to the barge.

- A Barge loading location – Terminal Forest Products facility at Langdale
- B Barge destination – Howe Sound Pulp and Paper Mills at Port Mellon
- 1 Tug tows barge into the channel
- 2 Tug makes the port turn towards Port Mellon
- 3 Barge does not follow port turn; tug girds and capsizes
- 4 Barge continues ahead under its own momentum and then drifts unattended once the towline parts
