Report on the investigation of the loss of
42 containers from the container ship

Ever Smart

700 miles east of Japan, North Pacific Ocean

30 October 2017

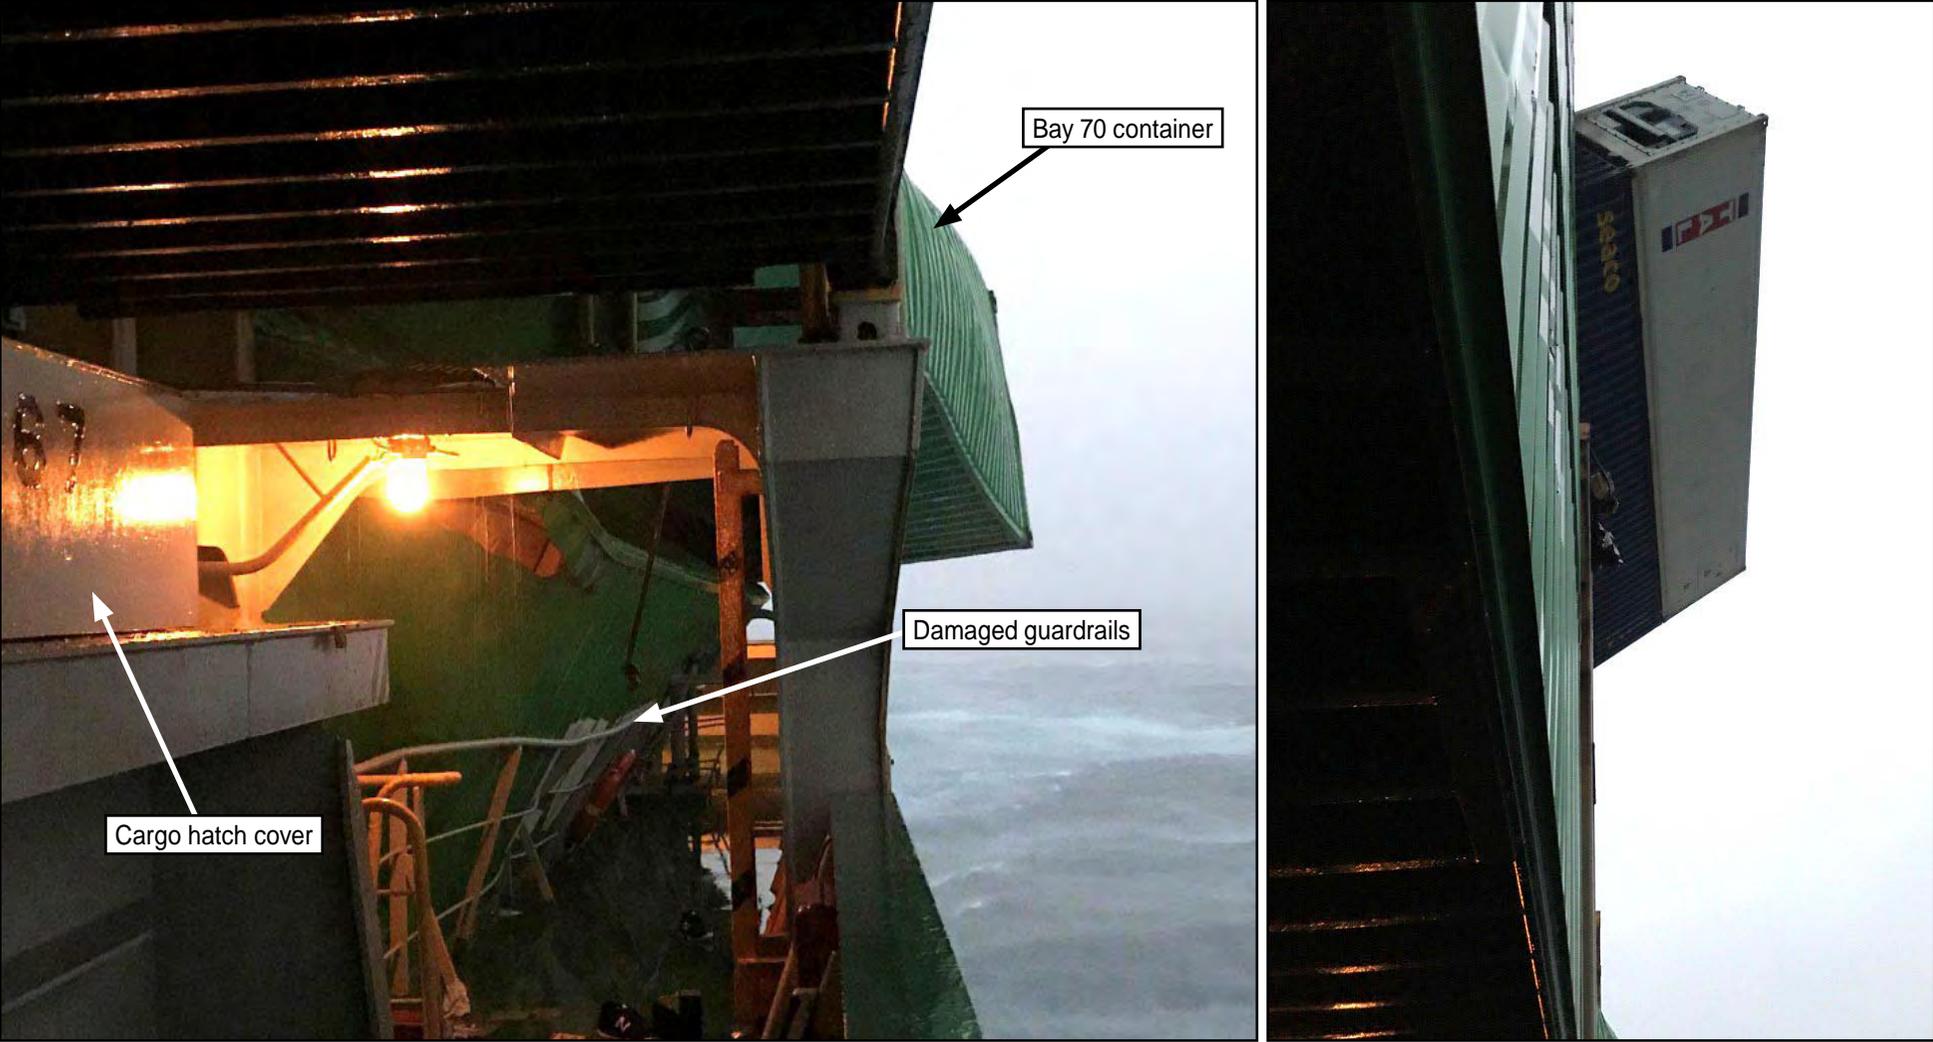
At 1648, one of the deck crew discovered that the container stacks in the ship's aftermost bay, bay 70 (**Figure 2**), had collapsed, and reported this to the C/O using a hand-held radio. The C/O called the master to the bridge and, once relieved, went aft to investigate.

Figure 2: Collapsed containers discovered in the afternoon of 30 October

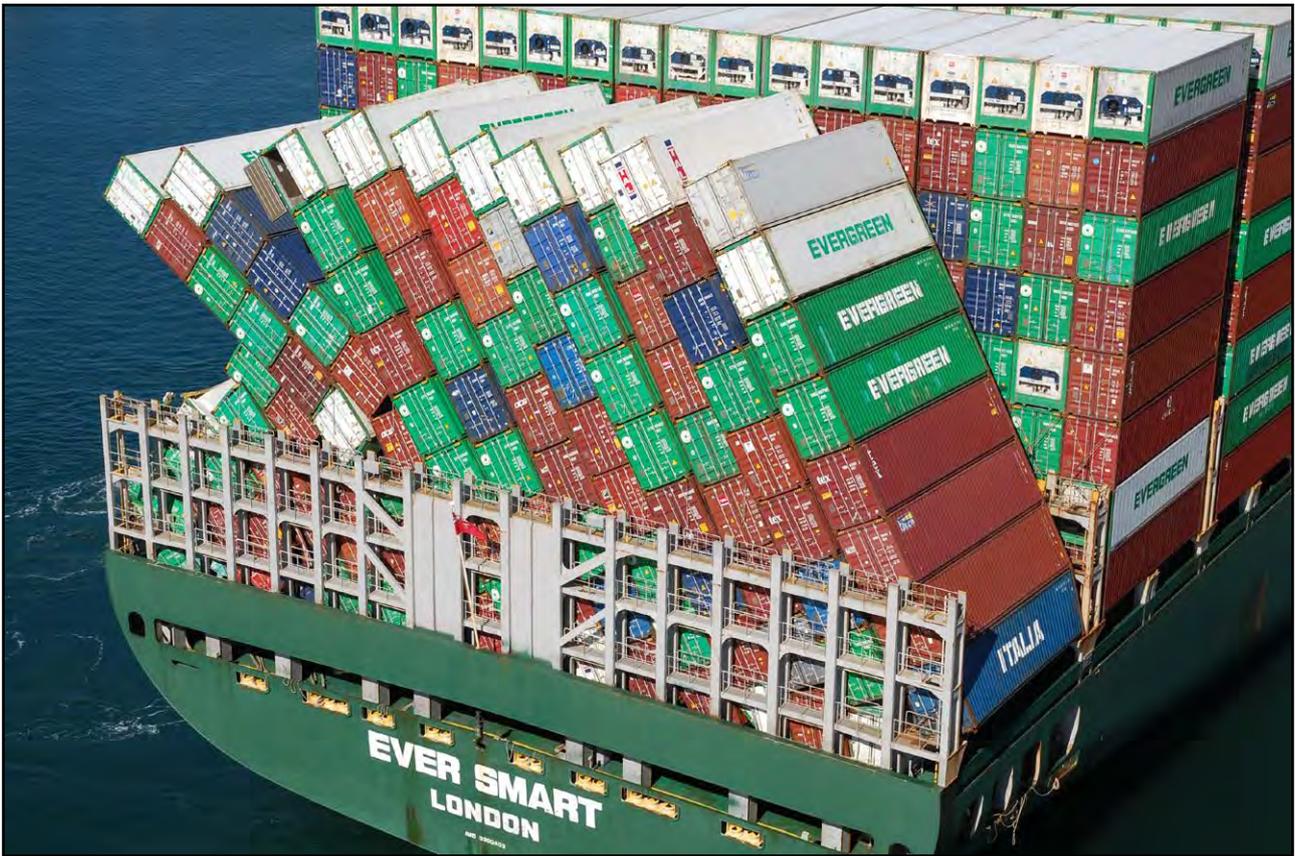
When the C/O arrived on the aft deck he discovered that all 17 of the container stacks stowed in bay 70 had toppled over to port (**Figure 3**). The two bottom tiers on the port side were crushed, three containers were hanging over the side of the ship and some were missing. The deck containers forward of bay 70 were checked and none were found to be missing or damaged.

Figure 3: Bay 70 container stow collapse to port

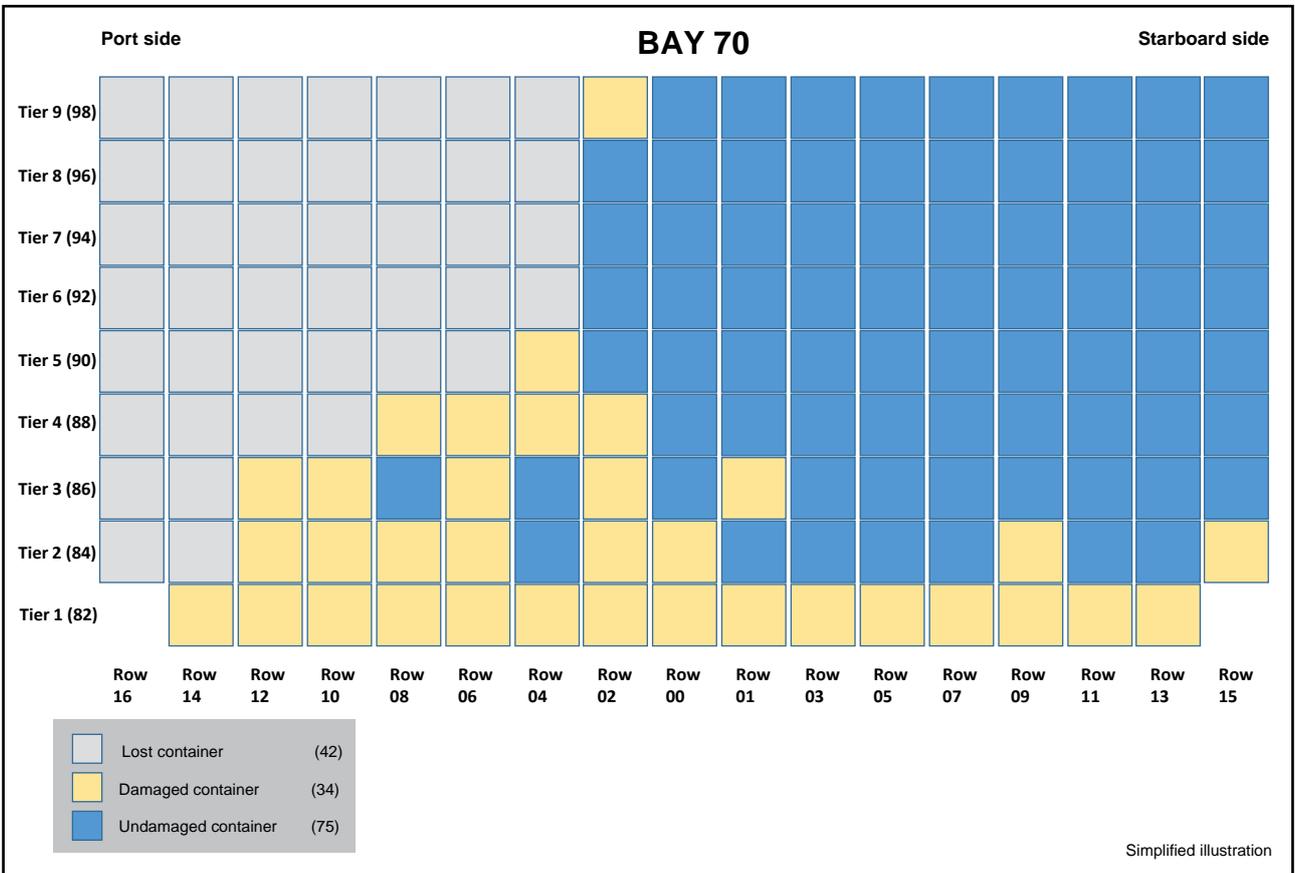
The next morning (31 October), *Ever Smart's* C/O inspected bay 70 and counted 42 containers missing (**Figure 4**); two of the containers that were previously hanging over the ship's side had disappeared overnight. The ship's aft structure was inspected, and no significant damage was found. The ship continued on passage and arrived in Los Angeles on 8 November and went to anchor for an initial damage assessment.

Figure 4: Aft end of bay 70 showing the original positions of the missing and damaged containers

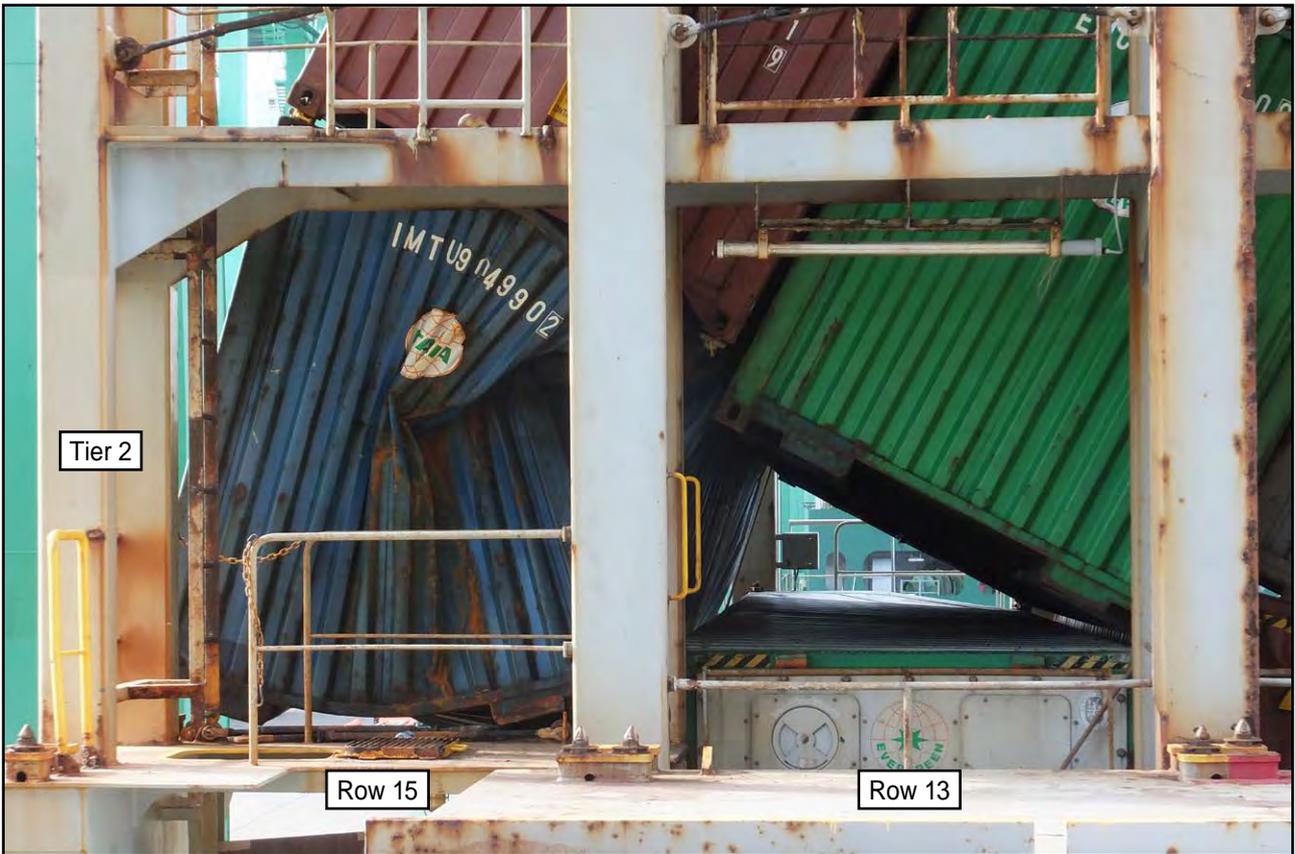
A total of 34 containers were damaged to varying degrees, and some of their doors had sprung open. The forward inboard corner post of the bottom container in bay 70's starboard outer stack (row 15, tier 2) was buckled and had collapsed (**Figure 16**). The container's aft outer corner casting had been torn away but was still attached to the deck by its twistlock (**Figure 17**). The forward outboard twistlock that had secured the container to the deck fitting, had failed. The adjacent container (row 13, tier 2) was undamaged, but the twistlocks between it and the tier 1 container below had failed and it had toppled over.

Figure 16: Bay 70: rows 15 and 13 tier 2 containers

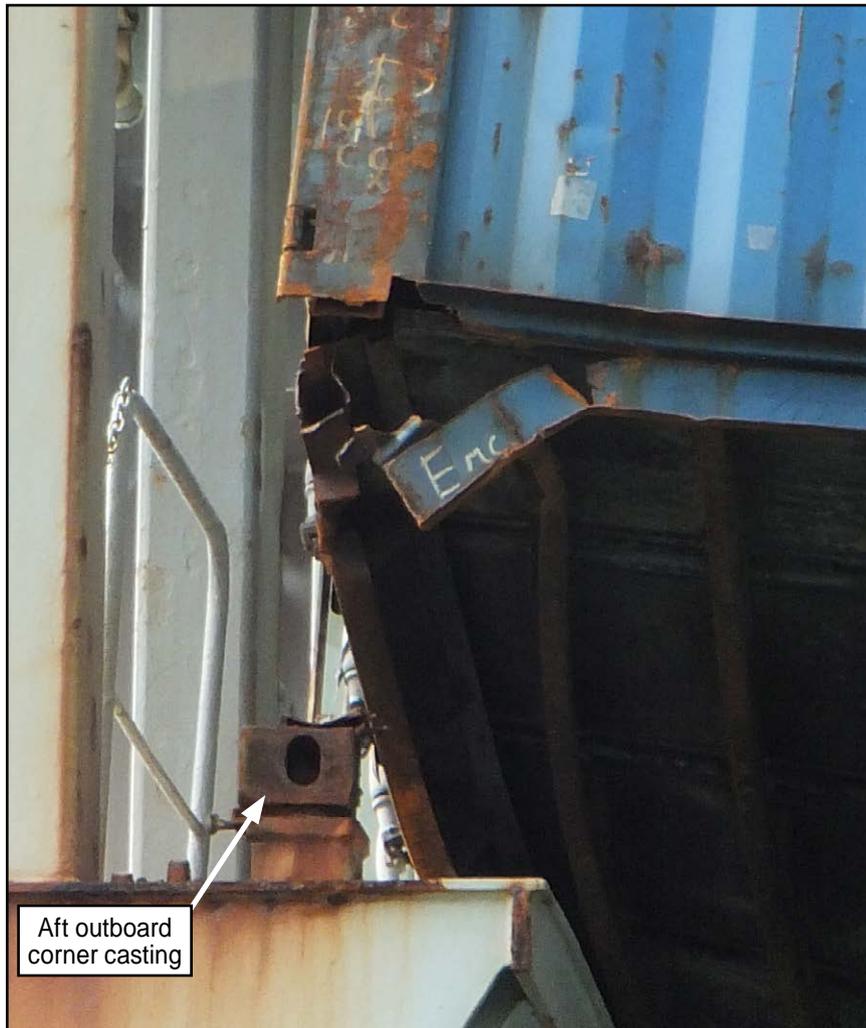
Figure 17: Aft outboard corner casting torn away from bay 70's row 15 tier 2 container

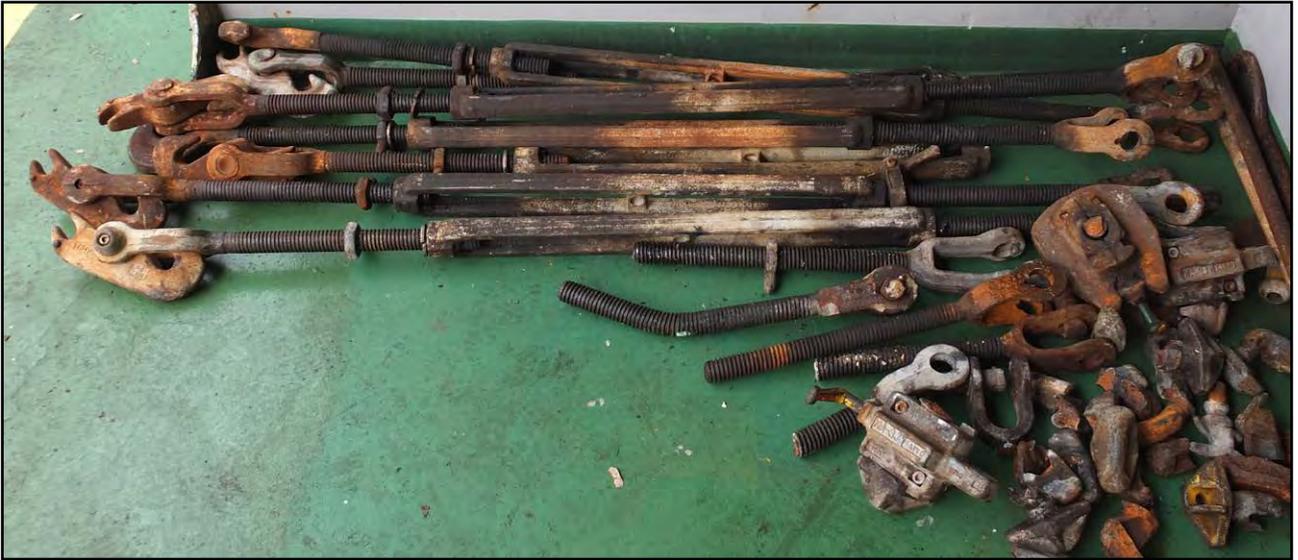
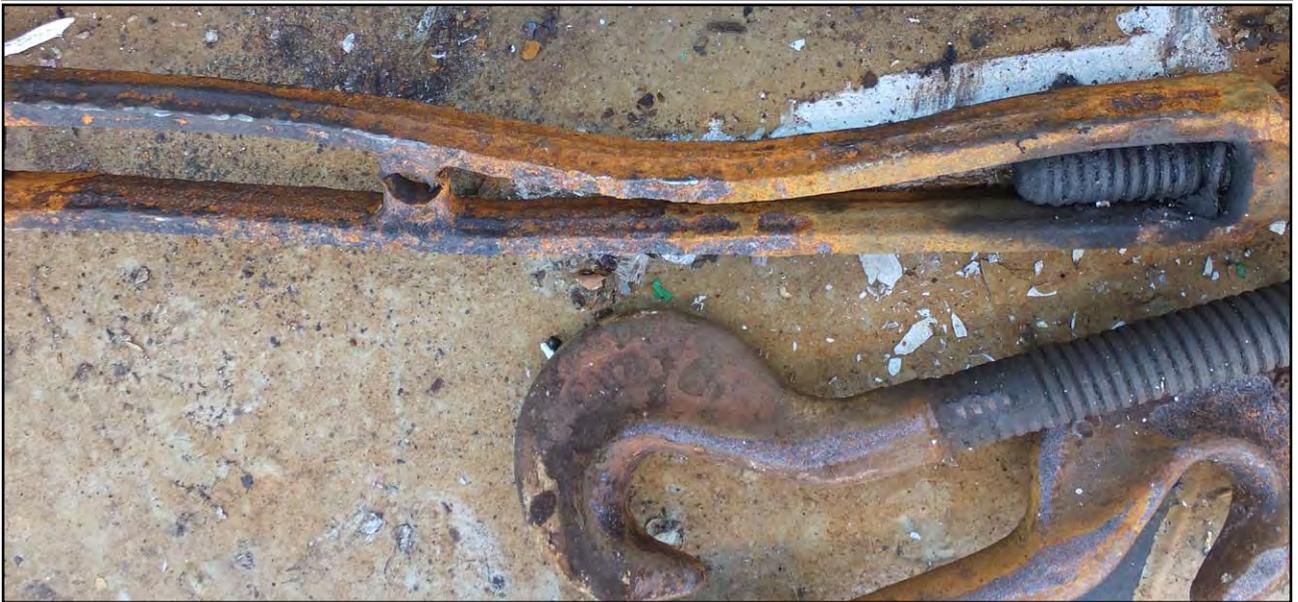
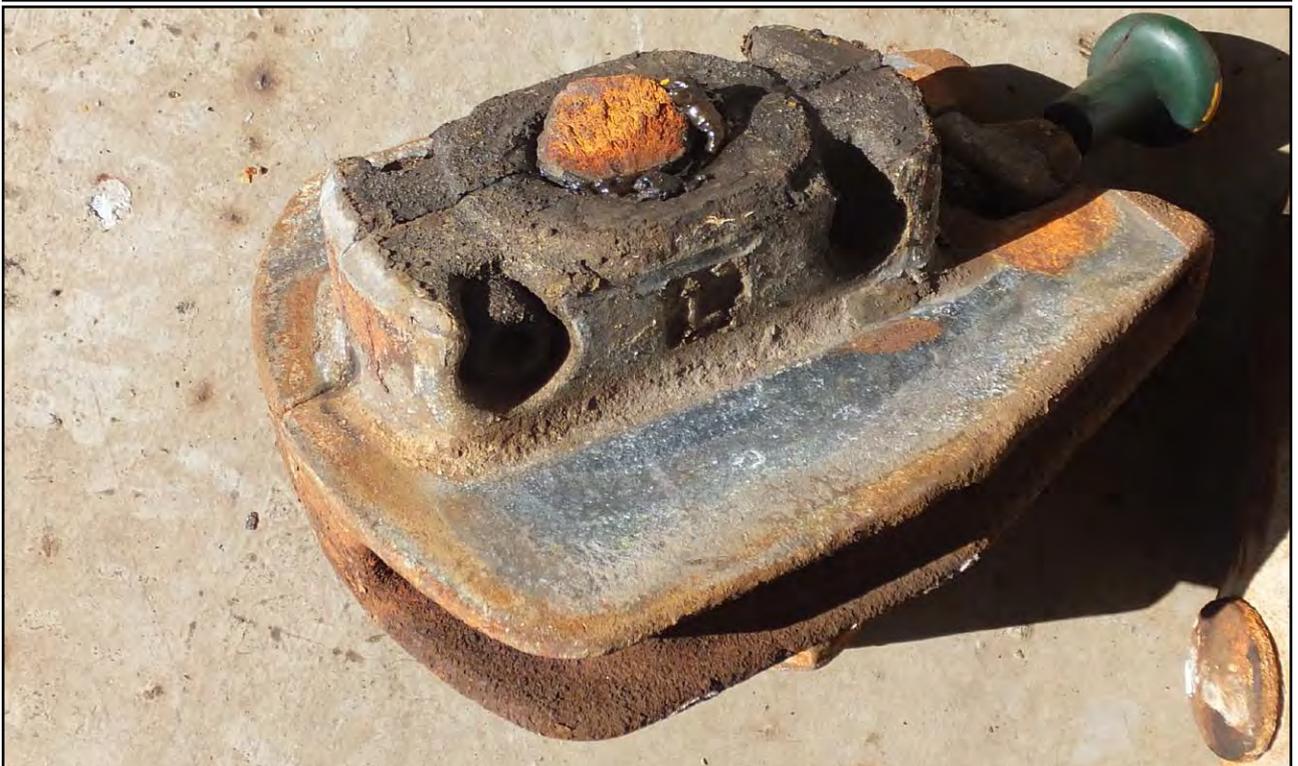
Several broken twistlocks and bent lashing rods and turnbuckles (**Figure 18**) were found close to the damaged containers. In most cases the original location of the lashing equipment could not be determined. Nevertheless, it was evident that the damage had been caused during the container stow collapse.

Figure 18: Bent and damaged turnbuckles, lashing rods and twistlocks

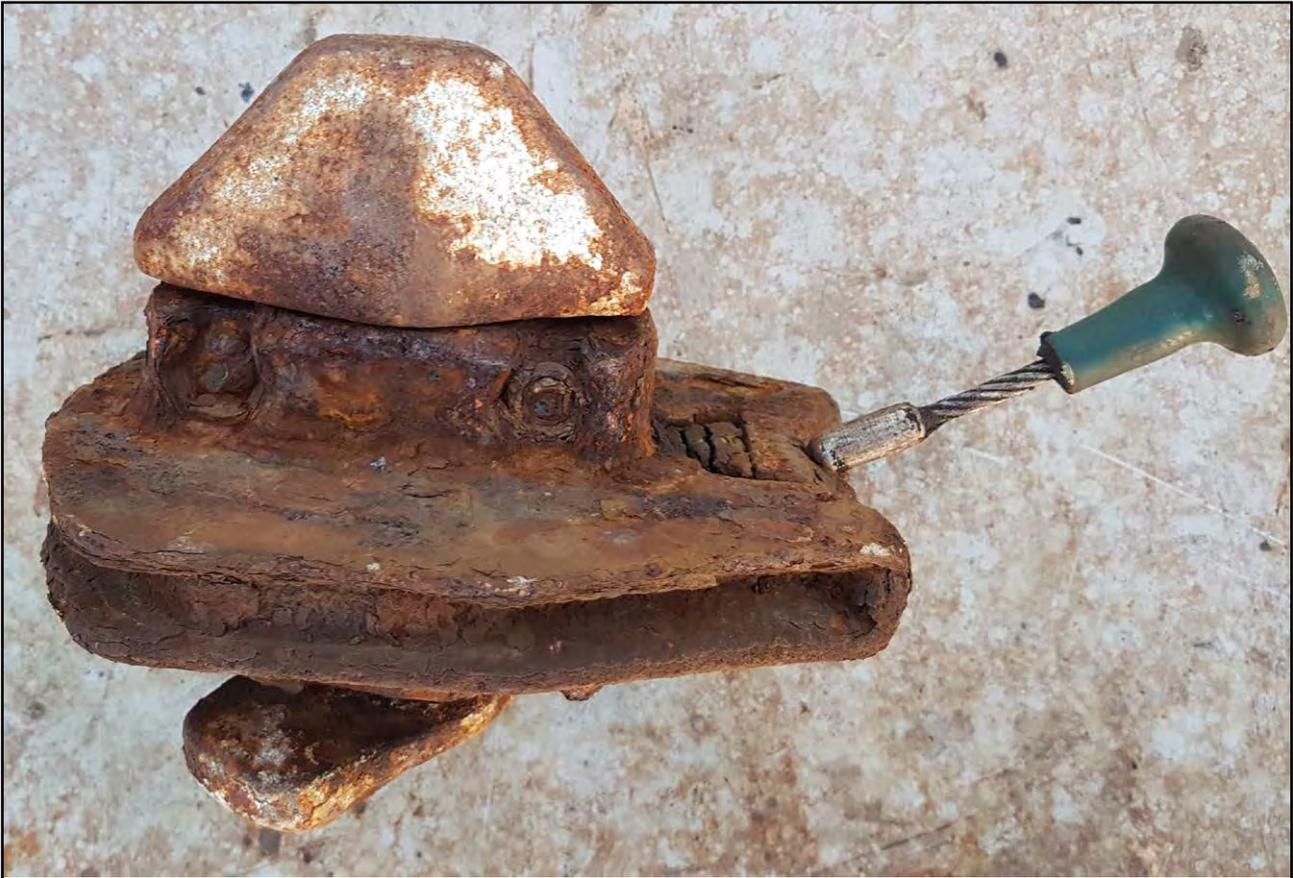
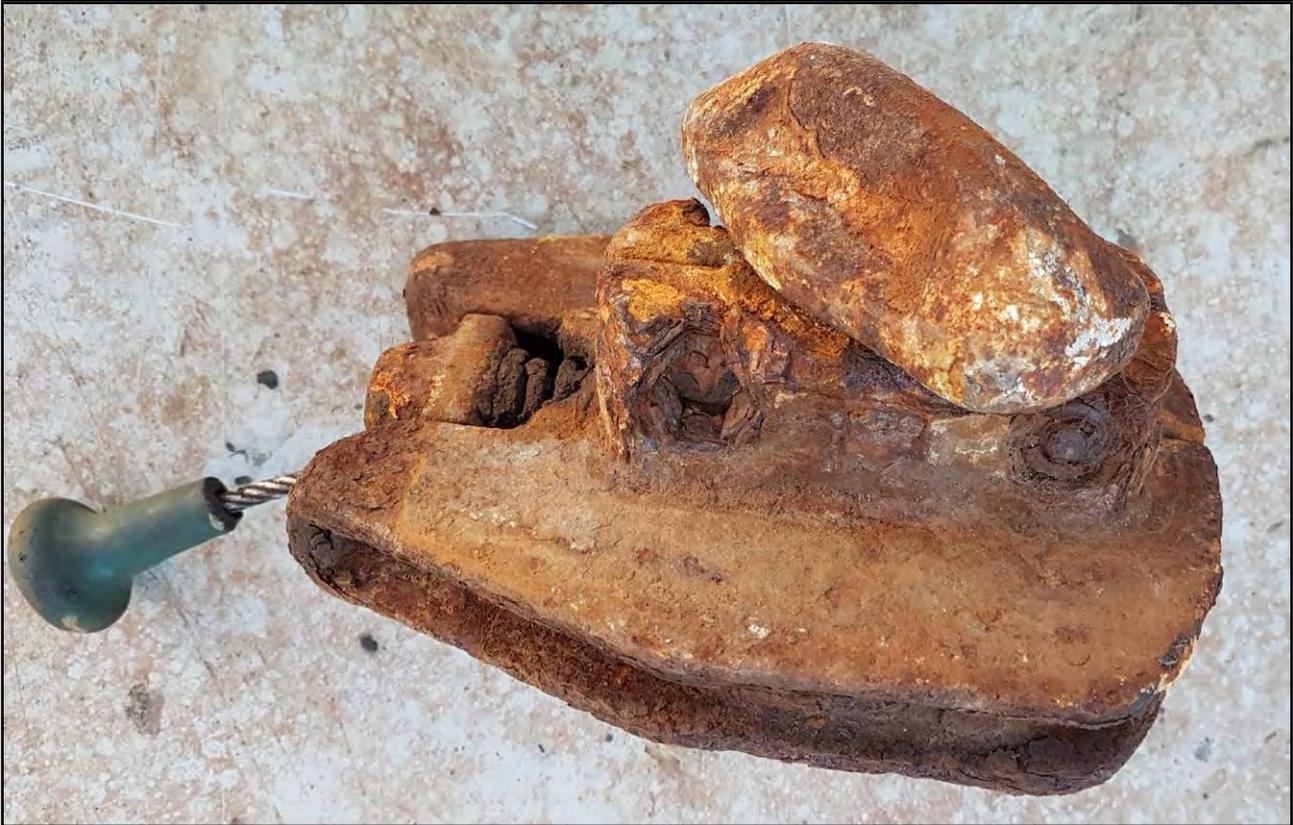
Several of the twistlocks from bay 70 were found to be corroded (**Figure 19**), but their main shafts appeared visually to be in sound condition. The ship's crew advised that twistlocks with that level of corrosion should be considered for disposal when seen.

Figure 19: Corroded twistlocks

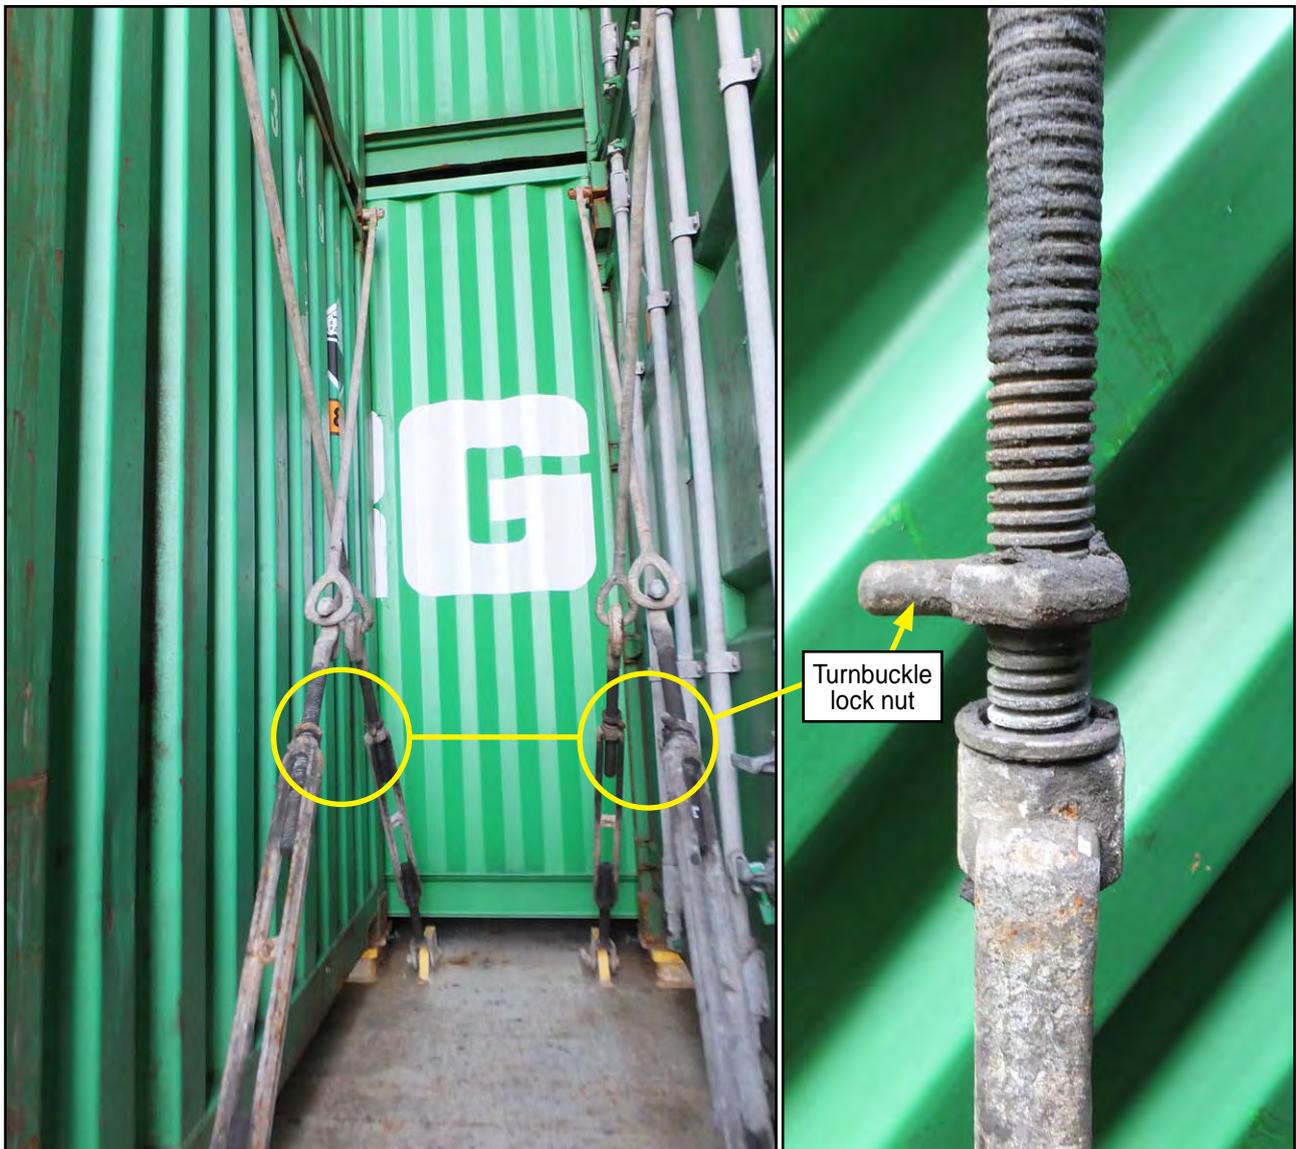
As the containers were being craned ashore, MAIB inspectors checked the lashing arrangements in bays that were not being discharged in Los Angeles. Several of the lashing rods inspected were found to be slack. It was also noted that many of the turnbuckle lock nuts had not been tightened and were loose (**Figure 20**).

Figure 20: Loose turnbuckle lock nuts

Several lashing rods and many turnbuckle lock nuts were found to be loose in unaffected bays during the MAIB's post-accident inspections. It was apparent that the turnbuckle lock nuts had not been applied, rather than vibrated loose, because most were two or three threads clear of their mating surfaces (**Figure 20**). It was therefore likely that the lock nuts had either not been tightened prior to sailing or had not been reapplied after the crew had re-tensioned the lashings during the passage. The former should have been identified and corrected during the crew's daily inspections of the lashings. Releasing and then reapplying the turnbuckle lock

nut each time a lashing rod has to be re-tensioned can be time consuming, however failure to apply the lock nuts increases the likelihood of lashings becoming loose. Loose lashings will increase the risk of contact between container stacks, and allow increased racking forces to act on the containers at the bottom of the stacks.

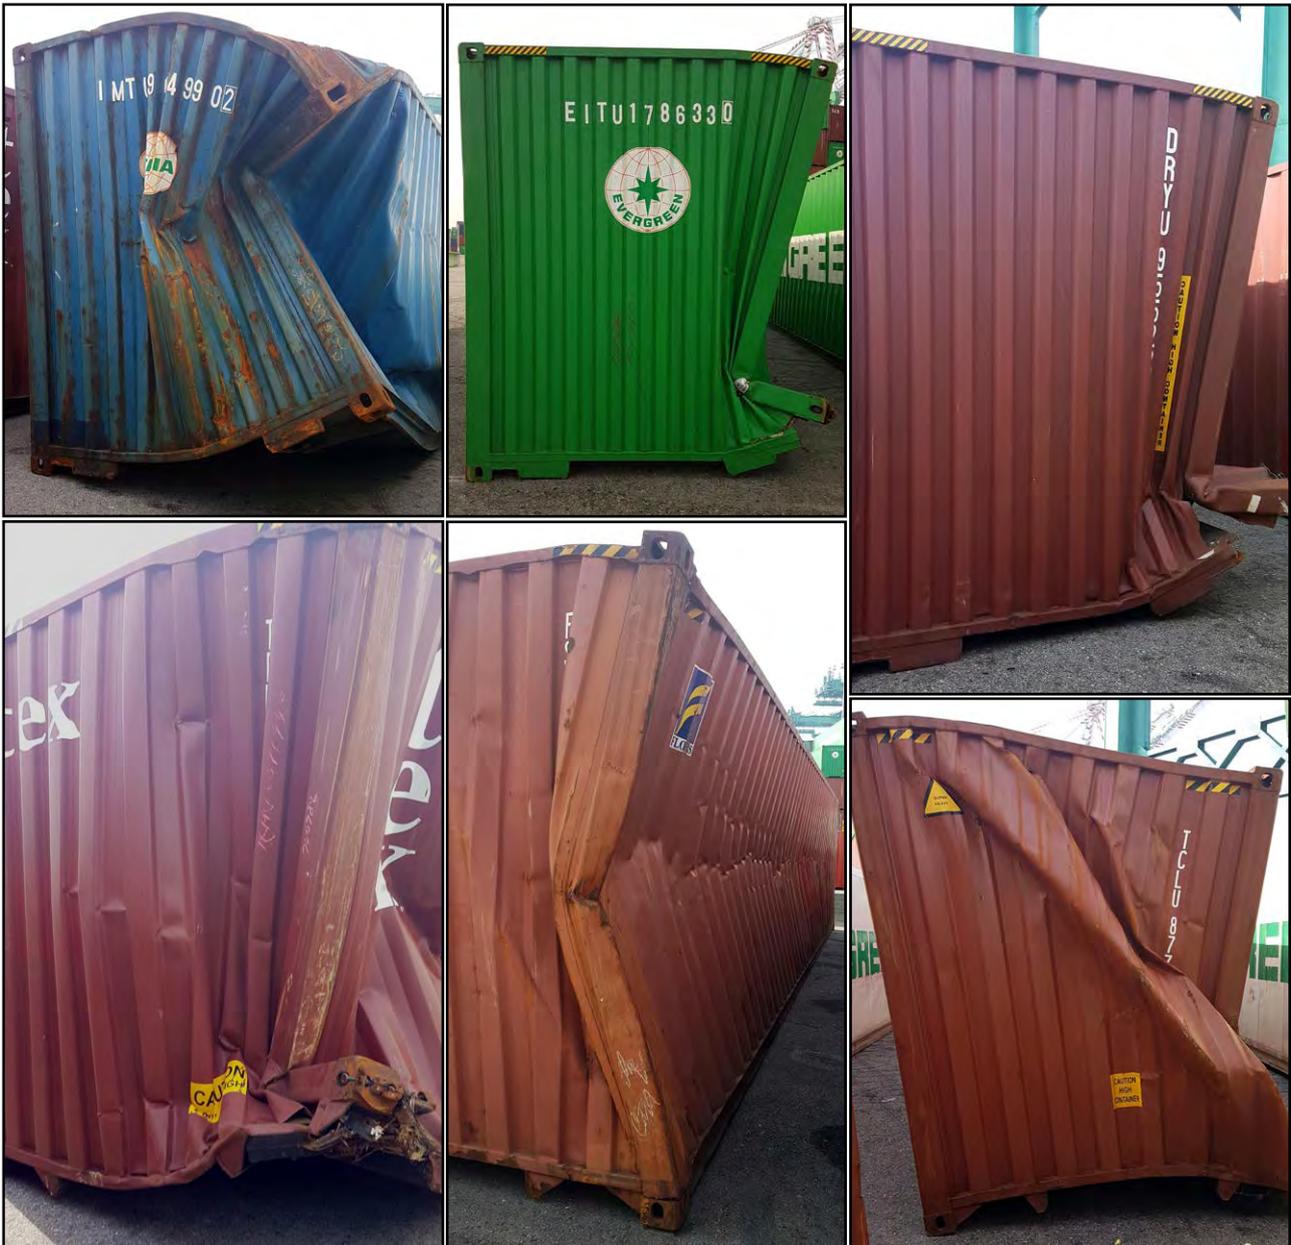
- Most of those stowed in the bottom two tiers had suffered varying degrees of buckling damage to the port forward corner posts (**Figure 21**).
- Some container side walls suffered creasing damage, mainly in line with the corner posts' buckles.

Figure 21: Damage to port forward corner posts of the containers stowed in Bay 70, tiers 1 and 2

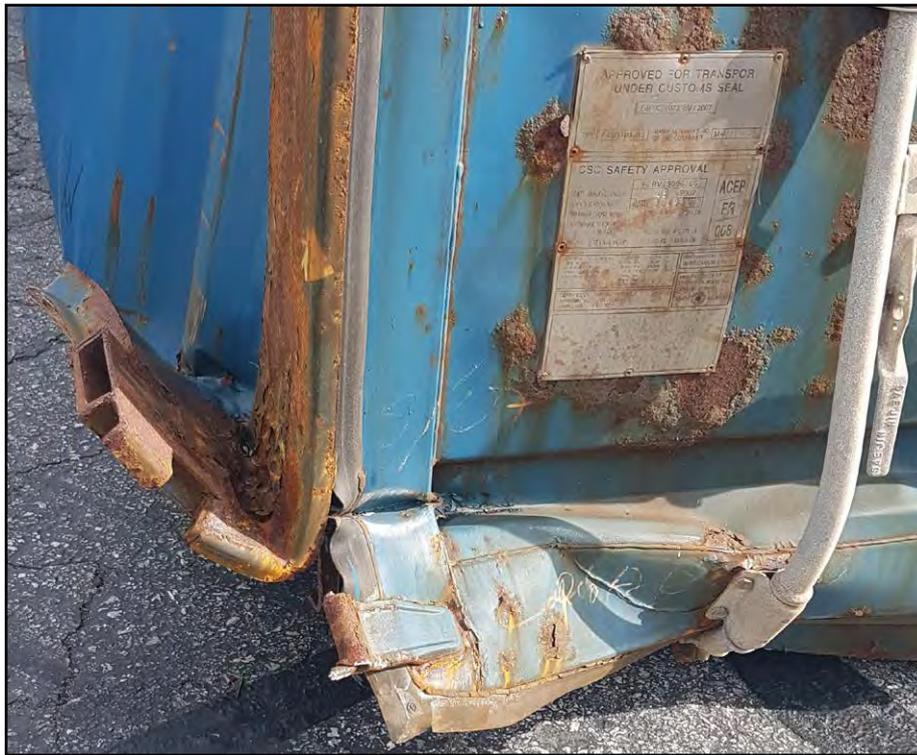
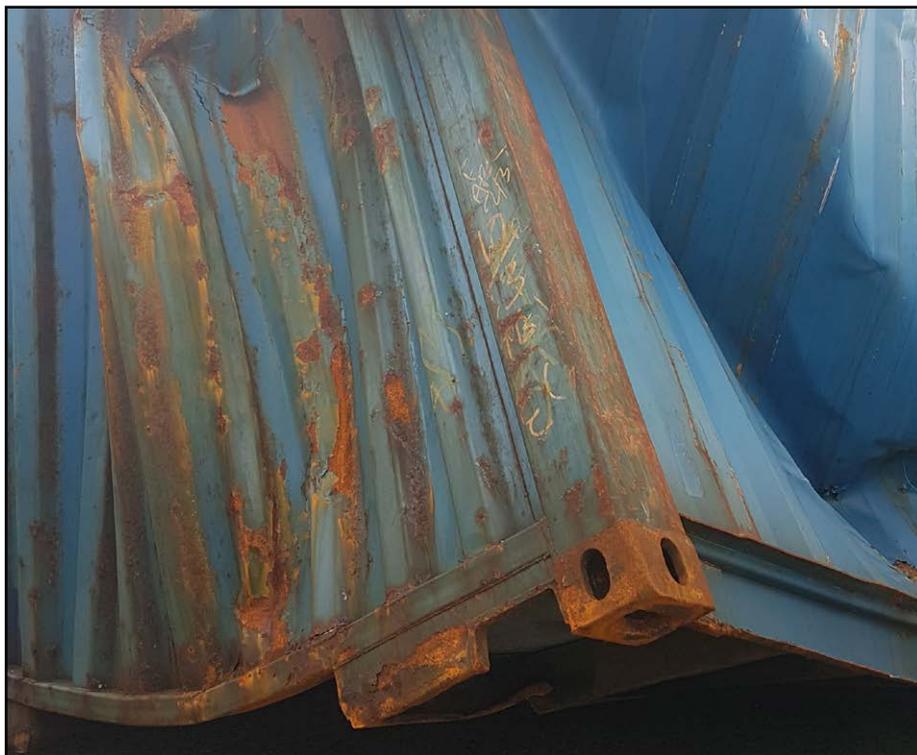
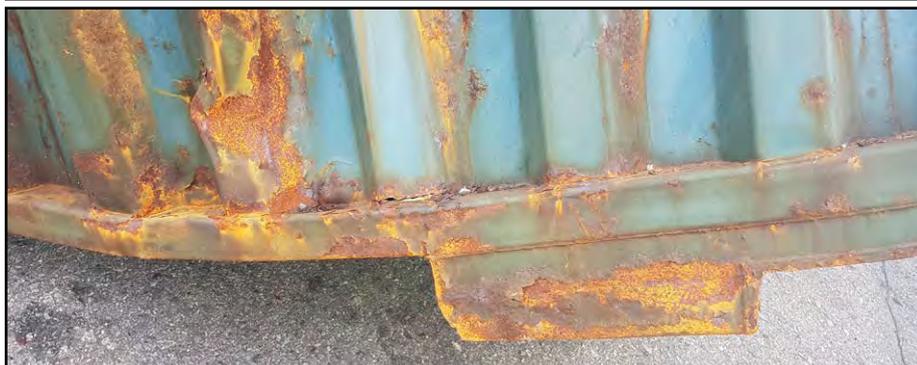
- Several corner castings had been torn from their corner posts.
- Patches of corrosion were visually apparent on the external walls of the container recovered from the bottom of the starboard outer stack (**Figure 22**).

Figure 22: Visually apparent level of corrosion to the container stowed at the bottom of Bay 70's starboard outer stack

All the containers recovered from *Ever Smart's* bay 70 had CSC plates and documentation showing compliance with the ACEP. The bottom container in the starboard outer stack was last inspected on 20 August 2016 (**Figure 27**). It had suffered corrosion and structural damage during its working life and had weld repairs.

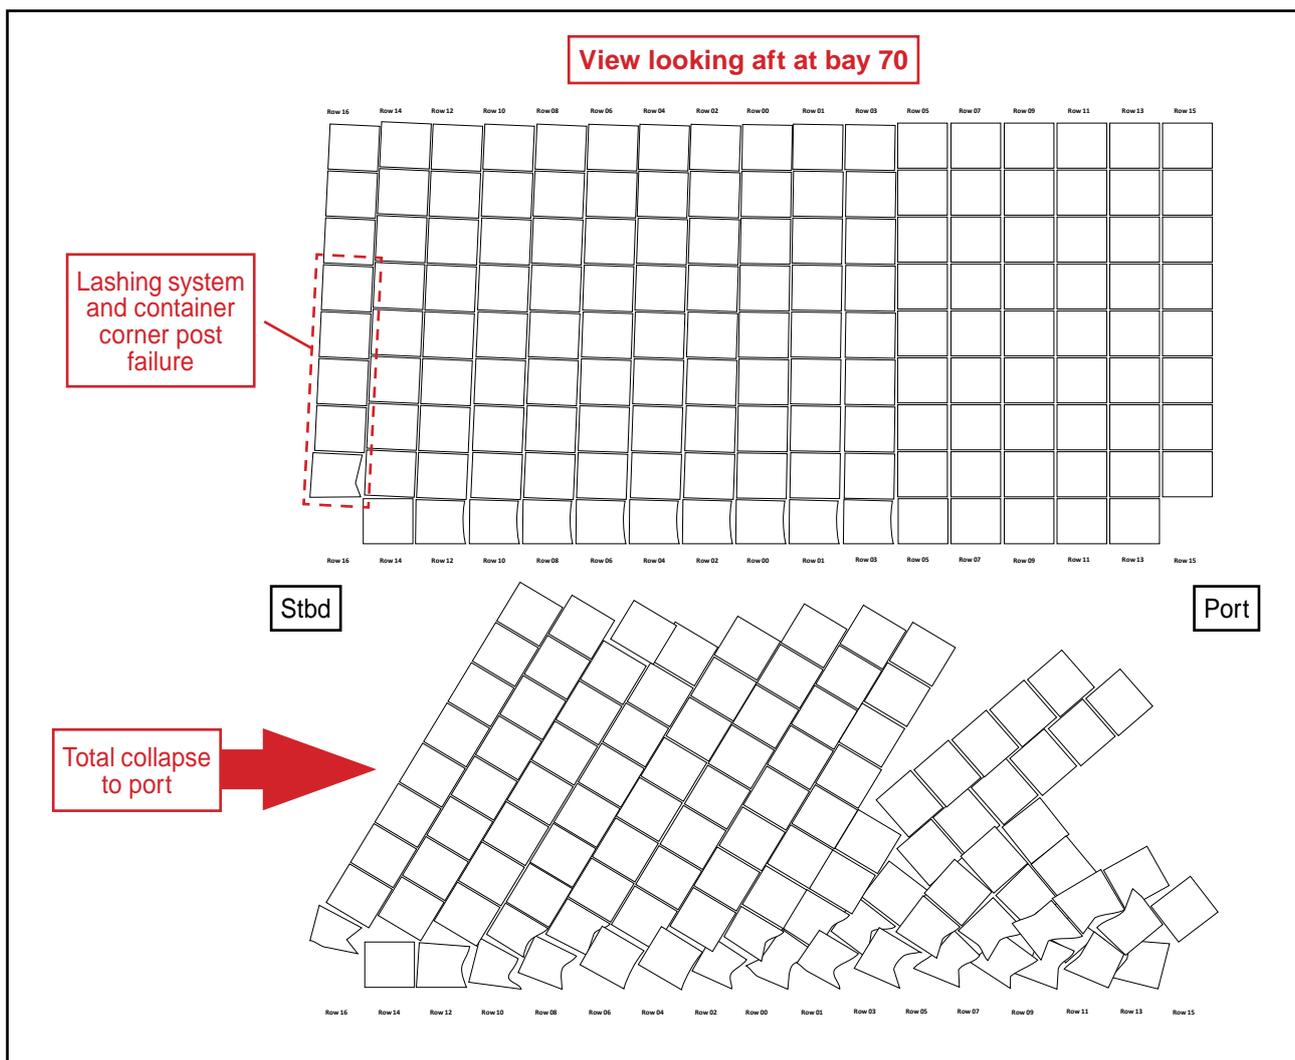
It was apparent that the collapse was initiated in bay 70's starboard outer stack (row 15) and propagated to port due to the forces created as the containers struck each other (**Figure 29**). The container at the bottom of the starboard outer stack was the only one that suffered significant structural damage. Its forward inboard corner post had buckled and its bottom aft outboard corner casting had torn free. The forward outboard twistlock had been pulled from its deck mounting. The containers in the adjacent row (row 13) suffered very little structural damage and toppled to port at tier 2 level. The port side corner posts at the forward ends of the tier 1 containers in the other stacks had all buckled and collapsed.

The evidence might suggest that the collapse was initiated by the structural failure of the bottom container in the starboard outer stack. However, rather than being the cause, the buckling of the container's corner post and the failure of its corner casting might have been the consequence of a lashing system or lashing equipment failure (**Figure 29**).

Figure 29: Likely sequence of the stowage collapse

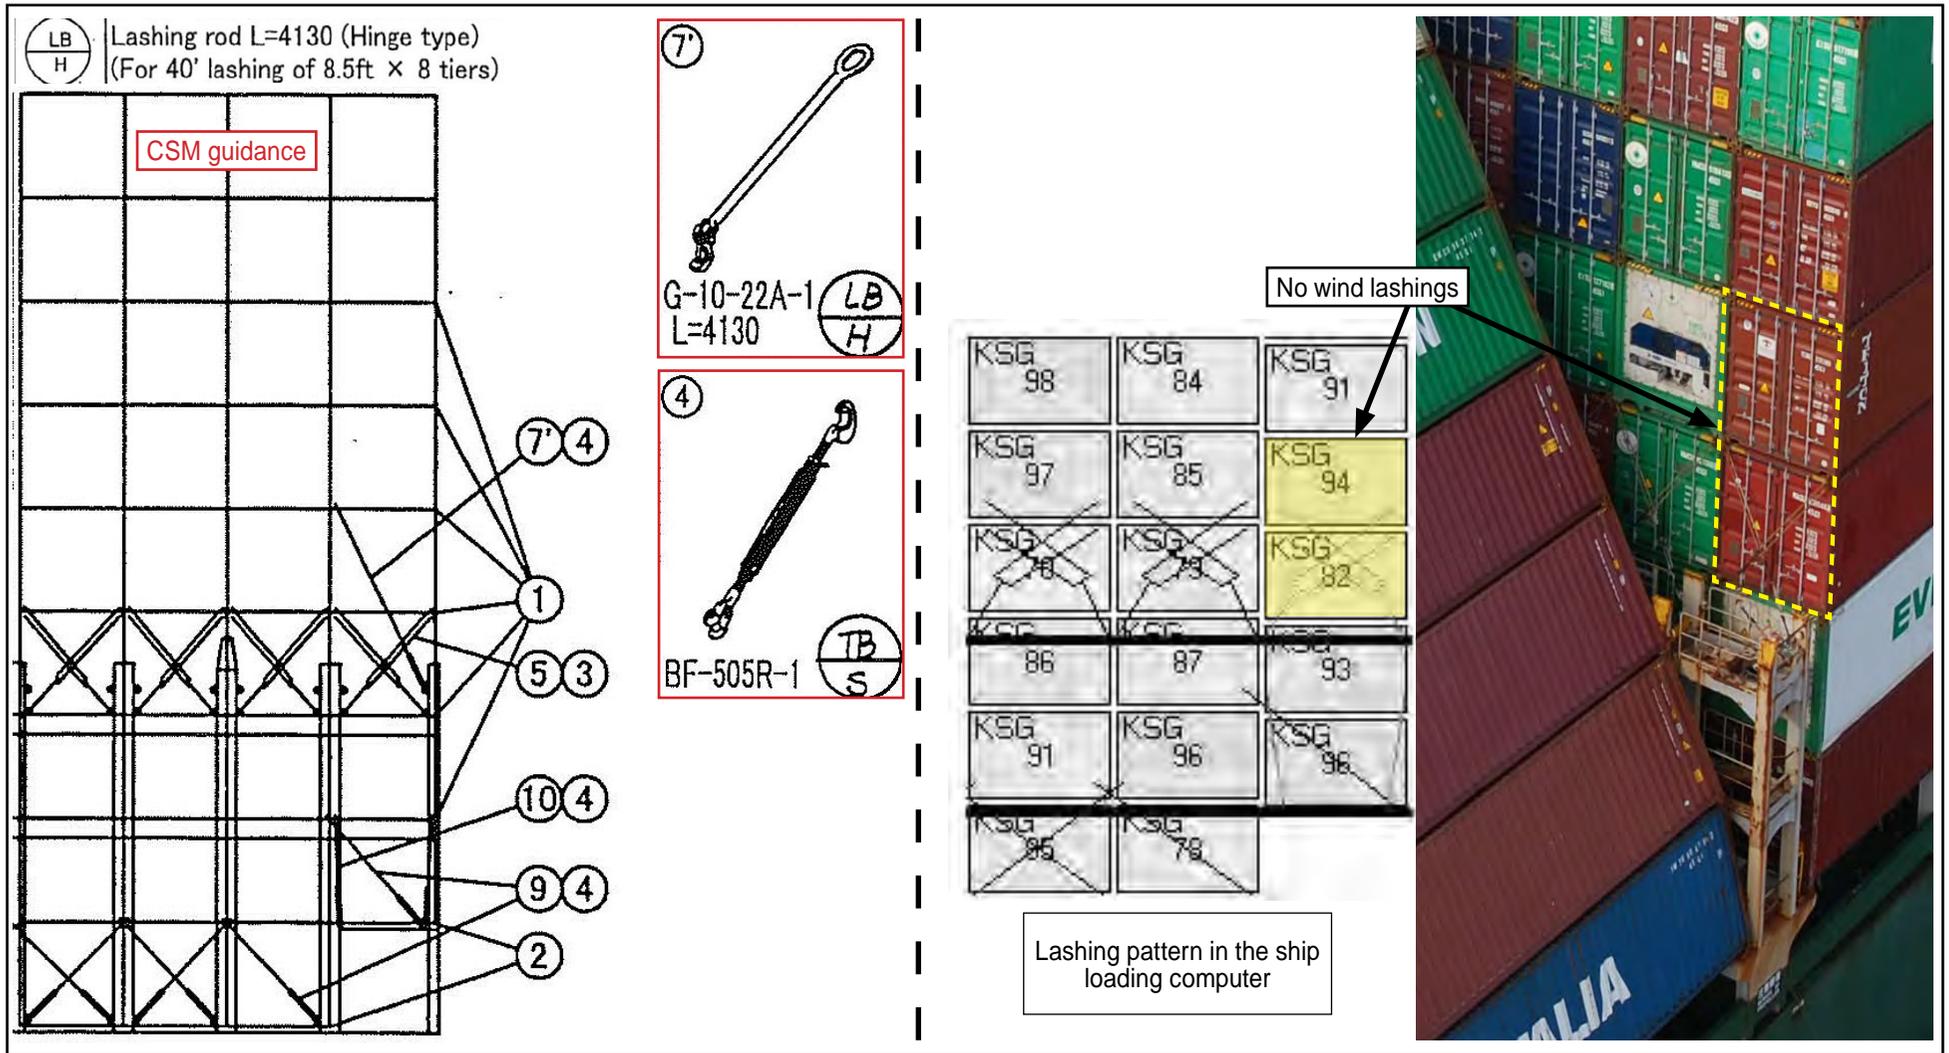
It is probable that the wind lashings had not been applied in the outer stacks of the stows aft of the accommodation block because the lashing rods were designed for standard 8'6" high containers and therefore were not long enough for a stack of hi-cube containers. This oversight would have reduced the effectiveness of the lashing system, particularly during strong winds.

Figure 31: Missing wind lashings at bay 70 and other bays aft of the accommodation block
