National Transportation Safety Board

Marine Accident Brief

Flooding and Subsequent Sinking of Unnamed Deck Barge and Moored Towing Vessels *Chattie Sue Smith*, *Mary Fern*, and *Mary-R*

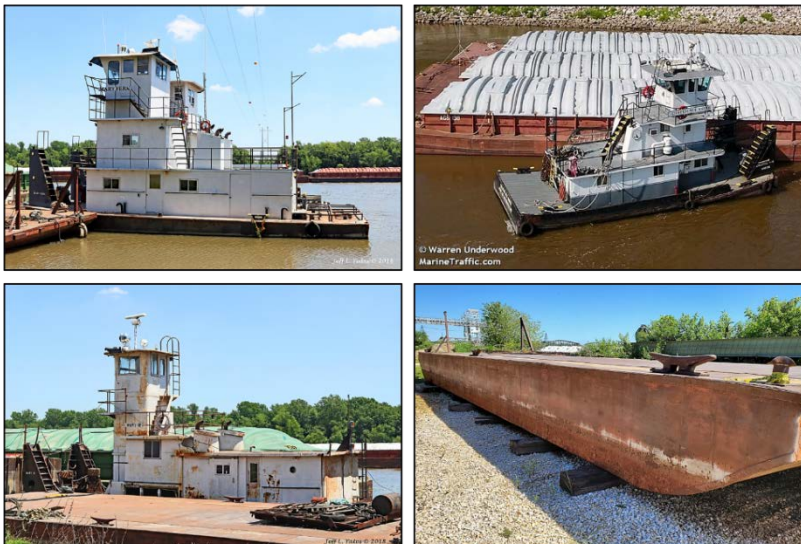
Counterclockwise from top right: Towing vessels *Chattie Sue Smith*, *Mary Fern*, and *Mary-R* at various times and locations before the sinking. At the bottom right is the unnamed barge after the accident. (Source: Warren Underwood, Jeff L. Yates, and Hex Stone)

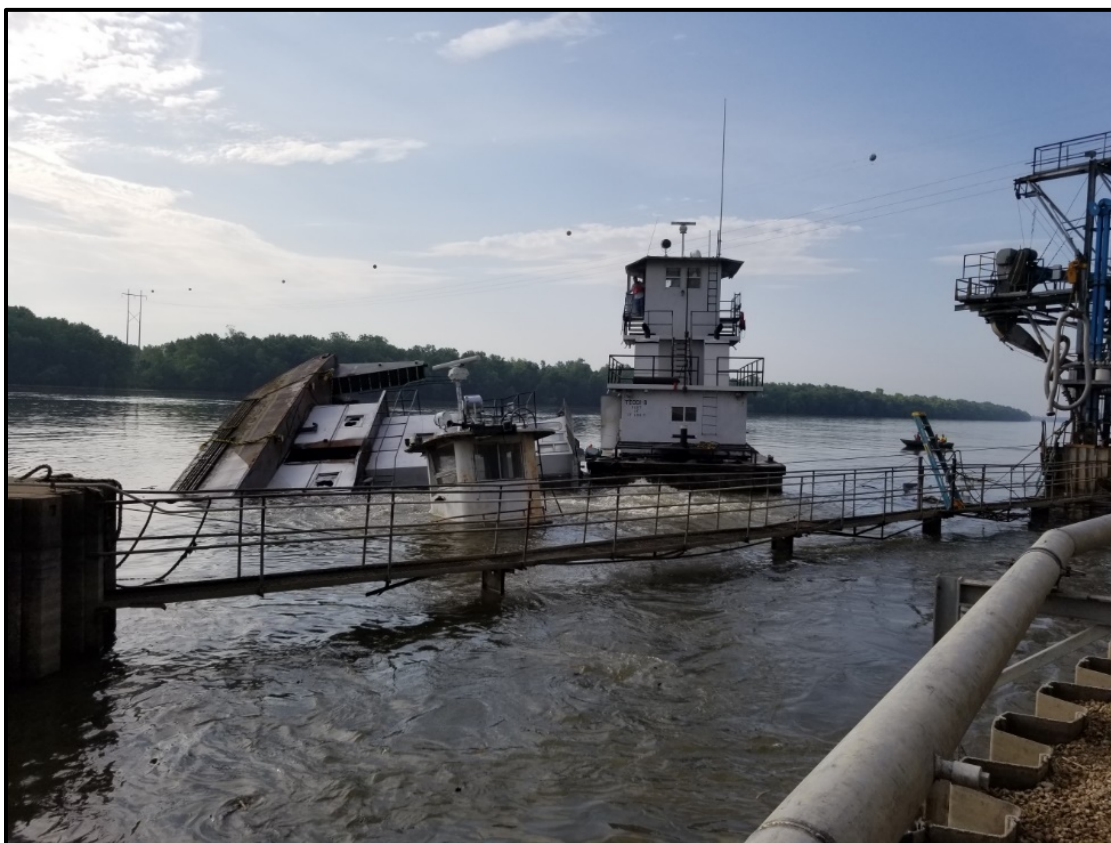
Mary Fern (capsized on left), *Chattie Sue Smith* (sunken in center), and *Teddi B* (upright on right) about 0800 on the morning of the sinking. (Source: Hardin Fire Protection District)

When Hex Stone personnel and first responders from the Hardin Fire Protection District arrived on scene, the *Chattie Sue Smith* was laying on its port side, submerged in the water, and the *Mary Fern* was taking on water and laying against the *Teddi B*. About 0800, company employees boarded the *Teddi B*, started an engine, and maneuvered it away from the *Mary Fern* to prevent both vessels from possibly capsizing. Once both towboats were separated, the *Mary Fern* capsized and sank in approximately 26 feet of water, near the location of the sunken *Chattie Sue Smith*. Later that day, a surveyor arrived and reported the *Chattie Sue Smith* was laying on its port side, bow upstream, with only a portion of the wheelhouse visible above the surface of the water. The deck barge sank completely where it had been moored, and the *Mary-R* was partially submerged to the upper part of the wheelhouse and sitting upright on the river bottom upriver from the *Chattie Sue Smith*. The *Teddi B*, the only vessel that did not sink, transited away from the sinking site under its own power, and was secured at another docking site.

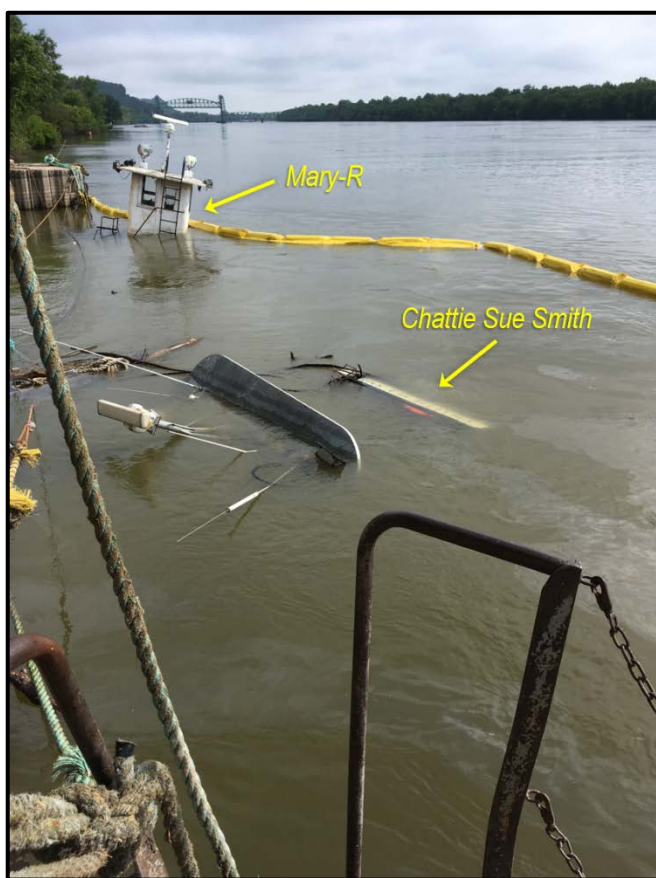
In the foreground, the sunken *Chattie Sue Smith* on its side. The wheelhouse of the *Mary-R* appears just above the water's surface in the background.

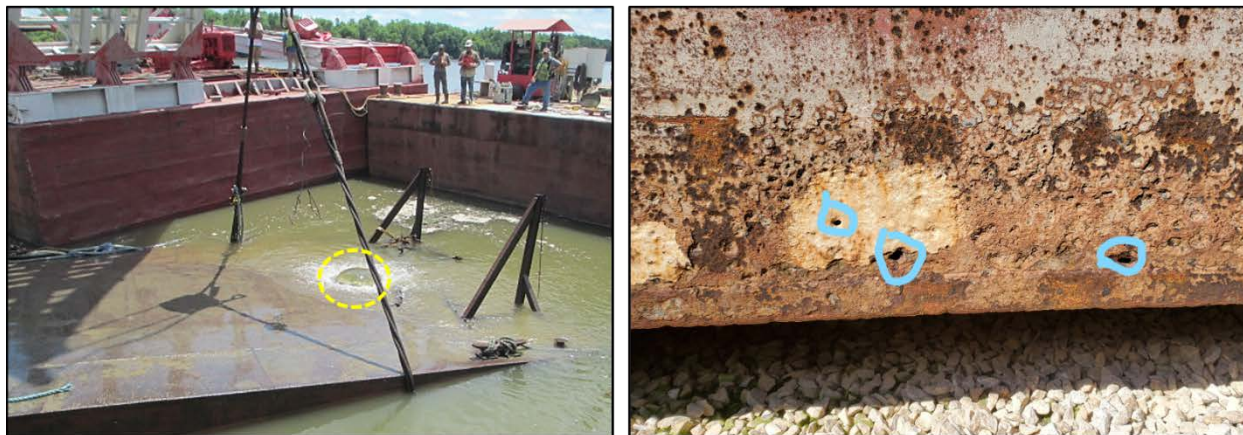
Between July 12 and 19, a salvage company recovered the *Chattie Sue Smith*, *Mary Fern*, *Mary-R*, and the deck barge that sank. An inspection for possible deficiencies that might have caused them to sink revealed no reported signs of water ingress from the three towboats. Aboard the barge, however, several small holes were found on the deck, the sides (about 6–12 inches from the bottom), and the bottom plating. An open watertight hatch (manhole) on the deck of the barge, which provided access to the midbody compartment for power cords and discharge hoses, was found during salvage operations. The barge was equipped with

two electrically operated submersible bilge pumps powered from shore, one in each of the midbody compartments. The pumps had 2-inch discharge ports and were designed to be activated automatically by float switches. Both pumps were tested after the sinking for proper function: one pump was found to be inoperable. Closer inspection of the areas of the hole on the sides of the barge showed pitting and several areas that had been previously repaired with an epoxy-like product.

At left, water bubbles from the manhole on the top deck of the barge during salvage. At right, an annotated photo from the vessel company identifies holes on the side shell of the barge near the bottom plating. (Source: Coast Guard and Hex Stone)

A post-salvage inspection of the deck barge revealed that there were several small holes on the deck that could have allowed rainwater to collect and enter the interior compartments. Additionally, holes found on the sides and on the bottom of the hull could have allowed river water to enter the barge. Based on a review of its condition, the holes likely had been present for a significant amount of time and were the source of barge flooding. The side and bottom holes would have allowed water to continuously flood the barge's compartments, which required the automatic bilge pumps to dewater the spaces at frequent intervals. Monitoring the frequency of the bilge pump operation and developing a trend of the volume of water being removed would have indicated the rate of water ingress and assisted in detecting hull leaks not easily visible.

As found in this barge sinking, failure of one of the automatic submersible bilge pumps would have prevented constantly accumulating water from being removed from its compartment and resulted in the space flooding. If the barge began flooding in this manner, the barge's freeboard would have been reduced, thereby submerging other holes that were above the waterline in the side plating and resulting in an increased rate of flooding. Once the upriver rake of the barge became submerged in the estimated 1–2-mph current, flooding would have occurred through the open manhole, and the current would have forced it under water. Since the towboats were secured by wires and mooring lines to the deck barge, the flooding and subsequent sinking of the deck barge pulled three of the attached towboats under the surface and nearly the fourth vessel as well.

The National Transportation Safety Board determines that the probable cause of the sinking of the towing vessels *Chattie Sue Smith, Mary Fern, and Mary-R*, along with a deck barge, was the deteriorated condition of the barge and the infrequent monitoring of the vessels, which allowed the barge to flood and sink, ultimately pulling down the moored towing vessels.

To protect vessels and the environment, it is good marine practice for owners and operators to conduct regular oversight and maintenance of vessel and barges, even during lay-up periods. Oversight should include periodic testing and maintenance of dewatering equipment.
