TORM MAREN

Marine accident report on loss of rescue boat

**MARINE ACCIDENT REPORT ON LOSS OF RESCUE
BOAT ON TORM MAREN ON 1 APRIL 2020**

The report is issued on 31 August 2020.

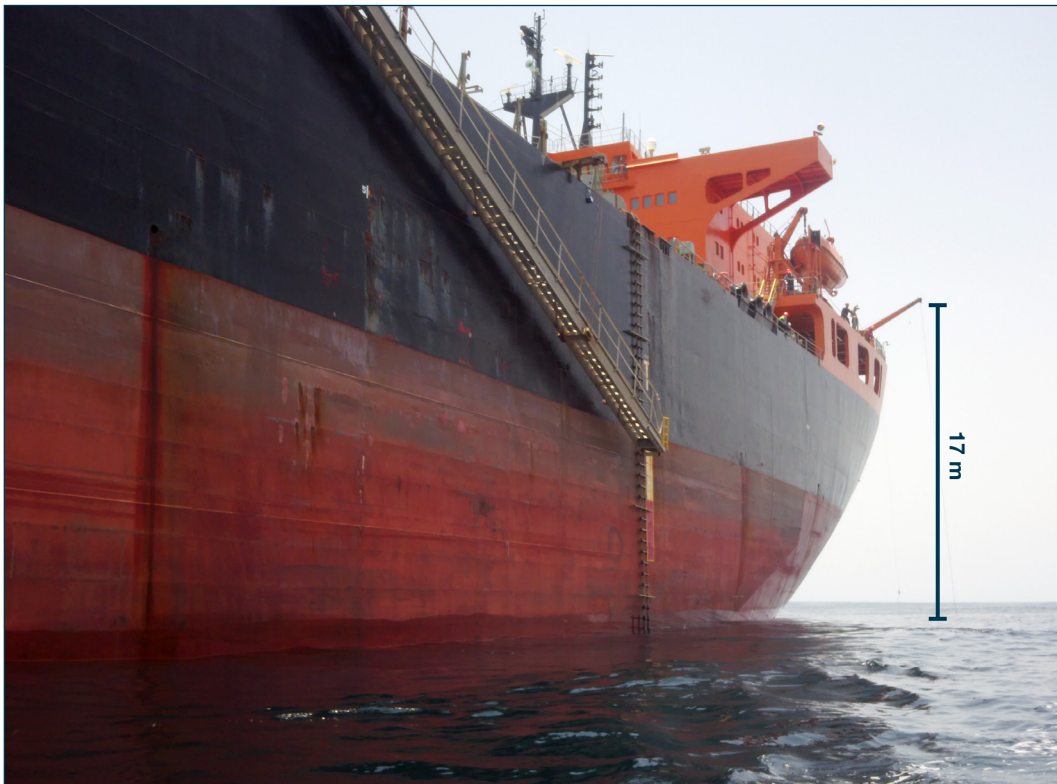
Figure 3: Height from where the boat fell
Source: TORM A/S

When the boat reached the boat deck, the 2nd engineer stopped the winch. Suddenly, the wire broke, and the boat fell 17 meters, and hit the water upright (figure 3). The engine was torn off its foundation, the bottom hull cracked, and it slowly drifted alongside the ship's port side with all three crew members still in the boat, but seriously injured. The 2nd engineer and 4th engineer, who stood by the crane, witnessed the boat fall and immediately called out for help. The time was 1537.

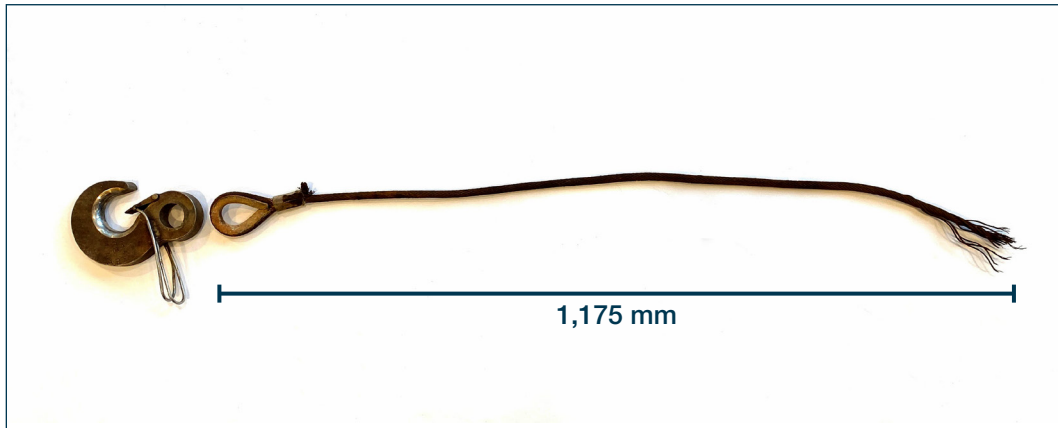
Figure 5: Parted wire rope from TORM MAREN
Source: DMAIB

DMAIB received the part of the wire rope which was attached to the rescue boat and approx. 4 m of wire rope which was left on the crane and winch. The wire rope had been broken off approx. 1,175 mm from the eye where the boat hook had been fitted (figure 5).

The wire rope was according to the wire rope certificate manufactured in January 2018 and was installed on TORM MAREN in October 2018. When the wire rope broke in April 2020, it had thus been in operation for 18 months and within that time-period a part of the wire rope had corroded to the extent that its load capacity had diminished causing it to part when exposed to load during the boat drill.

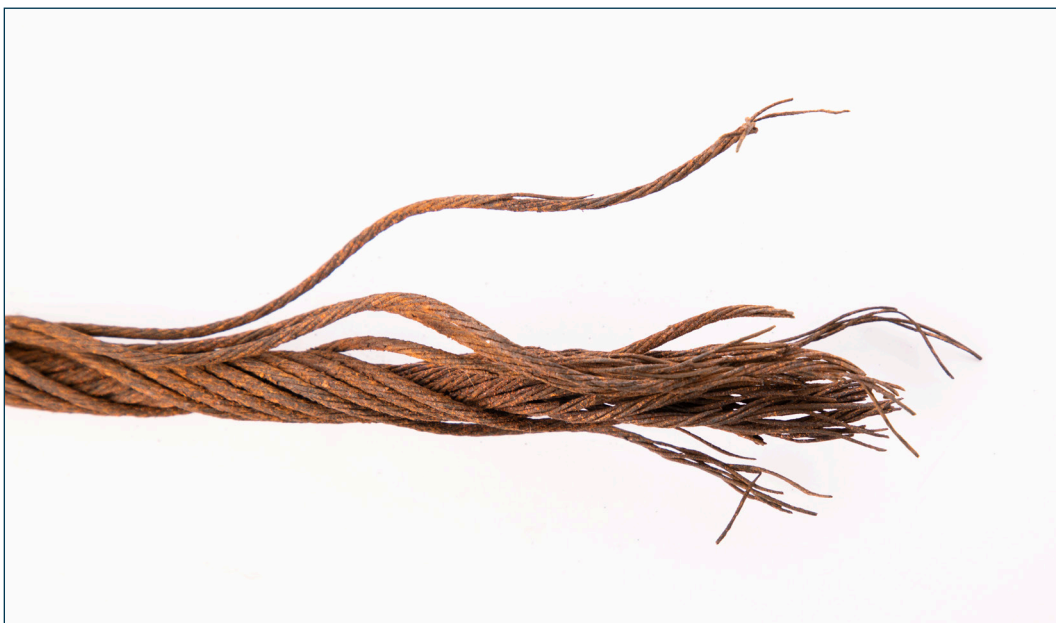
Figure 6: Parted wire from boat hook end
Source: DMAIB

Both ends of the parted wire rope were visibly corroded, and no zinc coating was visible on either ends of the parted wire rope (figure 6). No broken strands were found on the entire length of the received wire rope, indicating that the wire rope had not been subjected to general mechanical wear and tear. The majority of strands were found to be corroded and had little or no flexibility and broke if slightly bent, indicating a noticeable depth of corrosion had occurred. Other strands had some flexibility left.

Additionally, FORCE Technology concluded that a visual stereomicroscopic examination of the area where the wire rope parted showed it was severely corroded, and the wire strands had a reduction of diameter in the range of 25-50%. The corrosion was general among the wire strands. There was no zinc coating left. The examination also identified that the outer and inner wire rope strands were dry and there was little penetration of lubrication to the internal strands of the wire rope. As a reference, part of the wire rope which was left on the winch was also examined. Corrosion was found to be unevenly distributed among the outer and inner wire strands which had a reduction of diameter in the range of 10-25%. Some zinc coating and residue of lubrication was found.

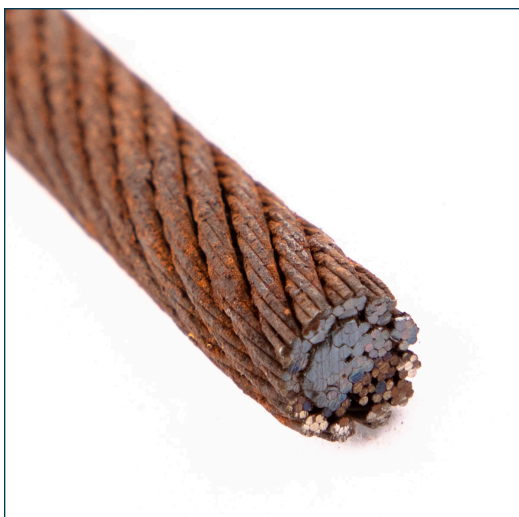
Figure 7: Sample wire 8m from the wire rope eye
Source: DMAIB

Wire rope samples, cut approximately 8 m and 25 m from the wire rope eye, were used as a comparative reference to the wire rope ends where the fracture occurred (figure 7 and 8). It was established that 8 m from the wire rope eye there was moderate corrosion and traces of lubrication were found. The latter part of the wire rope, 25 m from the wire rope eye, was normally stored on the winch when the rescue boat was in its stowed position and thus not as exposed to the environment as the part of the wire rope led to the sheave via the crane yard. Thus, a visual inspection of all the wire rope samples indicated that the condition of the wire varied significantly along its length.

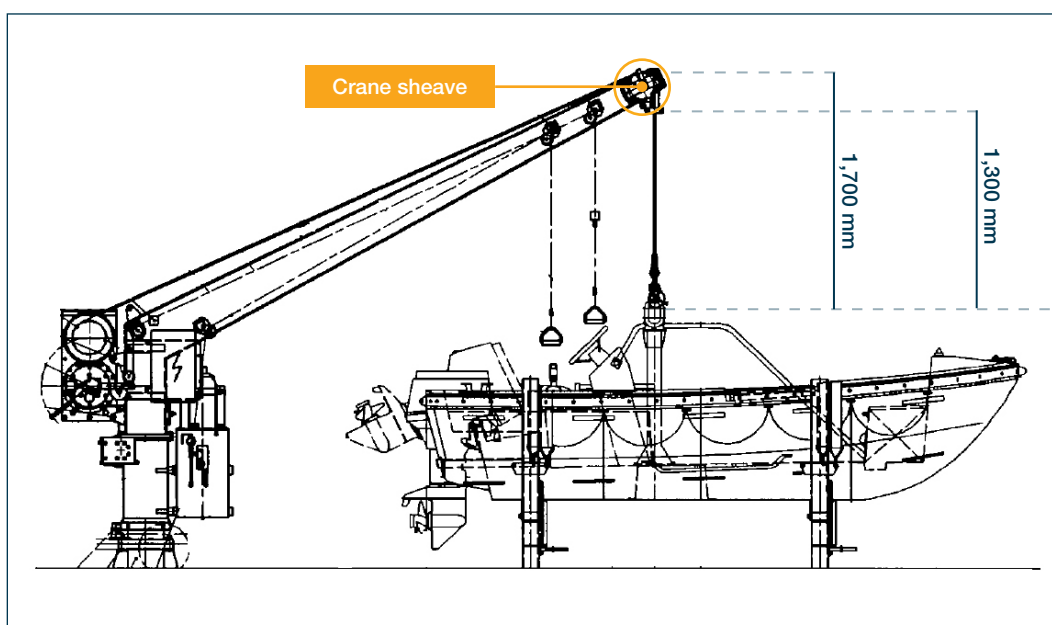
Figure 9: Technical drawing of the rescue boat system.
Source: TORM A/S / DMAIB

DMAIB hypothesised that the wire had been particularly exposed when it rested on the crane yard sheave (figure 9), bending it and exposing the inner strands to the marine environment and allowing sea water and rain to penetrate the wire rope. From the drawing of the rescue boat system it could be estimated that the distance from the arrangement suspension to the top of the crane yard was approx. 1,700 mm. As the parted wire connected to the hook measured 1,300 mm including the boat hook it is likely that the wire rope broke in the area where it normally passed through the guide plate (figure 9).

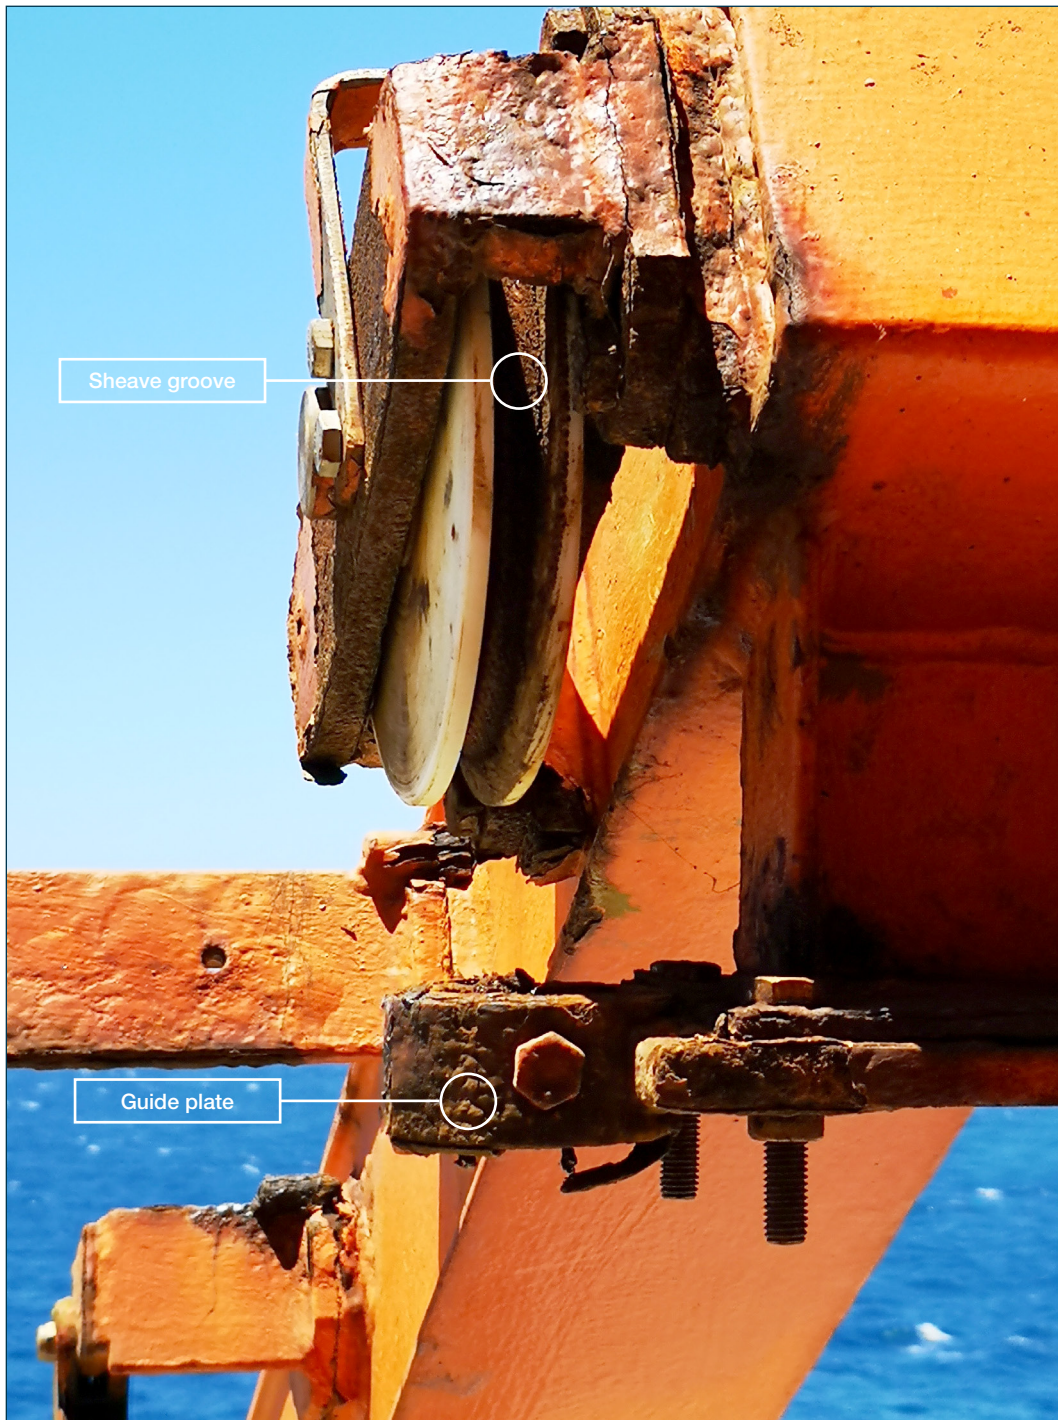
Figure 10: Crane sheave and guiding plate
Source: TORM A/S

In this area water could accumulate in the wire guide plate, exposing the wire to water (figure 10).

The sheave was made of polyamide and turned on a stainless steel shaft and was thus not subject to corrosion. From a visual inspection of the sheave it could be seen that it had traces of residue from the corroded wire rope and had visible imprints of the wire rope in its groove. The frame on which the sheave was mounted and the guide plate were also visibly corroded.

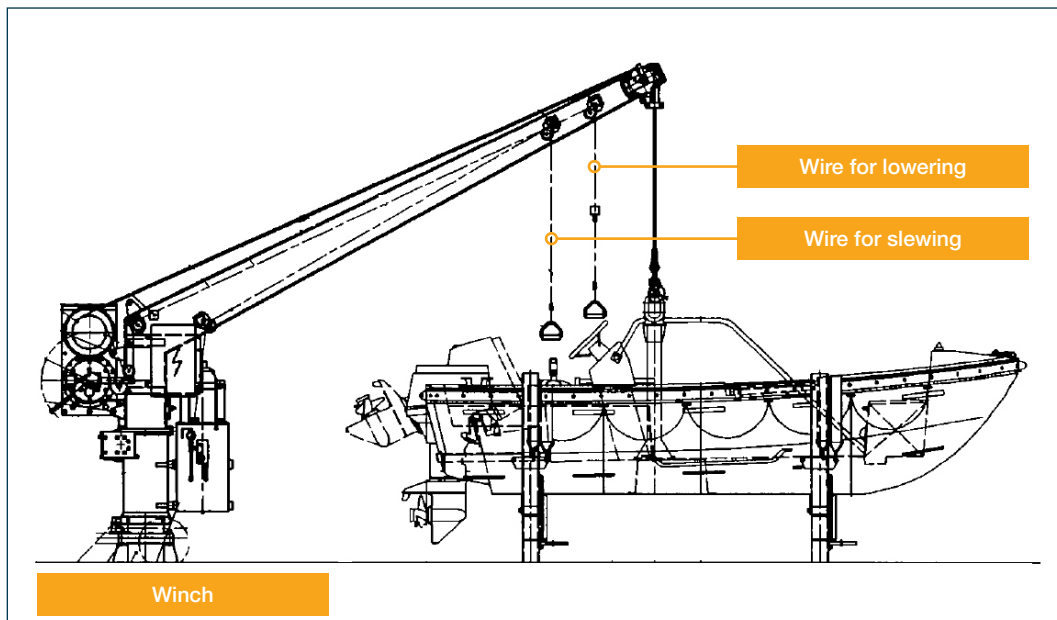
Figure 14: Rescue boat system
Source: TORM A/S / DMAIB

However, none of these mechanical features were aimed at preventing a single component failure to cause harm to the boat's occupants during the davit's man-riding operation. If the brake, hook, wire rope or the boat's hoisting fitting failed, the boat would be released and fall into the sea. In absence of mechanical redundancies, the reliability of the davit's man-riding capability depended entirely on preventive maintenance and regular inspection by competent personnel.
