National Transportation Safety Board

Marine Accident Brief

Explosion aboard Barge *IB1940*

Accident type	Fire/Explosion	No. DCA20FM002
Vessel name	<i>IB1940</i>	
Location	Chicago Sanitary and Ship Canal, Illinois Marine Towing facility, Lemont, Illinois 41°40.99' N, 87°59.37' W	
Date	November 4, 2019	
Time	0929 central standard time (coordinated universal time – 5 hours)	
Injuries	None	
Property damage	\$1,750,000	
Environmental damage	None	
Weather	Visibility 10 miles, overcast, winds light at 10 mph from the west southwest, air temperature 38°F	
Waterway information	The Chicago Sanitary and Ship Canal is a waterway linking the south branch of the Chicago River with the Des Plaines River at Lockport, Illinois. The canal is 30 miles long and has a minimum width of 160 feet, a minimum depth of 9 feet, and 2 locks.

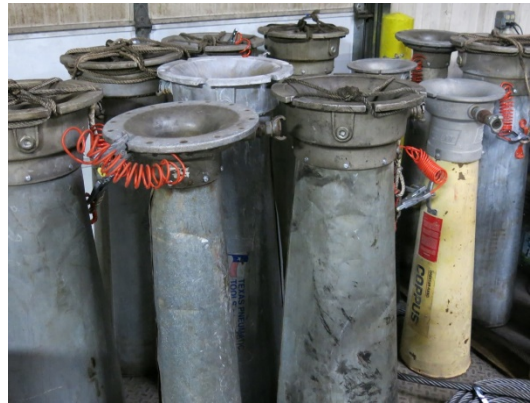
Types of air movers from IMT's shop used aboard the barge IB1940 on the morning of the explosion. (Photo taken after the explosion and after new bonding straps were attached to air movers.)

After the accident, Coast Guard investigators found the air movers in various locations on the barge of the damaged *IB1940*. The two smaller air movers were found on top of cargo tanks 2 and 3. The larger air mover was found on the port side of the barge outboard of cargo tank 1. The two smaller air movers did not have bonding straps attached to their frames, and the spring-loaded bonding (alligator) clamp of the larger air mover was engaged on the securing rope. It is unknown if the smaller air movers had been previously equipped with bonding straps.

In the days after the accident, the air movers in IMT's shop were overhauled and outfitted with grounding wires. In a postaccident interview, the second technician (who placed the air movers in the hatches of the *IB1940*) stated that he had never completed a pre-inspection of the air movers and believed he had received some in-house training on establishing a proper ground by digging the ground clamp into the paint, but did not recall any formal training.

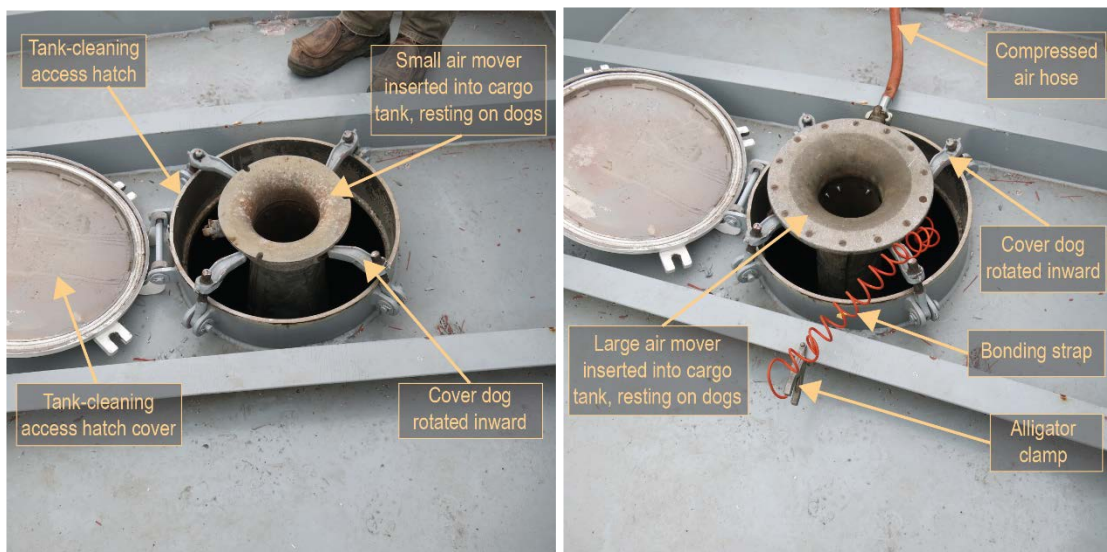
The second technician placed a 6-inch-diameter air mover in the 18-inch tank-cleaning access hatch of cargo tank 3 by inserting the discharge horn into the tank and resting the cast aluminum bell flange on the inward-rotated dogs used to secure the tank. He attached the compressed air connection to the fitting on the side of the air mover.

Demonstration of air-mover-installation methods reconstructed after the accident. Left: Smaller (6-inch diameter) air mover without compressed air hose and bonding wire. Right: Larger (11-inch-diameter) air mover connected with compressed air hose and bonding wire with clamp.

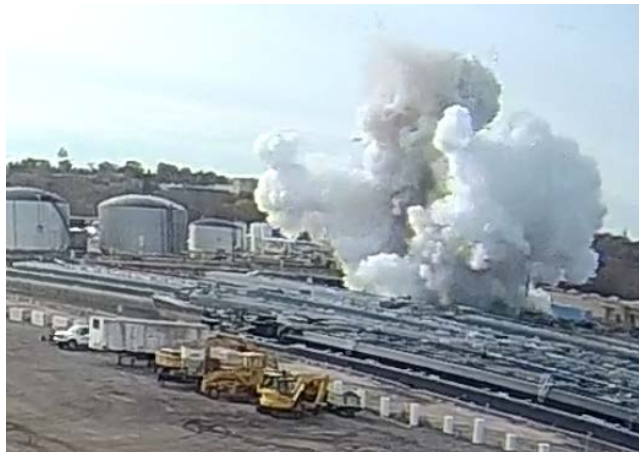
At 0929, as the workers were stepping off the barge *IB1940*, they felt a vibration as the explosion occurred within minutes of the compressed air supply to the air movers being applied. Security video footage from a nearby facility captured the explosion aboard the barge *IB1940* and showed the explosion was located approximately at the center of the barge in the vicinity of cargo tank 2. The workers ran to the IMT facility muster point and were directed to turn off the boiler, which was enclosed in a trailer about 60 feet from the stern of the barge. After hearing the explosion from the office, a shoreside worker called 911 and took a head count of the employees at the muster station. The local fire department arrived on scene and met with the manager. Together, they boarded the barge, which had a small fire at the base of each of the cargo tanks. Using two handheld dry chemical fire extinguishers through the holes created by the explosion, they extinguished the fires in each of the three cargo tanks.

View from nearby facility of the barge *IB1940* on the morning of the explosion. (Source: Illinois and Michigan Oil Company)

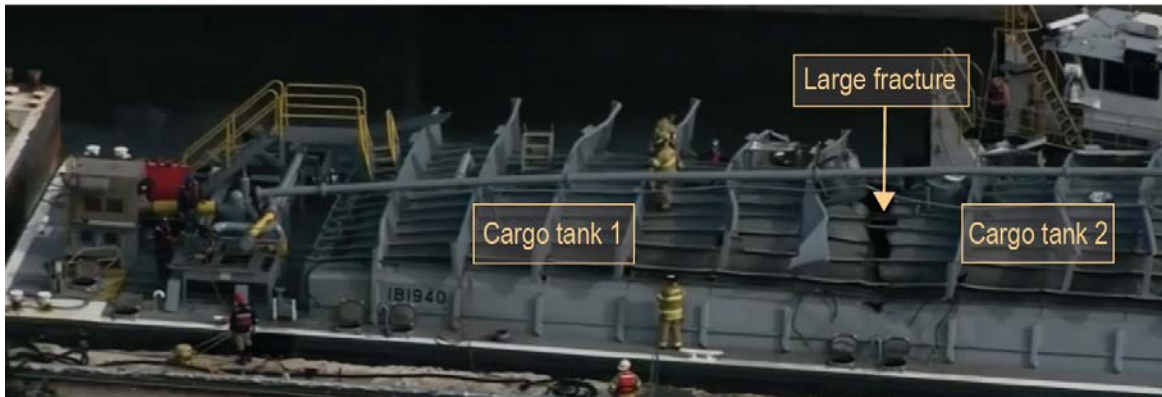
A postaccident survey found that the barge *IB1940* sustained extensive damage. The normally rectangular cross-section configuration of the raised cargo tank above the main deck had been bowed out in all directions. There was upward distortion of the tank-top of about five feet over the barge's entire length with numerous transverse tank top stiffeners torn. Several holes were torn in the tank-top plating.

Aerial view of top side of the *IB1940* after the explosion (Source: NBC News Chicago, annotated by NTSB)

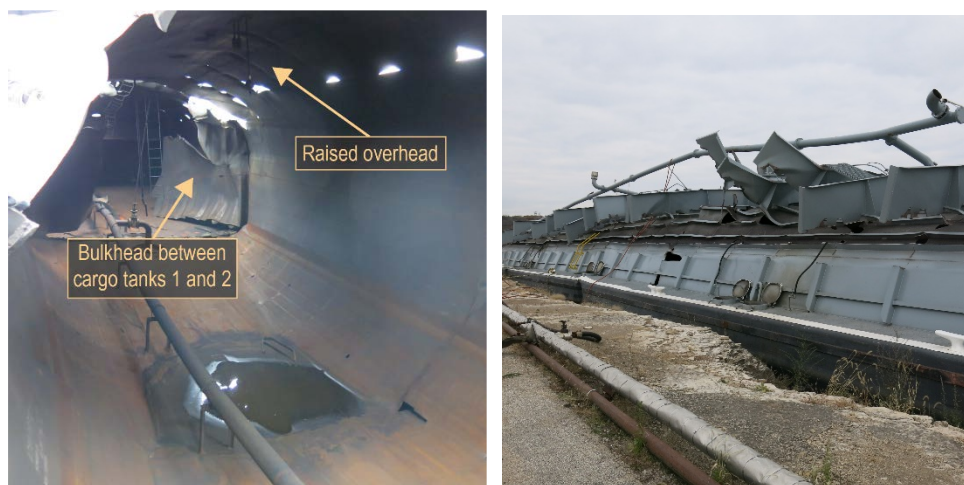
The forward bulkhead originally separating cargo tanks 1 and 2 had mostly separated from the tank-top and was displaced forward. The aft bulkhead separating cargo tanks 2 and 3 was mostly detached and was displaced aft into the space of cargo tank 3. Both sides of the barge's hull were buckled in the midship area (cargo tank 2). A diver repaired several holes in the bottom plating to prevent the barge from taking on water and possibly sinking. The barge *IB1940* was determined to be a constructive total loss.

Damage of the *IB1940* after the explosion. Left: Cargo tank 2 showing distorted overhead and bowed forward bulkhead. Right: Exterior view of distorted portside tank bulkhead and raised tank-top.

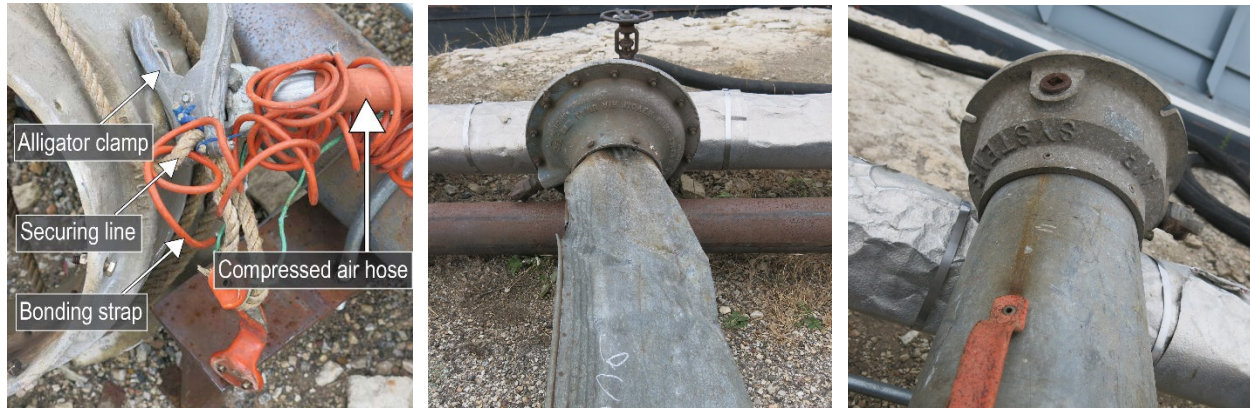
Air movers used aboard the *IB1940* and removed after the explosion for inspection. Left: Alligator clip of bonding strap engaged in line of large blower. Center and Right: Small air mover with missing bonding strap.

Based on a nearby facility's video showing the explosion near the center of the barge in the vicinity of cargo tank 2 and the most severe damage to the barge found in that area, cargo tank 2 was the likely location of the initial explosion. The source of ignition was most likely a static electrical discharge from the air mover that was resting on the painted dogs of the tank-cleaning access hatch of cargo tank 2. The technician who installed the air movers could not recall if they had been bonded to the barge (ensuring that the air mover was properly bonded to bare metal on the barge) but did recall that they had not been tied off to prevent movement. Postaccident testing indicated that resting the cast aluminum bell of the air mover on the four painted dogs of the tank-cleaning access hatch without proper bonding did not provide good electrical bonding between the air mover housing and the barge. An inadequately bonded air mover would allow the accumulation of electrostatic charge generated by the flow of the compressed air stream with water droplets and rust particles. Without a proper bonding connection, a static electrical charge would likely not safely dissipate to the grounded barge, but could instead accumulate, causing a potential spark hazard.
