# National Transportation Safety Board

## Marine Accident Brief

### Engine Room Fire aboard Towing Vessel *City of Cleveland*

<b>Accident type</b>	Fire	<b>No.</b> DCA20FM014
<b>Vessel name</b>	<i>City of Cleveland</i>	
<b>Location</b>	Lower Mississippi River, mile 348, near Natchez, Mississippi <sup>1</sup> 31°24.43' N, 091°28.24' W	
<b>Date</b>	February 26, 2020	
<b>Time</b>	1600 central standard time (coordinated universal time – 6 hours)	
<b>Injuries</b>	None	
<b>Property damage</b>	\$2 million est.	
<b>Environmental damage</b>	None	
<b>Weather</b>	Visibility 10 miles, mostly cloudy, winds 10 mph from northwest by north, gusts up to 18 mph, air temperature 49°F	
<b>Waterway information</b>	The Lower Mississippi River near mile 348 was 1.1 miles wide, and the current was estimated at 3 mph. The nearest river gage at Natchez, Mississippi (mile 363.3), read 58 feet, 10 feet above flood stage, and was rising.

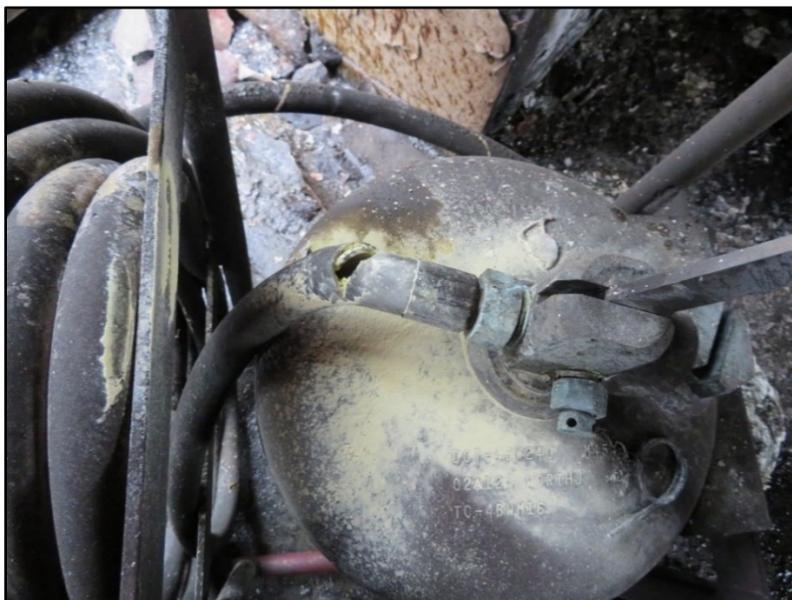
Per company policy, the doors from the weather deck to the engine room were closed since the *City of Cleveland* was under way, but the exterior windows were open, which a deckhand stated was for engine room ventilation. The crew was unable to close them due to heat and smoke from the fire. The steel door between the rudder room and the upper engine room was open, and fire spread aft to that space. Semi-portable fire extinguishers were located in the upper engine room, just inside the port and starboard doors from the weather deck. Crewmembers opened the starboard door to the engine room and attempted to activate the starboard extinguisher; however, the discharge hose ruptured proximate to the extinguisher, rendering the extinguisher ineffective. The crew could not reach the port extinguisher due to the fire.

Semi-portable extinguisher in starboard engine room following the fire.

The vessel’s firehoses were accessible, but the crew could not use them because the running generator in the upper engine room was starved of combustion air and shut down, and the vessel lost electrical power, rendering the single fire pump inoperable. Therefore, the two semi-portable extinguishers, stowed on each side of the upper engine room, were the only means for the crew to fight the conflagration. The crew had previously performed fire drills aboard the *City of Cleveland* and planned to fight a possible engine fire by dropping the semi-portable extinguisher hoses and nozzles to the lower engine room and releasing the extinguishers’ dry chemical. However, the portside extinguisher was inaccessible due to the flames, and the hose on the starboard extinguisher failed proximate to the extinguisher. Additionally, given that the fire was largely fueled by flammable liquids, initially outboard of the port engine and well forward of where the extinguishers were stowed, it is unlikely the crew’s initial plan to use the extinguishers would have succeeded.

The *City of Cleveland*’s single fixed electric fire pump was located outboard, in the lower starboard engine room. However, due to the loss of electrical power, the fire pump was unavailable to provide water to fight the fire. The towboat did carry gasoline-powered dewatering pumps for use on the barges; however, these pumps were not designated fire pumps and did not have adapters on the discharge side for firehoses. There was no fixed fire-extinguishing system in the engine room, nor did existing regulations require one. After the accident, Jantran moved the semi-portable extinguishers on their vessels up one deck, to the exterior upper deck, just above the engine room doors, and added a third semi-portable extinguisher in the upper engine room.

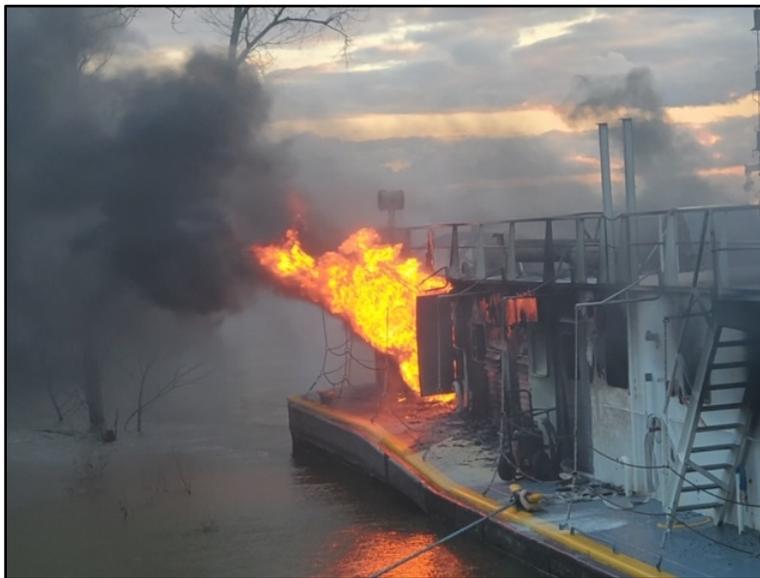
The *City of Cleveland's* starboard main engine remained running, so the chief engineer reboarded the vessel and pulled the engine's remote fuel shutoff, which was located at the starboard weather deck door. The shutoff failed to stop the starboard engine (the ball valve in the fuel line connected to the remote shutoff cable was later found to have been pulled past its closed position), so the chief engineers from the *City of Cleveland* and the *Jackson Platte* secured the engine by using a pole to reach the shutoff on the governor. Crews directed hose streams through the engine room and rudder room windows. Crewmembers told investigators that the fire in the rudder room proved challenging to fight, as steering gear hydraulic oil, having spilled from burnt hoses, was burning while floating on the firefighting water and was spreading further by the hose streams.

Flames coming from the starboard rudder room door. (Source: US Coast Guard)

The failure of the connecting rod and subsequent catastrophic damage to the crankcase likely allowed hot pressurized fuel and oil to spread to the lower engine room and thereby ignite. The significant heat and smoke damage to the upper engine room indicated that the fire spread up the port side of the engine room, then aft in the upper engine room, and eventually to the rudder room. Although the doors to the engine room were closed, the exterior windows in the upper engine room were open, and there were no means for the crew to close them from outside of the engine room. The air drawn through the open windows likely further exacerbated the fire’s spread.

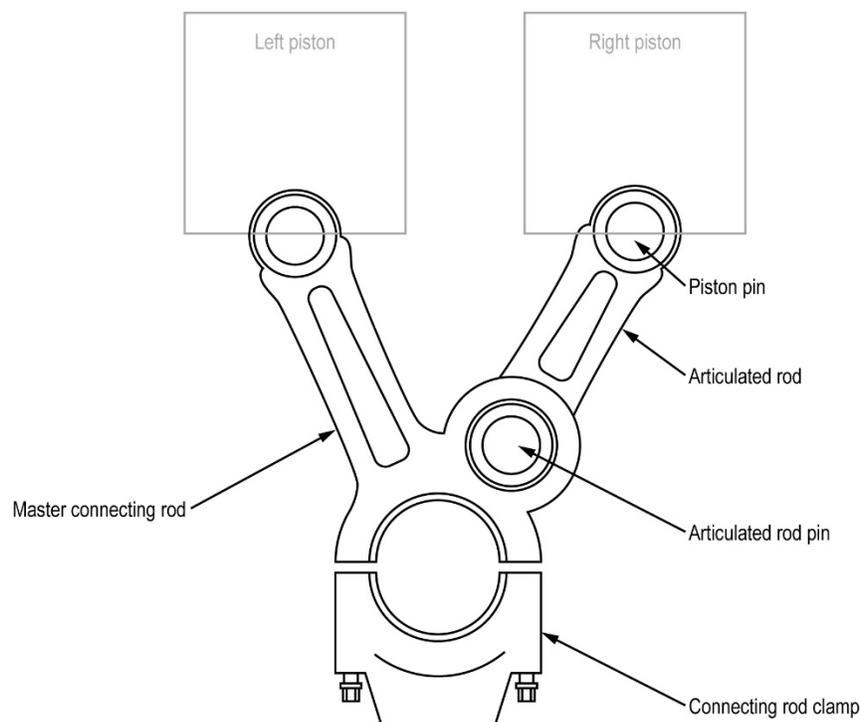
The *City of Cleveland*'s propulsion system included twin General Electric 7FDL12, 12-cylinder, 4-stroke diesel engines.<sup>2</sup> These engines consisted of two banks of six cylinders and rods, left and right, with the cylinders numbered forward to aft. Each connecting rod assembly included a master connecting rod on the left bank, as viewed from aft, fastened around the crankshaft with a connecting rod clamp. Articulating connecting rods on the right bank connected at a 45-degree angle to a pin in the master connecting rod.

**Connecting rod assembly, viewed from aft (Source: GE Transportation)**

During a postaccident examination of the wreckage, the no. 4 left and right cylinder master connecting and articulating rods were found still attached to each other outside the crankcase, and the piston pin and connecting rod clamp were missing. Therefore, the initial failure was likely with the connecting rod clamp or the bolt that held the piston pin. Regardless, the force of the driven loose connecting rods inside the engine was enough to puncture a hole in the side of the crankcase on the port side and eject the piston head through the no. 4 right cover on the starboard side.

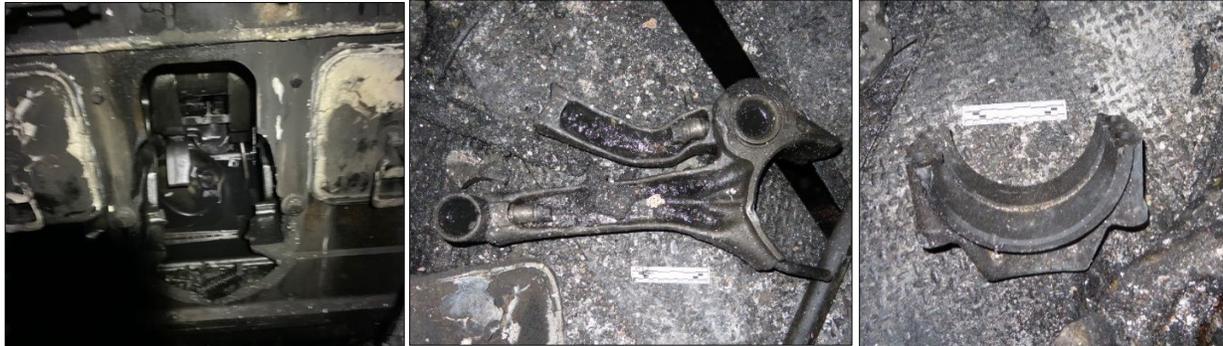
A postaccident examination of the port engine showed extensive damage: the no. 4 right cylinder crankcase inspection cover had been knocked off, and the no. 4 right piston head was found on the deck along with the connecting rod clamp, inboard (to starboard) of the engine. A

large hole was found in the crankcase at the no. 4 left cylinder crankcase inspection cover. The no. 4 left master connecting rod was lying on the deck with the piston pin bolt missing, outboard (to port) of the engine with the bent no. 4 right articulating arm still attached to it.

Holed crankcase at no. 4 left cylinder inspection cover (*left*), no.4 left and no. 4 right connecting rods (*middle*), and connecting rod clamp (*right*).
