SAFETY INVESTIGATION REPORT

REPORT NO.: 03/2021

MT VALTAMED **Fatality in the pump room** **at Ceyhan OPL Anchorage, Turkey,** **in position 36° 20.6' N 035° 09.66' E** **03 February 2020**

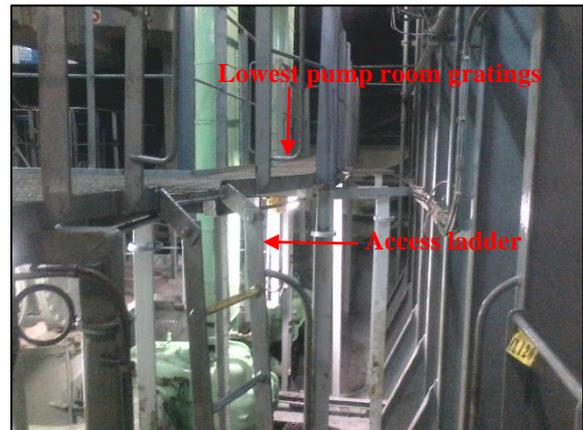
Figure 5: Access towards starboard side bilge alarm sensor

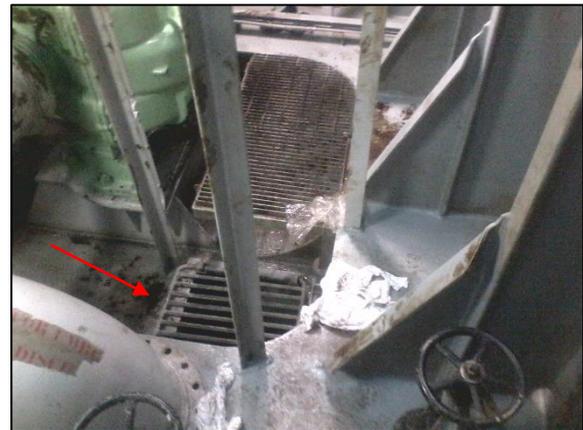
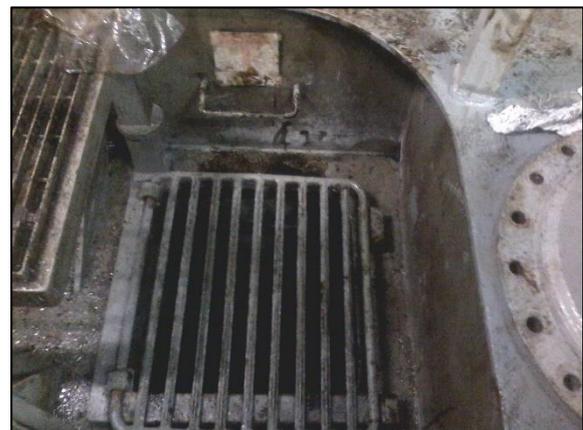
Figure 6a: Access manhole for starboard side bilge alarm sensor (red arrow)

To access the starboard sensor, crew members had to go down below the lowest gratings (Figures 5), access a manhole (Figures 6a and 6b) of about 2.0 m depth and

Figure 6b: Access manhole for starboard side bilge alarm sensor

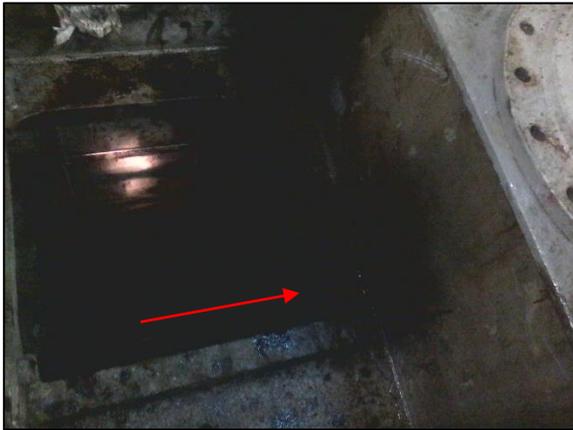
turn into another compartment through a lightening hole (Figure 7).

Figure 7: Access manhole opened (red arrow indicates direction towards starboard side bilge alarm sensor, through a lightening hole)

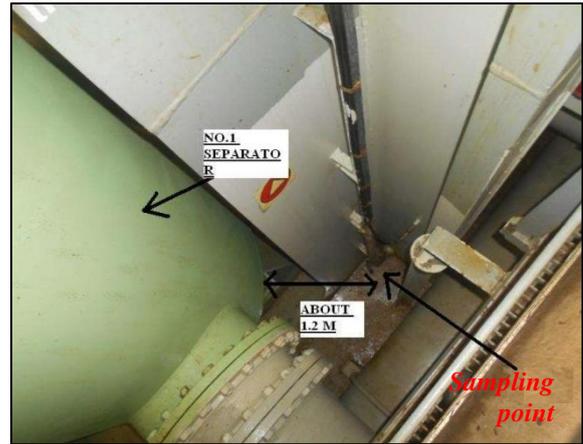
The H₂S sampling point was located 4.5 m to the port side of the access manhole to the starboard side bilge alarm sensor.

Figure 10: Location of LEL and H₂S sampling point

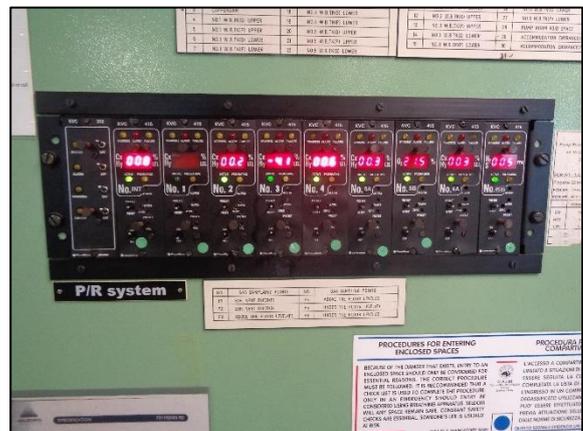
Figure 11: Display panel of the fixed gas detections system

This system was last maintained for checks and calibration by a shore service provider on 27 September 2019. During the calibration procedure, it was observed that the hydrocarbon samples extracted from above the lowest gratings and the pump room bottom, on the port side could not be set to match the contents of the calibration gas used. The same was noticed for the H₂S

samples extracted from the pump room bottom on the starboard side. Furthermore, a smell of the calibration gas was detected, indicating a possible leak in the system. The attending service technicians had recommended retrofitting a new system since the one on board was considered obsolete.

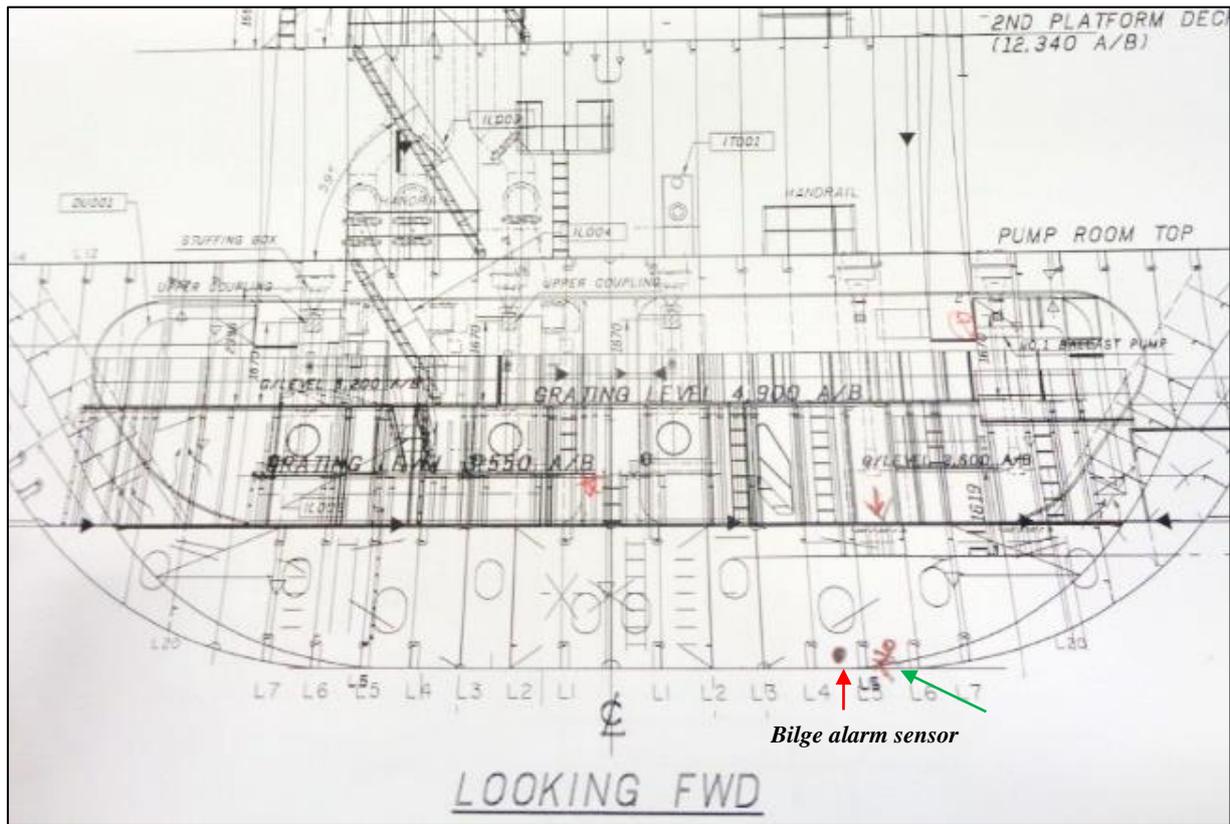
On looking closer, they saw that the pump man lying in the bilge (Figure 14) with his helmet off. They also observed a small amount of oily water in the bilge.

Figure 14: Location where the fatally injured pump man was found (green arrow)

The autopsy revealed that the pump man had a laceration on the vertex of his scalp, which had caused a hematoma under the scalp around this region. The crew member also suffered from fractured ribs and abrasions to his legs.

during the warming-up of the steam-driven stripping pump, resulted in accumulation of a small quantity of oily water in the starboard bilge space. It is possible that this oily water may have caused the pump man to slip, struck his head and fall unconscious while attempting to exit the space.

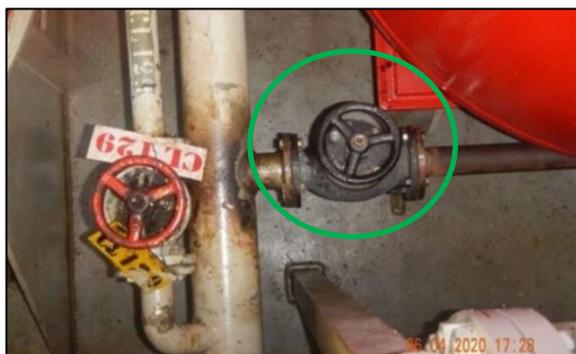
Following the accident, further investigations revealed a small quantity (approximately 4.0 cm in depth) of an oily-water mixture in the vicinity of the starboard bilge alarm sensor. The source of the oil component of the mixture, was observed to have been a small leak in the suction valve of the bilge space (Figure 15).

Figure 15: Suction valve (circled in green) of the starboard bilge of the pump room

The leak was found after Company personnel conducted a pressure test on this valve, while trying to investigate the source of the leak. The water reportedly originated from drain valves of the steam-driven stripping pump, which were drained during the warming-up of the pump at the time of cargo unloading operations.

5. All valves on the stripping pump suction line and the suction valves of the pump room bilges were overhauled and pressure tested.
6. The arrangement for stripping the AUS drain tank was modified to eliminate the risk of accidental contamination of the bilge spaces by cargo residue and vapours (Figures 19 and 20).

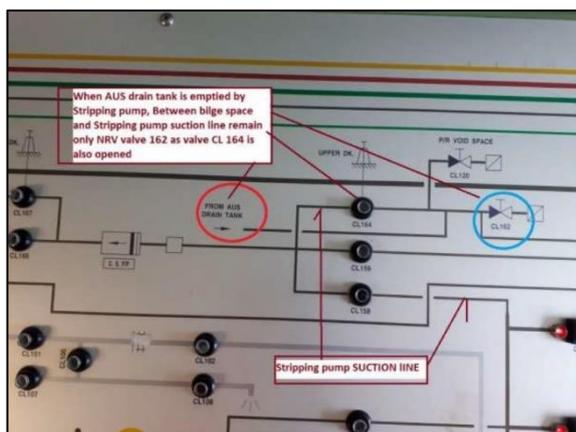
This valve was of the non-return type and was connected to the line used for stripping off the contents of the automatic unloading system's (AUS)⁵ drain tank (Figure 16).

Figure 16: Location of the pump room's starboard bilge suction valve (circled in blue)

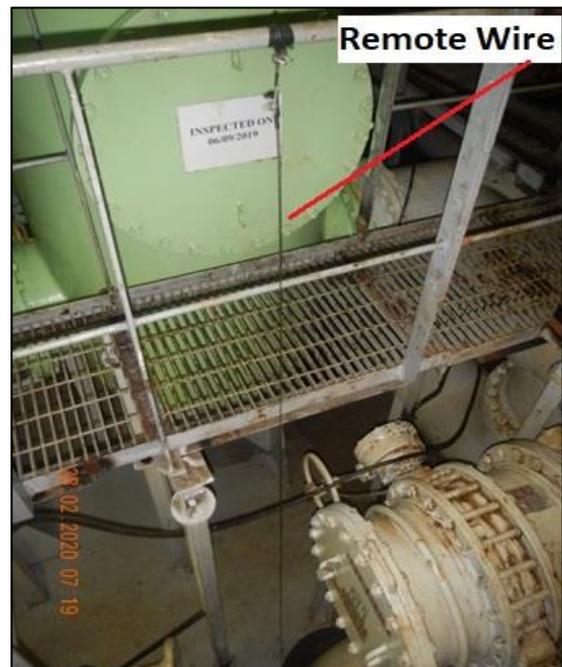
Figure 17: Wire to remotely test the starboard bilge alarm

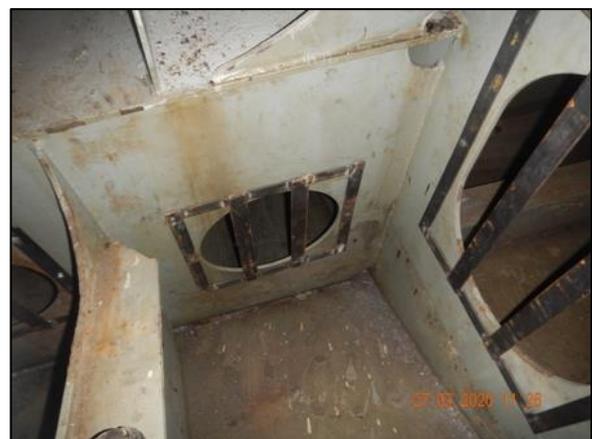
The construction of this space was such that it would allow for pockets of gases to get trapped within the area. Therefore, persons accessing this sensor would be exposing themselves to the hazards of this space, which in turn would increase the probability as well as consequences of an accident, thereby increasing the levels of risk.

Figure 18: Lightening holes within the starboard bilge space blocked

considered as part of the pump room (Figure 18).

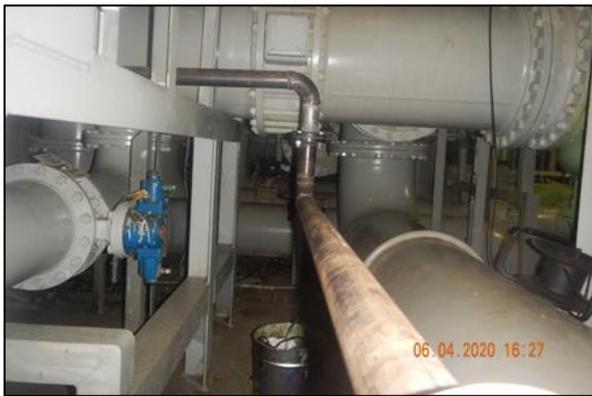
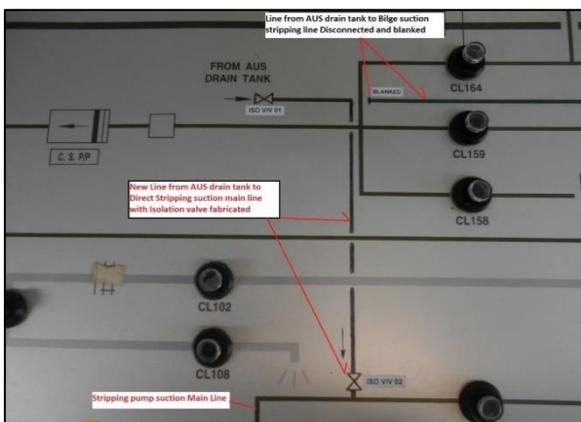
Figure 19: Modified arrangement for stripping of the AUS drain tank

Figure 20: Line diagram showing the modified arrangement for stripping of the AUS drain tank
