# SAFETY INVESTIGATION REPORT

REPORT NO.: 07/2021

**MV CROATIA**  
**Cargo explosion**  
**in position 03° 38.7' N 105° 37.7' E**  
**23 February 2020**

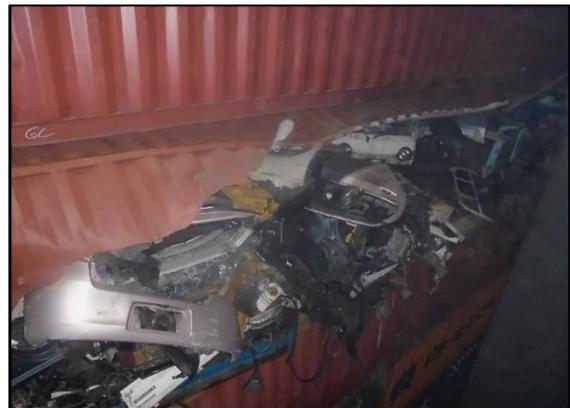
Once inside the cargo hold, the fire-fighting team found that one container had explosion damages (Figure 2), but no active fire was raging. Debris from the container was seen lying in various locations of the cargo hold (Figure 3). The fire-fighting team also reported that five other containers were partially damaged and that some of the vessel's fittings had been affected.

Figure 2: The exploded container in the cargo hold

Evidence submitted to the MSIU revealed that the container stowed in position 500612 had sustained substantial internal overpressure and one of its side walls and the door-leaves had been blown off. Reportedly, the container was loaded with used auto parts.

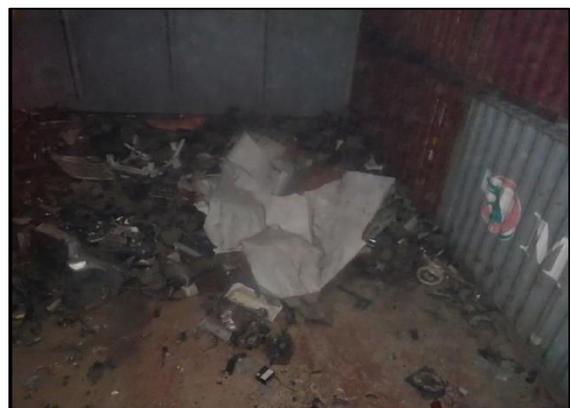
Figure 3: Container and Cargo debris on tank top

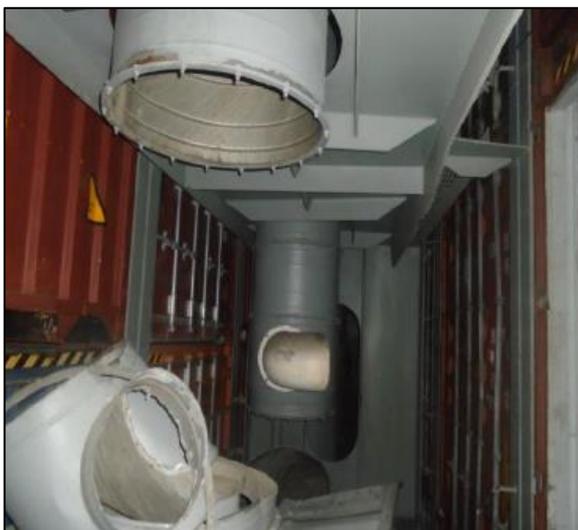
- ventilation ducts nos. 1, 2 and 3 on port side were found distorted and damaged (Figure 4);
- the safety railing on deck platform no. 2 was noted to be bent for about 2 m in length;
- the steel walkway on no. 2 deck platform was found distorted (Figure 5); and
- the safety steel wire no. 2 deck platform was found parted for approximately 2 m in length.

Figure 4: Mechanical ventilation duct damaged

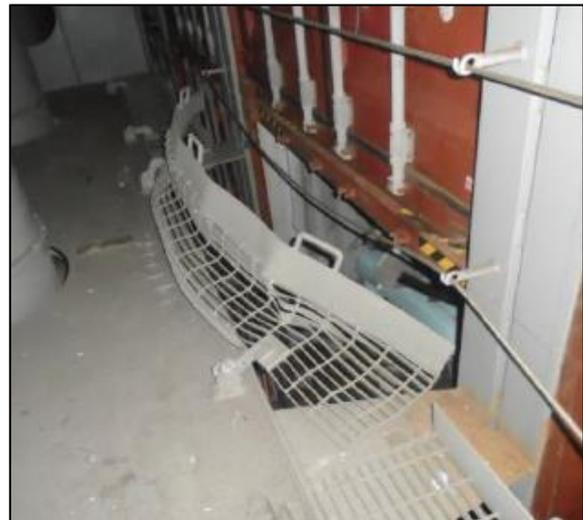
Figure 5: Distortion of steel walkway platform

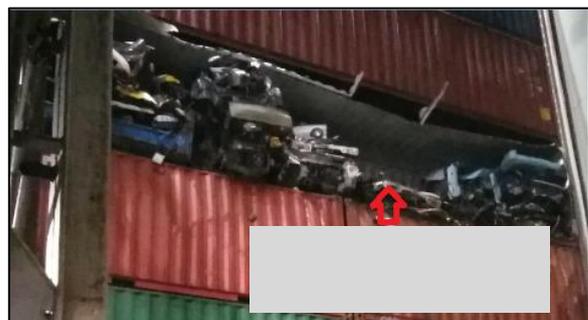
The container inside which the explosion had happened was in position Bay 50, Row 06, Tier 12 (500612) (Figure 6). As a result of the explosion, the entire right panel and the access door were ripped off, exposing the cargo contents (Figure 7).

Figure 7: Exposed cargo contents

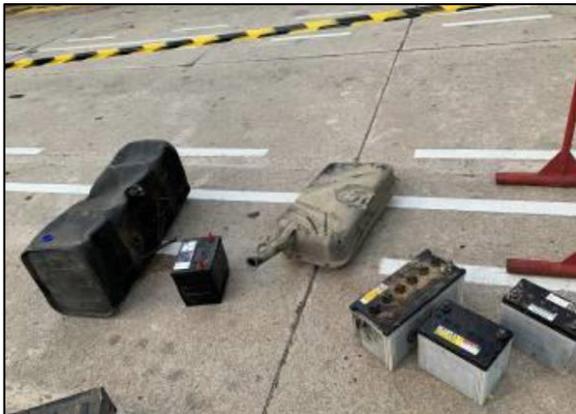
On 09 March, a re-working of the exploded container's contents into another intact container was carried out. The inspection report on the container's contents, revealed the presence of a partially filled fuel tank, car batteries, a cigarette lighter and several flares (Figures 8 and 9).

**Figure 8: Fuel tanks and batteries**

An examination of the ejected debris revealed the presence of at least eight automotive metal fuel tanks, four of which had a ballooned appearance, consistent with the effects of internal over pressurization. The information available to the safety investigation revealed that gas measurements of the internal atmosphere of several of these fuel tanks, indicated the presence of flammable vapours within the explosive range.

It was not excluded that fuel may have leaked from one or more of the tanks, which gradually led to an explosive atmosphere within the container. Although no old / damaged batteries were sighted in the container, it was not excluded that an intermittent electrical spark, could have been the likely source of ignition.

Amongst items from the container that were sighted were automotive metal fuel tanks which had a 'ballooned' appearance. This indicated that the vehicle's tanks were not completely empty from fuel. Considering the flammable liquids present in these tanks, this cargo could have been considered to fall under Class 3<sup>6</sup> of the IMDG Code. Moreover, several vehicles' batteries were found amongst the debris and depending on their type (*i.e.*, alkaline or lithium), these had to be classified either under Class 8<sup>7</sup> or Class 9<sup>8</sup>.

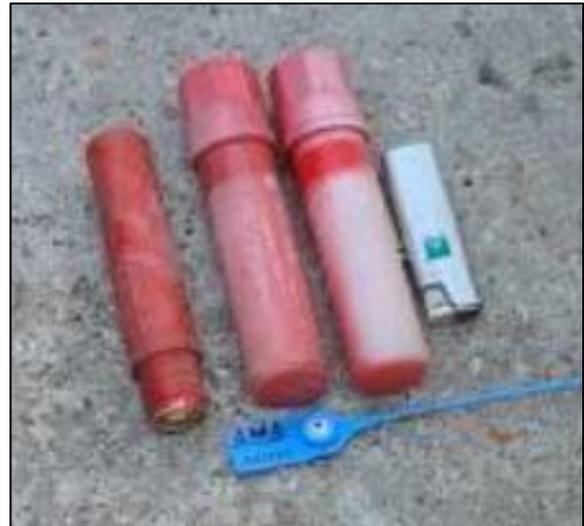
**Figure 9: Flares and cigarette lighter**

The safety investigation neither came across specific details on the flares and the cigarette lighter, nor the reason why these were stored inside the container. However, flares are

considered as pyrotechnics<sup>9</sup> and would have to be classified under the appropriate hazard division of Class 1<sup>10</sup> of the IMDG Code.
