National Transportation Safety Board

Marine Accident Brief

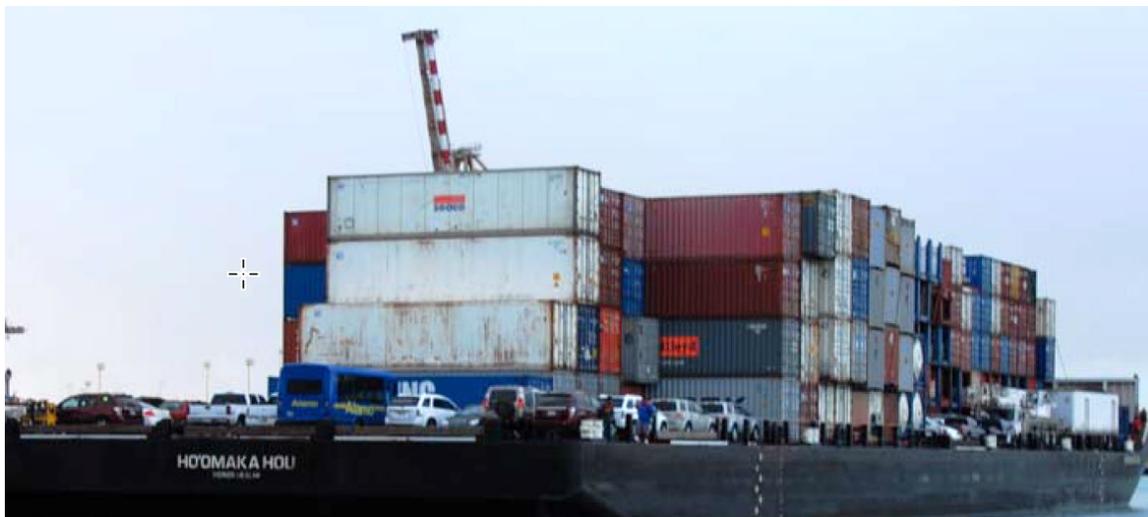
Photo of the barge *Ho'omaka Hou*, loaded for a previous voyage, as viewed from the stern. Note the loading of the barge was not the configuration of the accident voyage. (Source: Young Brothers, LLC)

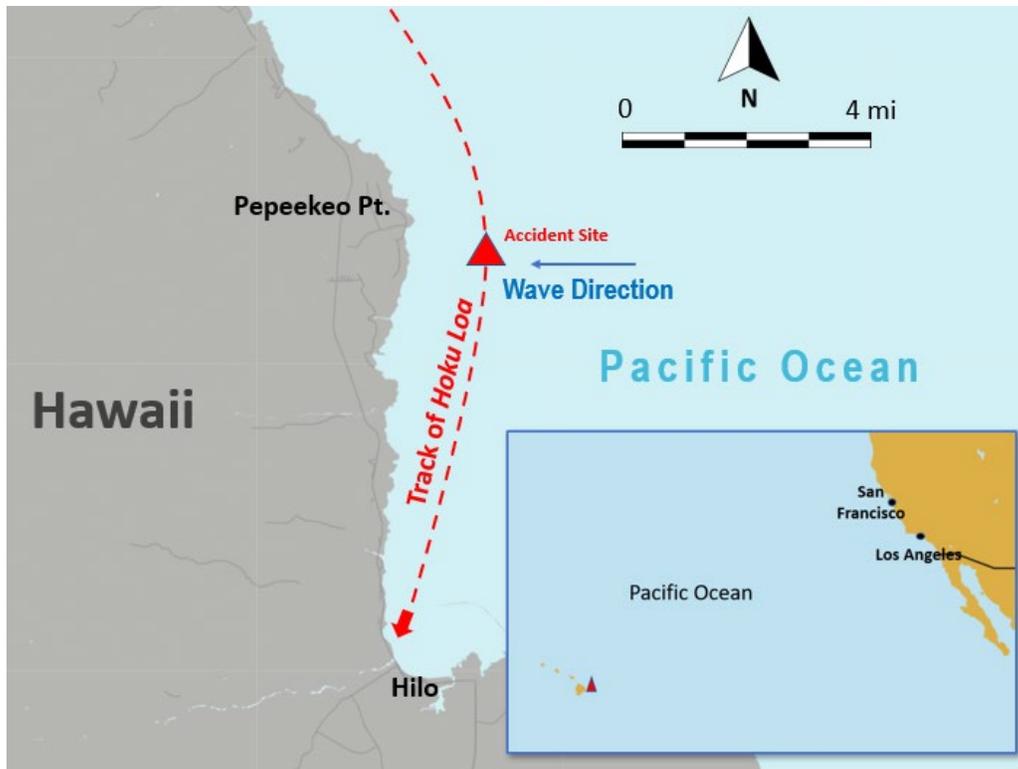
Area where the *Hoku Loa* tow was transiting; the red triangle indicates the tug's position when the collapse occurred. (Background source: Google Maps)

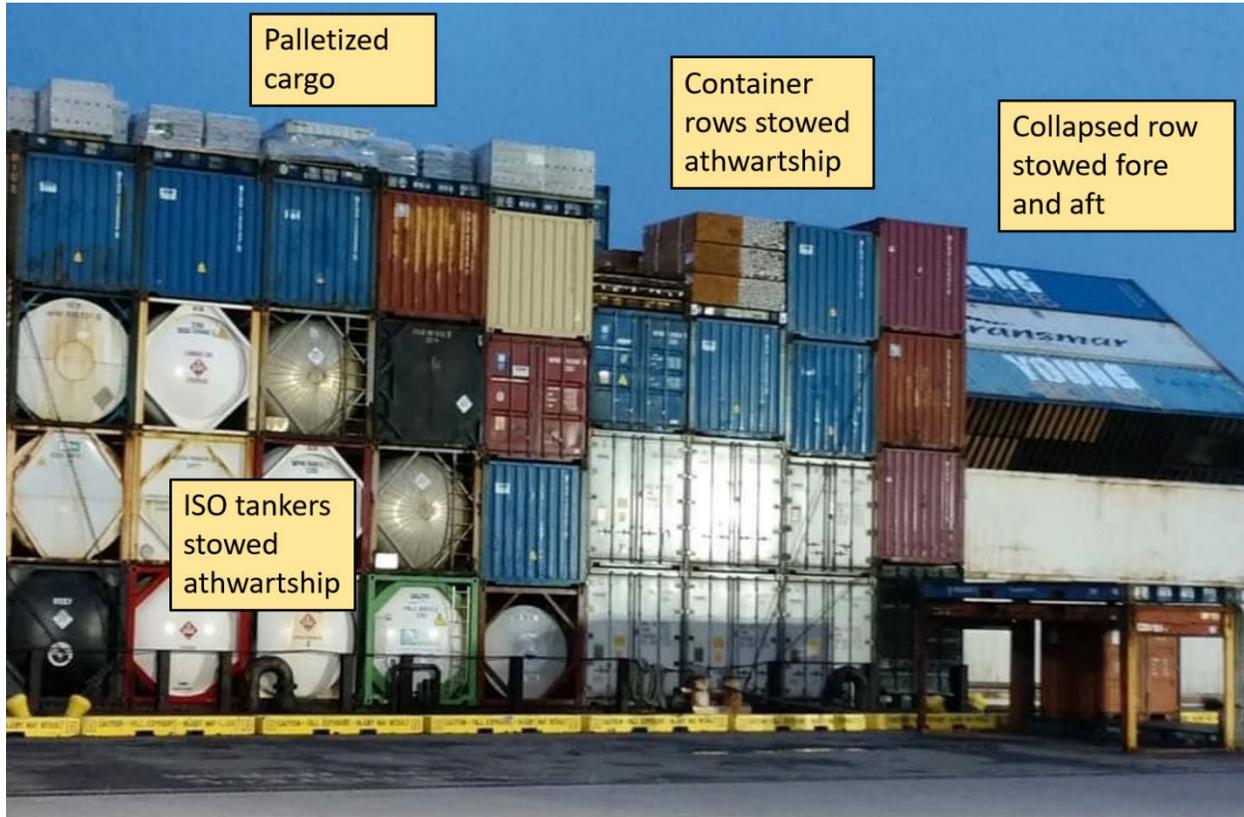
Cargo on the *Ho'omaka Hou* upon arrival to Hilo at the end of the accident voyage.

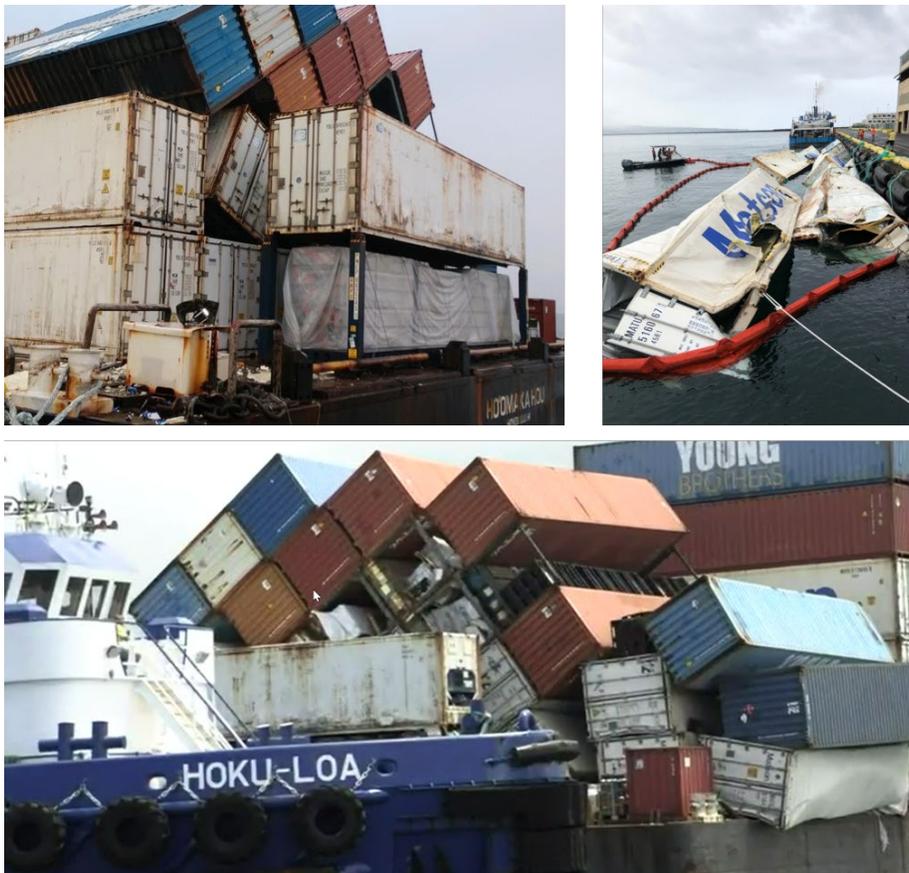
Clockwise, from top left: The collapsed row of containers on the barge in Hilo; salvaged containers, pier side in Hilo; and the collapsed row of containers, from the starboard quarter of the *Ho'omaka Hou*. (Source: Coast Guard)

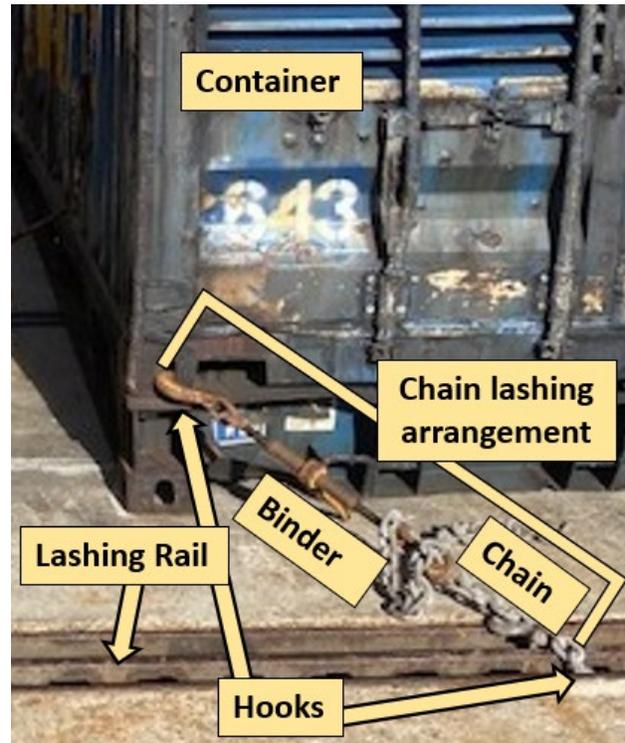
A typical chain lashing securing arrangement similar to those used to secure collapsed row of containers. (Source: Coast Guard, annotated by NTSB)

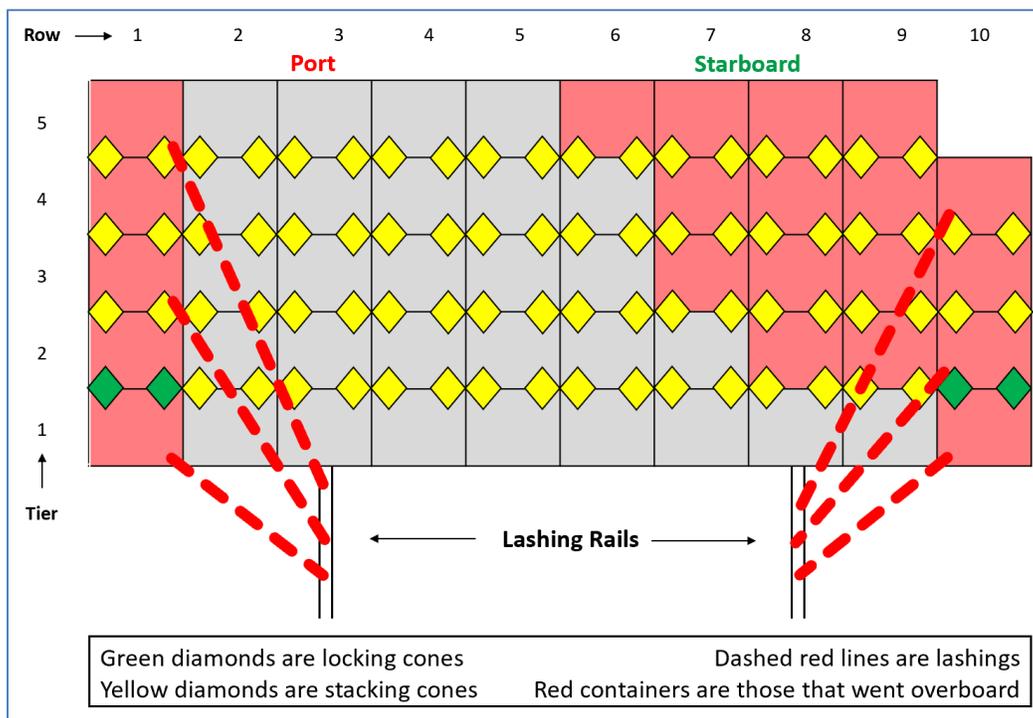
Lashing diagram of collapsed row of containers on *Ho'omaka Hou*, as viewed from aft.
