## Fatal accident to a fish farm worker involving the workboat *Beinn Na Caillich* Ardintoul, Glenshiel, Scotland 18 February 2020

### SUMMARY

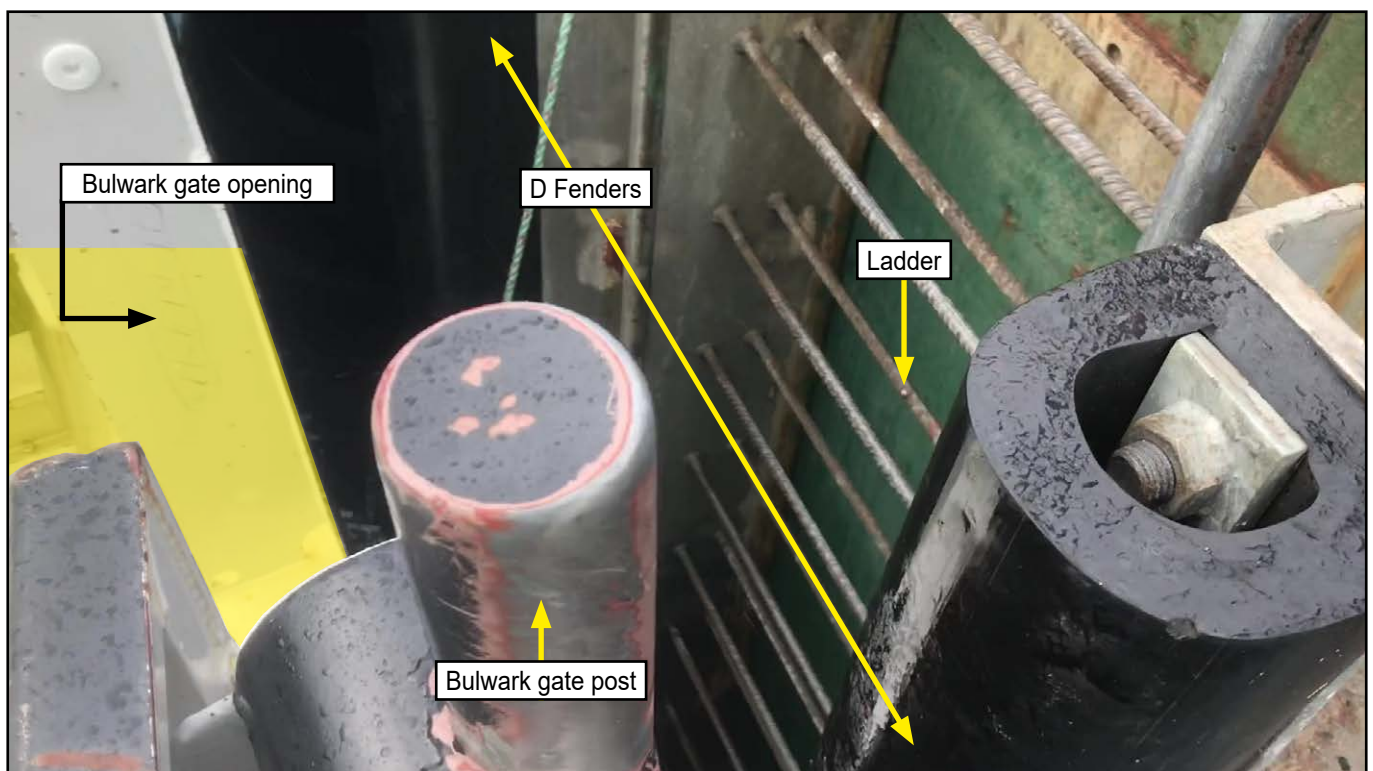
**Figure 4:** *Beinn Na Caillich's* bulwark gate and barge ladder

At about 1510, with *Beinn Na Caillich* still moving slowly ahead, the assistant manager stepped through the open gate and on to the barge access ladder. *Stolt Madah's* skipper saw this from the back of *Beinn Na Caillich's* bridge and, realising the danger, shouted out in surprise. As he did so, *Beinn Na Caillich's* bulwark gate post caught the assistant manager and crushed him against the barge ladder's fender structure (**Figure 4**).

Ardintoul fish farm's assistant manager was crushed between *Beinn Na Caillich's* bulwark and the barge ladder structure because he stepped across onto the ladder while the workboat was still moving ahead. He drowned because he was unable to hold onto the ladder and slipped out of his lifejacket before entering the water.

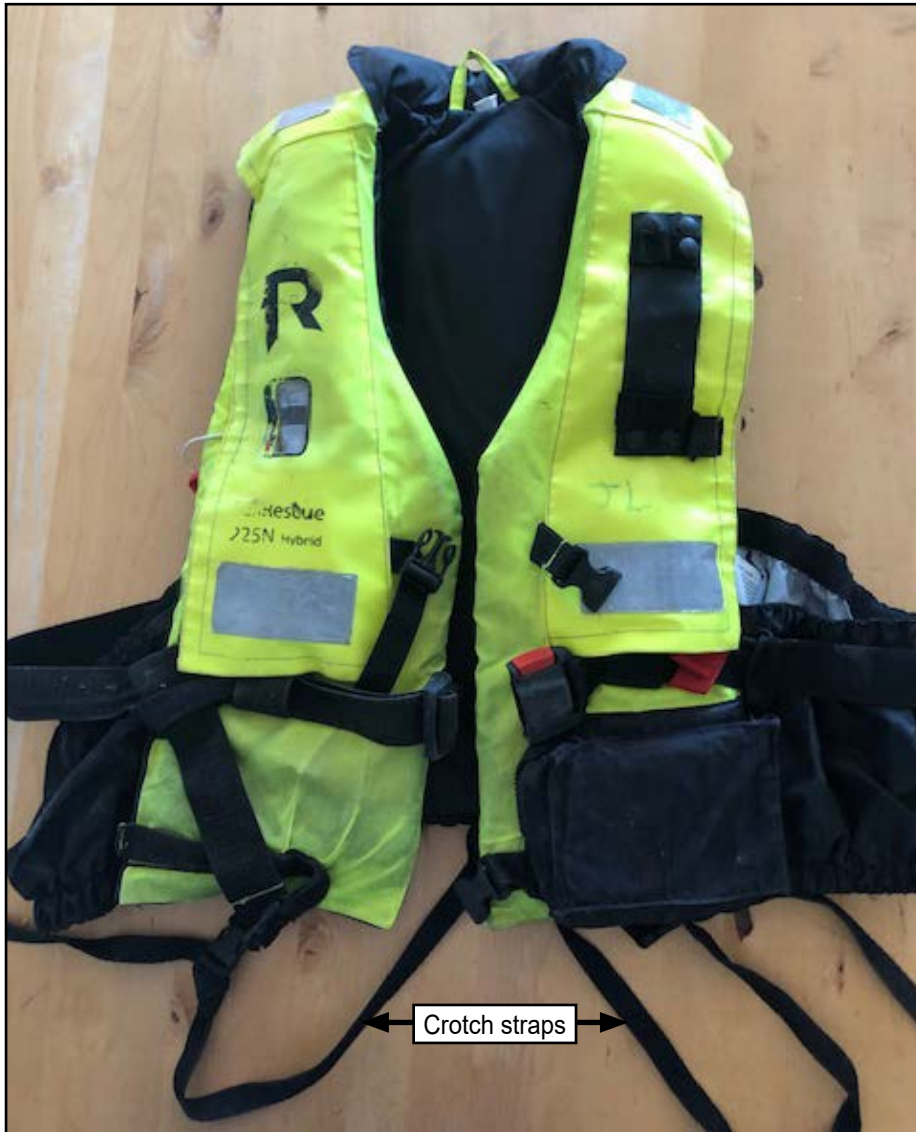
**Figure 5:** The assistant manager's personal flotation device

The technician saw the assistant manager hanging from the ladder and grabbed hold of the strap at the back of his lifejacket (**Figure 5**). The assistant manager told the technician that he could not use or feel his legs. Shortly after, the assistant manager lost his grip on the ladder, slipped out of his lifejacket and oilskin coat, and fell 2.7m into the water. The technician was left holding the lifejacket and oilskin coat.

The assistant manager was wearing company issued oilskin bib and braces, oilskin jacket and wellington boots. He was also wearing a Regatta SeaRescue Hybrid 225 Newton auto-inflation lifejacket (**Figure 5**). The lifejacket was fitted with crotch straps, which were unfastened at the time of the accident.

The assistant manager suffered severe crush injuries before he fell from the ladder into the water; however his cause of death was drowning. The assistant manager was wearing a lifejacket when he stepped from the boat. However, he slipped out of it as he fell from the ladder, with the result that he was unsupported in the water.

It is unknown how well fitted the lifejacket was, but as permitted by company policy, its crotch strap had not been fastened. Crotch straps are designed to stop lifejackets riding up on entry to and while in the water; they are not designed to support the weight of the person wearing it. However, had the assistant manager's crotch straps been fastened, it is possible that he would not have slipped out of his lifejacket.

Mowi's policy of allowing the wearer to decide whether or not to attach the crotch strap was contrary to best practice and published guidance from both the MCA and the International Maritime Organization. Properly fitted lifejackets with fastened crotch straps will help keep an unconscious or incapacitated casualty's airways clear of the water and therefore significantly increase their chances of survival.

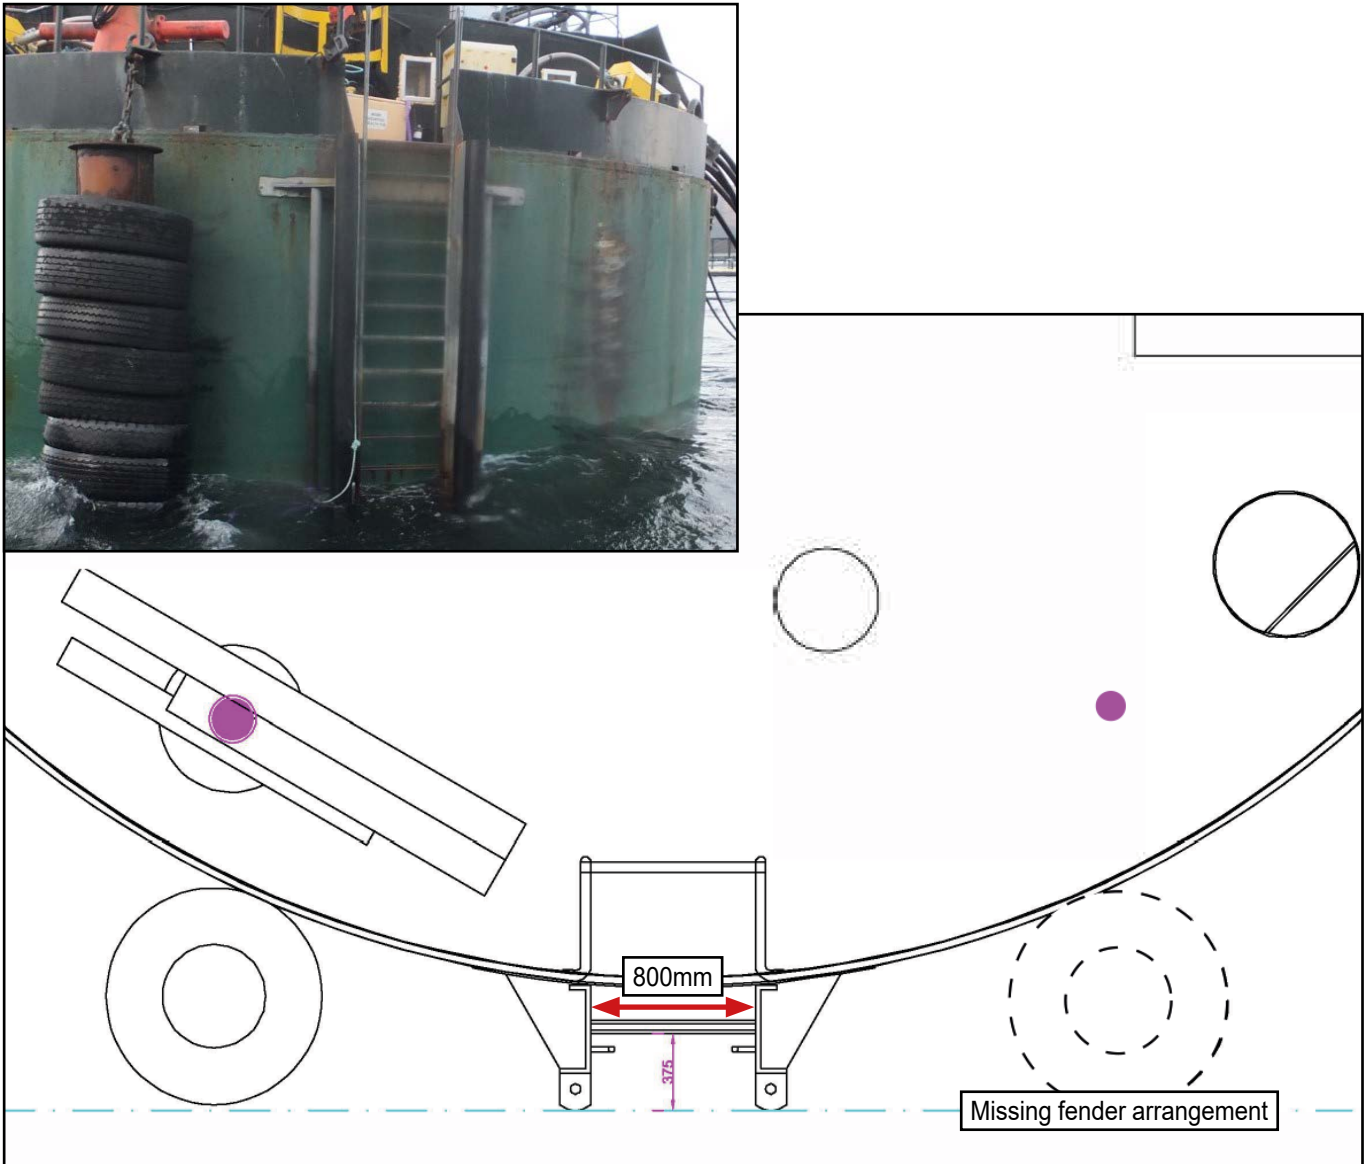
**Figure 6:** Plan view of the barge ladder arrangement

The primary means of access to the barge was via an 800mm wide vertical fixed ladder (**Figure 6**) with double reinforcing bar rungs and handrails. The ladder was protected on either side by steel structures with rubber D-shaped fenders, and the depth from the ladder rungs to the outside edge of the D fenders was 375mm. On either side of the ladder there should have been a vertical rubber tyre fender arrangement designed to provide protection when larger vessels were mooring alongside. However, the vertical fender on the right-hand side of the ladder was missing after becoming detached following a heavy contact during a feed delivery on 8 February 2020.

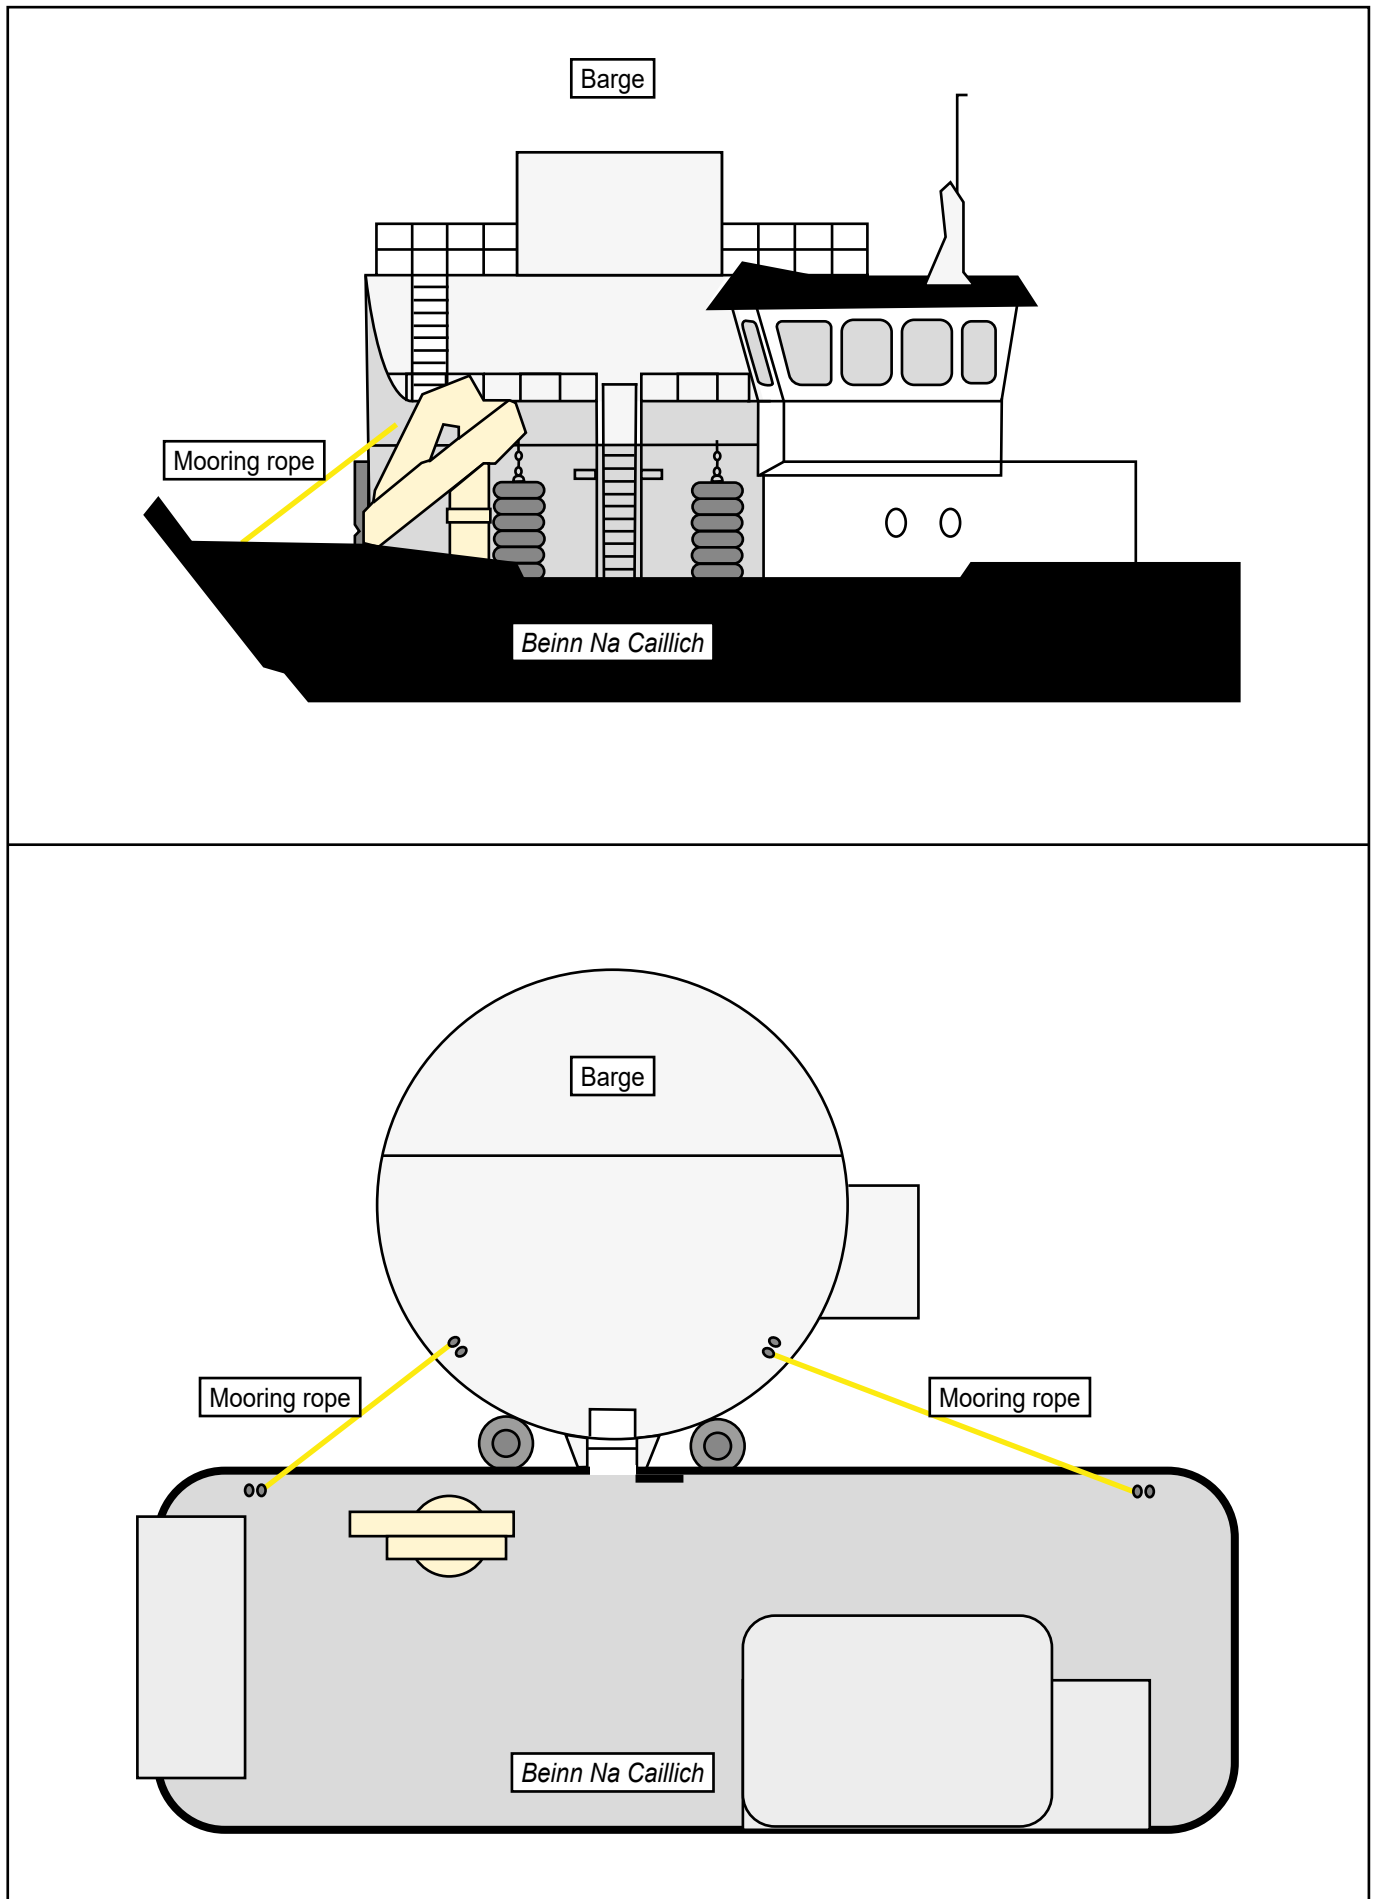
**Figure 7:** Illustration of the method usually used to secure the workboat alongside the barge

*Beinn Na Caillich's* skipper agreed to the assistant manager's request and decided to carry out a 'touch and go' transfer rather than secure the workboat to the barge using mooring ropes (**Figure 7**), the procedure usually used for longer stays alongside. This was probably because he wanted to save time; however, his decision might also have been influenced by the fact that one of the mooring fenders was missing. Regardless, the skipper did not discuss his plan with the assistant manager and did not inform his crew or the fish farm technician on the barge of his intentions for the transfer. This was probably because he had an expectation that the assistant manager understood his intentions and knew not to step onto the ladder until it was lined up with the bulwark door and the vessel was stopped.
