Report on the investigation of  
the foundering of the whelk potter

***Nicola Faith (BS58)***

resulting in three fatalities  
in Colwyn Bay, North Wales

REPORT NO 8/2022

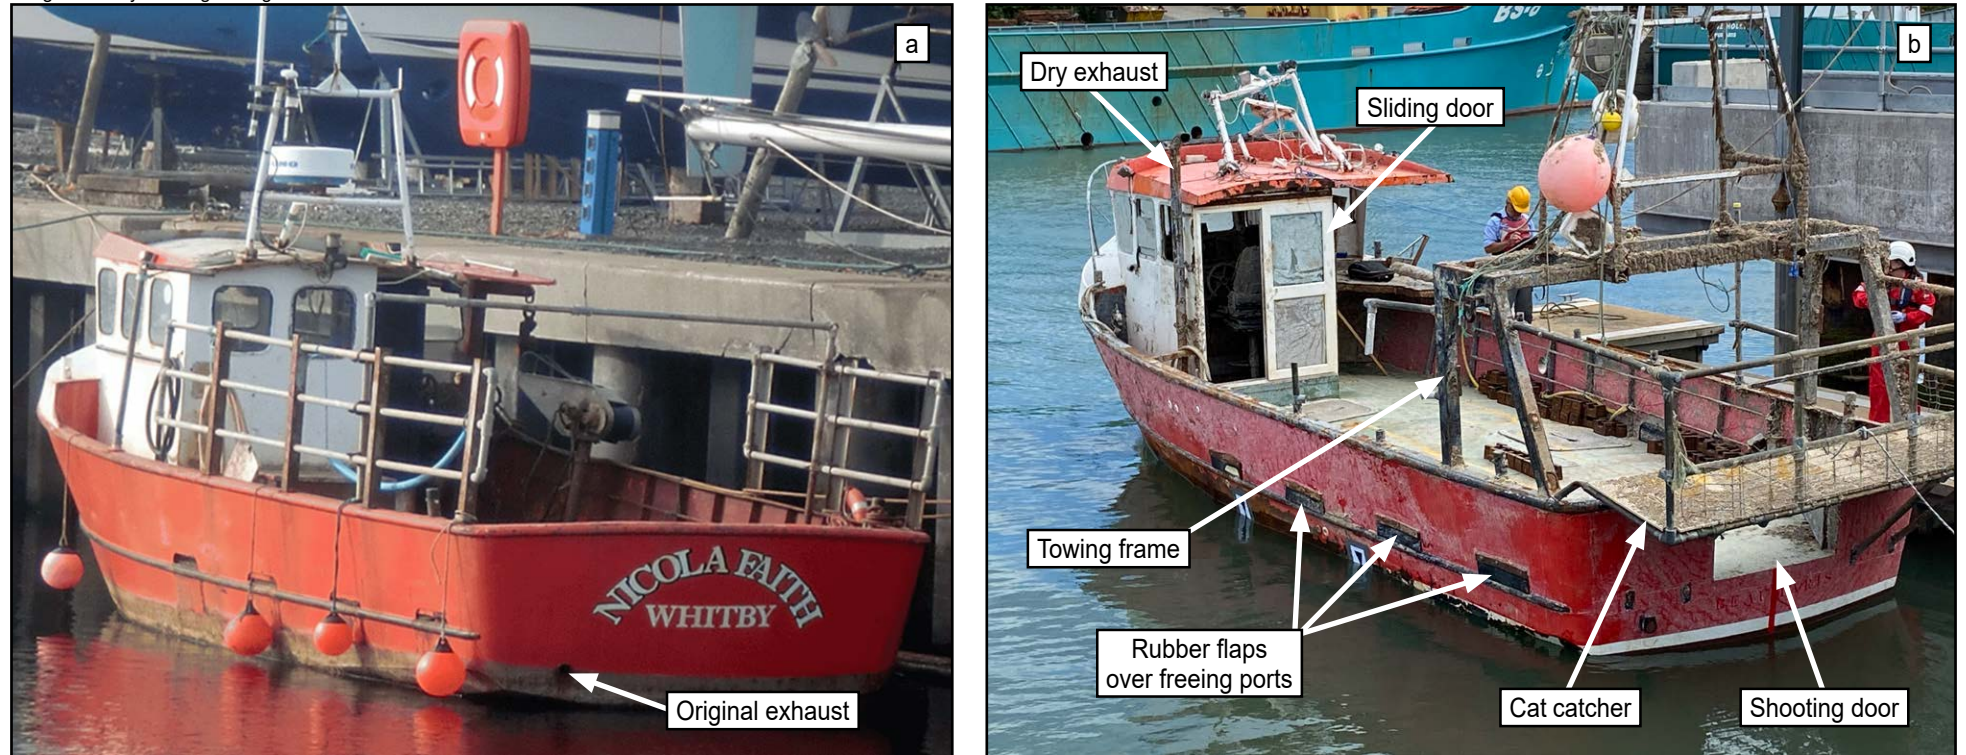
*Nicola Faith* was a 9.81m steel-hulled potter built in 1987 (**Figure 5a**). During its life it was modified to operate as a stern trawler, but later converted back for use as a potter (**Figure 5b**). It had a forward wheelhouse that was enclosed from the centreline to the port side of the vessel only. Forward of the wheelhouse, below the main deck, was a cabin that extended across the full width of the bow and was accessed from inside the enclosed wheelhouse. This cabin was used for storing equipment and tools.

**Figure 5:** *Nicola Faith* as it was built, before any significant modifications (a) and *Nicola Faith*'s recovered wreck, showing modifications (b)

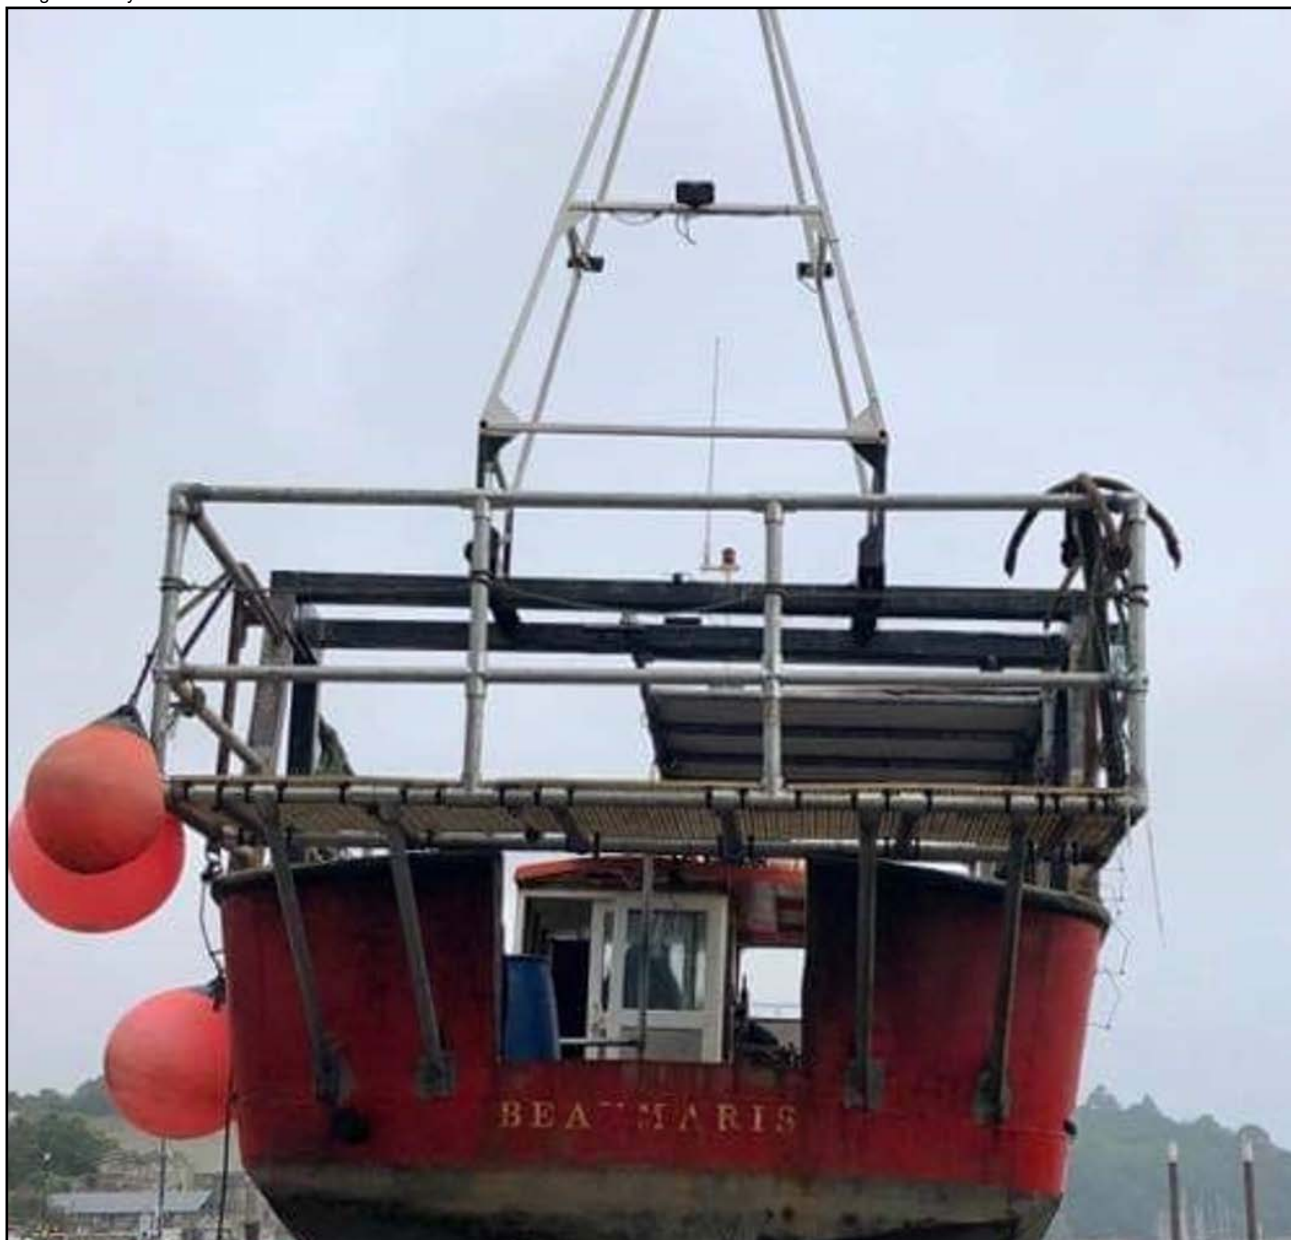
**Figure 7:** Large cat catcher fitted to *Nicola Faith's* stern

On 5 May 2019, an unannounced inspection of *Nicola Faith* was carried out by an MCA surveyor following several engine breakdowns that had required the RNLI to tow the vessel into port. The MCA surveyor noted that the larger cat catcher had been fitted and reminded the skipper that significant modifications should be discussed and approved by the MCA before being made.

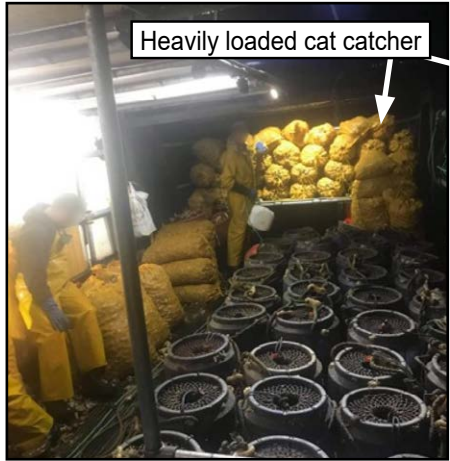
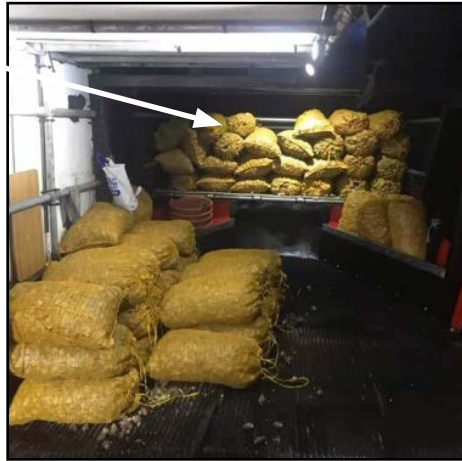
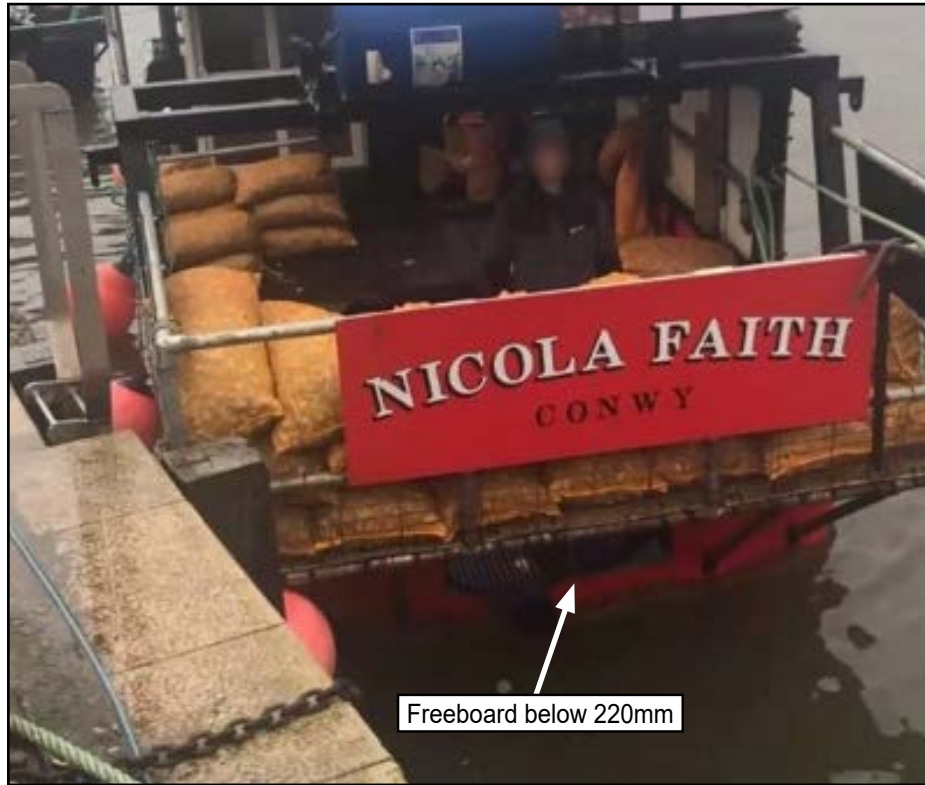
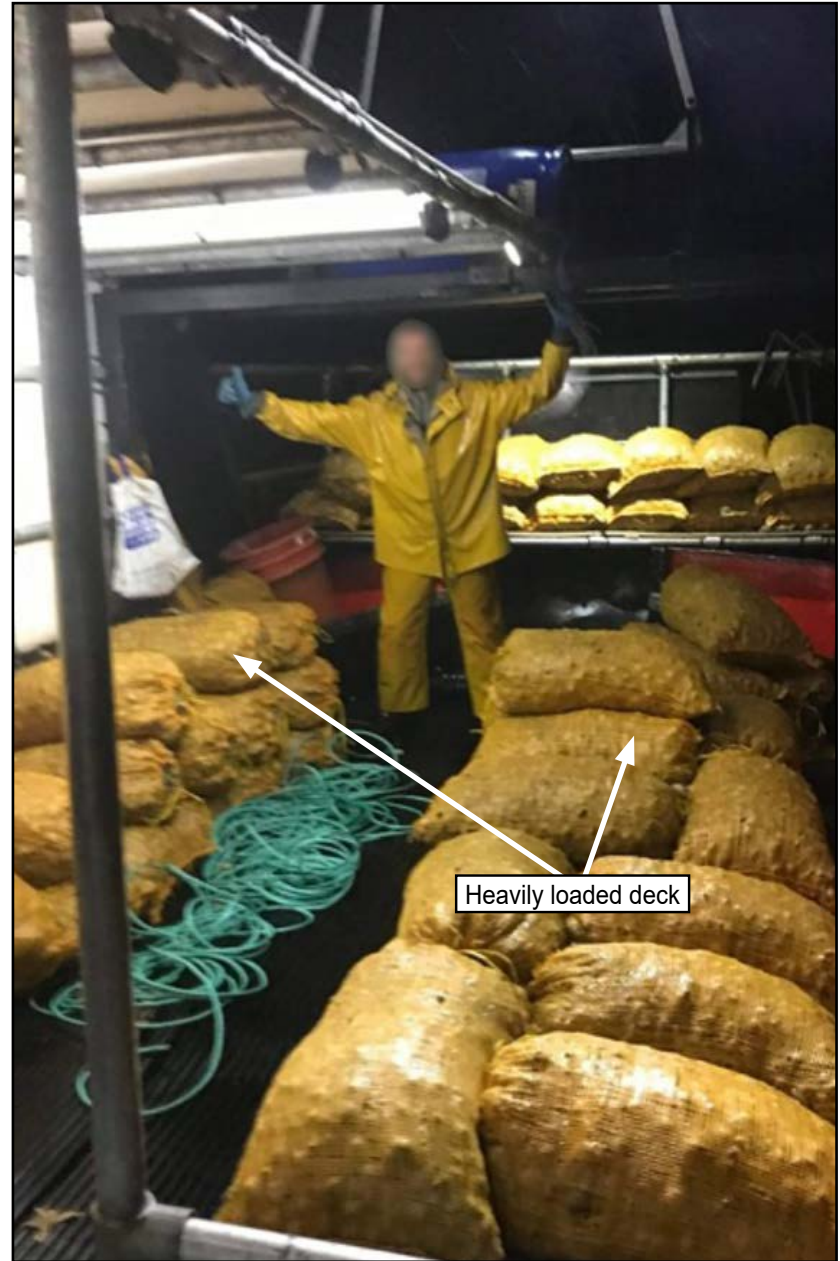
Figure 10: Nicola Faith loaded on voyages in 2020

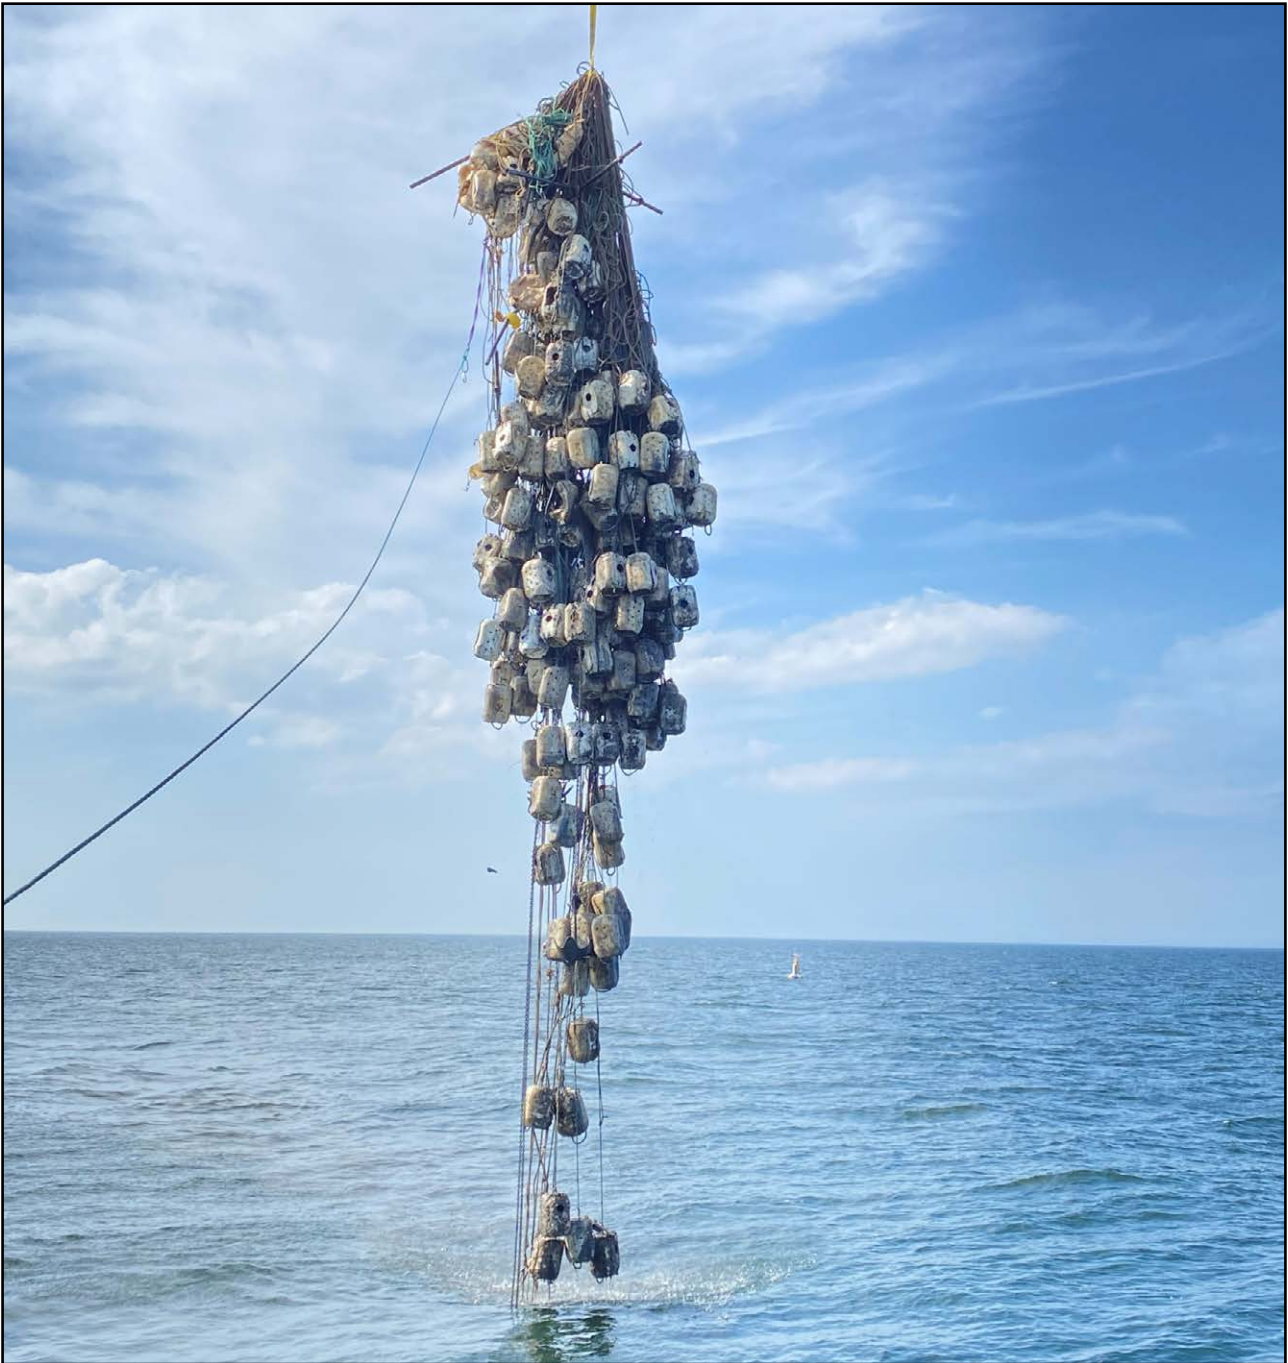
The wreck of *Nicola Faith* was recovered with 223 whelk pots (**Figure 14**). The associated gear found with the pots included hundreds of metres of leaded polypropylene rope, 11 anchors, and several pot marker buoys.

A calibrated load cell was used to weigh the equipment: the pots, rope and anchors weighed 2436kg; a large quantity of tools and spare gear found in the forward cabin area weighed 1100kg.

**Figure 14:** Whelk pots and associated gear being recovered from the seabed

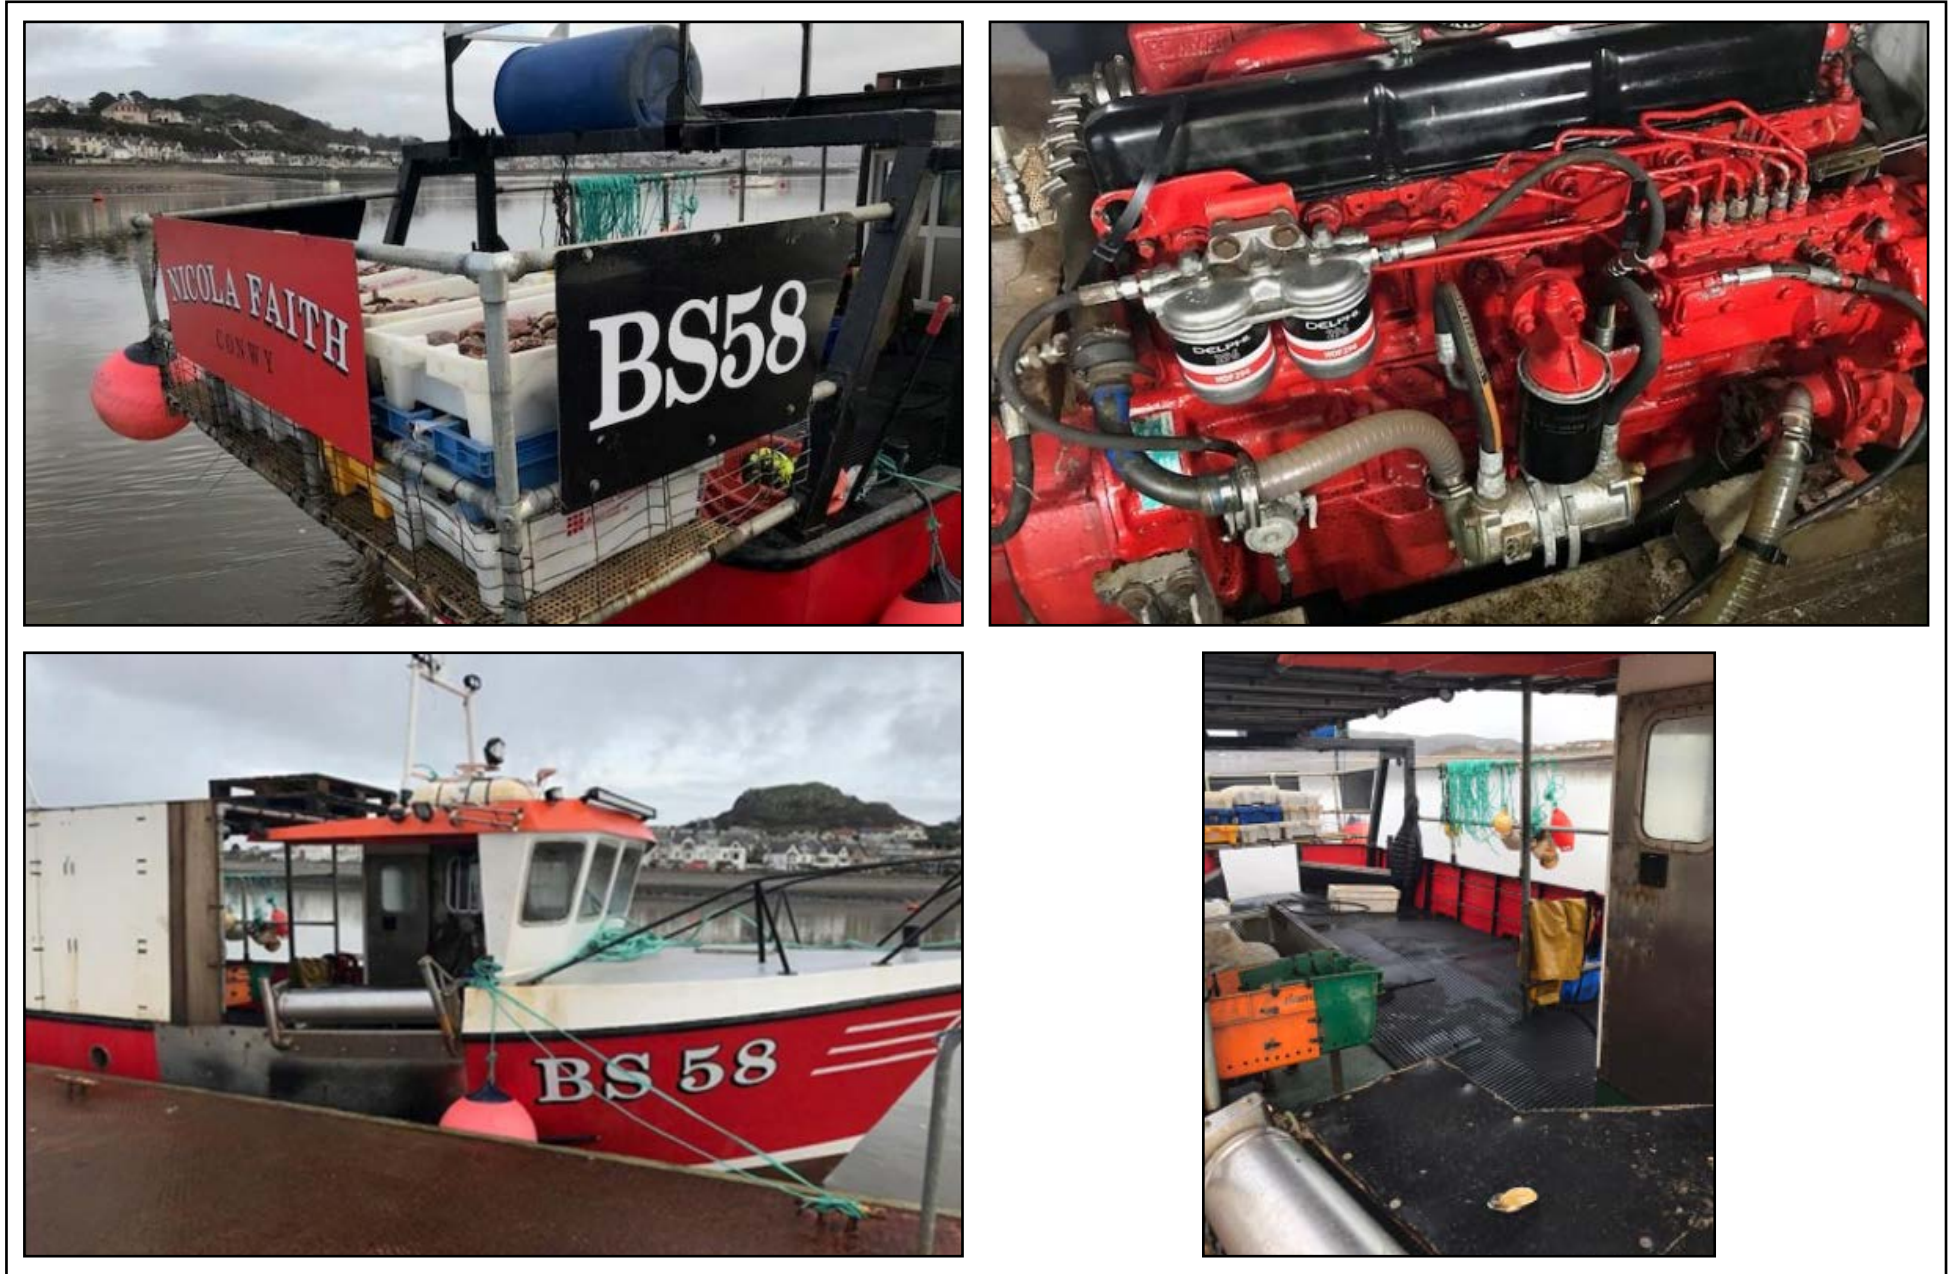
On 11 December 2020, an MCA surveyor carried out a further unannounced inspection following another engine breakdown. During the inspection the new wheelhouse door, modified engine exhaust, freeing port flaps and deck canopy were observed and photographed by the surveyor (**Figure 15**).

**Figure 15:** Photographs of *Nicola Faith* taken by an MCA surveyor on 11 December 2020

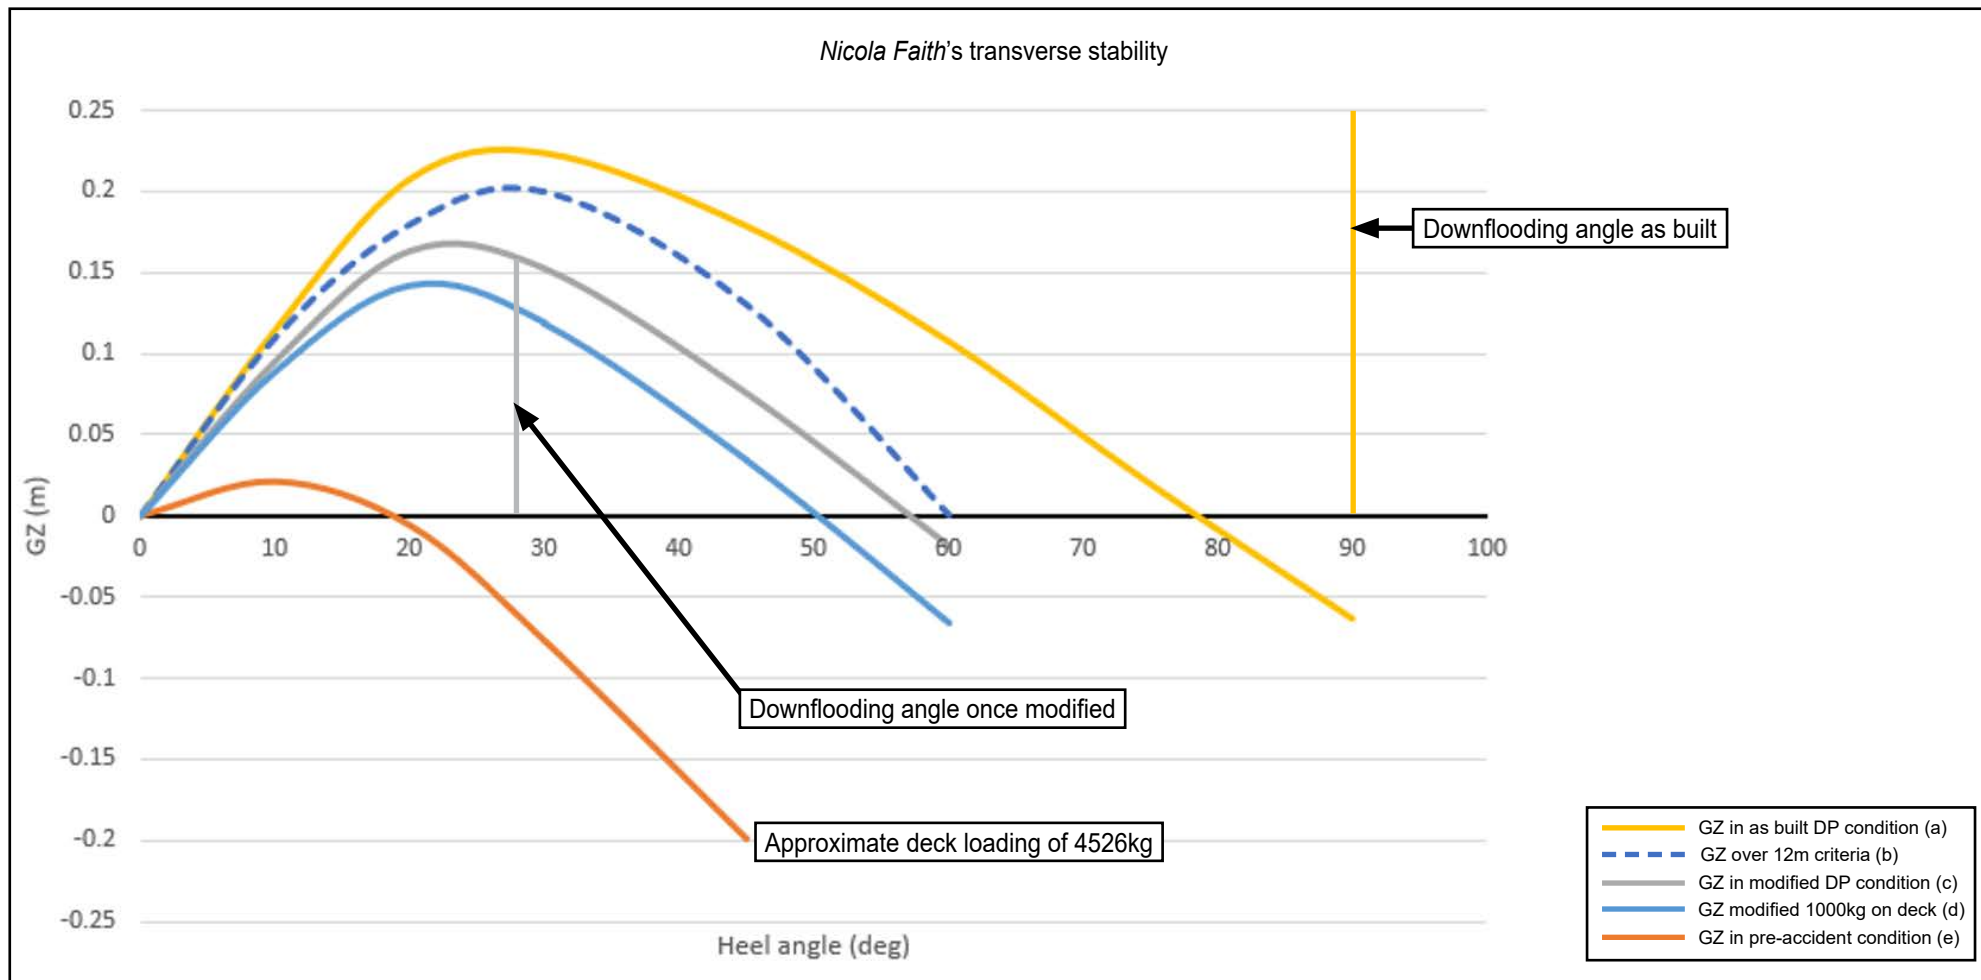
The calculations further revealed that after its modifications *Nicola Faith* failed to meet minimum stability requirements in all tested conditions, except for lightship (non-seagoing), and that immediately before the accident *Nicola Faith's* transverse stability was at a critically low level. The calculations performed by the naval architect indicated that the vessel was almost certainly heeling slightly to port because the centre of gravity was not on the centreline, the maximum righting lever<sup>12</sup> was negligible, and the range of stability was very low at about 15° (**Figure 18**).

**Figure 18:** Graph of *Nicola Faith's* transverse stability throughout its life

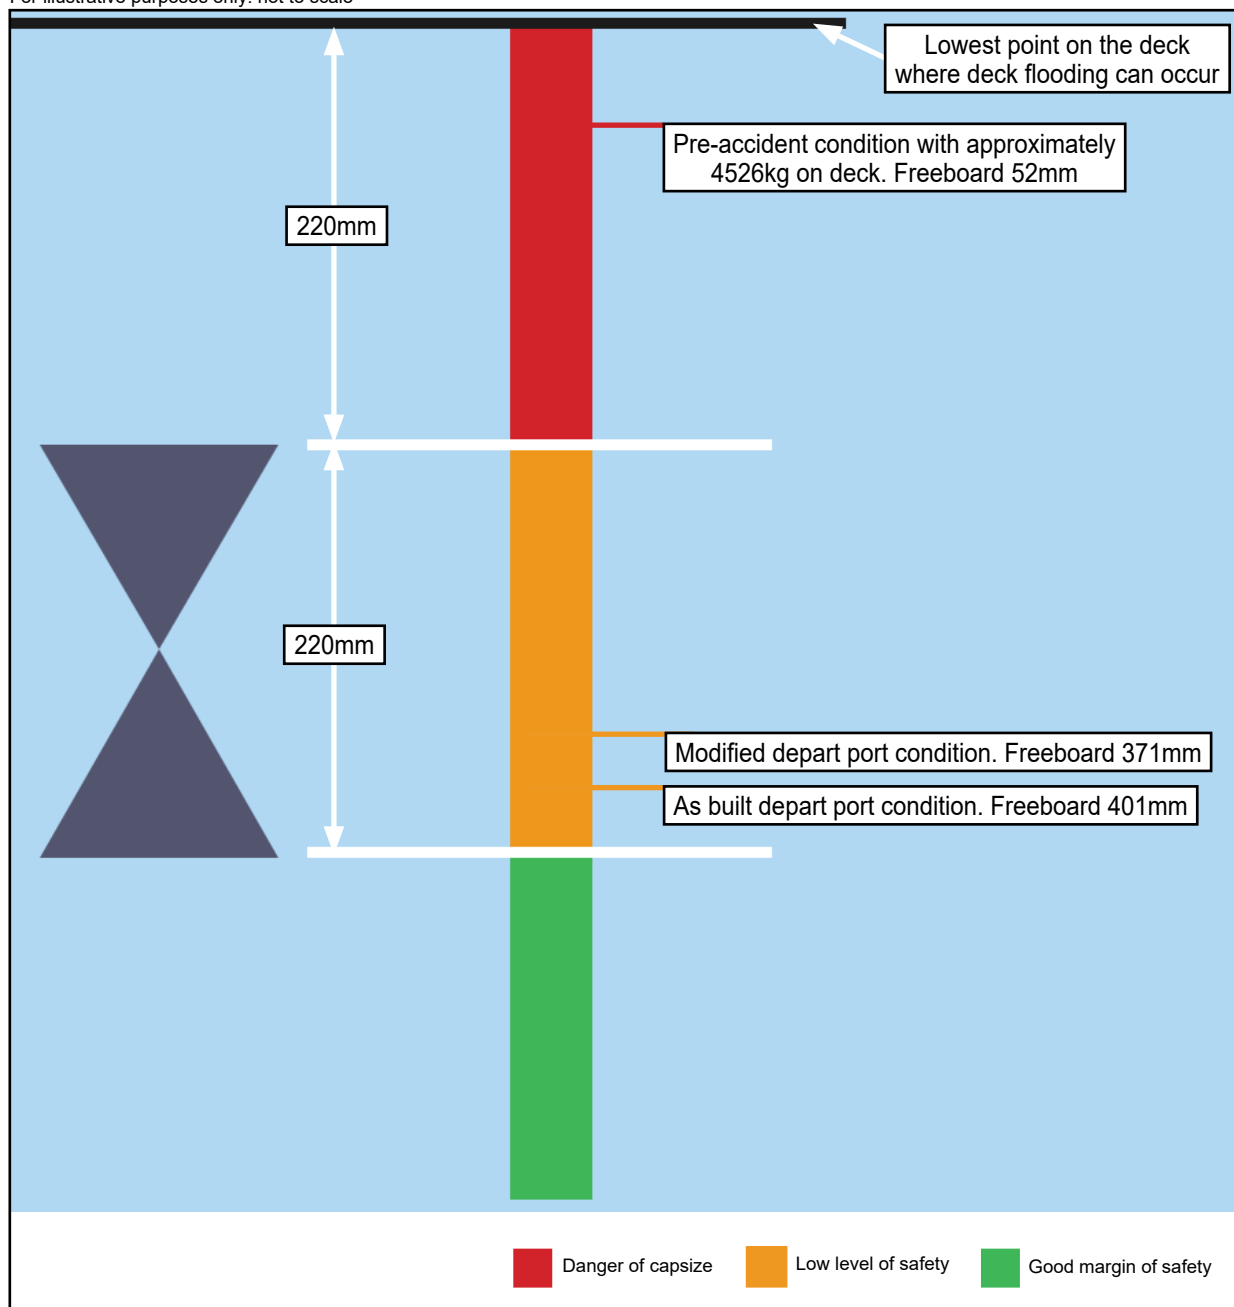
- In its as-built condition, in which the vessel passed full stability criteria, the freeboard was in the amber zone of the guidance mark under all loading conditions, indicating a low safety level of stability.
- In its modified state under condition No.2, depart port with 100% consumables on board, and condition No.6, depart grounds with 1000kg of catch stowed on deck, the Wolfson calculation indicated the freeboard to be in the amber zone.
- In the accident condition, the freeboard reduced into the red zone of the guidance mark.

Figure 19: Wolfson Stability Guidance Method guidance mark for *Nicola Faith*

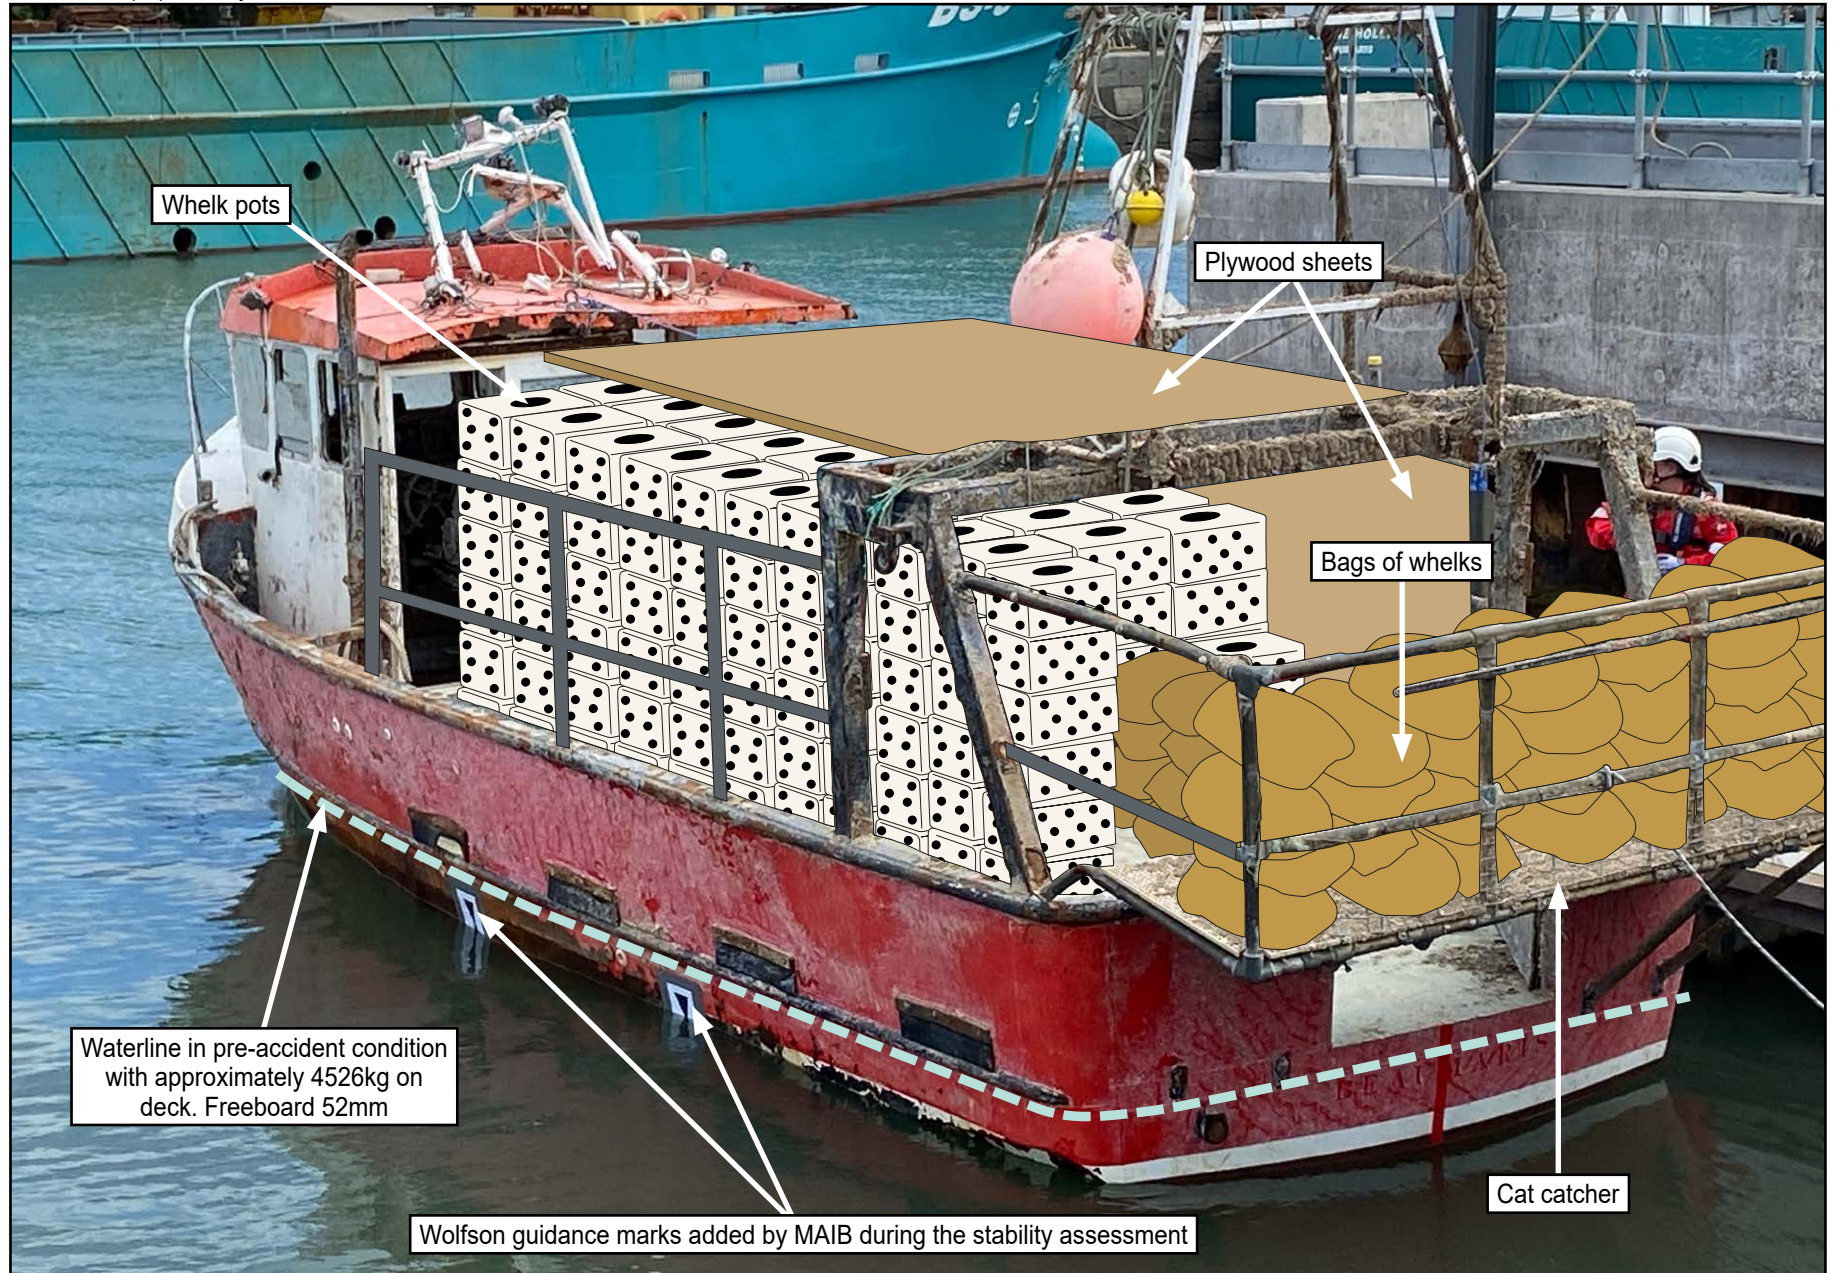
**Figure 20:** Possible loading condition of *Nicola Faith* before the accident
