**Extracts from
The United Kingdom
Merchant Shipping
(Accident Reporting and
Investigation) Regulations
2012**

Regulation 5:

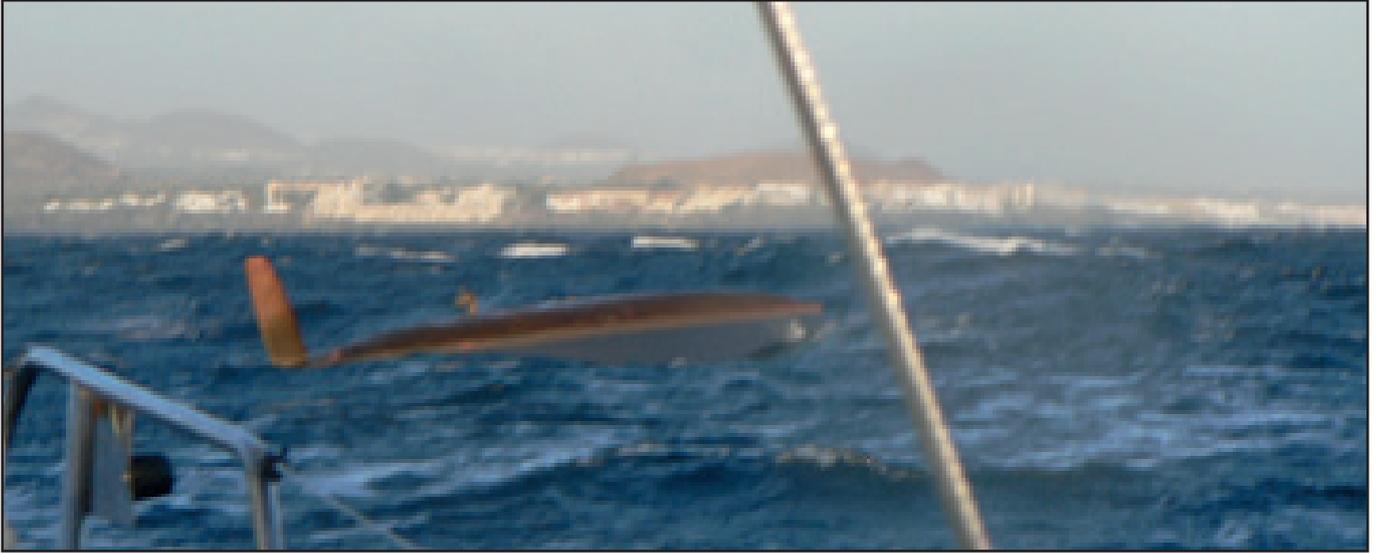
Figure 1: *Tyger of London* post-capsize

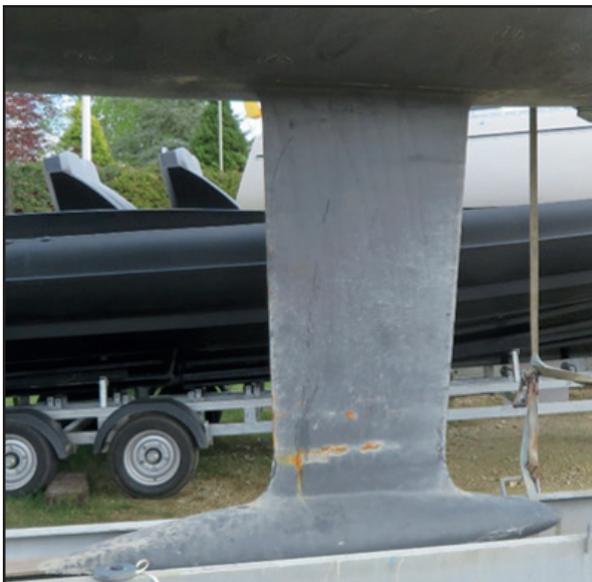
Figure 2a: Deep draught bulb keel not affected by this safety bulletin

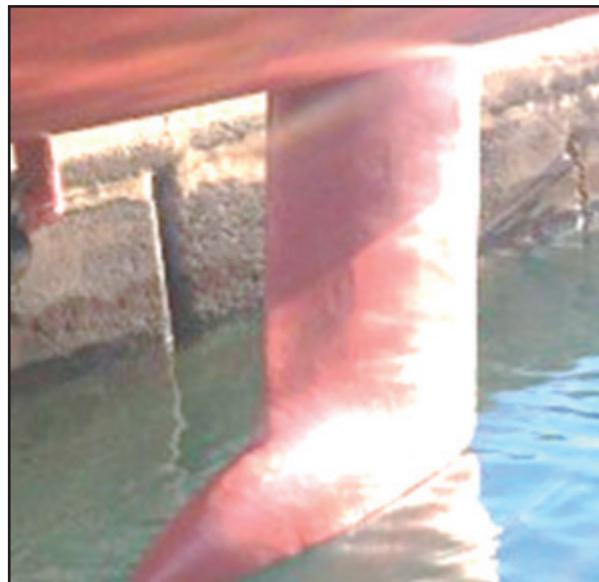
Figure 2b: Shallow draught, lead keel, fitted to *Tyger of London*, subject of this safety bulletin

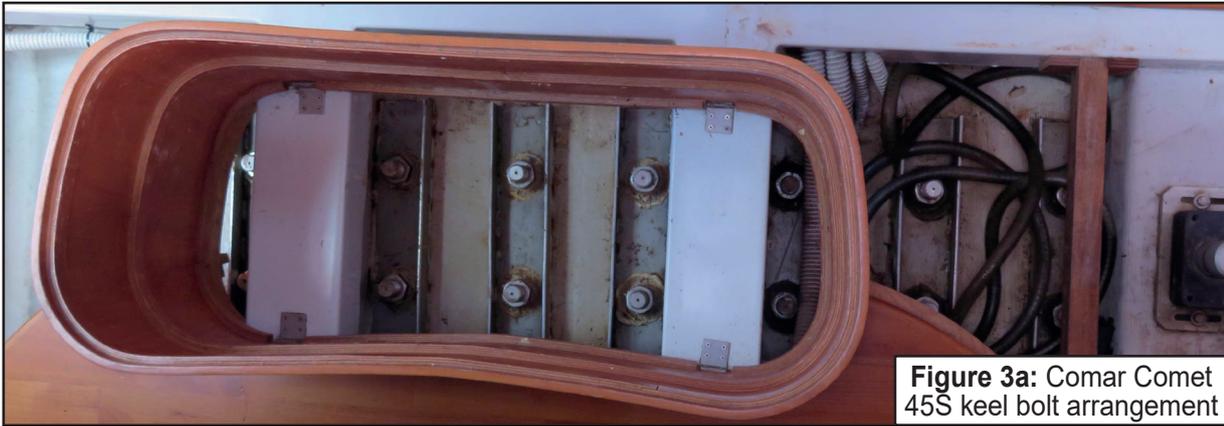
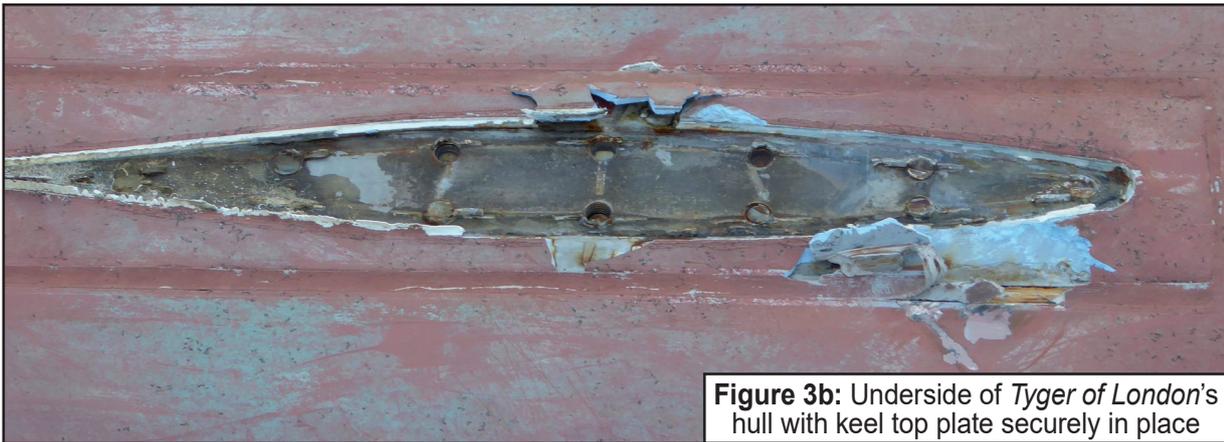
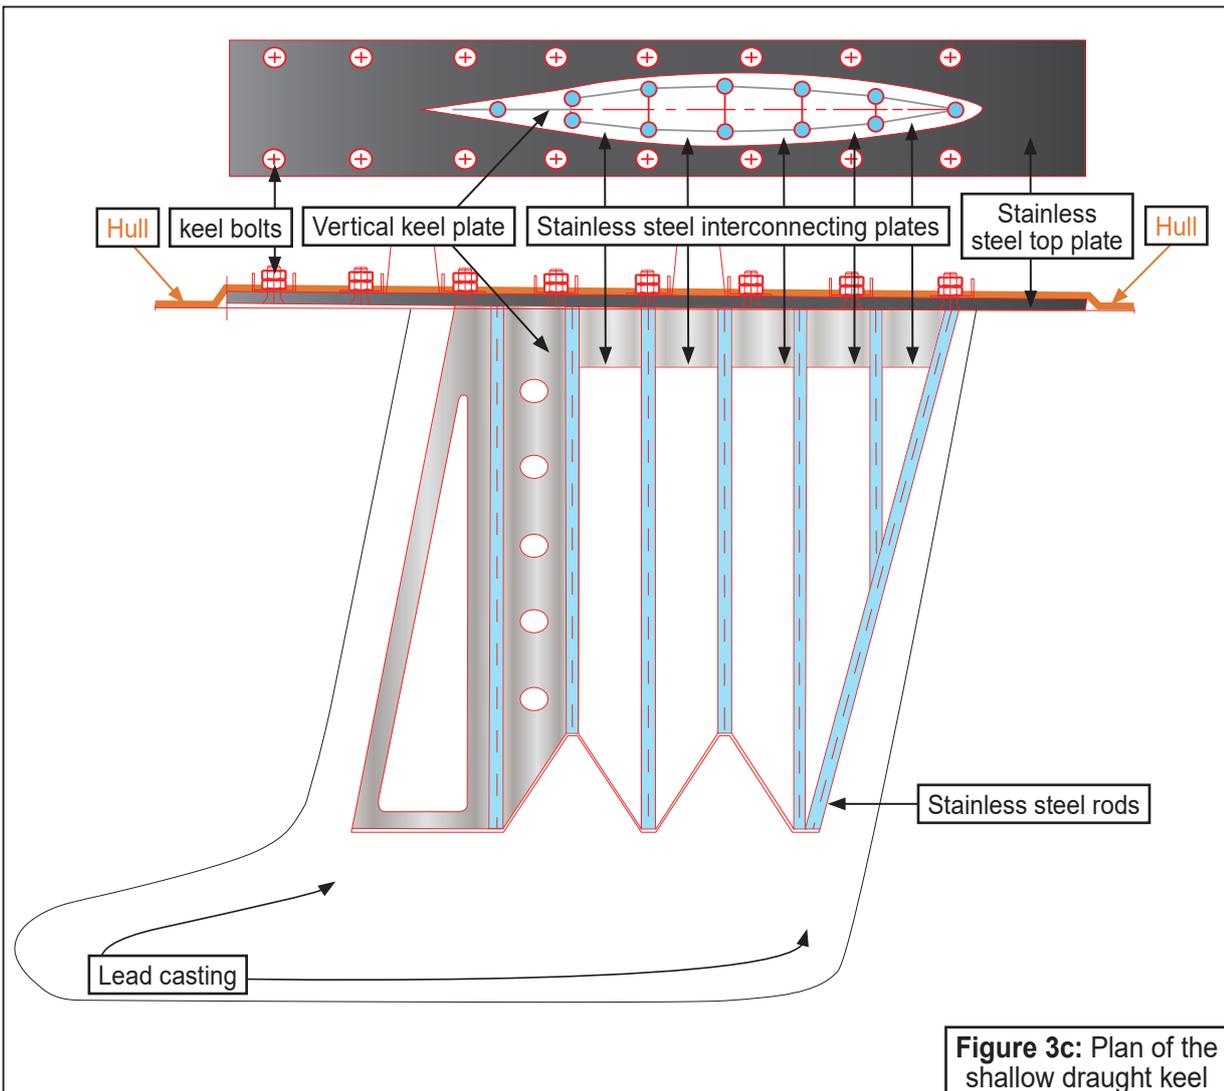
- To note that although the manufacturer, Comar Yachts s.r.l, has ceased trading, technical advice may be sought from **Gesti Nautica s.r.l**, a ship repair yard that has experience of these vessels. Their contact details are:
