SAFETY DIGEST

Lessons from Marine Accident Reports

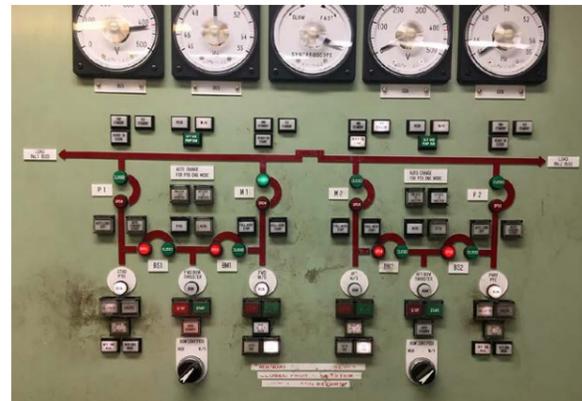
Figure 1: Main switchboard

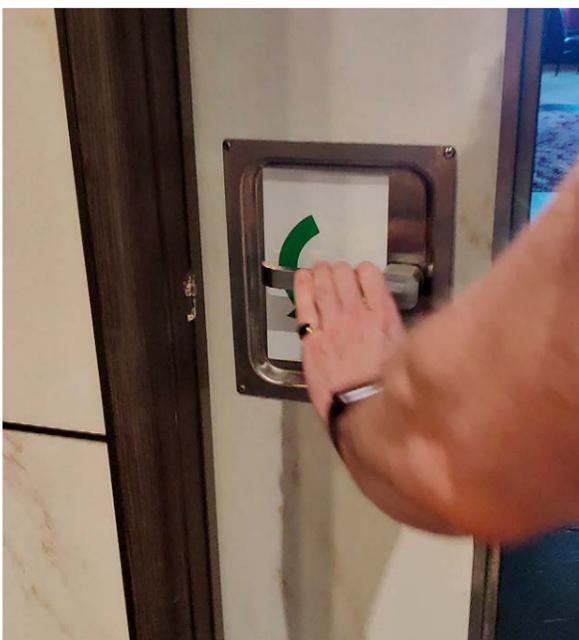
Figure 1: Door operating handle

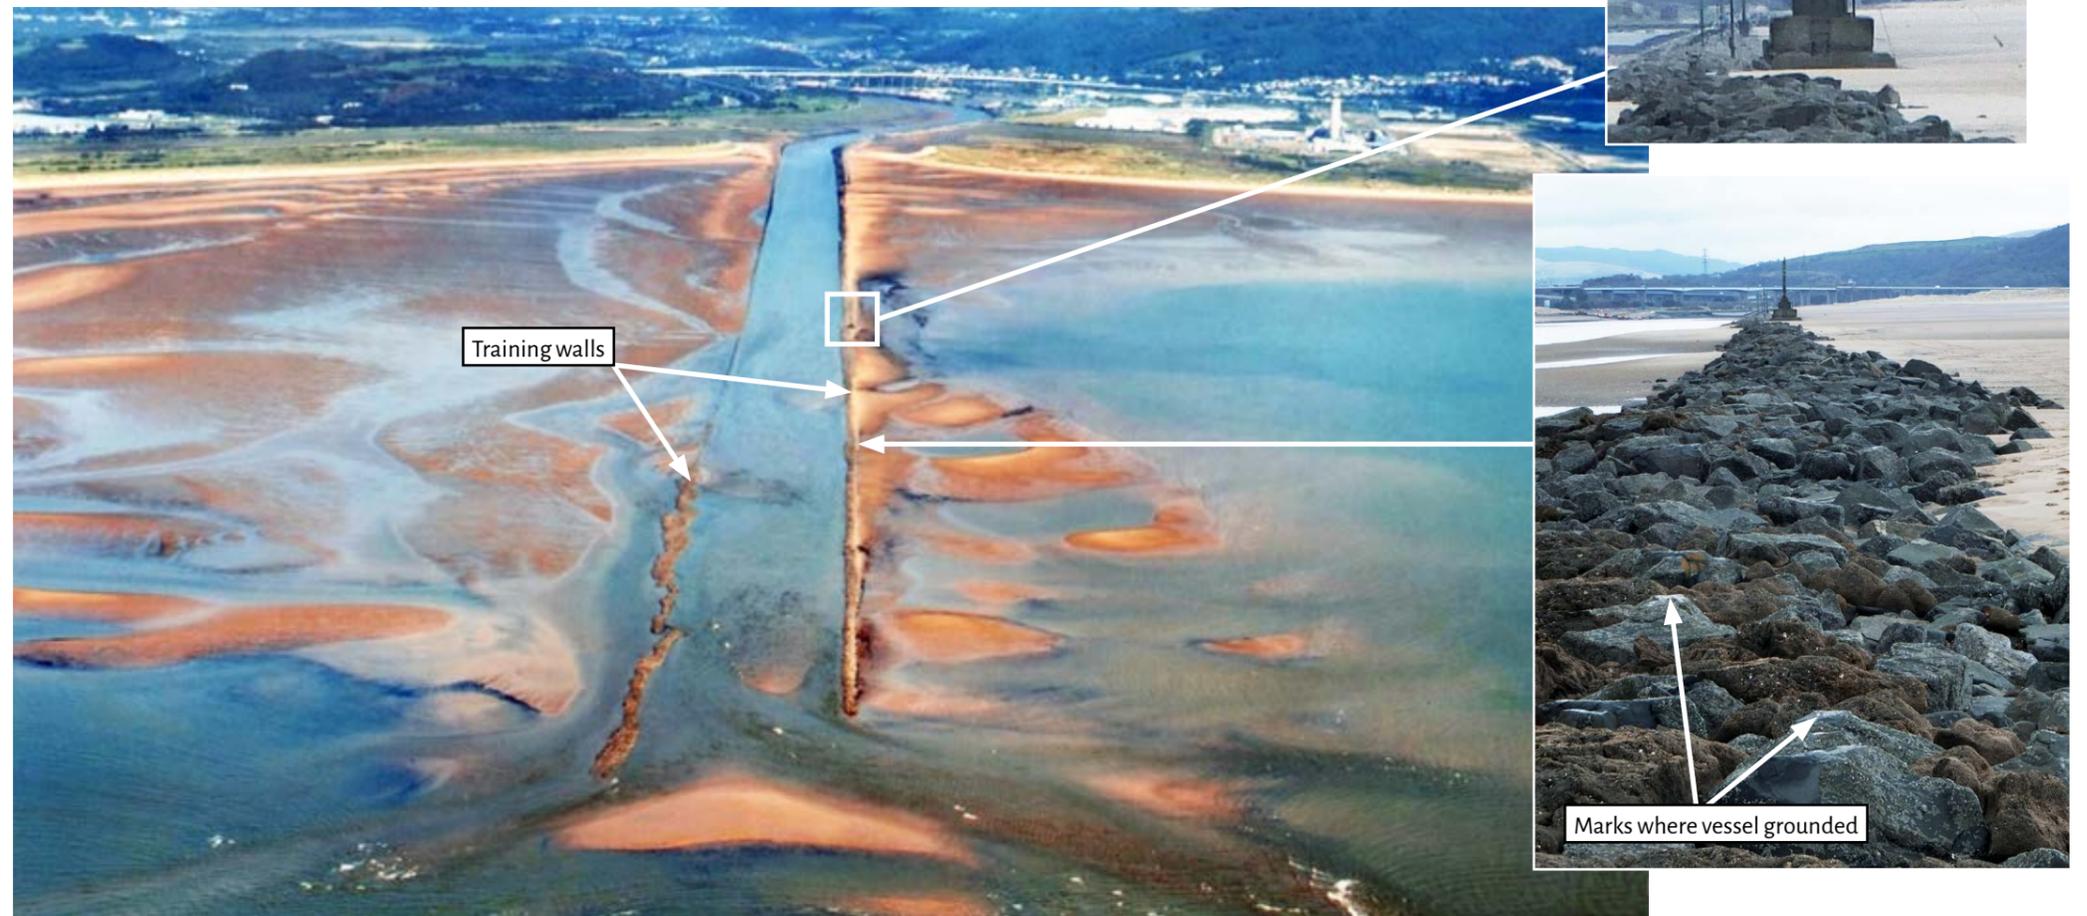
Figure: Channel and training wall vessel grounding position (low tide)

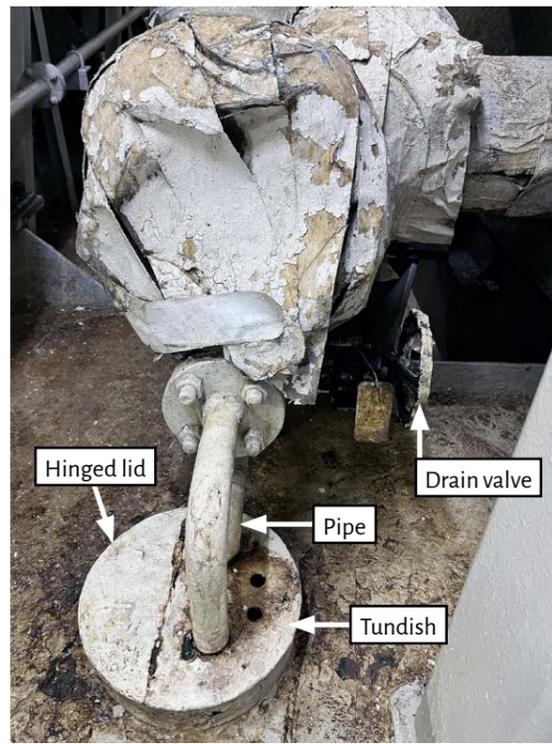
Figure: Economiser drain valve and tundish

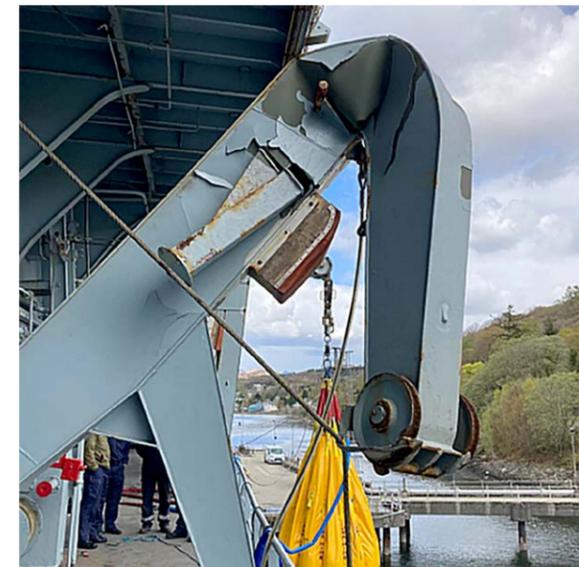
Figure 1: Failed davit

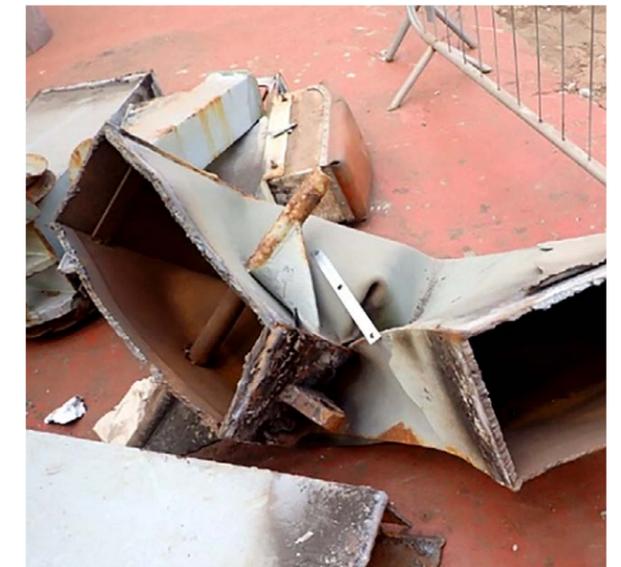
Figure 2: Buckled section of davit

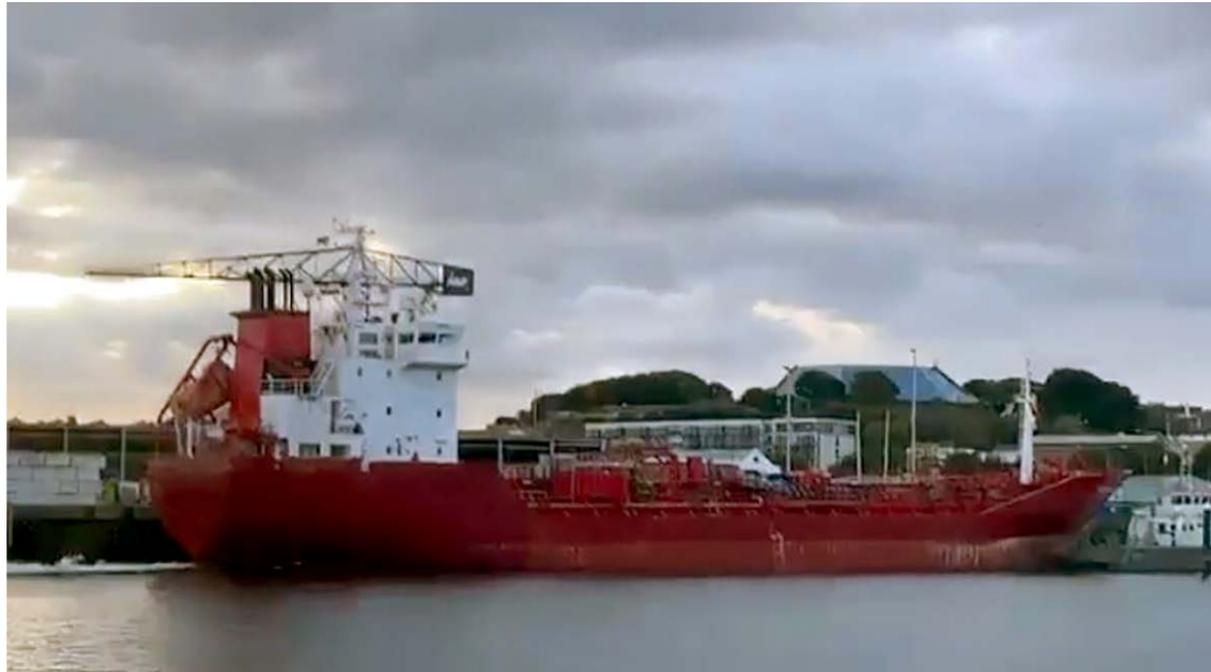
Figure 1: Tanker unexpectedly moving ahead on berth

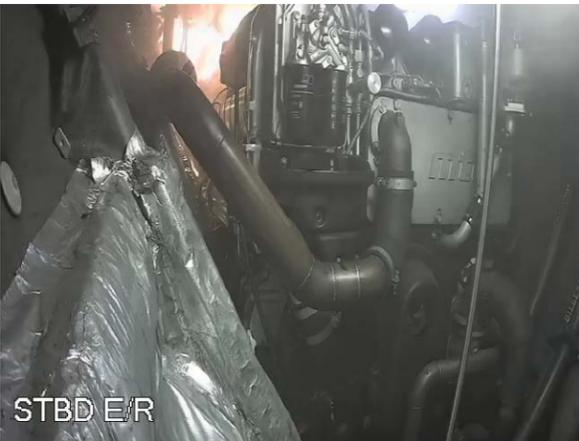
Figure 1: Engine fire seen on the CCTV

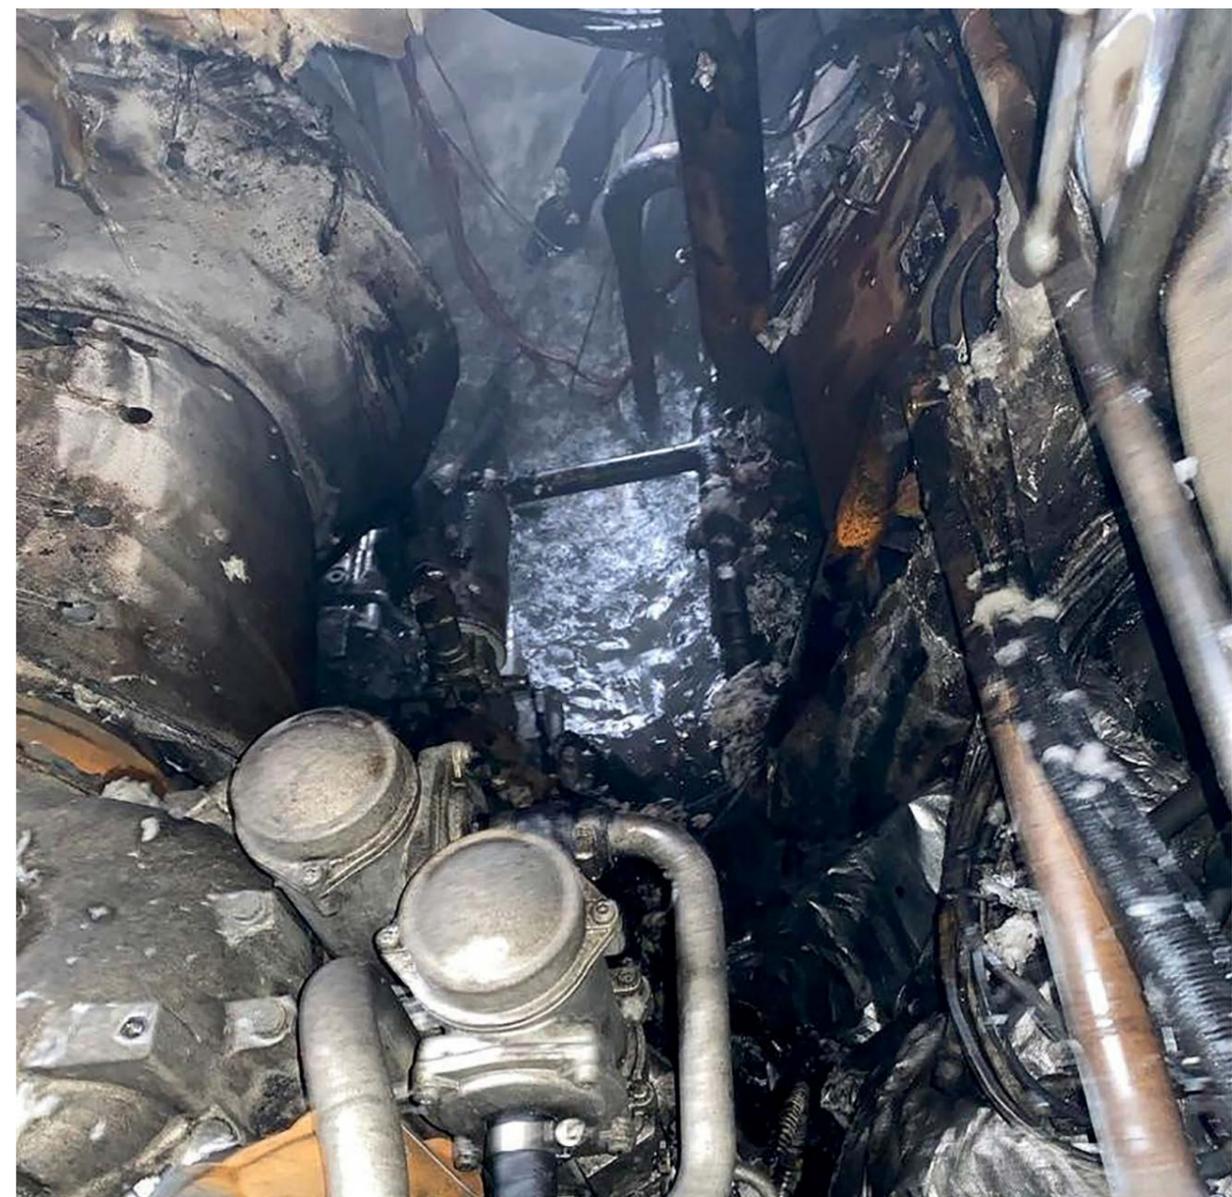
Figure 3: Fire damage in the engine compartment

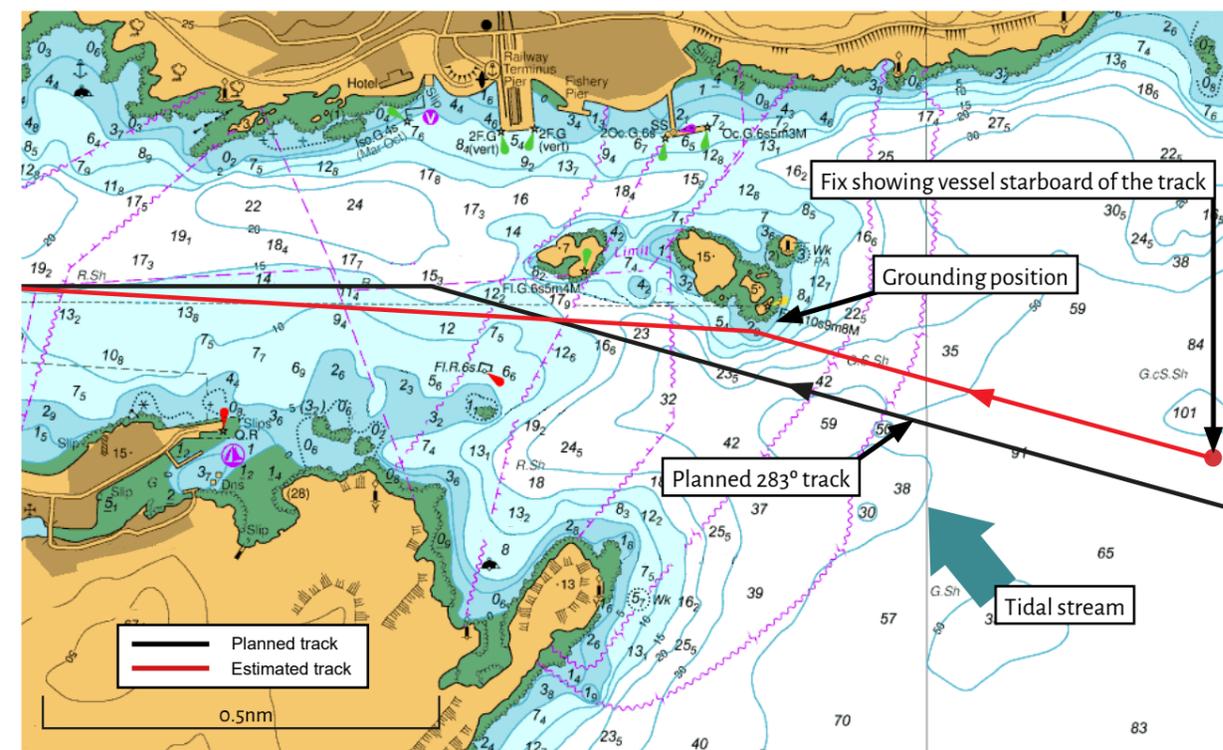
Figure 1: Chart showing planned track and estimated track

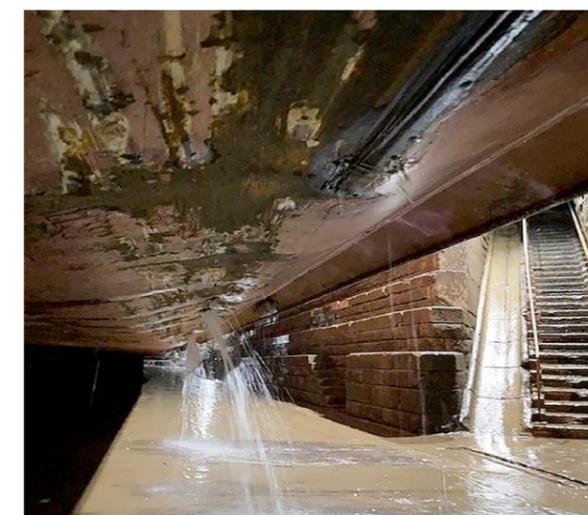
Figure 2: Damage to shell plating

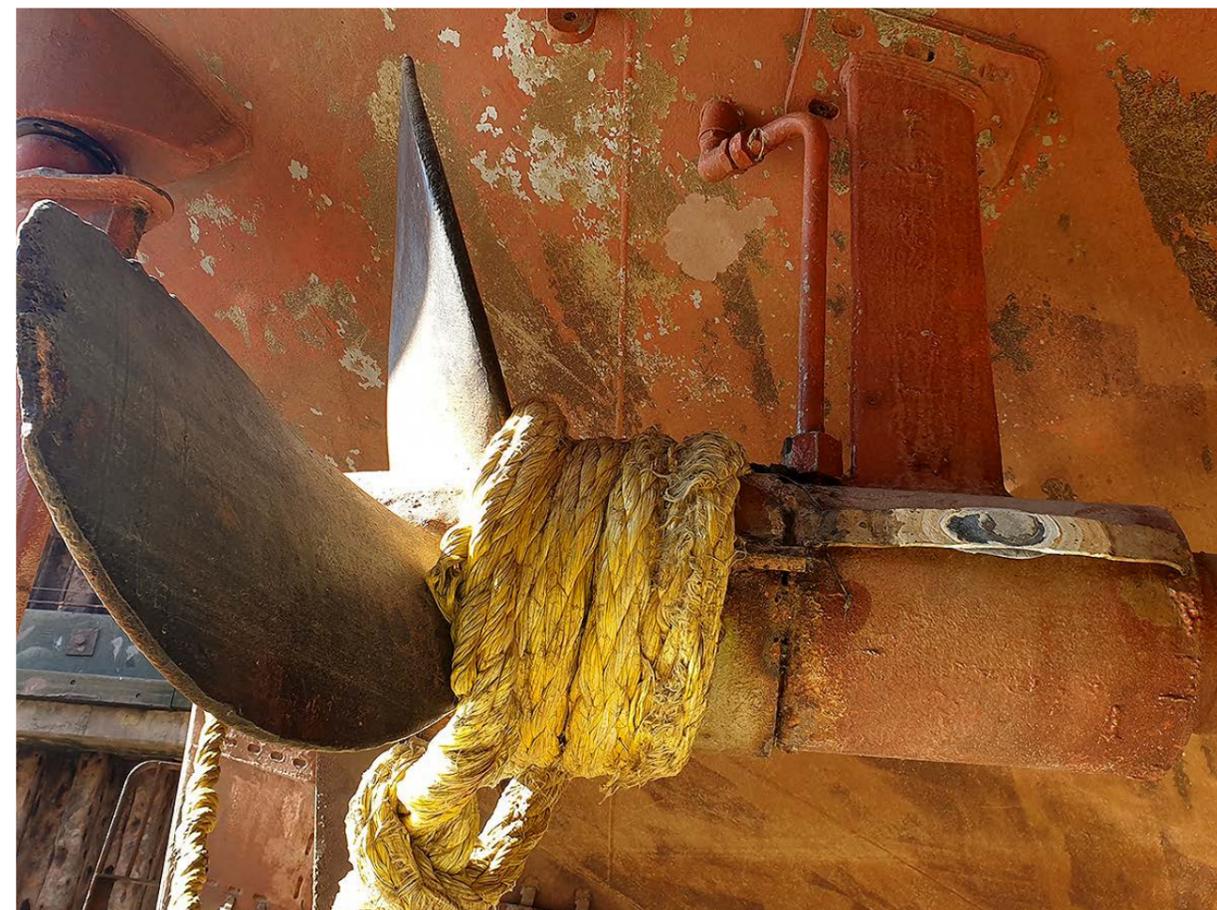
Figure: The fouled tow rope around the dredger's starboard shaft after dry docking

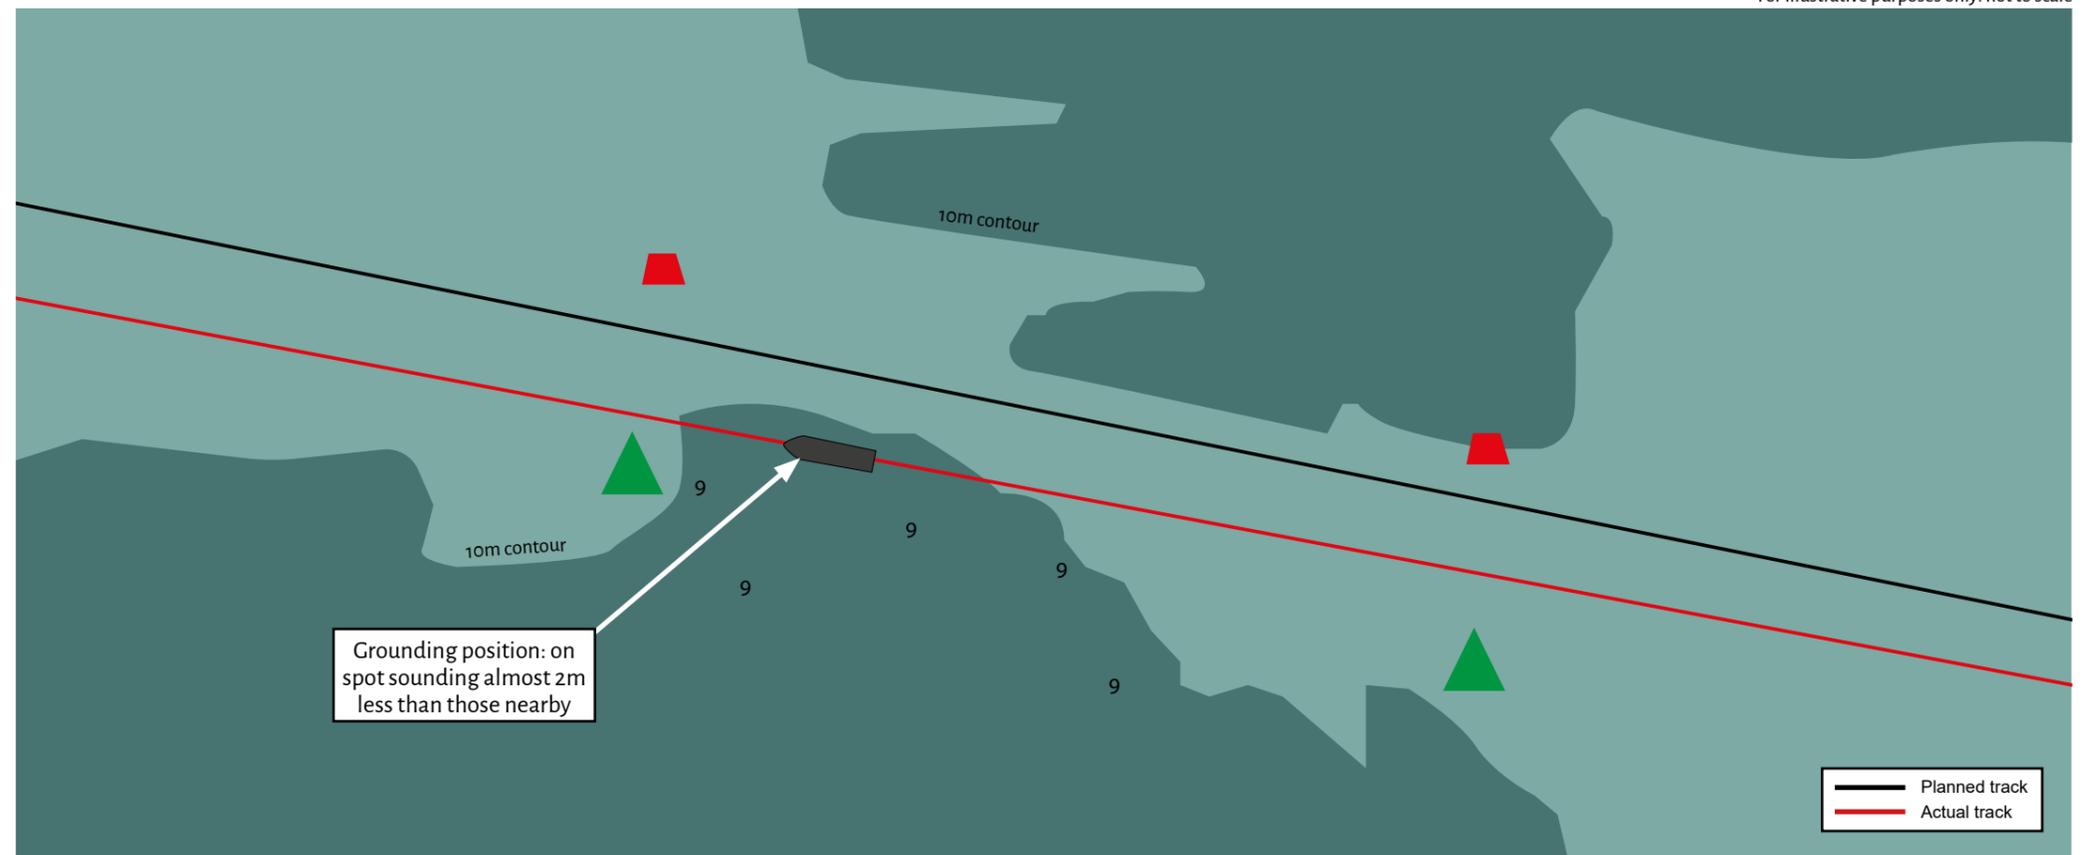
Figure 1: Chart showing position of ferry grounding

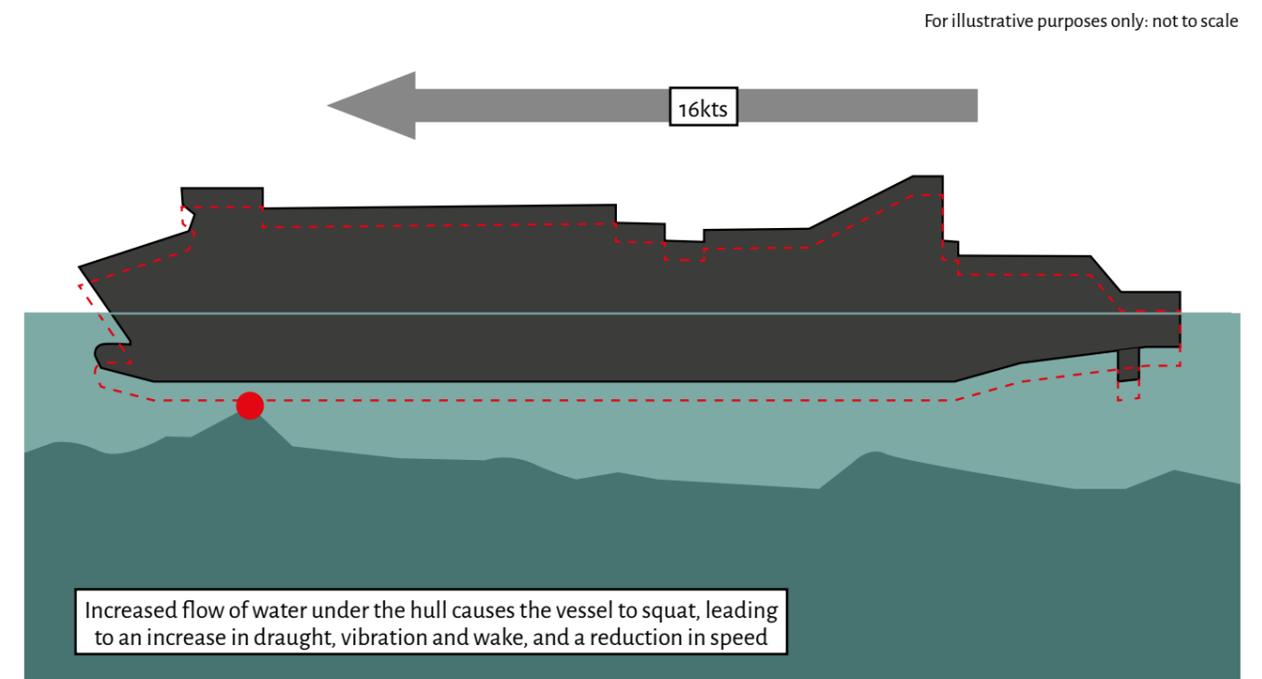
Figure 2: The effects of squat

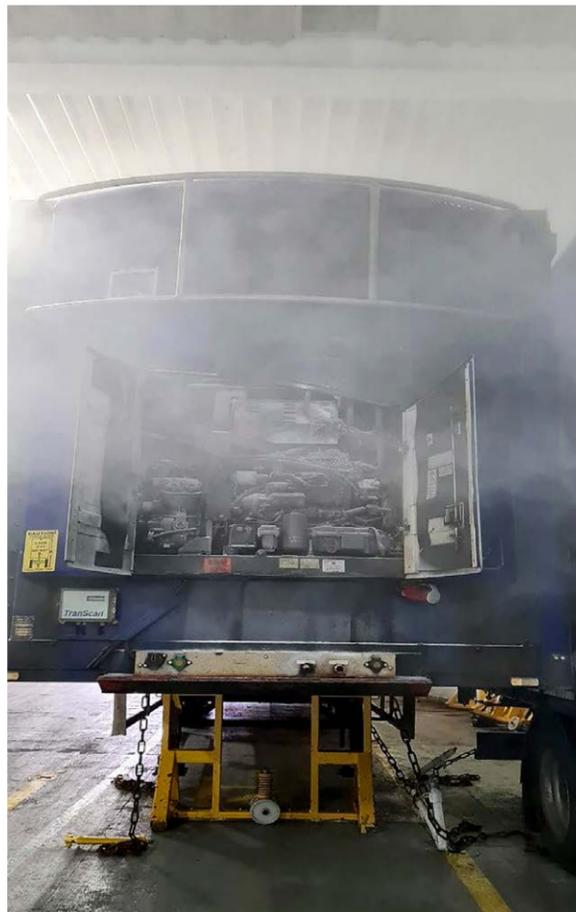
Figure: The refrigerated unit on the trailer

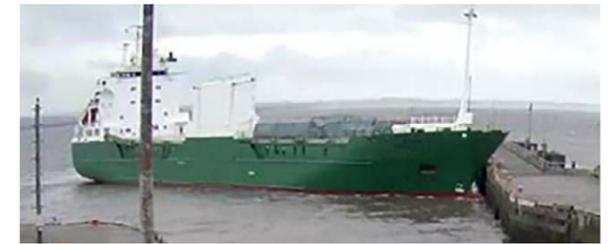
Figure: The vessel making contact with the lock wall

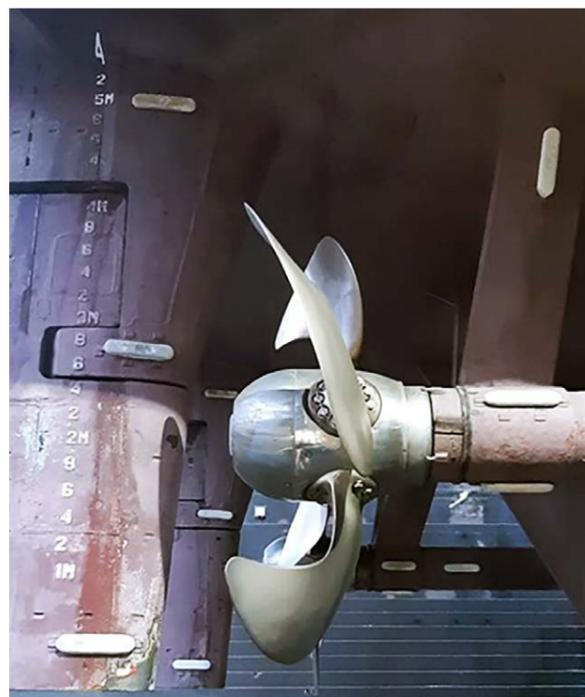
Figure 1: Damage to propeller blades and abrasion of rudder antifouling

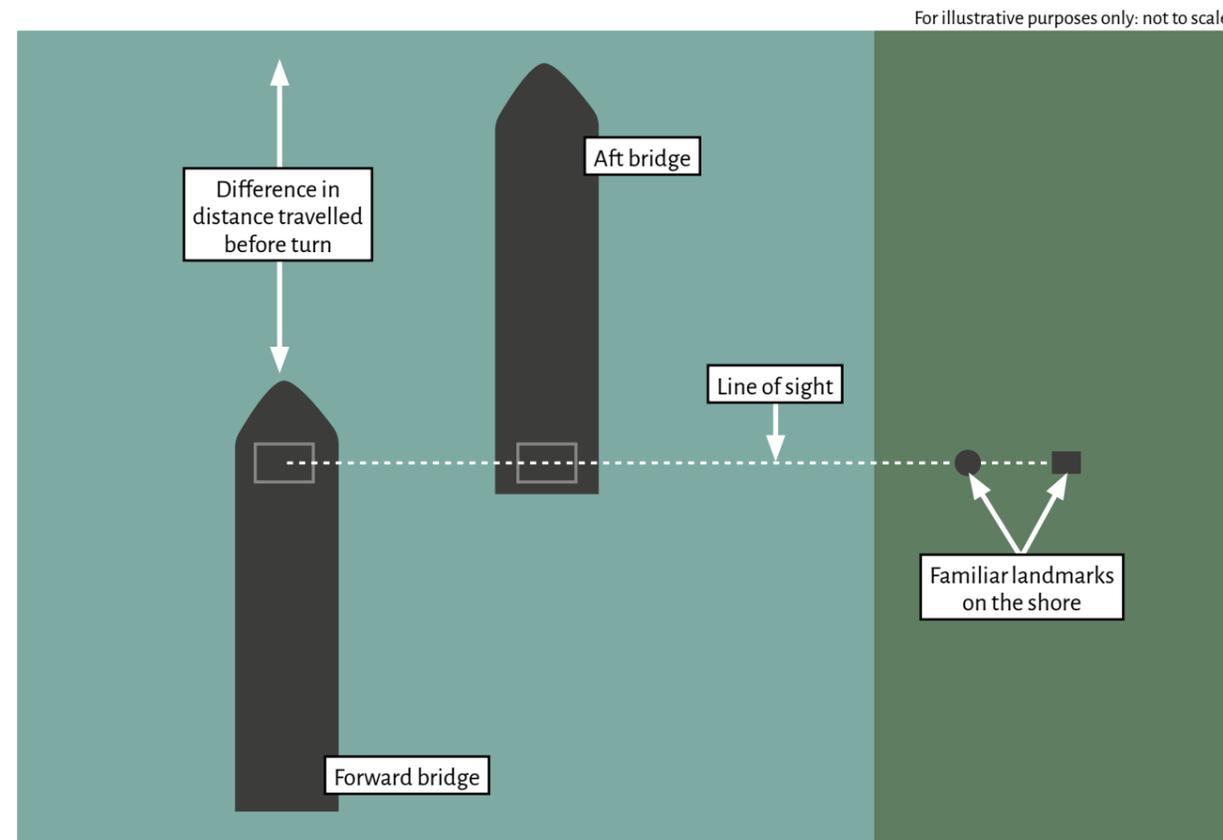
Figure 2: The difference between applying the same visual reference to a vessel with a forward and aft bridge superstructure

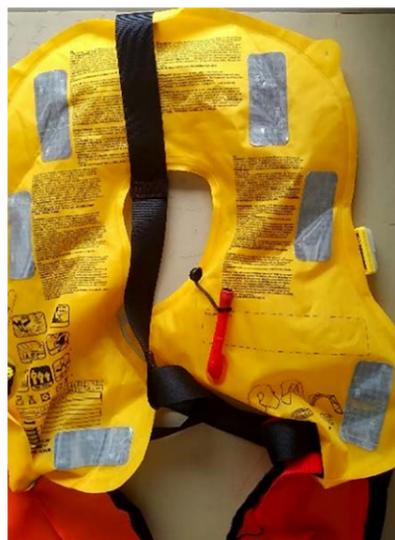
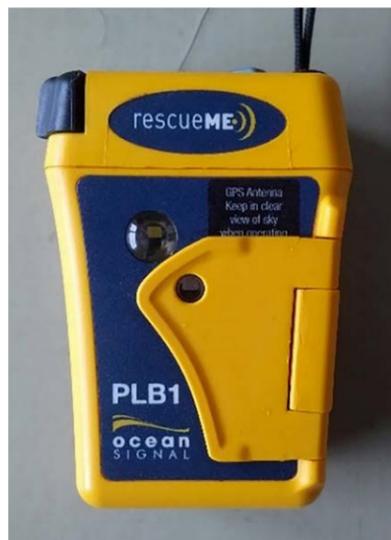
Figure: PFD and PLB used by the crew member

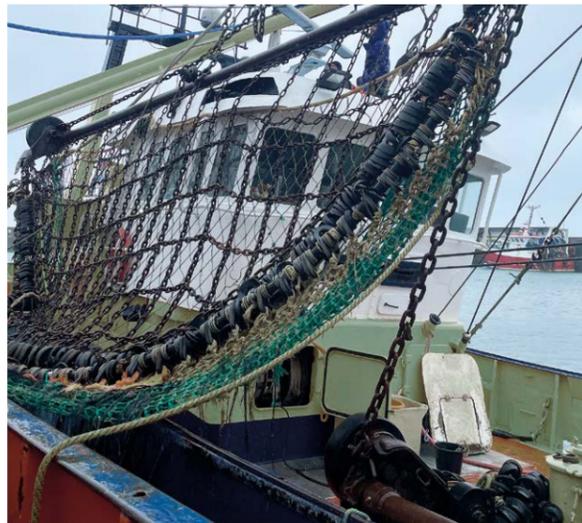
Figure 1: The fallen fishing gear on the outboard fishing vessel

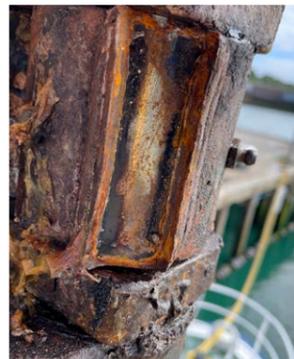
Figure 2: The failed weld on the gooseneck joint

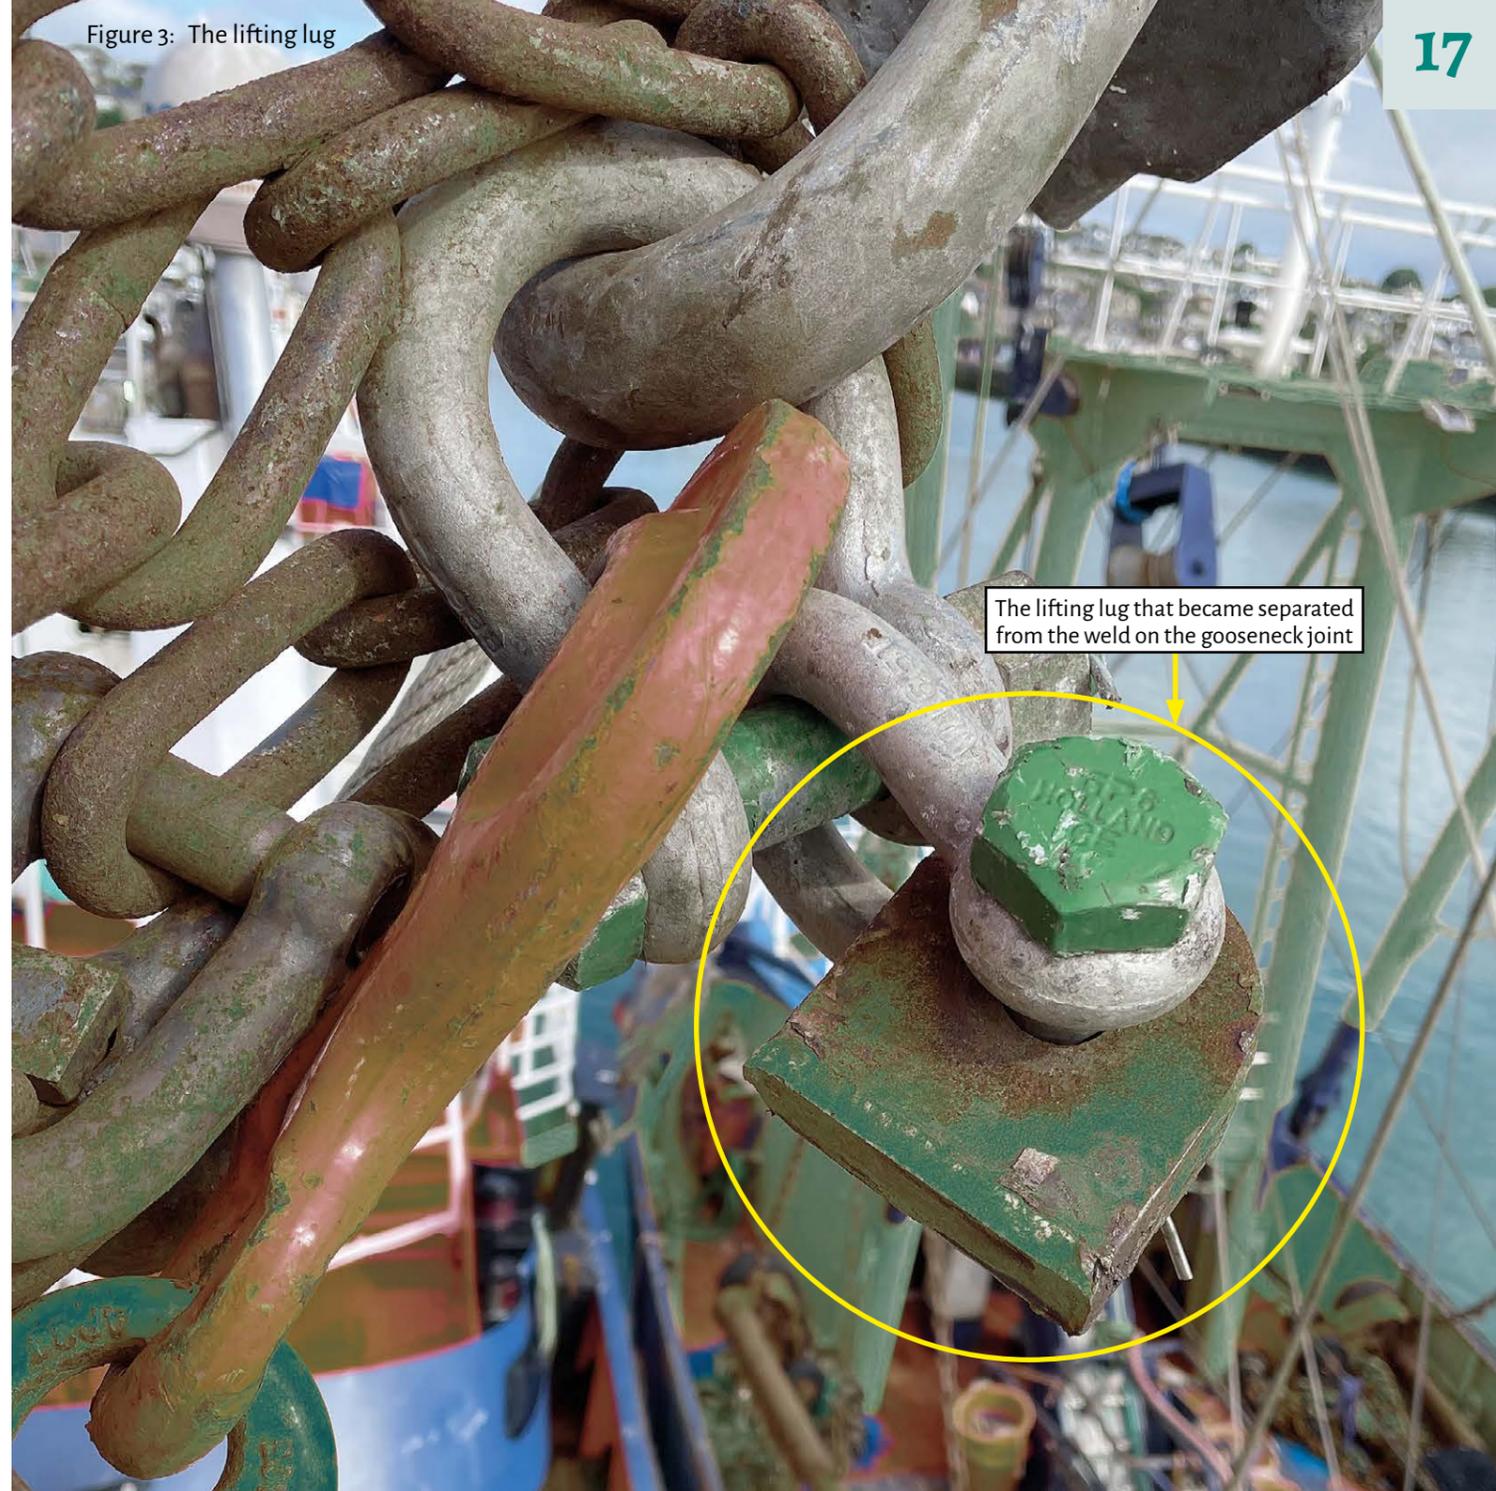
Figure 3: The lifting lug

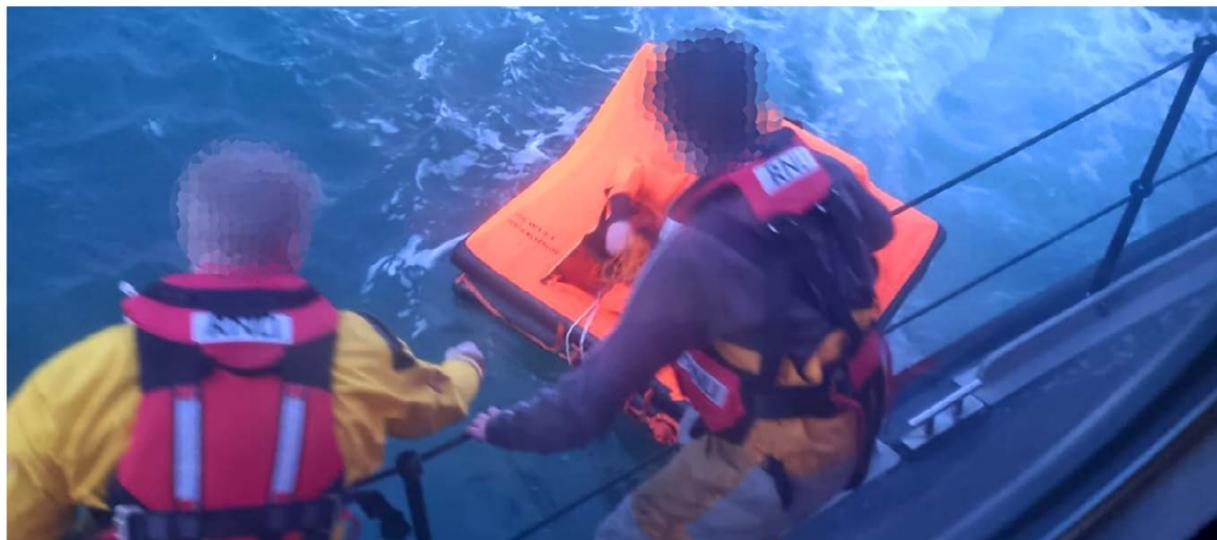
Figure 1: RNLI rescue of the crew from their liferaft

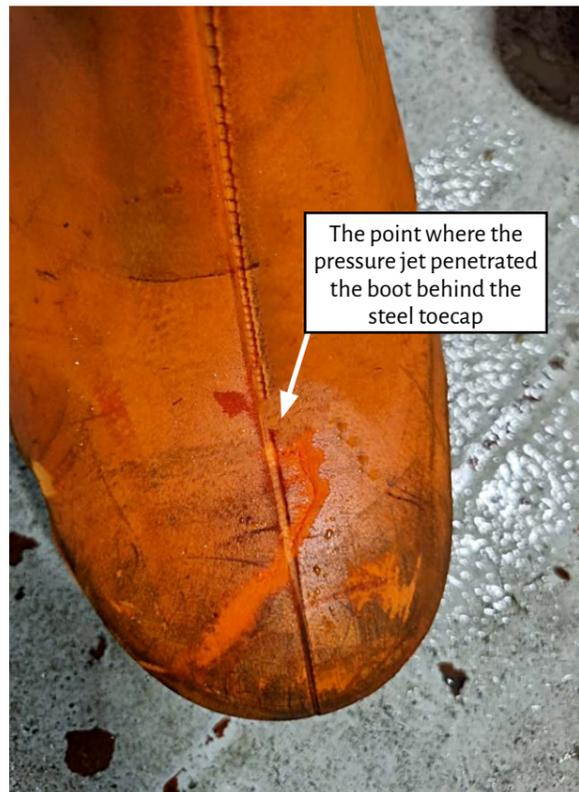
Figure 1: The protective boot

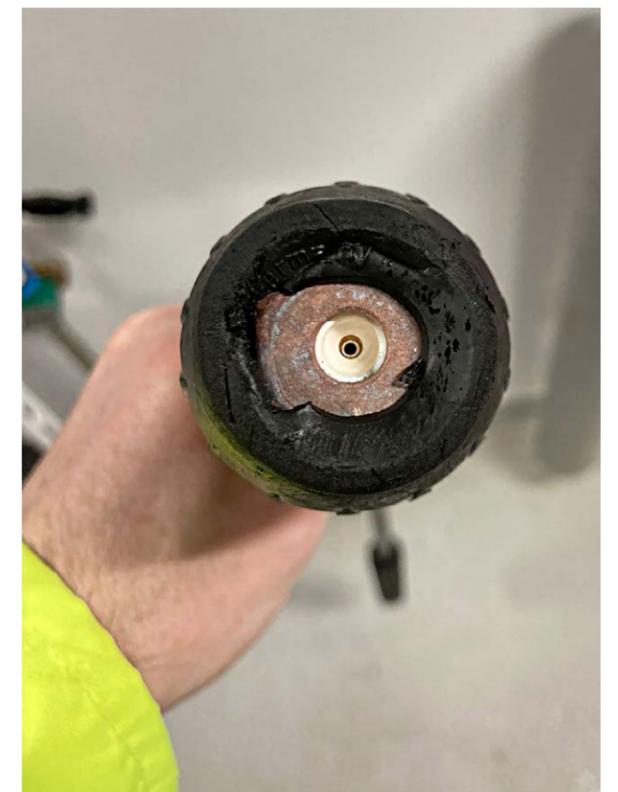
Figure 3: The damaged pressure washer lance nozzle

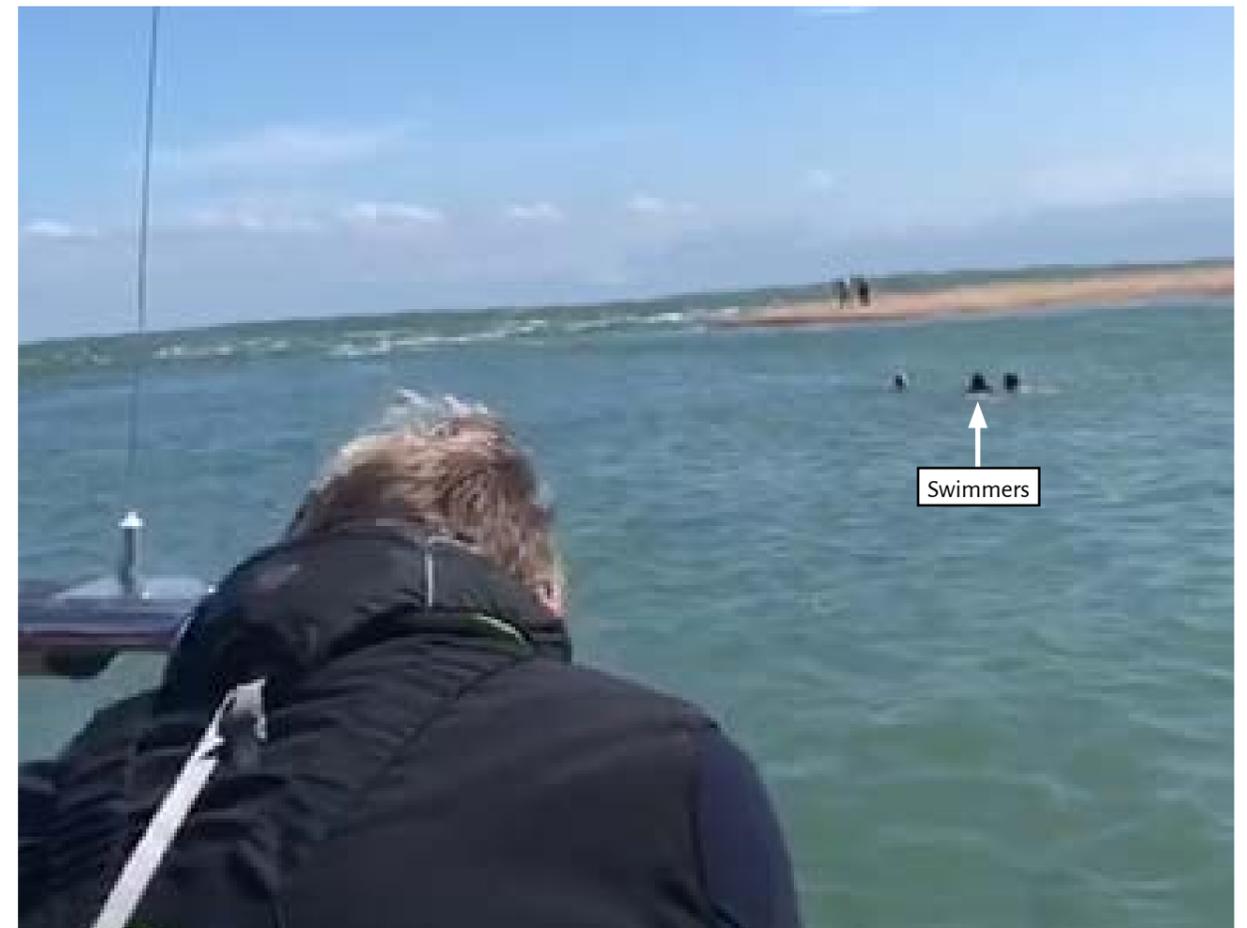
Figure: Swimmers drifting away from the anchored boat

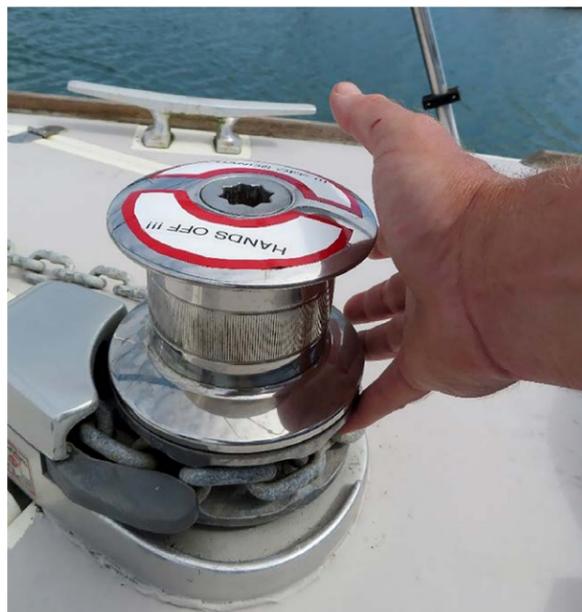
Figure: Sailing yacht windlass

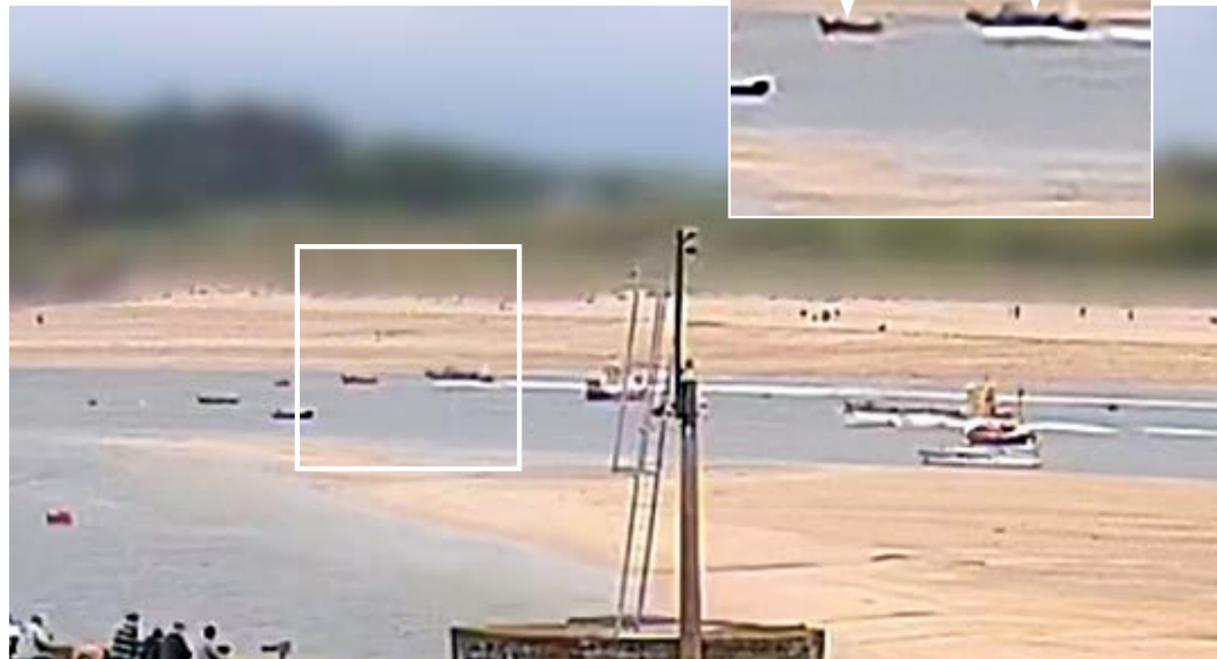
Figure 1: CCTV image just prior to the collision

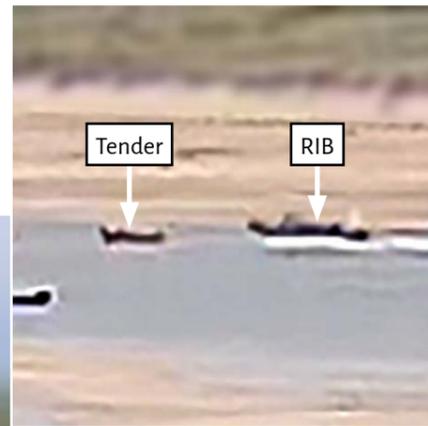
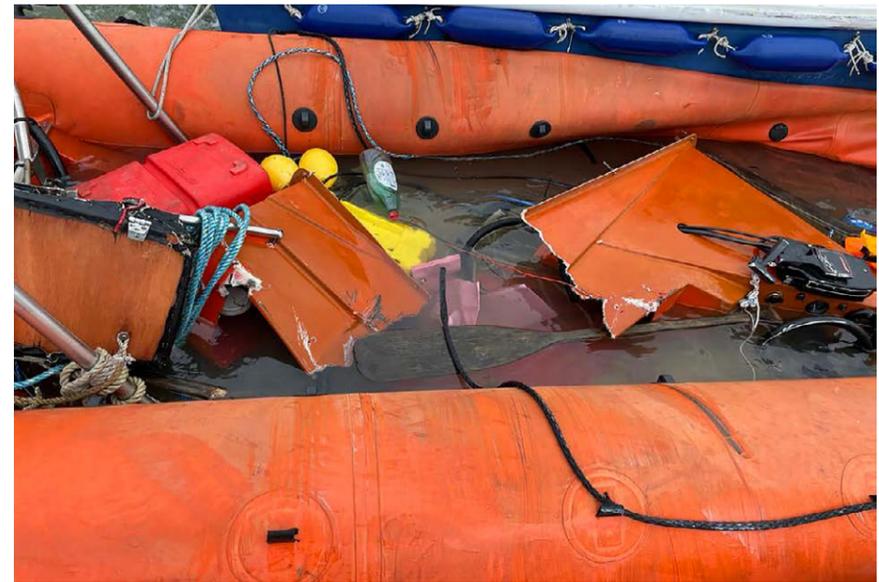
Figure 2: Damage to the unmanned moored tender

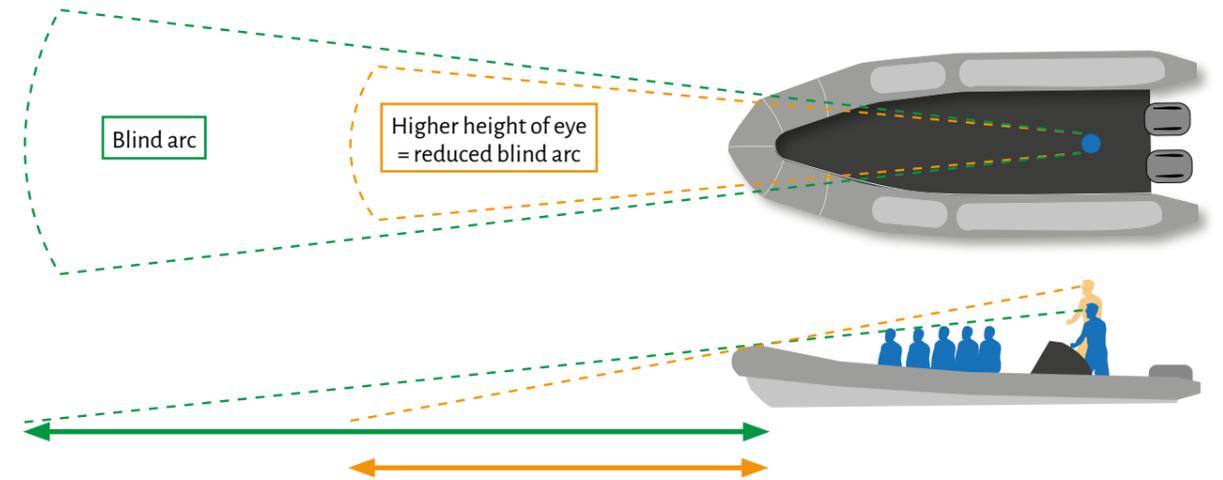
Figure 3: The effect on blind arc by raising the driver's height of eye
