SAFETY DIGEST

Lessons from Marine Accident Reports

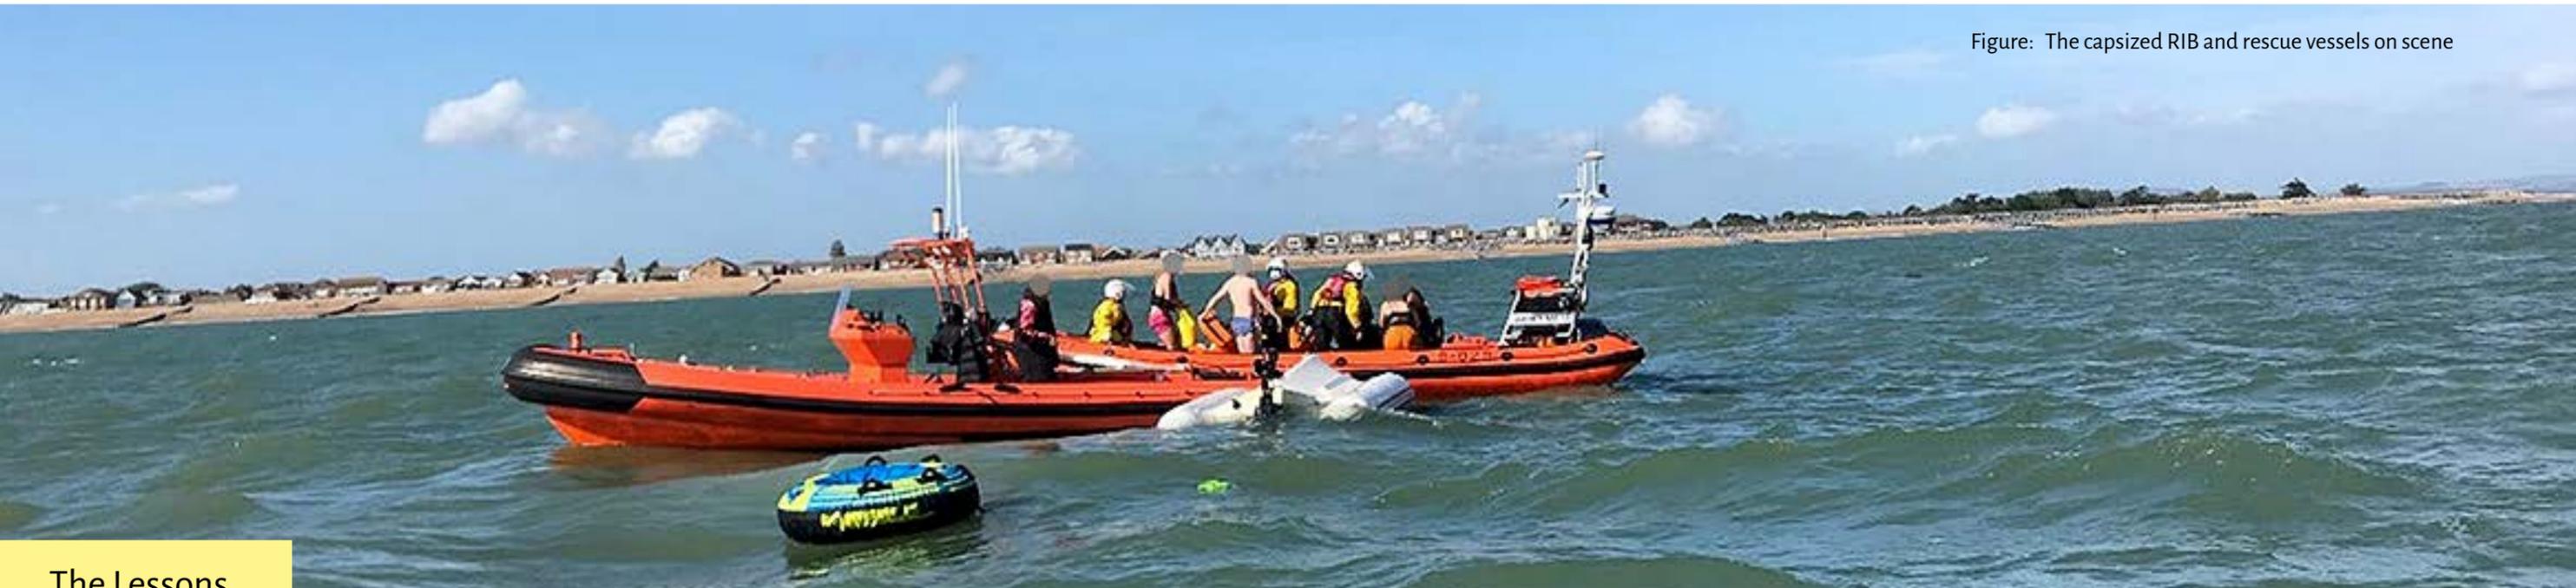
Figure: The capsized RIB and rescue vessels on scene

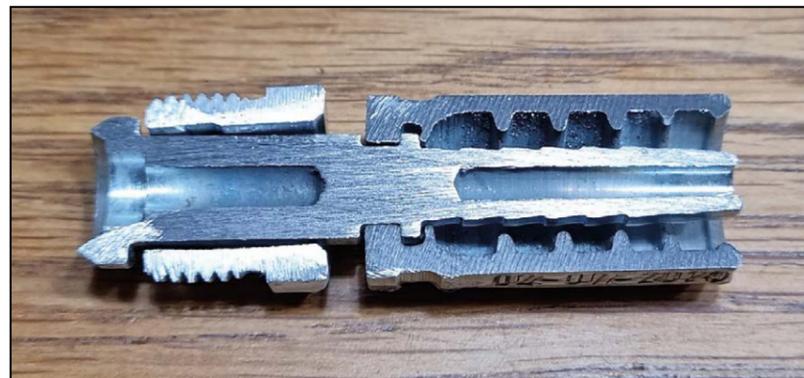
Section through blocked CO₂ pilot hose coupling showing incomplete bore through the stem

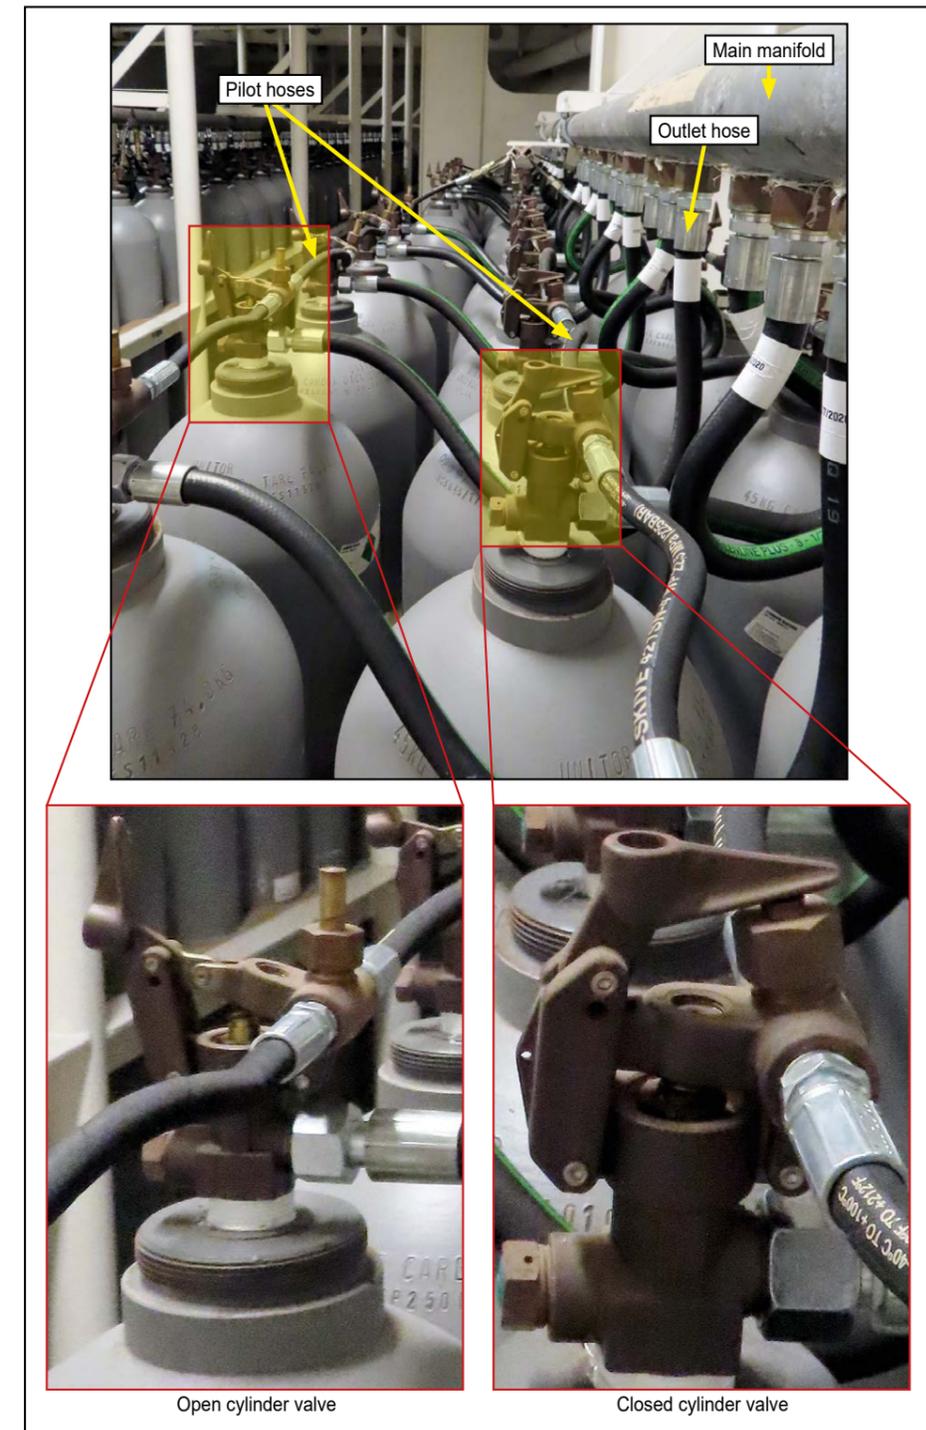
Figure 1: Part of the *Finnmaster* CO₂ fire extinguishing system post-accident

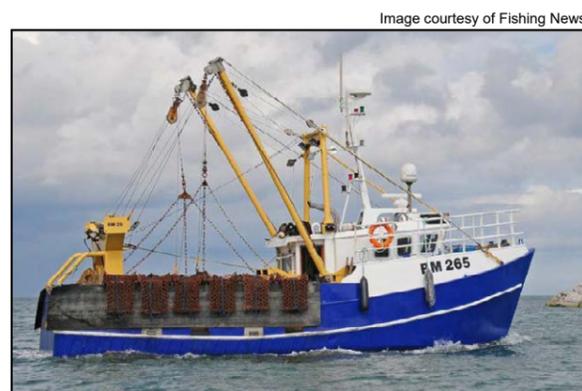
3. Automatic lifesaving appliances need to be arranged so that they float free and aid survivors. After *Joanna C* sank, the float free liferaft was released from its cradle by the Hydrostatic Release Unit (HRU) but did not subsequently inflate (**see figure**). This meant that it did not come to the surface to provide refuge for the skipper and mate, adversely affecting their chances of survival.

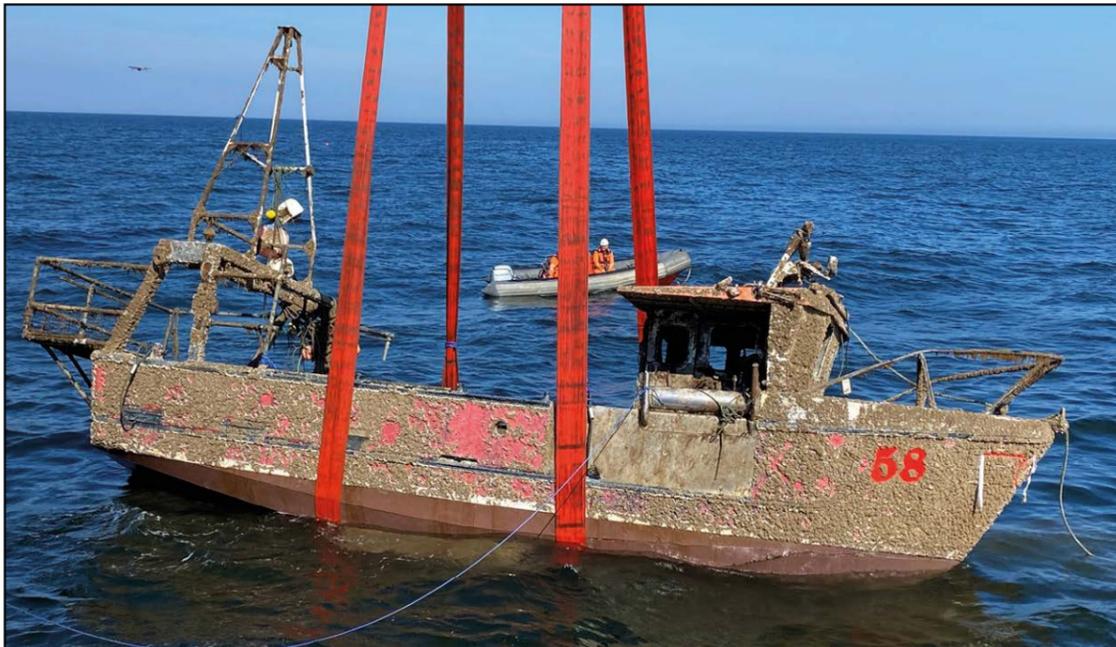
Foundering of the whelk potter *Nicola Faith* (BS58), resulting in the loss of all three crew, in Colwyn Bay, North Wales, on 27 January 2021
