National Transportation Safety Board

Marine Accident Brief

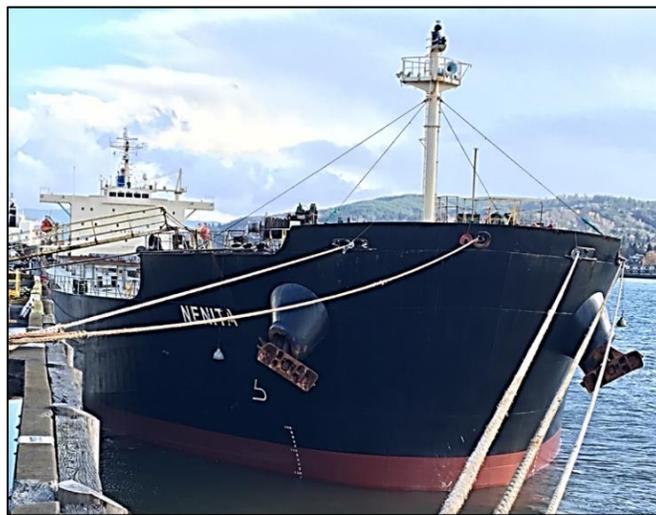
Nenita undergoing temporary repairs at Longview, Washington, following the accident.

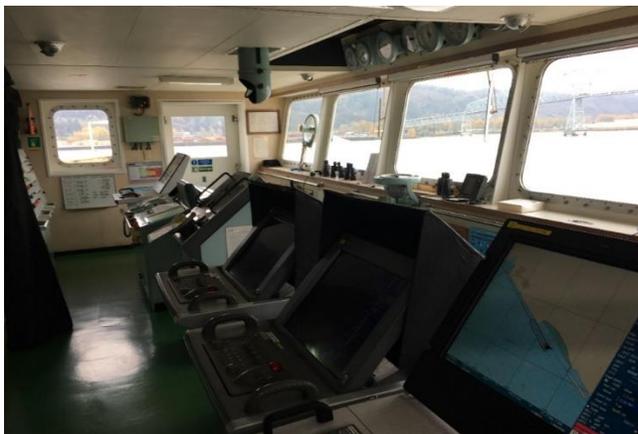
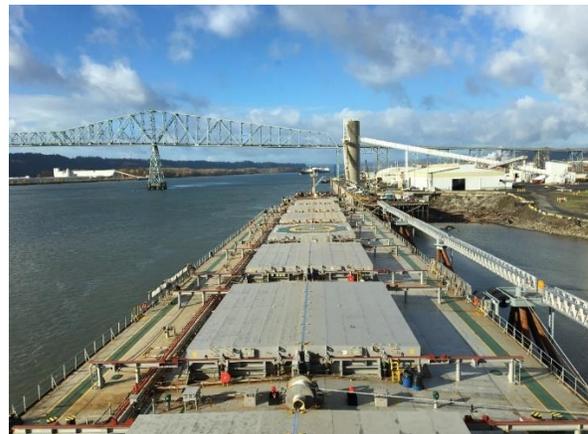
Left is photo of the *Nenita* navigation bridge. Right is photo looking forward on the *Nenita* from the navigation bridge.

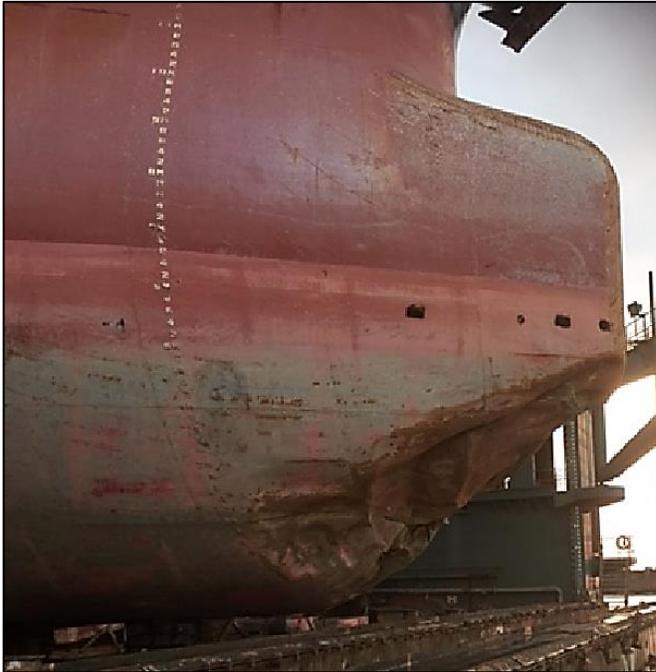
Damage to *Nenita's* bulbous bow starboard side.
(Photo by Spring Marine Bulk, S.A.)

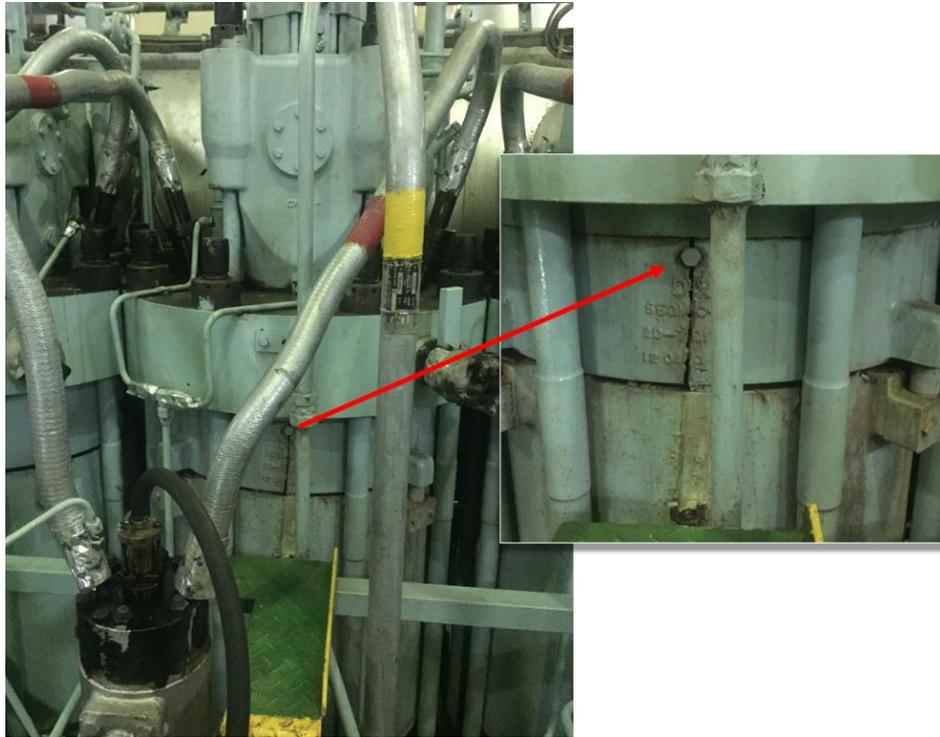
Cracked cooling jacket on main engine no. 3 cylinder, postaccident. Arrow shows one of four hex head securing bolts for the jacket cover. (Photo by Coast Guard)

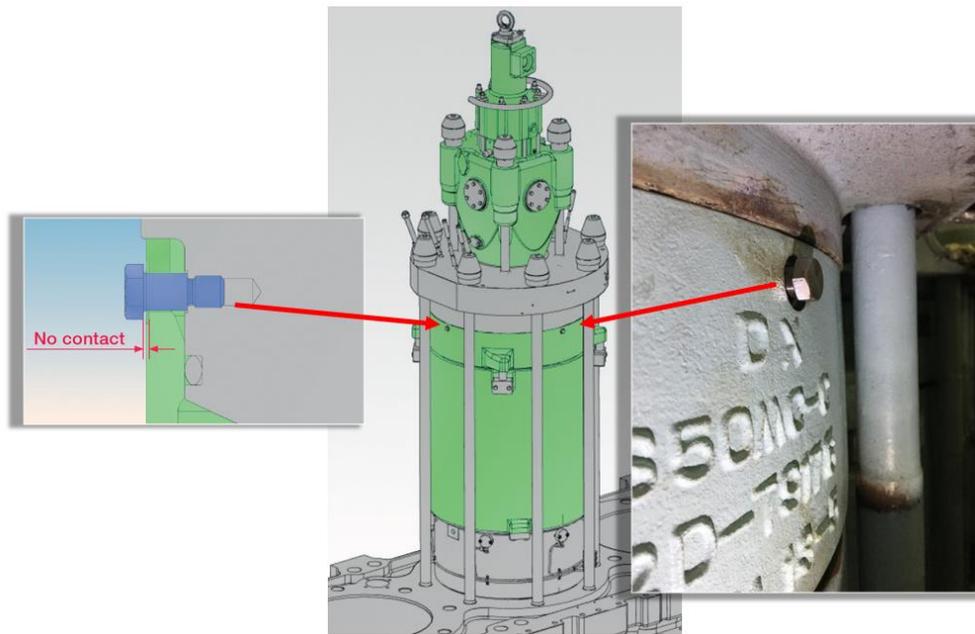
Simplified drawings of the hex head bolt and cooling jacket space. At right is the replacement hex head bolt and new cooling jacket installed on *Nenita*'s no. 1 cylinder. (Diagrams by MAN Diesel & Turbo SE)

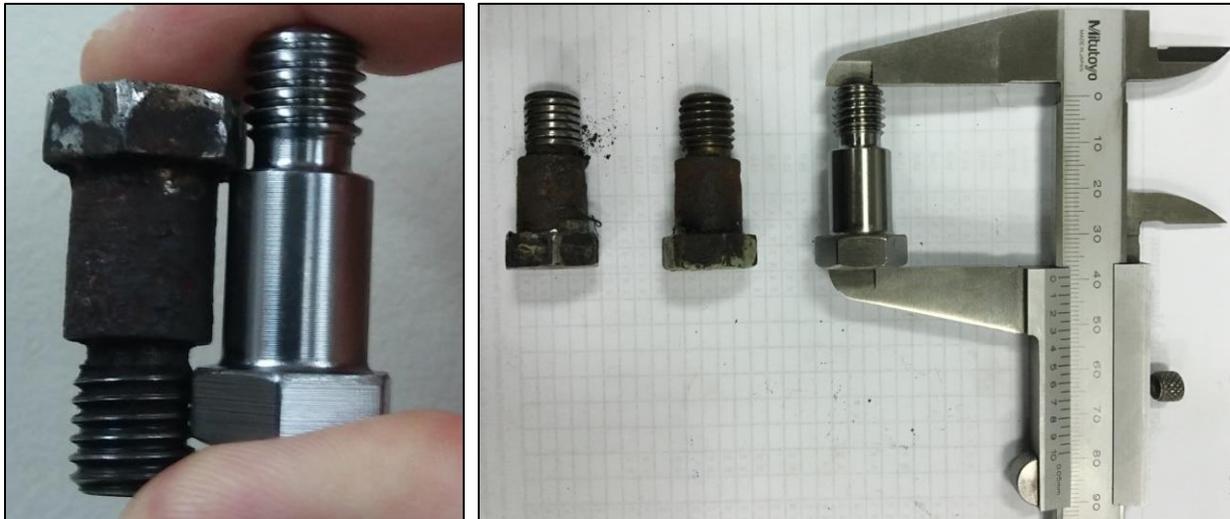
Comparison of bolts removed from no. 3 cylinder cooling jacket and replacement bolts shows same diameter and thread length, but unthreaded shoulder length of the replacement bolt was 2 millimeters longer. Also note damaged threads on leftmost bolt in right photo.
