MARINE SAFETY INVESTIGATION REPORT

Safety investigation into the fatality on board the Maltese registered chemical tanker

SCOT BERLIN

at the Oil Tanking Terminal, M'Xlokk, Malta on 13 August 2017

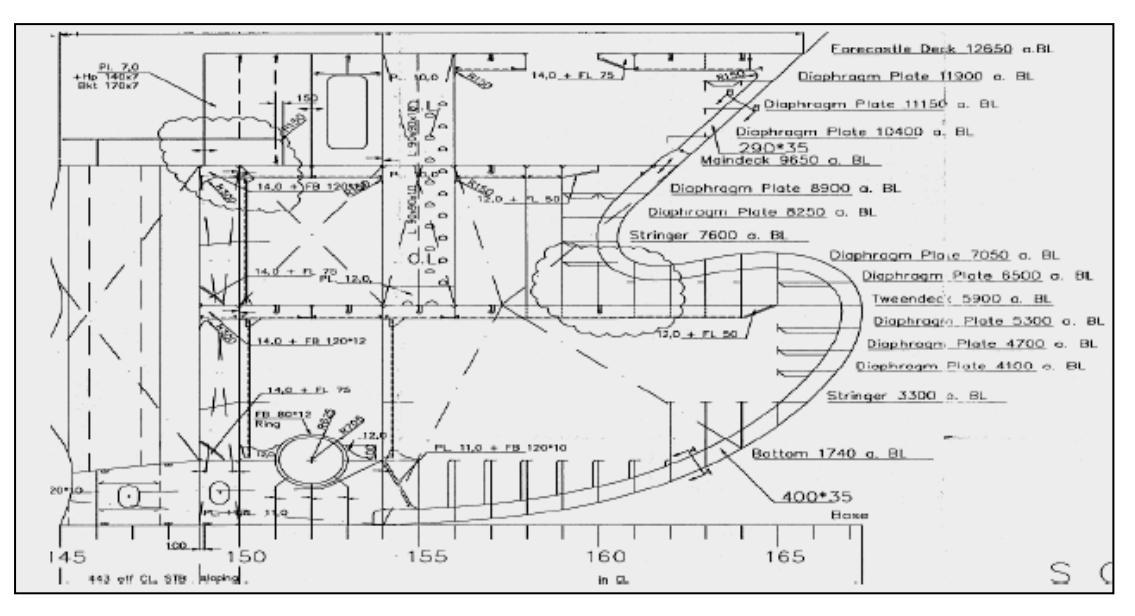
The bow thruster motor is located inside the compartment, which is also fitted with the bow thruster tunnel, running atwartships (Figure 4). The bow thruster compartment is mechanically ventilated $(12,000 \text{ m}^3 \text{ hr}^{-1})$. An electrical motor, rated at 4.0 kW runs the ventilation fan at 2,840 rpm. Air intake is *via* a louvered opening on the mast house (Figure 5).

Figure 4: Bow thruster compartment

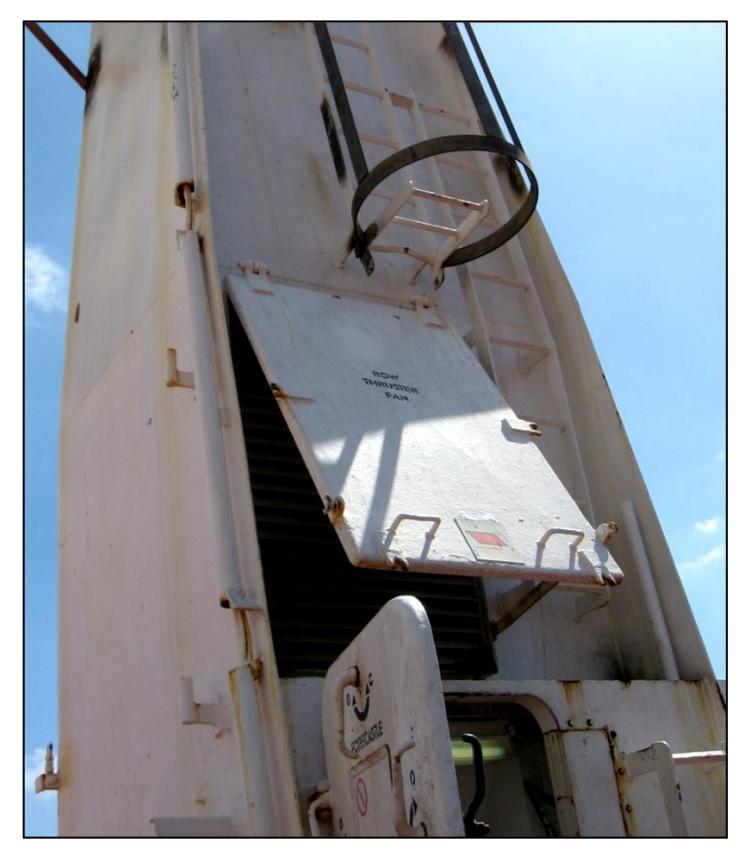
Figure 5: Ventilation intake leading down to the bow thruster compartment

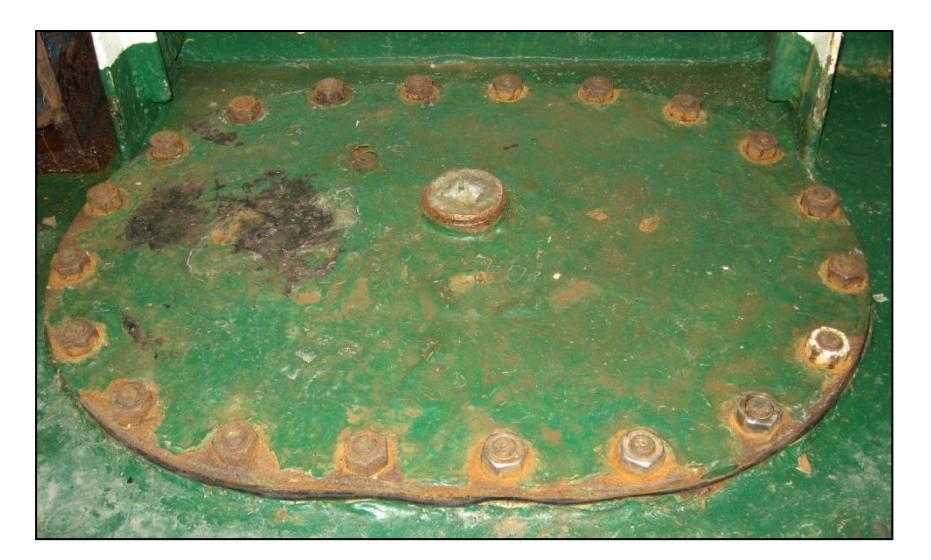
As instructed, the bosun made his way to the bow thruster compartment. Going down to the bosun's store level, he immediately noticed water escaping from the forepeak tank's manhole (Figure 7). The bosun also noticed that the overflowing water from the leaking forepeak tank manhole cover had reached the bow thruster compartment entrance and was flowing over the sill plate (Figure 8), cascading on the bow thruster motor. One of the bilge alarms in the bow thruster compartment, triggered the high level alarm when the water level reached a height of about 145 mm (Figure 9).

Figure 7: Forepeak tank manhole cover

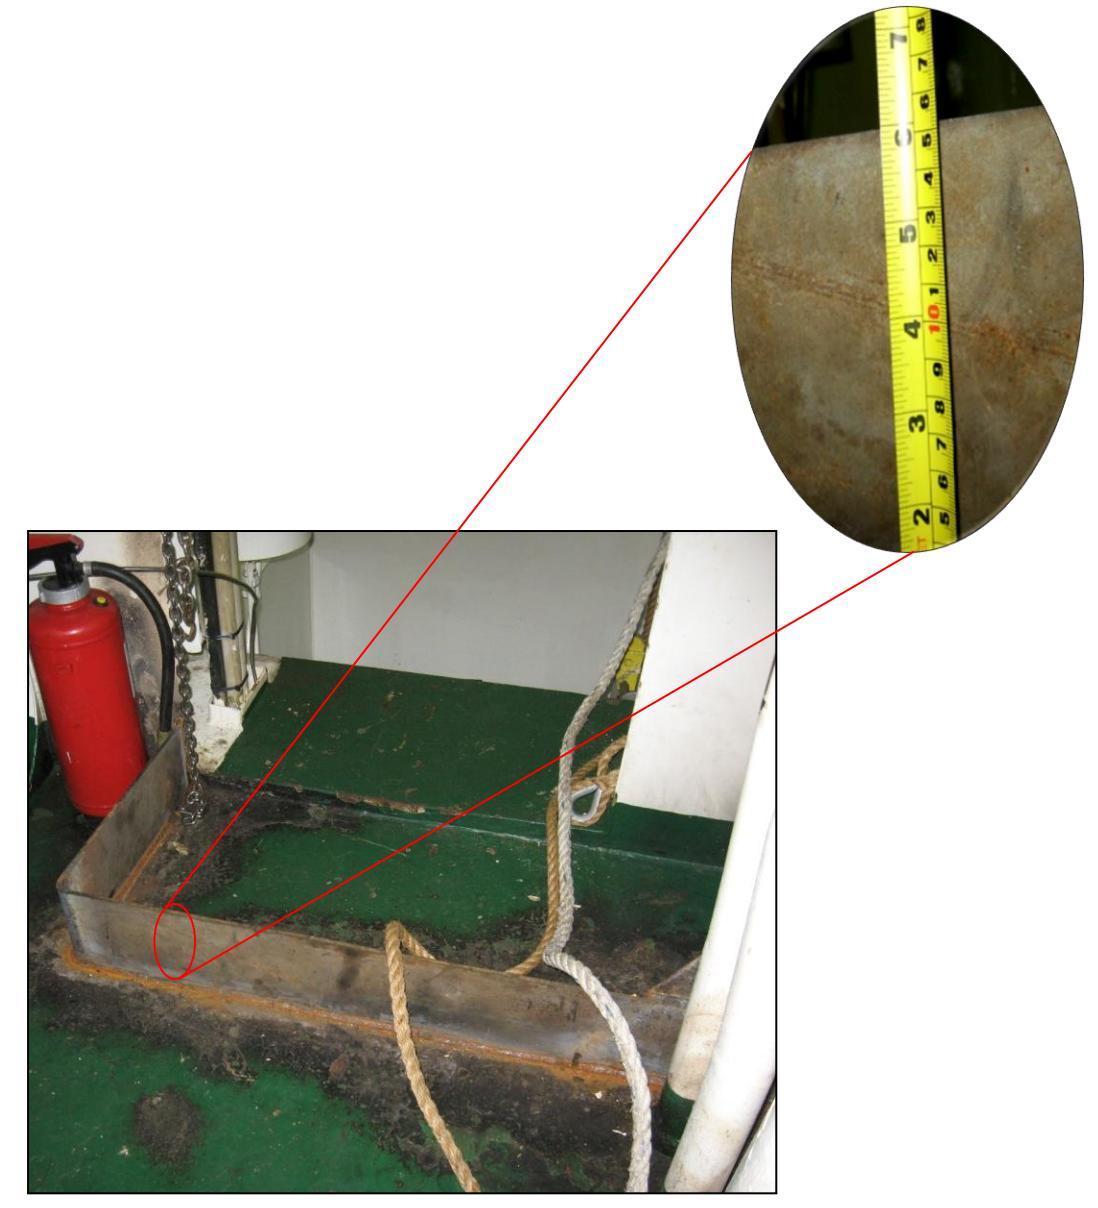
Figure 8: Entrance sill which had a height of 150 mm.

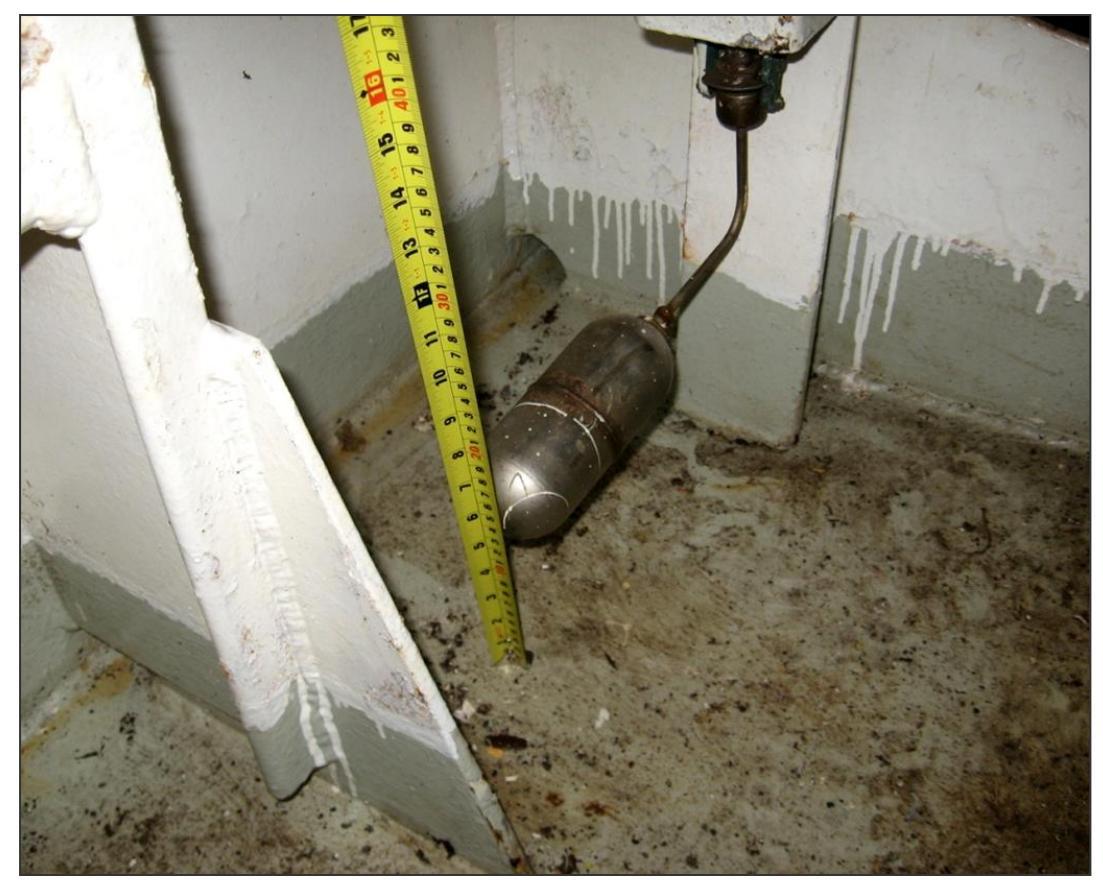
Figure 9: High level alarm inside the bow thruster compartment bilges

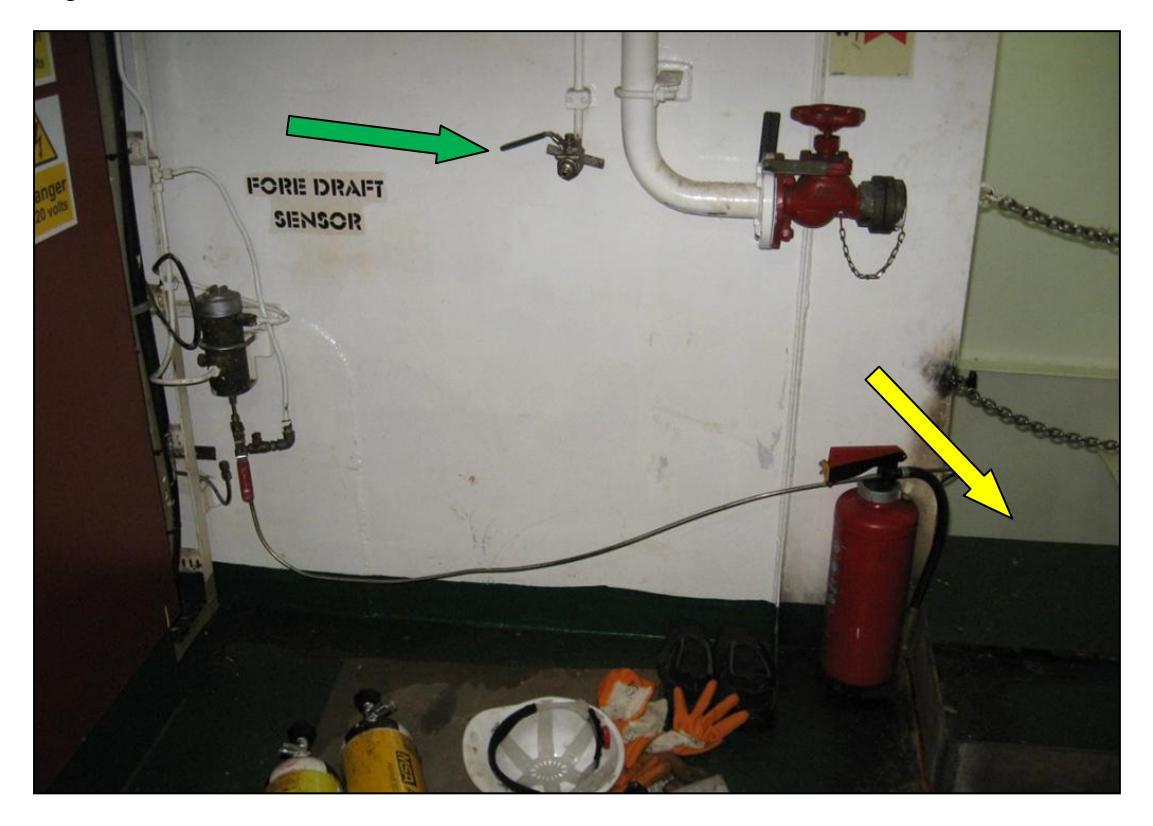
Following these discussions, both the bosun and the electrician proceeded again to the bow thruster compartment, carrying some tools. They also lowered a spray gun. Air supply was available right at the entrance to the bow thruster compartment (Figure 10).

Figure 10: Working air pressure supply at the bow thruster compartment entrance (yellow arrow)

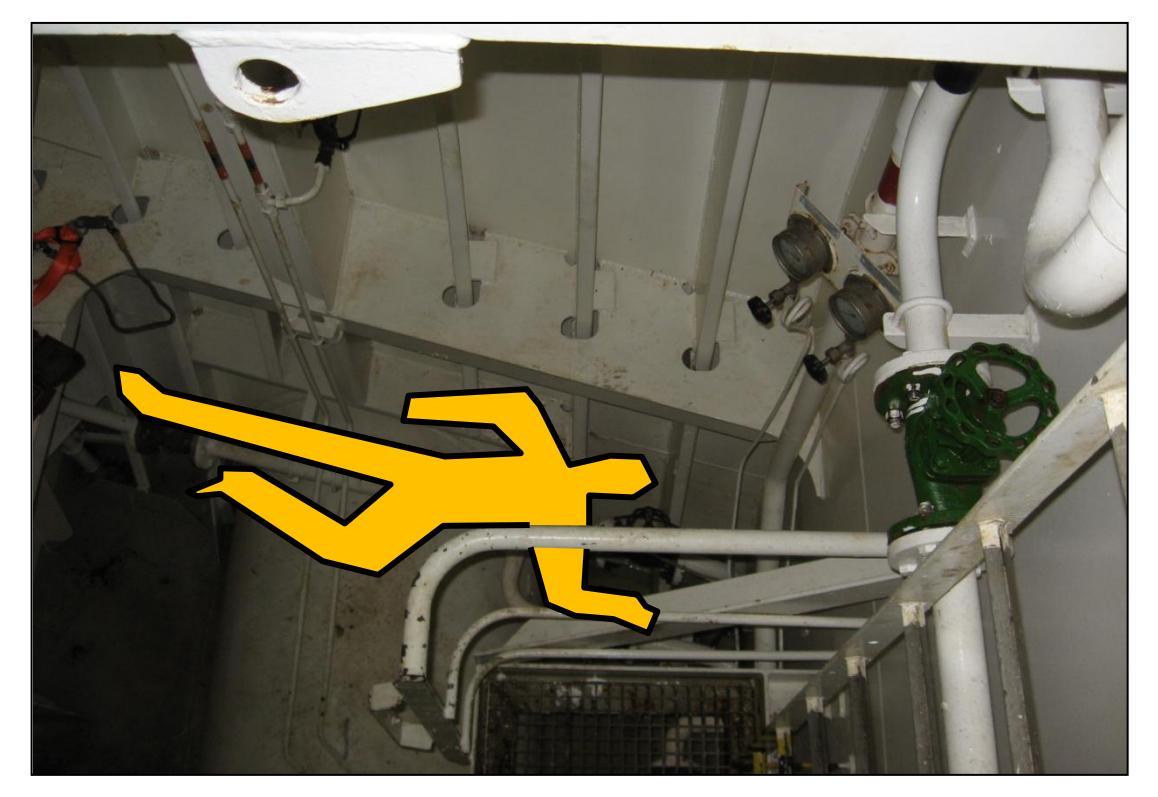
Upon reaching the entrance to the bow thruster compartment to climb down the ladder, the bosun noticed the electrician lying face down on the bottom platform (Figure 11).

Figure 11: Position of the electrician, as found by the bosun

Evidence collected by the MSIU confirmed that the body was found on the bow thruster tunnel in a fore and aft position (Figure 11). This was suggestive that the electrician was most probably going down the ladder but was also somewhere close to the ladder's lower platform. It was considered rather difficult for the electrician to fall on the bow thruster tunnel from the inside of the ladder's safety cage. Nonetheless, it has to be stated that the electrician was noticed walking towards the bow thruster compartment, carrying three bottles of water.

The bottles of water were found in the bow thruster compartment bilges and it was apparent that these may have been dropped from a height. As indicated in sub-section 1.5.3 of this safety investigation report, the MSIU did not have access to the autopsy and toxicological reports and therefore, the cause of death remains unconfirmed to this safety investigation. The crew members recalled that the electrician had an injury in the thoracic area, suggesting a fall from a height. It was not excluded that the electrician may have also lost his grip and fell from the lower section of the ladder / lower platform onto the bow thruster tunnel.

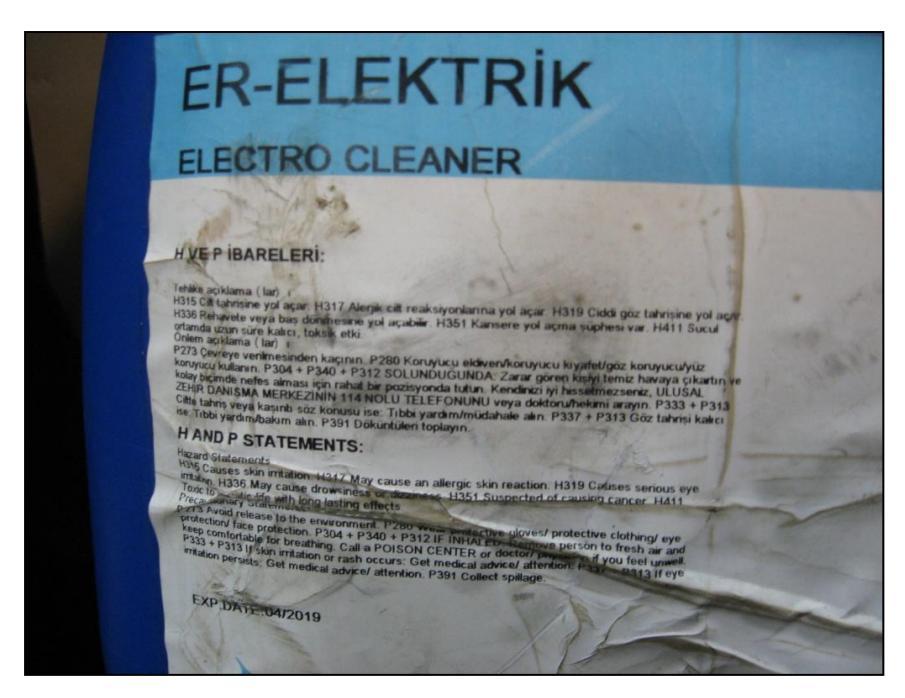
The chemical used for the cleaning of the bow thruster motor was 'ER-Elektrik', a transparent electric cleaner (Figure 12), and was applied by means of a spray gun (Figure 13).

Figure 12: The chemical used in the bow thruster room

The chemical composition of the substance was tetrachloroethylene (between 30 % and 50 % by weight) and other chemicals, which did not contribute to the classification of the product – hence, not classified (50 % to 70 % by weight). The electro cleaner available on board was carried in a 25-litre blue, plastic container. The label on the container carried a number of hazard and precautionary statements, the most relevant being that if inhaled, the exposed person should be removed to fresh air and to keep comfortable for breathing. In addition, as a first aid measure, artificial respiration had to be applied.

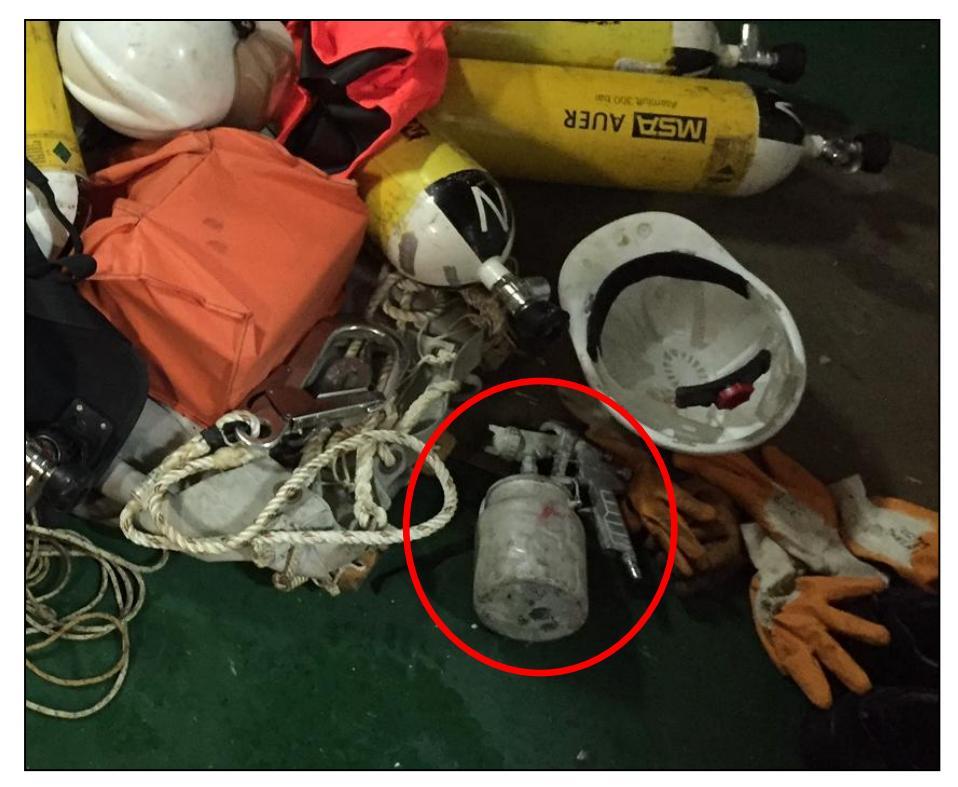
Figure 13: The spray gun used inside the bow thruster compartment, after it was recovered by the Civil Protection Department personnel
