CHIRP Maritime

The Maritime Confidential Hazardous Incident Reporting Programme

Annual Digest of Reports, and Insight Articles

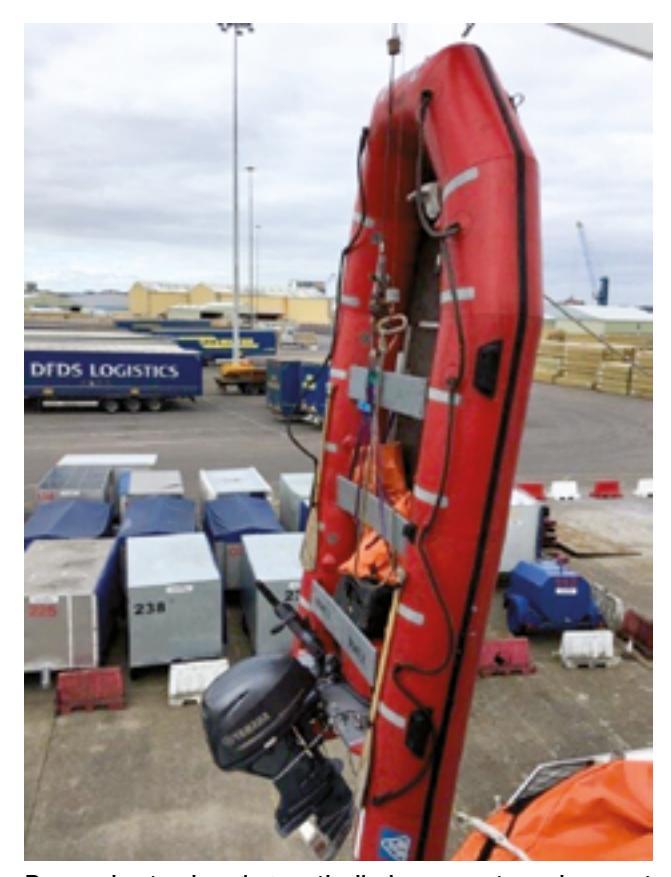
The lifting strops for the vessel's two inflatable rescue boats, (IRB's), had recently been renewed. At the time of the incident the vessel was alongside, and the opportunity was taken for some familiarisation training. This included swinging out the port rescue boat. Unfortunately, the deck crew who had fitted the new strops attached the aft strops to strongpoints on the hull, and not to the correct lifting points on the transom. This resulted in an unstable lift as the weight of the outboard motor caused the boat to rotate about the aft strops and assume a vertical position, bow up, as shown in the photograph below.

Rescue boat – hanging vertically because strops have not been fitted correctly

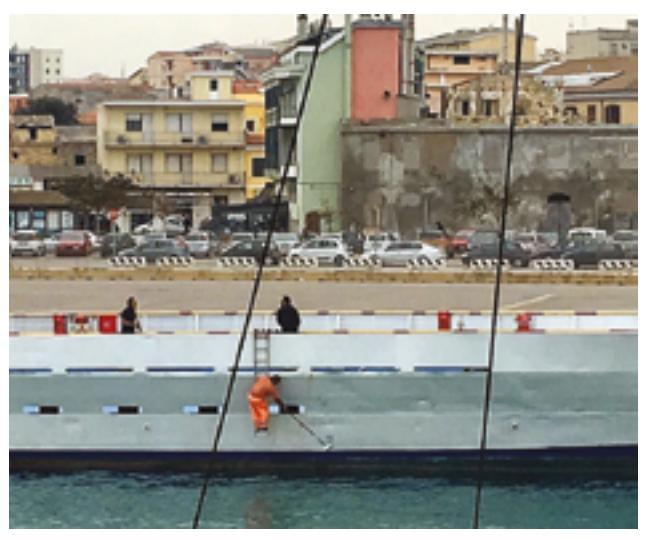
Painting over the side - lack of safety precautions

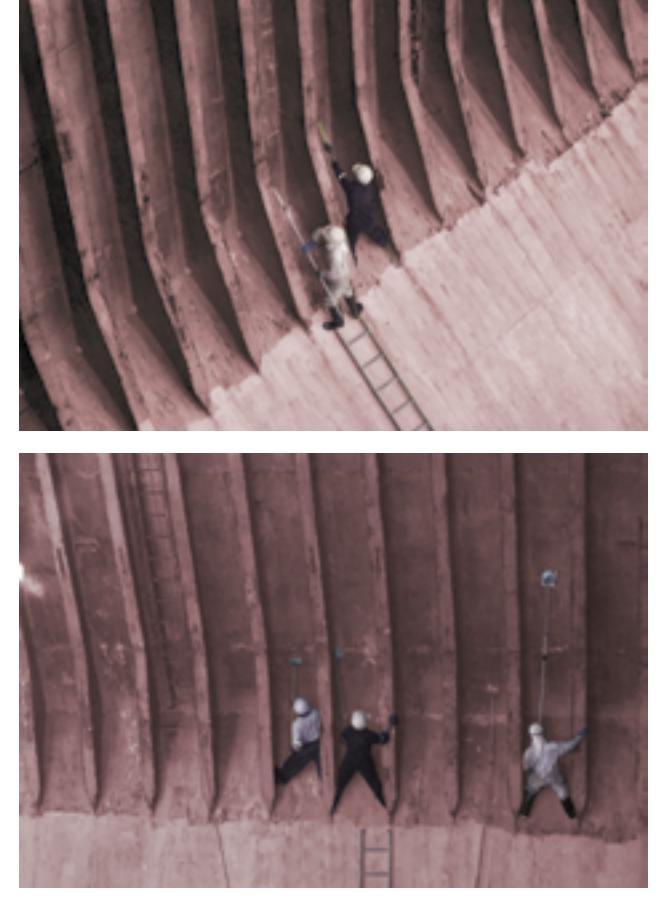
Ladder not secured and crew in a precarious location with a risk of falling

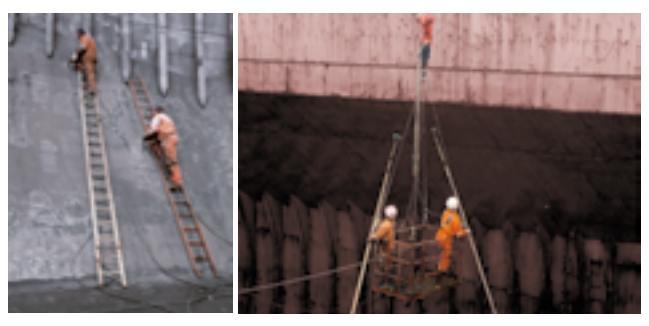
A vessel reported unsafe working conditions whilst engaged in rust removal and painting of the cargo holds from the hatch coaming to the tank top. This involved using the ship's crane with a cage, or sometimes a bosun's chair, suspended from the crane.

Unsafe work practices Crane Riding

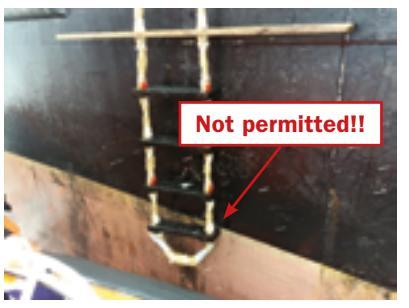
1 – Dangerous loop at bottom of ladder

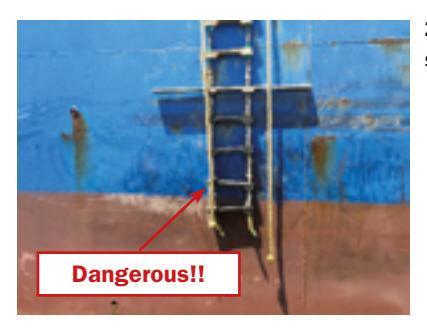
2 – Uneven ladder step

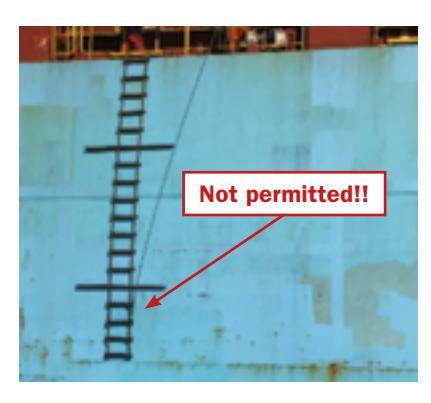
• Rung bent on rubber ladder steps. Tripping line fitted below spreader. Side ropes not continuous as also mentioned in the comment for picture two (see picture 4).

3 – Tripping line below spreader

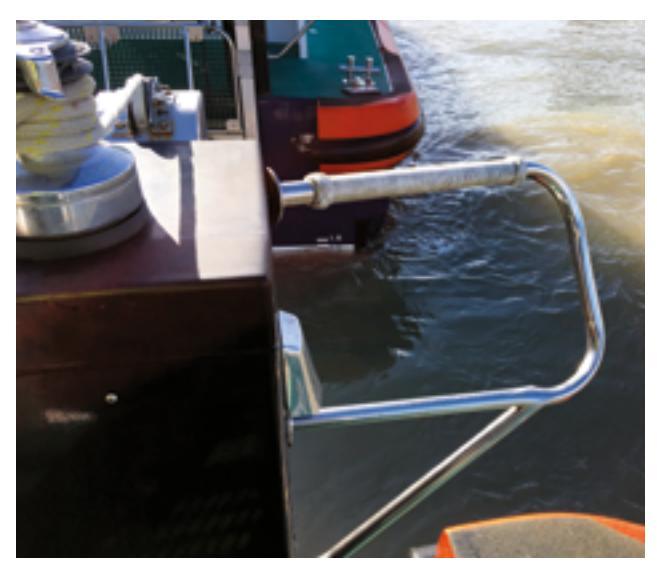
Damage to pilot cutter

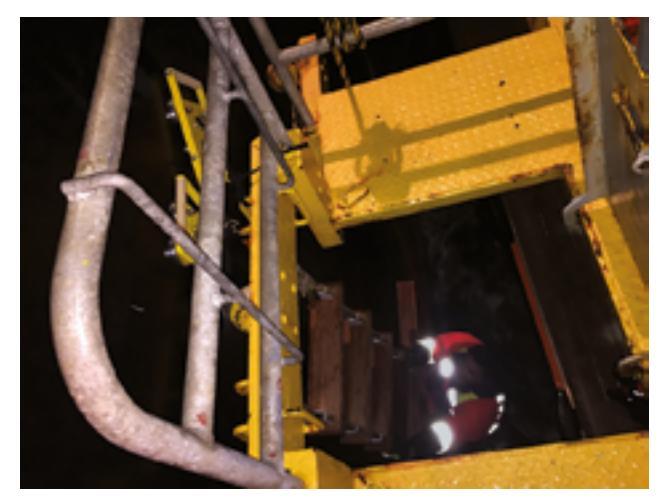
Figure 2 – Non-Compliant platform trapdoor arrangement *Photo courtesy of Ports of Auckland Limited (POAL)*

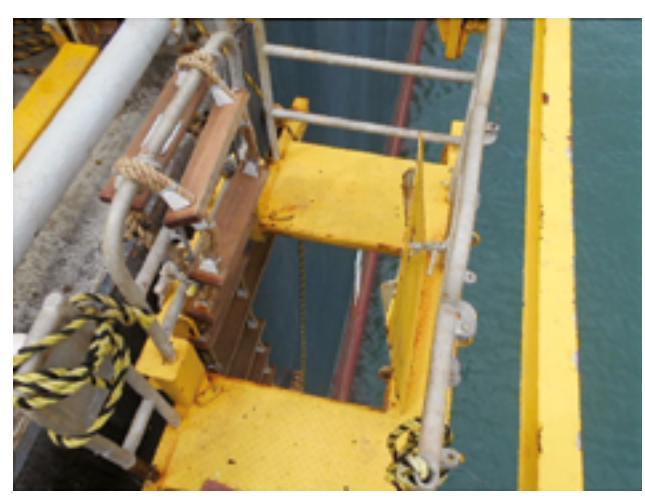
Figure 3 – Non-Compliant platform trapdoor arrangement Photo courtesy of Ports of Auckland Limited (POAL)

Figure 3 shows the same ladder as Figure 2, but it has been raised to be flush with the maindeck. However, it still raises concerns as to the safety of the arrangement. For departure, the ladder had been removed from the eyebolts and rigged over the railing of the accommodation ladder prior to being reconnected to the eyebolts. This was done in order to comply with the requirement that a ladder must extend 1.5 metres above the platform. This configuration led to the ladder not being flush against the ship's side as shown in Figure 4. It also led to the pilot ladder being angled outboard towards the trapdoor at the point of embarkation, so the pilot had to lean back in order to board/disembark. This in turn impacted upon the safety of the transfer of the pilot from pilot ladder to accommodation ladder and vice versa. Finally, the pilot ladder in its entirety is supported solely by the accommodation ladder railing, which it is a load it is not designed for.

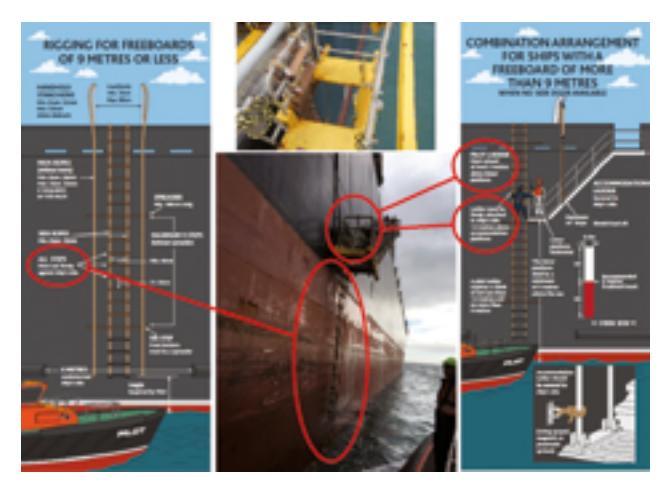
Figure 4 – Non-Compliant platform trapdoor arrangement *Photo courtesy of Ports of Auckland Limited (POAL)*

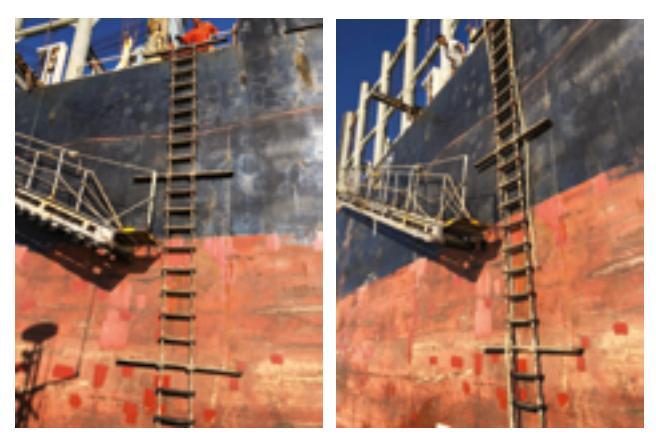
Figure 5 – Non-Compliant combination (courtesy of CHIRP Reporter)

All of the evidence in Figures 5 and 6 indicate a complete lack of awareness of requirements, a lack of maintenance, a lack of supervision, and a lack of company oversight.

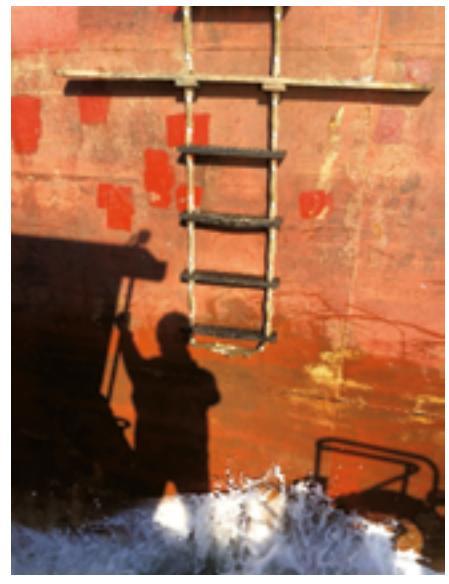
Figure 6 – Non-Compliant combination (courtesy of CHIRP Reporter)

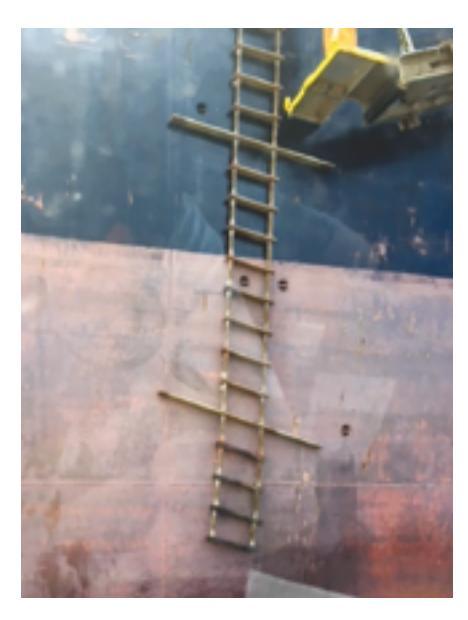
Figure 7 – Non-Compliant combination (courtesy of **CHIRP** Reporter)

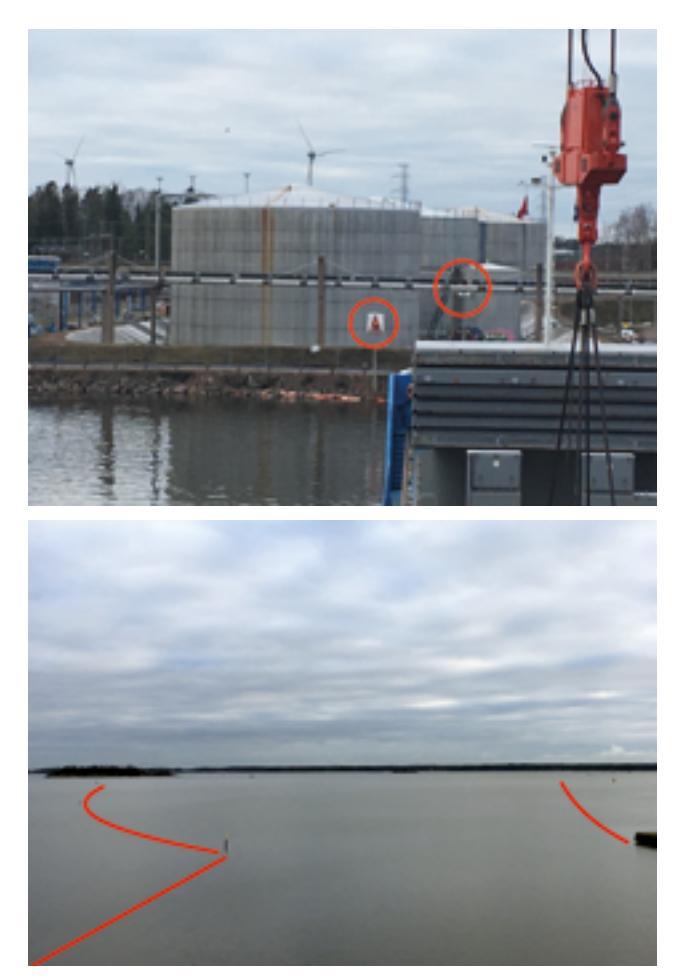
There are two problems with this berth. The main leading line is mostly useless because the upper light is obstructed by a pipeline. According to a pilot, this issue was reported to the authorities six years ago, but it still has not been rectified. Another problem is the position of one of the buoys. The location of this buoy makes for a challenging approach in a strong northerly or southerly wind. I have already experienced several close encounters with this buoy, and it is not helped that the buoy is unlit. Re-positioning of the buoy would help a lot. (See pictures below).

Leading lights obscured by a pipeline, and a view of the approach to the berth – looking west.

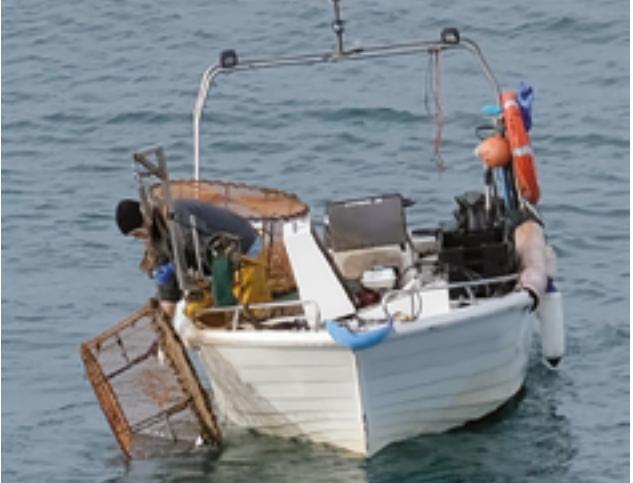
A small fishing vessel – the sole occupant is not wearing any floatation aid.

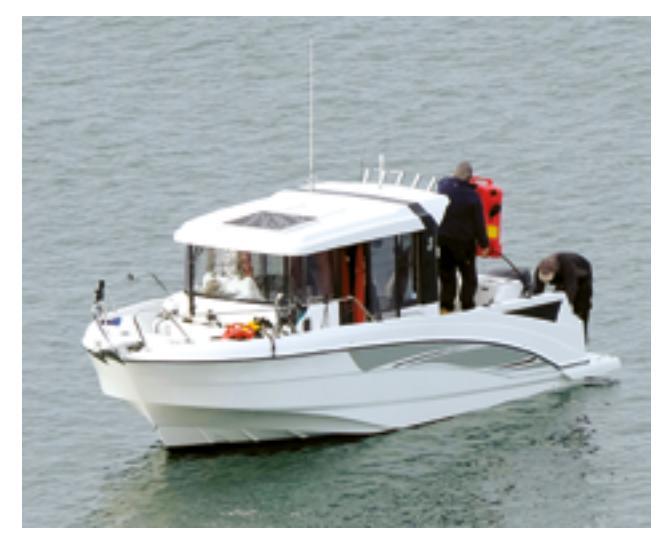
A small leisure vessel used for angling – no lifejackets being worn.

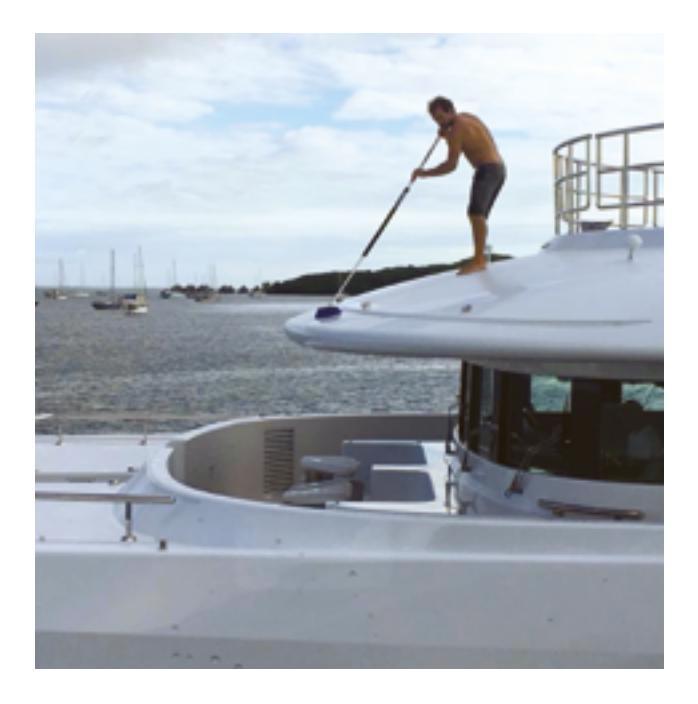
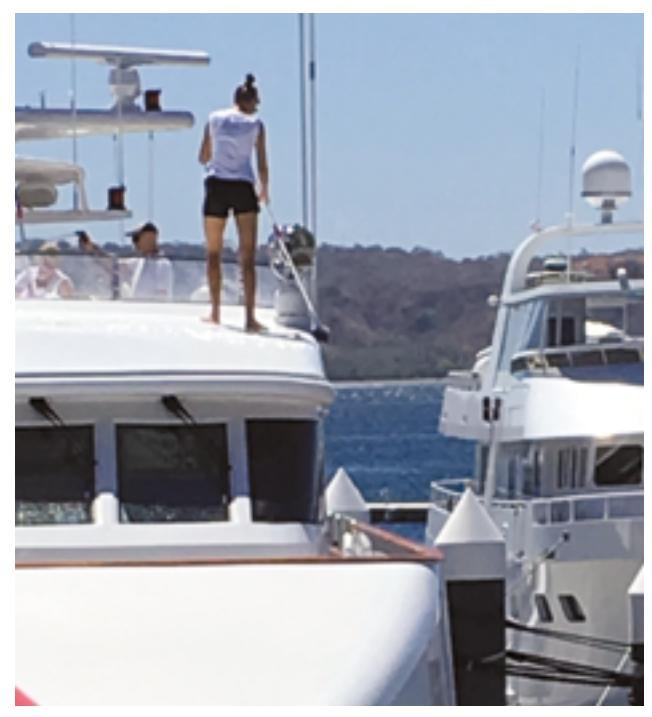
Two examples of washing down and placing yourself in danger.

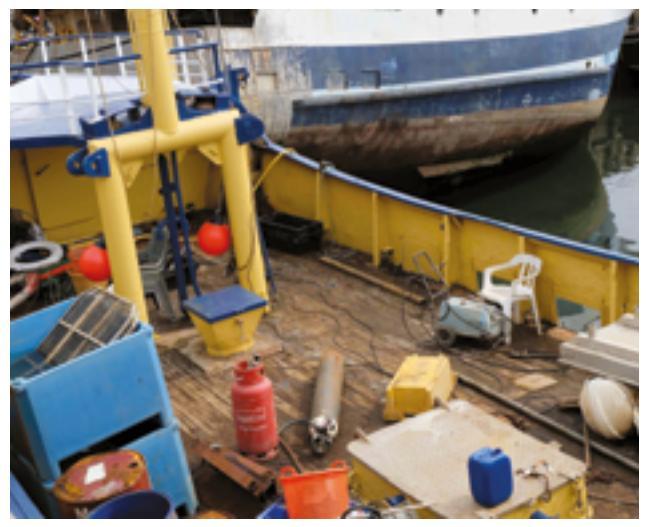
Plenty of housekeeping hazards here - how many can you spot?
