Bundesstelle für Seeunfalluntersuchung
Federal Bureau of Maritime Casualty Investigation
Federal Higher Authority subordinated to the Ministry of Transport
and Digital Infrastructure

Investigation Reports 455/15 and 58/16

Serious Marine Casualties

**Charcoal cargo fire
on the container vessels
MSC KATRINA
in the Elbe estuary
on 20 November 2015
and
LUDWIGSHAFEN EXPRESS
in the Red Sea
on 21 February 2016**

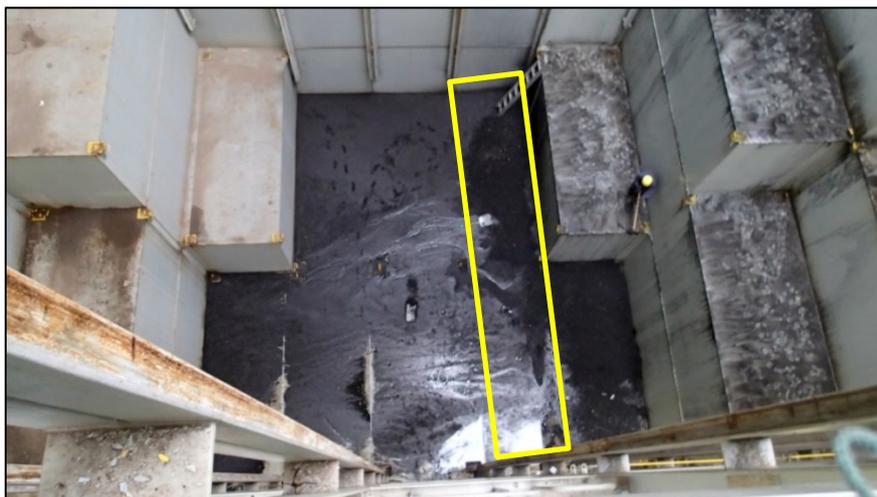
Figure 5: Container stack's slot in row 03

The cargo hold affected by the fire was already fully discharged at the time of the survey. A large amount of charcoal sludge on the floor of the cargo hold was in the process of being cleaned up. This allowed the conclusion that the fire had destroyed the floor of the affected container in at least one area, as charcoal had evidently been washed out when the fire service flooded the container. The second officer explained that the container stack with the charcoal cargo was standing on its own, meaning there was no imminent risk to adjacent cargo. The fire service was able to access the containers directly at one of the end walls from the passable supporting transverse bulkhead.

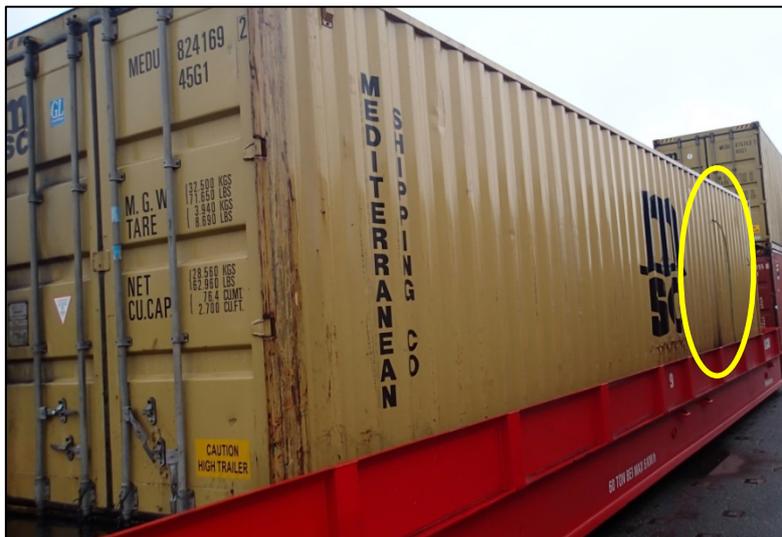
Figure 7: Container affected by the fire with fognail and hose

After completion of the survey of the ship, the seven containers making up the stack were viewed at their stowage position in the port. No traces of fire were found on the accessible outer sides of the container affected by the fire. It merely exhibited one large bulge. A fognail and the associated hose were still on one side.

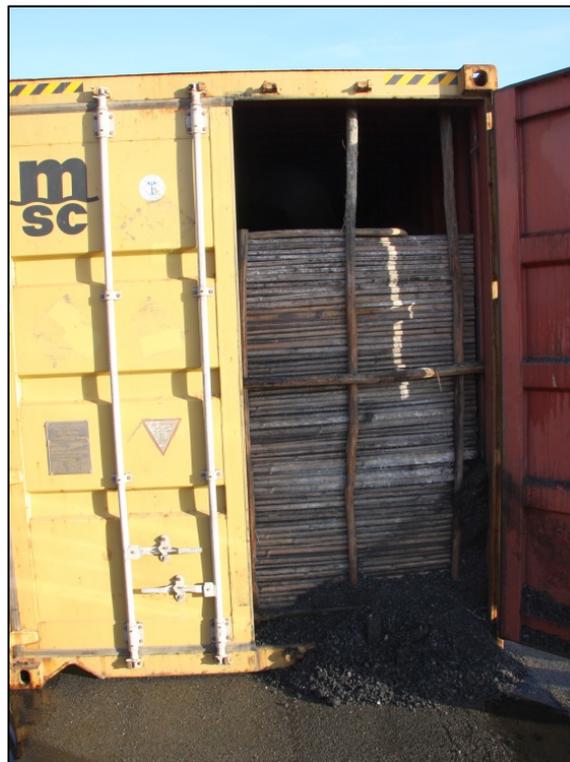
Figure 8: Open container unaffected by fire

It was found after the container was opened that the charcoal was loaded inside it in bulk, as per the cargo documents. A partition at the entrance made using unprocessed branches and bamboo sticks prevented the charcoal from escaping after the doors were opened. The charcoal was stowed up to 0.8 m below the roof, i.e. the stowage height stood at about 1.9 m at the highest points.

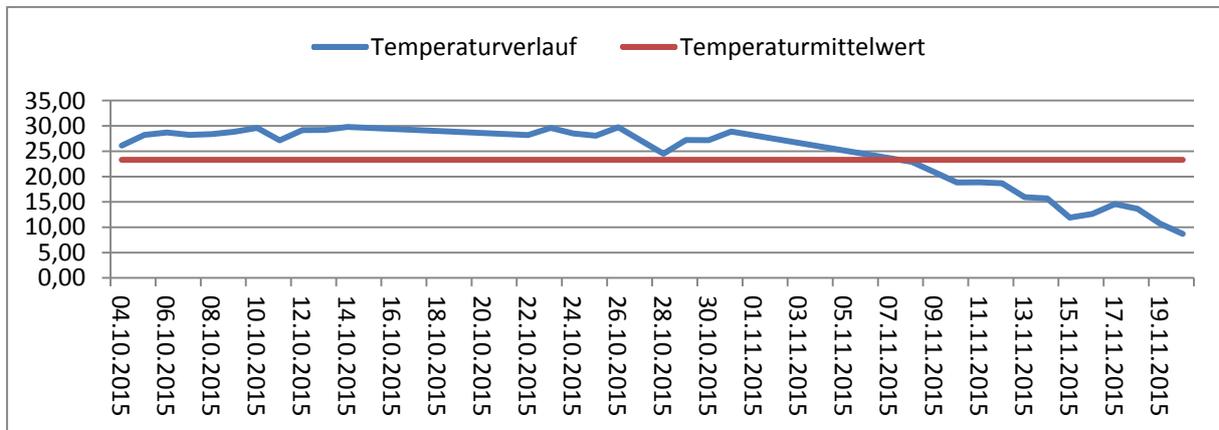
Diagram 1: Variations in outside temperature during transportation¹⁴

Germany's National Meteorological Service (DWD) provided the outside temperatures for each leg of the voyage shown in Diagram 1.

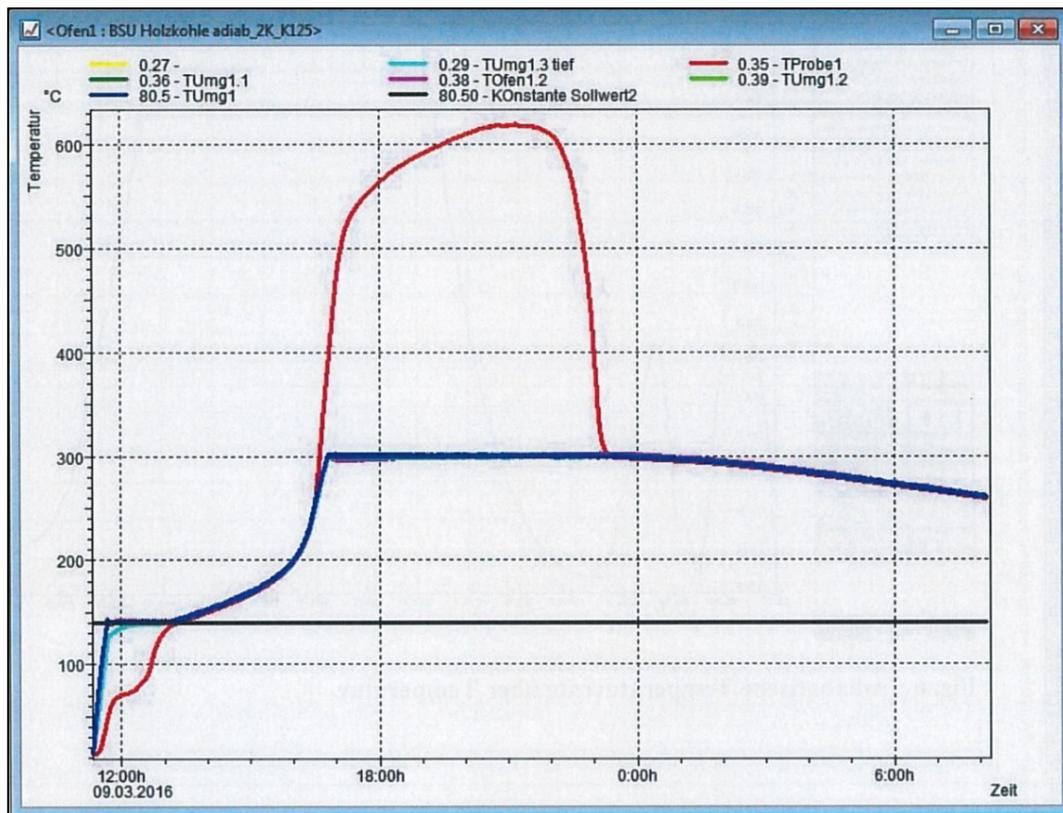
Diagram 2: Adiabatic temperature-time curve in 125 cm³ cube

During the adiabatic hot storage test, the company commissioned inserted a sample of the charcoal into a 125 cm³ wire basket with an overtemperature²² of 2 K. The starting temperature was 140 °C. The expert noted the following in this context: "The adiabatic test has the advantage that it is not affected by volume. This means that numerous conclusions can be drawn from a single test. The test [...] was repeated for reasons of quality. This did not affect the test result."²³

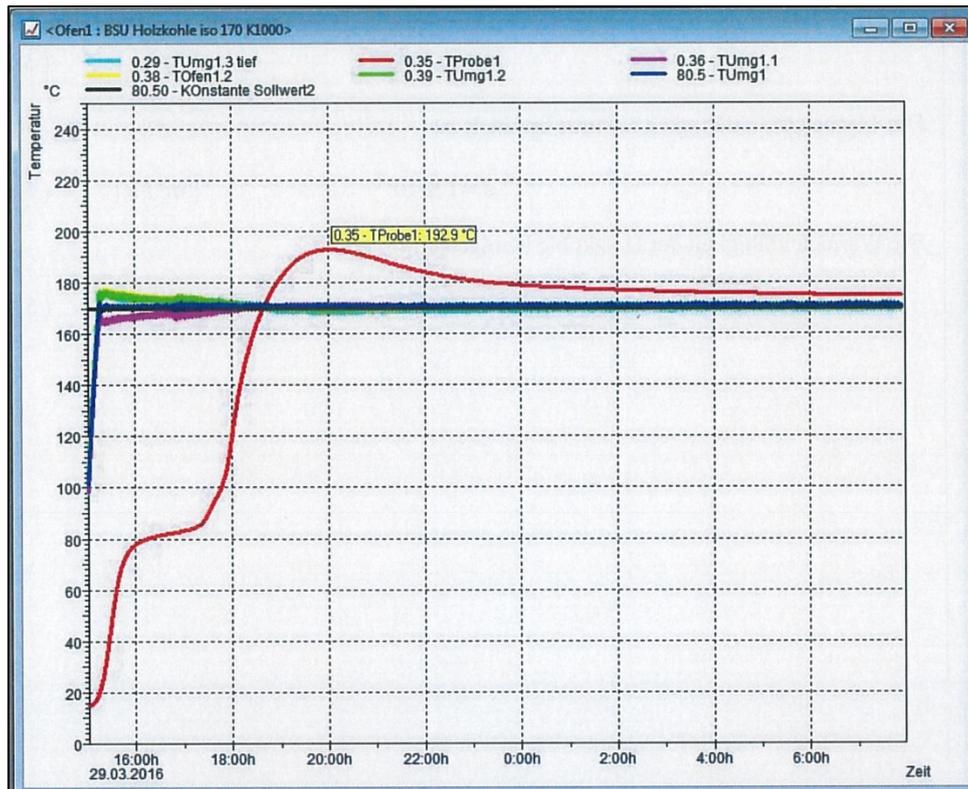
Diagram 4: Isoperibolic temperature-time curve of charcoal in a 1 litre cube at 170 °C.

"A wire cube with a volume of 1 litre was used in the isoperibolic hot storage tests. This isoperibolic test is carried out to establish the auto-ignition temperature of the charcoal at this volume. [Previously] it was merely determined that the auto-ignition temperature is greater than 140 °C."²⁷

The expert found the following with regard to this test: "The maximum temperature of the charcoal is 193 °C. An increase in temperature of 23 °C occurs. There is no ignition. The auto-ignition temperature of charcoal in the 1 litre cube is slightly higher. The test result [...] clearly indicates that the charcoal examined here is either a mixture with other substances or specially prepared charcoal (activated charcoal)."²⁸

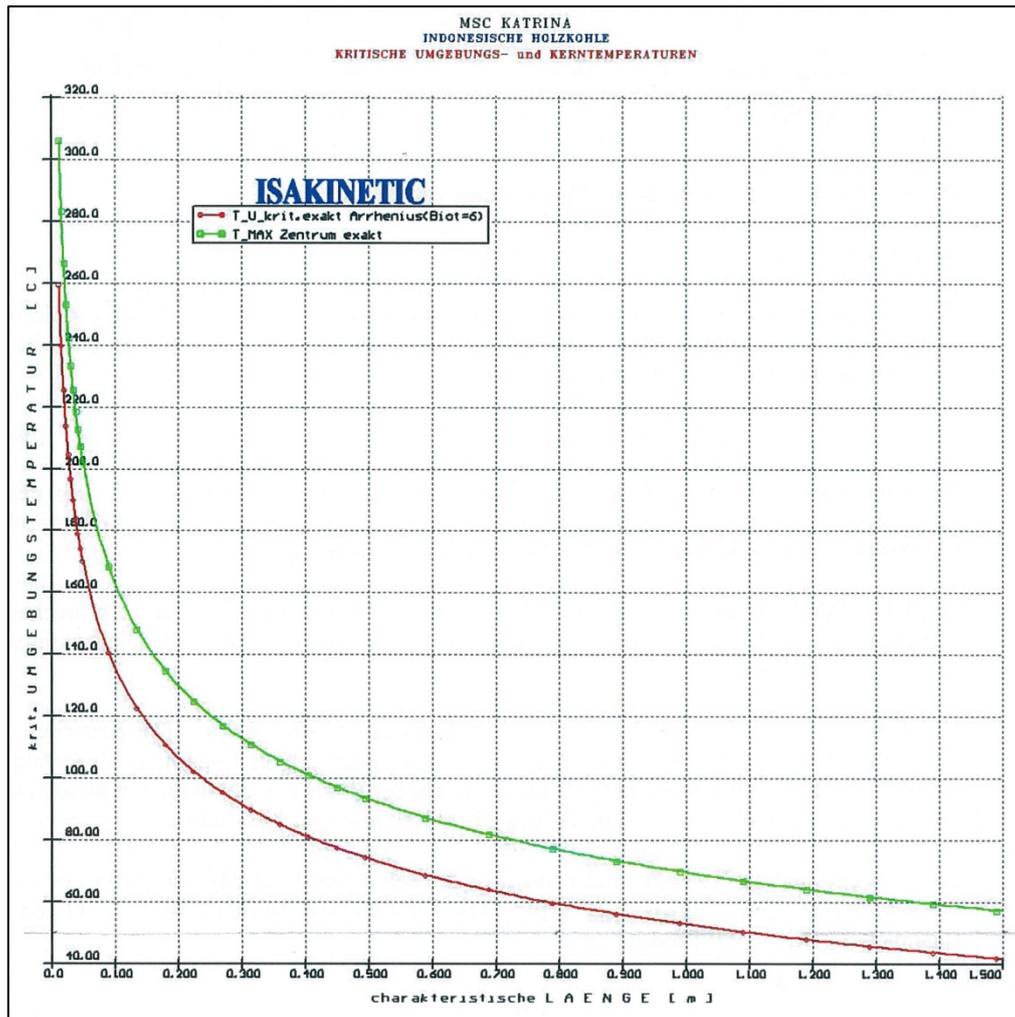
Diagram 5: Volume-dependent critical ambient temperature for charcoal

"The function $T_{U, krit.}(L)$ in relation to the characteristic length L ²⁹ is based on the [previously determined] kinetic parameters [...] and on the thermometric conductivity [...]. The specific sea container is still not included in this consideration at this stage."³⁰

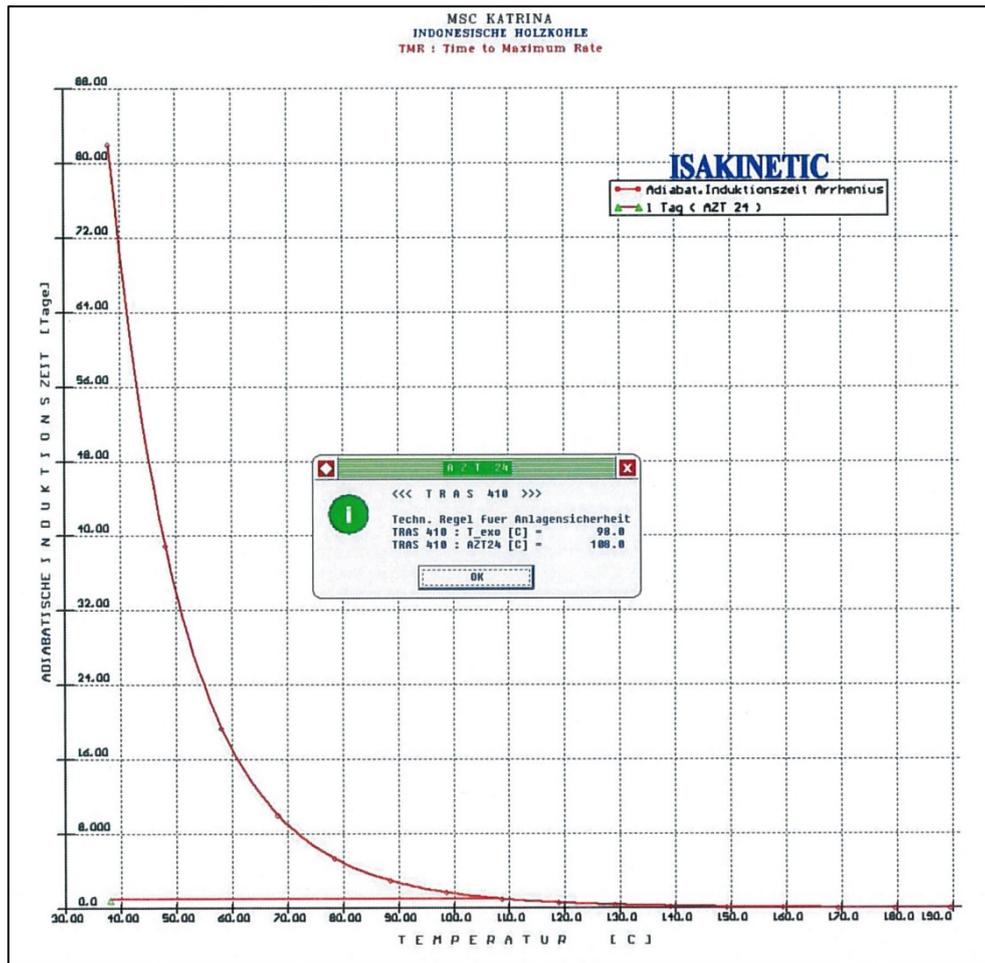
Diagram 6: Adiabatic induction periods for Indonesian charcoal

Based on these general considerations, a temperature of 44 °C arises according to [Diagram 6] under adiabatic conditions."³⁴ This means that at a constant temperature of 44 °C in the container, a runaway reaction can be expected after 46 days, i.e. a fire will develop.

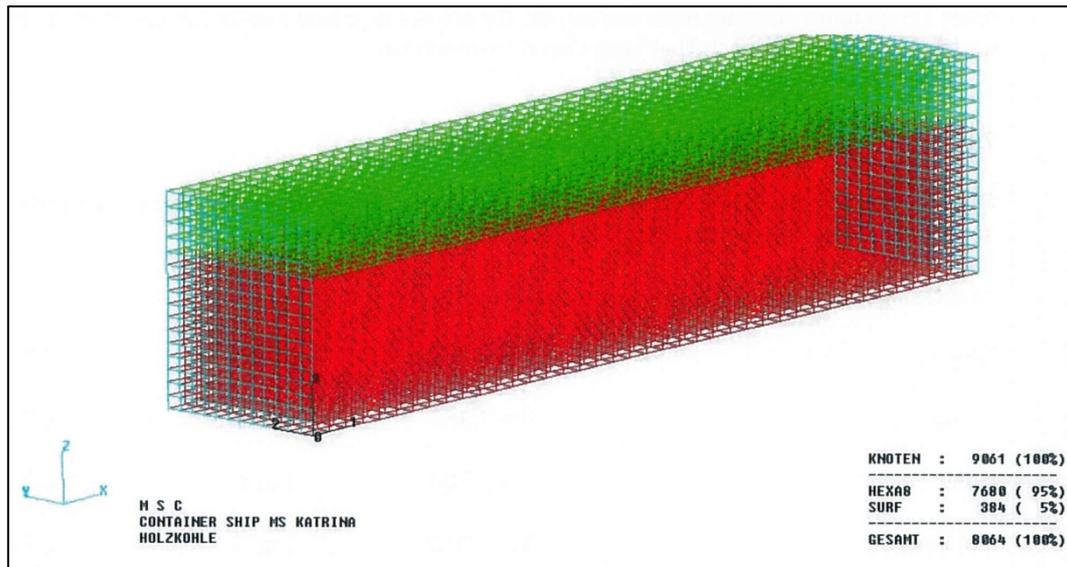
Figure 10: Container model with charcoal, air layer and heat transfer

"The finite element model maps the container with charcoal inside. The filling level is approximately 72%. The assumed filling height is 2.0 m.

The entire model comprises 8,069 elements and 9,067 nodes. It is a volume model. The red volume element is charcoal and the green element the layer of air. The heat transfer elements are the colour cyan.

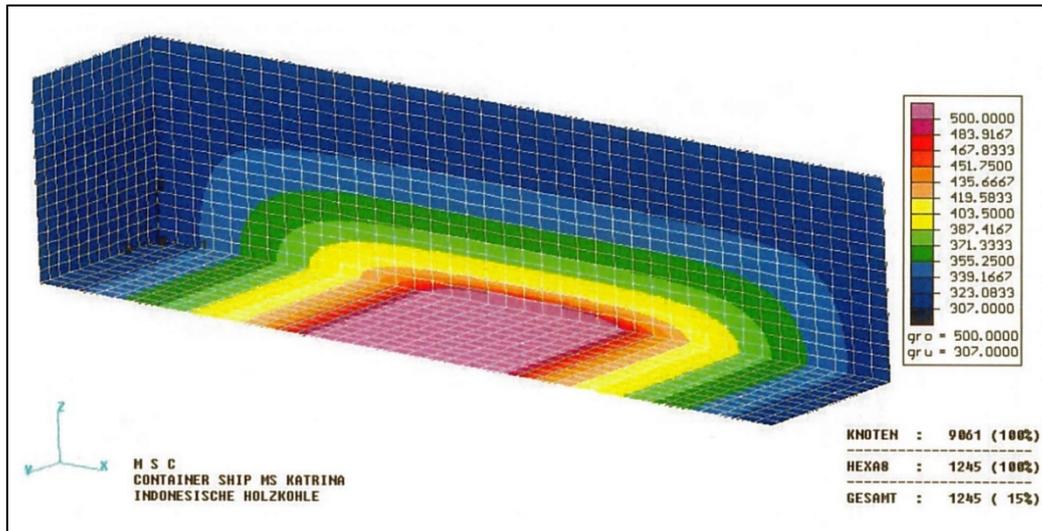
Figure 11: Temperature distribution in the charcoal after 52 days

"The calculation delivers a period, in days, after which a temperature of 100 °C is reached in the container, which the fire service observed during the firefighting operation. [Figure 11] shows the temperature distribution in the charcoal and in the air layer."³⁹

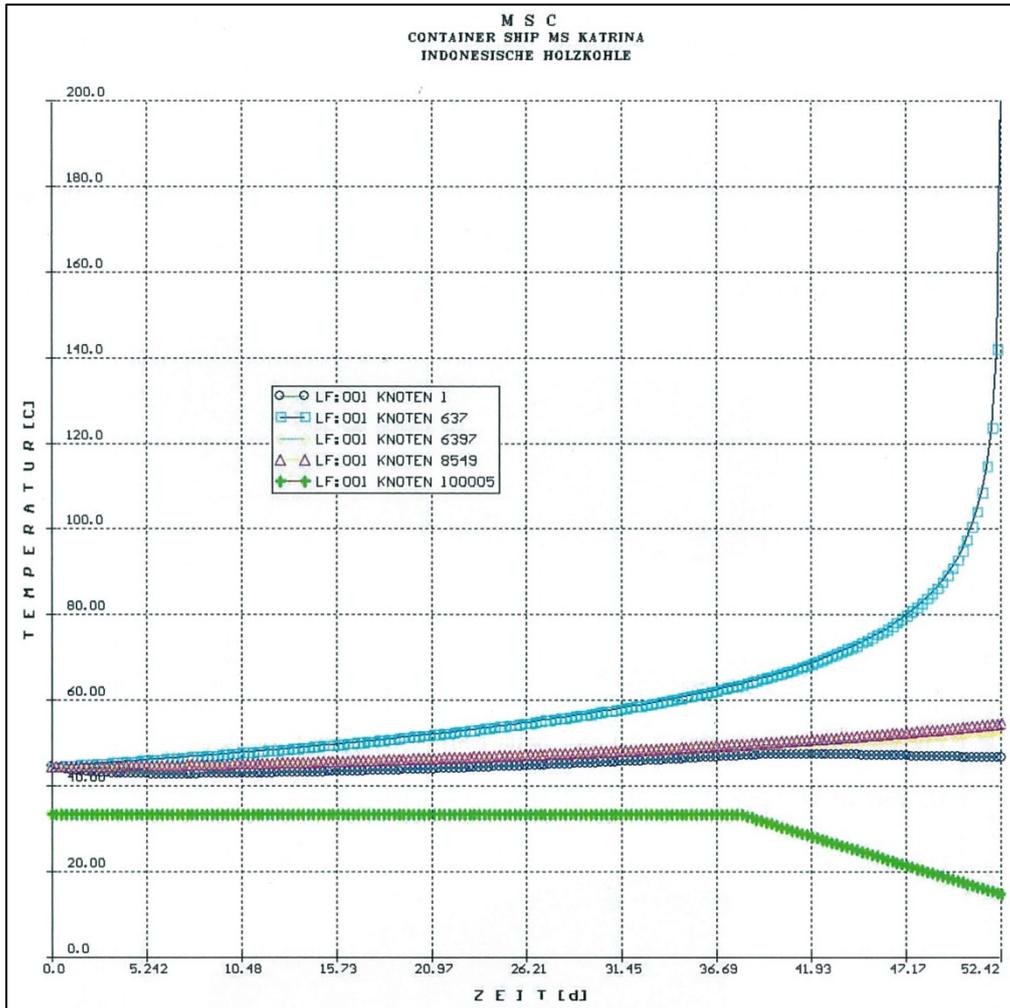
Diagram 8: Temperature curves at selected positions in the charcoal

"Under the agreed conditions, a hot zone forms at the bottom of the container. After 52 days, a thermal explosion⁴⁰ occurs – see [Diagram 8]."

"[Diagram 8] shows that a temperature of 100 °C is reached at the bottom of the container after 50 days. The green line in [Diagram 8] reflects the idealised ambient temperature curve."⁴¹

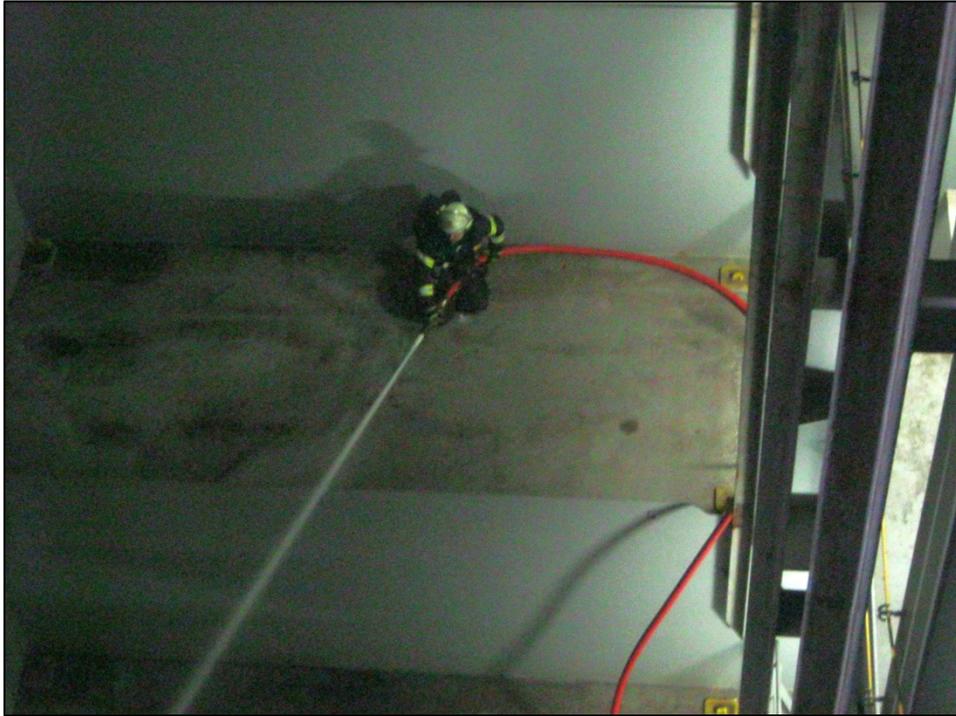
Figure 12: The fire service cooling the container stack

After the fire service's operational commander contacted the ship's command of the MSC KATRINA and preliminary arrangements had been made, the fire service carried out its own survey of the scene. It was found in the process that the outer side of a container in the fifth tier⁴⁵ had heated up to more than 100 °C. The container beneath also exhibited an increased temperature in the empty space above the actual charcoal cargo. The firefighting then began. Two nozzles were initially used for external cooling to prevent the fire from spreading.

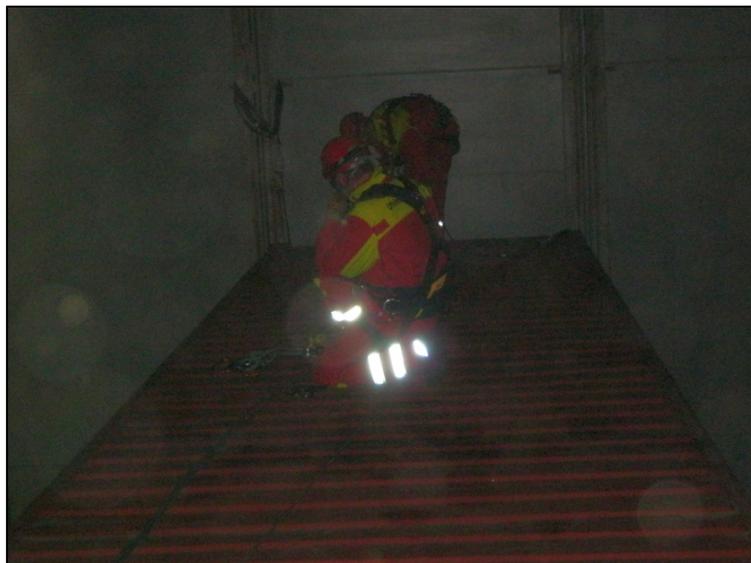
Figure 13: Erecting safety equipment on the roof of the uppermost container

The container affected by the fire could not be reached by ladder due to the stowage height. Consequently, high-altitude rescuers belonging to the second fire service group fixed rope safety equipment on the uppermost container of the stack concerned. The firefighters were then able to abseil down from there and attach a fognail to the container affected by the fire.

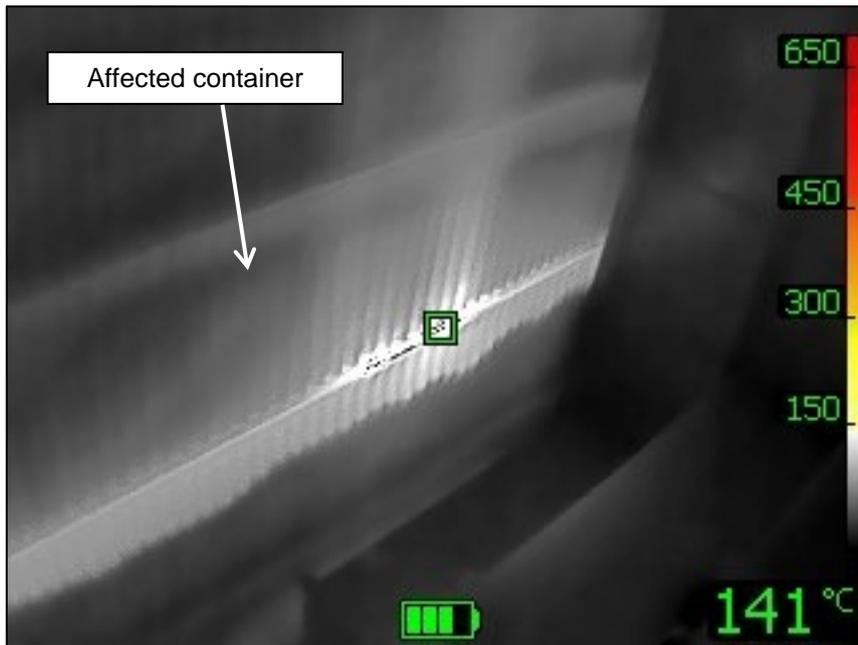
Figure 14: Temperature measurement by the fire service on the starboard side of the stack: 141 °C

The temperature measurements show that the area in which the outer skin of the container reached 130-141 °C was spatially confined and mainly on the right-hand side. The temperature dropped immediately adjacent to it and was only slightly above the ambient temperature of about 4 °C. It is also evident that the temperature in the area over the cargo in the container beneath the one that was on fire exhibited higher values (more than 20 °C) than the empty space of the burning container. This is probably due to the fact that much of the wood bottom of the container affected by

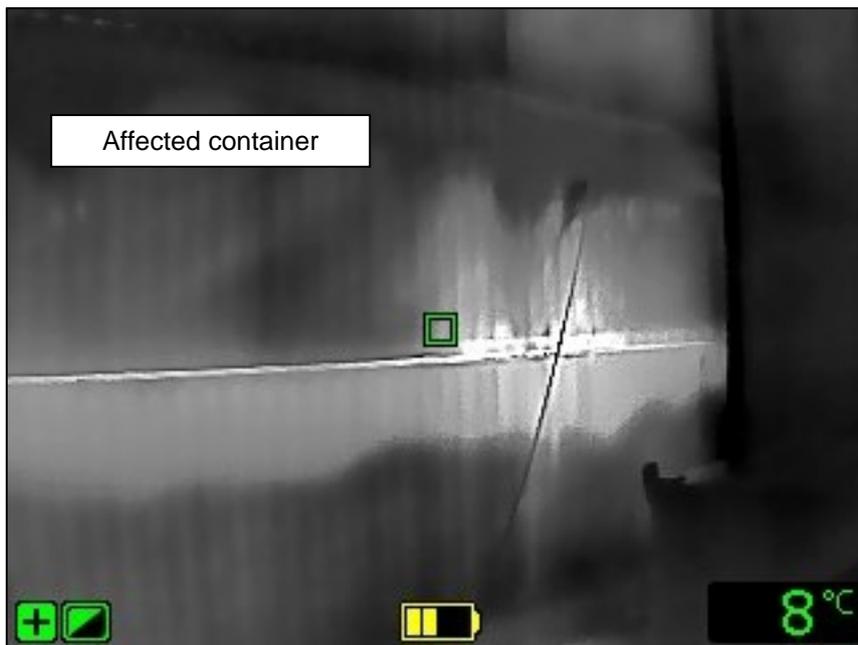
Figure 15: Temperature measurement by the fire service on the starboard side of the stack: 8 °C

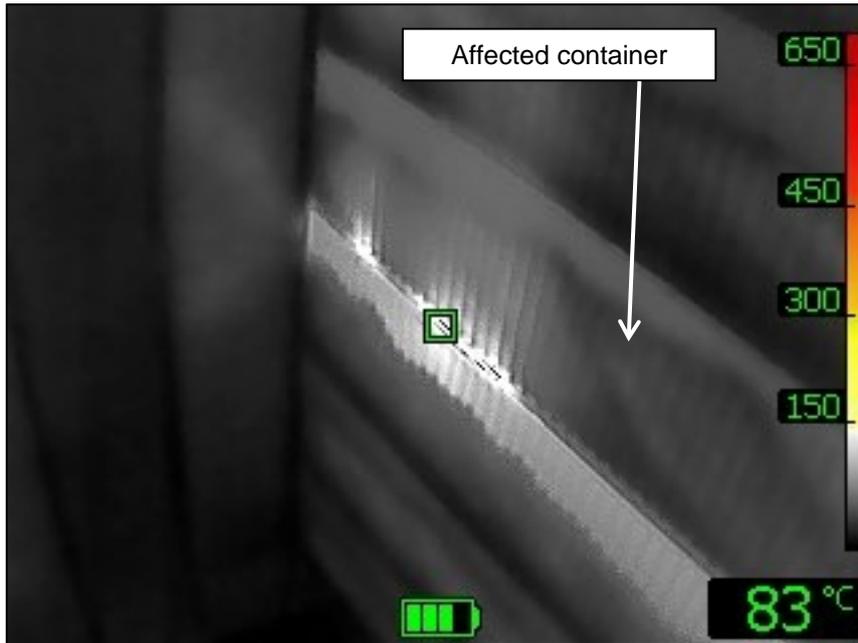
Figure 16: Temperature measurement by the fire service on the port side of the stack: 83 °C

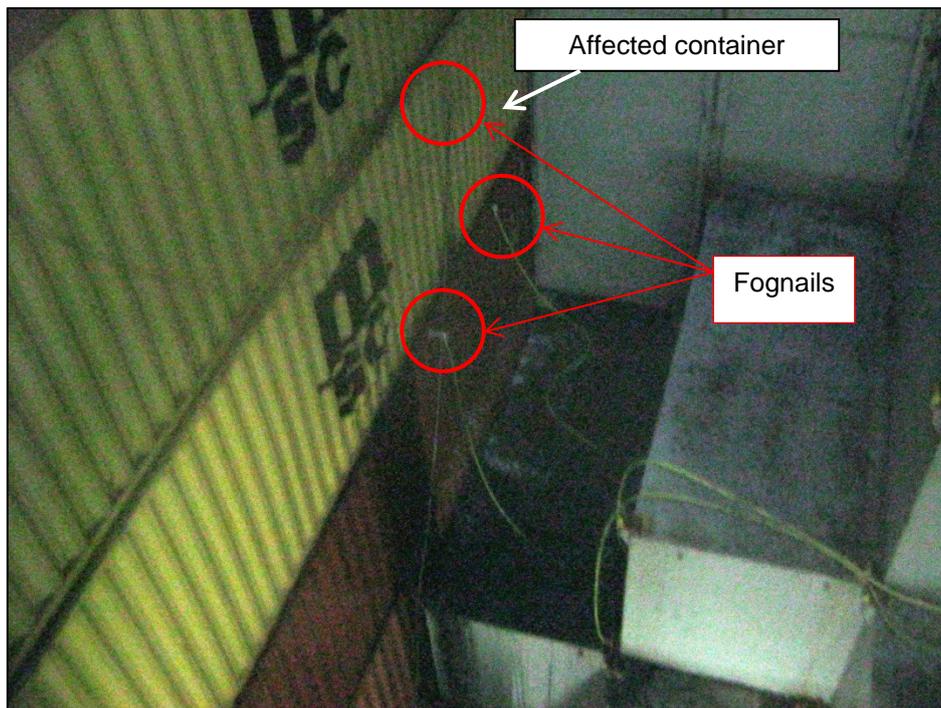
Figure 17: View of the starboard side of the stack with three fognails attached

The container beneath the one affected by the fire could be reached by ladder. It was cooled using two fognails punched into the area above the cargo. The development of the temperature in the containers was continuously monitored until the end of the operation using a thermal imaging camera and a laser thermometer.

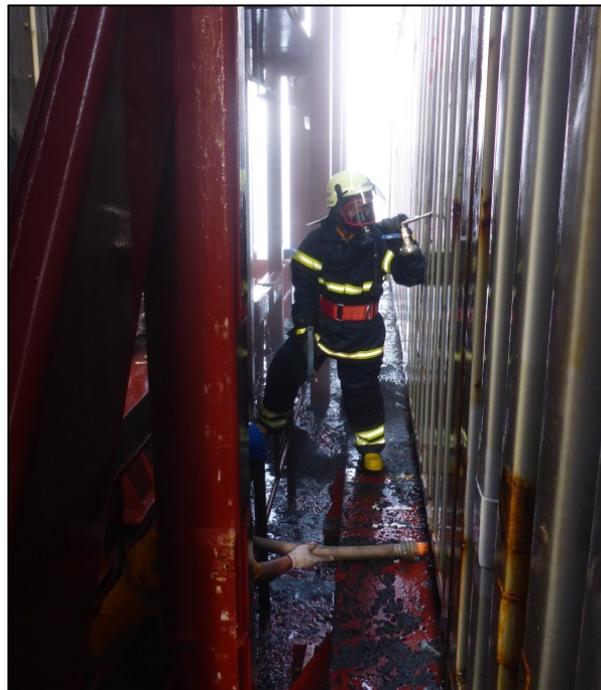
Figure 18: Attachment of a fognail

Using a laser thermometer, the crew found that the immediately adjacent container (slot 700982) also exhibited a high temperature at 1720. The cargo documents indicated that this container was also carrying charcoal. A fognail was also punched into this container to discharge water into it. The inspection of CH 9 was completed at 1747. No irregularities were found.

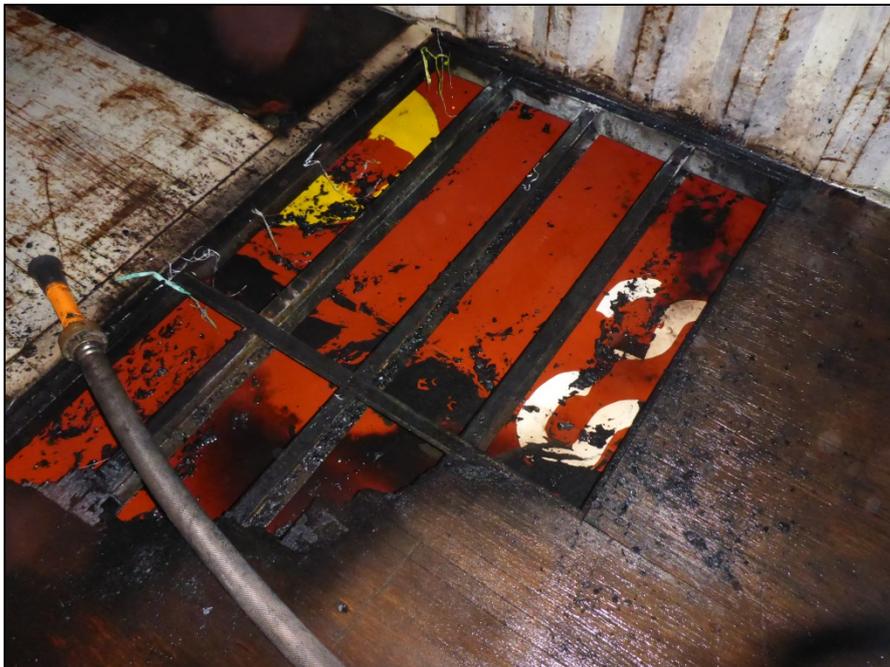
Figure 20: Container bottom burnt through

All the charcoal from the first container was washed out by 0054. Accordingly, the fire was extinguished in this container. The fognail on this container was then also fixed to the second container affected and activated.

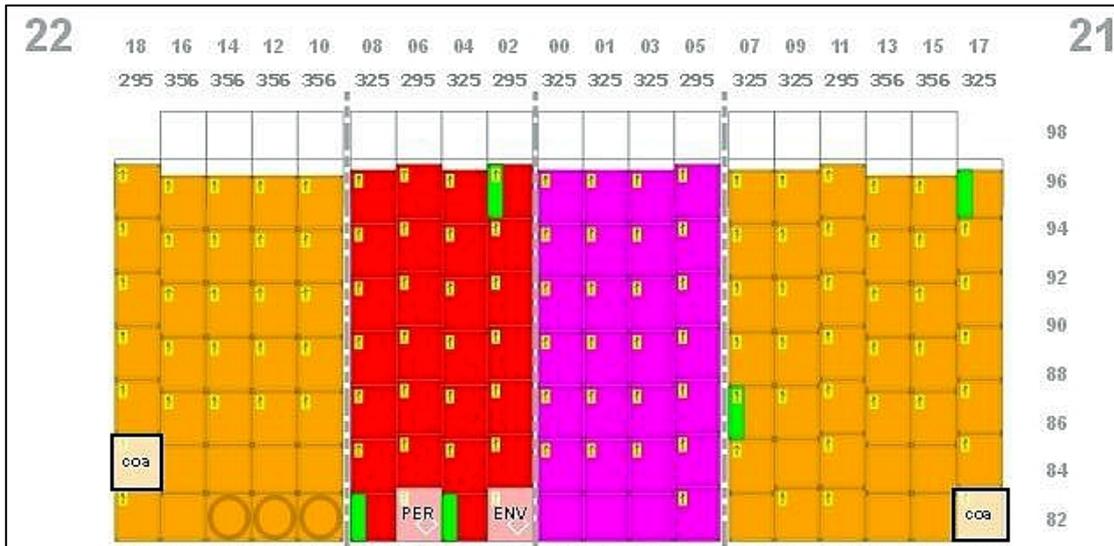
Figure 21: Extract from the stowage plan (bay 22)⁴⁸

The extract from the stowage plan (Figures 21 and 22) gives an overview of the position of the charcoal containers. It is evident that all the containers carrying charcoal were shipped as deck cargo.

During the temperature measurements carried out periodically on the other charcoal containers after the fire, all the cargo units were initially normal, even though three containers were exposed to increased sunlight due to the slot.

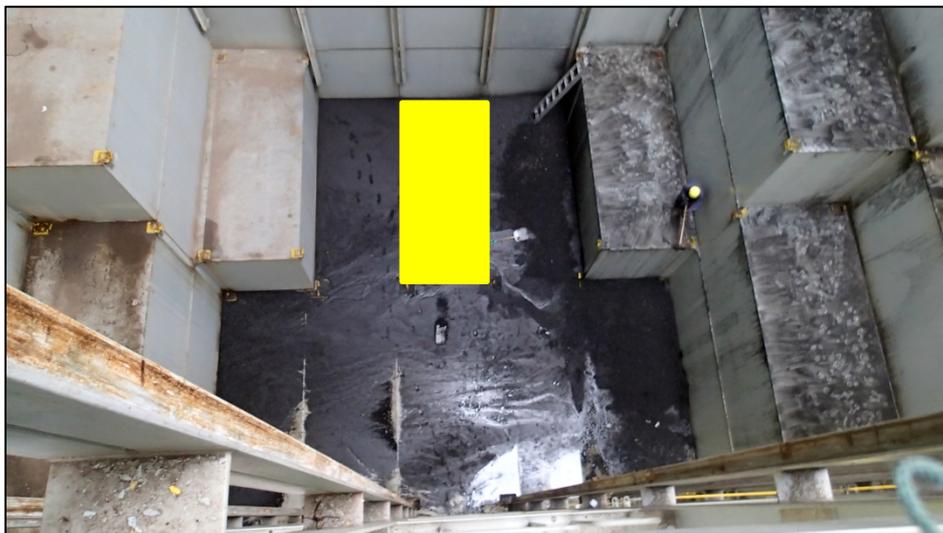
Even in the case of a 20-ft container, firefighting would have been possible at least at an end wall if transported on deck.

Figure 25: Example for a poorly achievable storing position of a 20-ft container
