Wet Damage on Bulk Carriers

How to avoid wet damage on bulk carriers

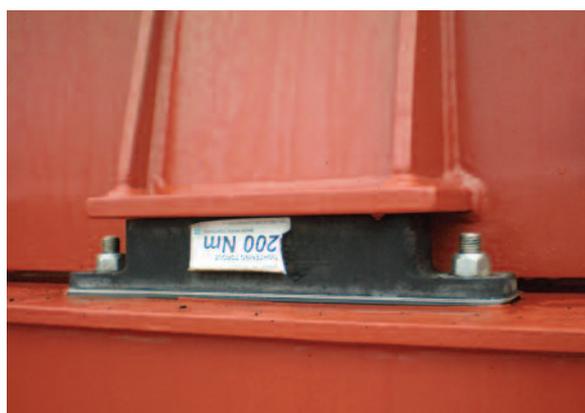
When repairing the bearing pads it is important to check/replace the gaskets at the same time. If the gasket has lost its original elasticity there will not be enough compression of the gasket to achieve a proper weathertightness of the hatch covers.

After the repair of the bearing pads the weathertightness of the hatch covers should be tested with a hose test or using ultrasonic testing equipment.

Bearing pads need to be repaired when the pad is worn approximately 5 mm, i.e. well before there is steel to steel contact between the coaming and the side plate of the hatch cover panel. Proper function of the hatch cover gaskets and the weathertightness of the hatch covers is risked when the height position of the hatch covers is shifted from the original.

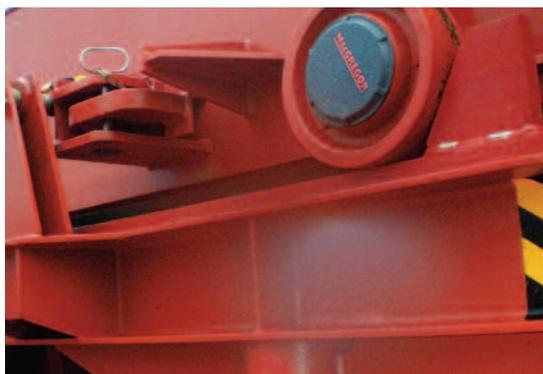
Locators and stoppers:

- Ensure correct positioning of panel both transversal and longitudinal
- Allow coaming deflection
- Control rubber compression in the cross-joints
- Absorb acceleration forces

The correct longitudinal position of the closed hatch covers and the weathertightness of the panel joint is achieved by the correct adjustment of stoppers. Wear and corrosion on locator wedge surfaces on the hatch cover and coaming cause a lack of rubber compression in the cross-joint between the hatch cover panels, as panels move apart from each other. Too large a gap causes leakages, as does improper alignment.

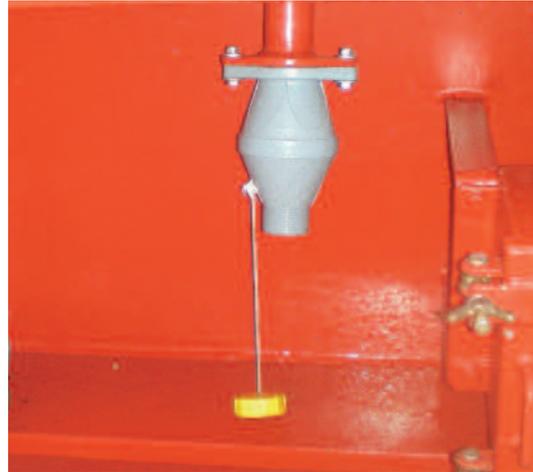
Drain valves are located close to hatch corners and the joints between the hatch cover panels. In rough sea the ship hull flexes, generating movement between the hatch cover panels and the coaming. This might cause leakage in the hatch cover sealing system. Leak water passing the seals is captured by the drain channels and the water is led to drain pipes on the coaming.

Non-return drain valves are installed to the drain pipes. They allow water to drain out onto the deck but stop water from the deck entering the cargo hold.

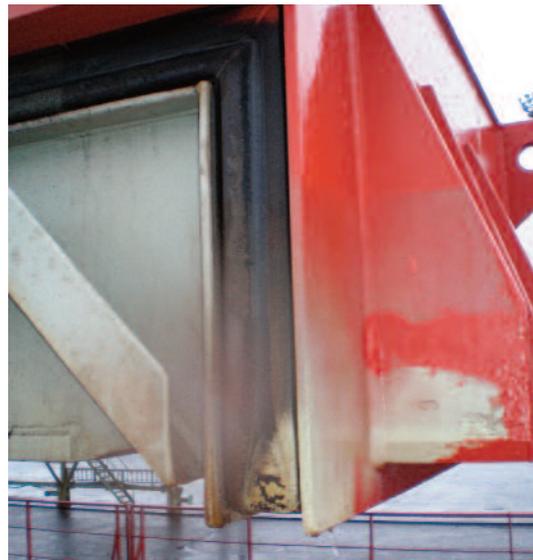
If gaskets are damaged then they must be replaced immediately, before the next voyage. Ageing of the rubber material has an effect on the mechanical strength and elasticity of the seals. Replace the seals when the permanent set is greater than 5mm. A tightness test is recommended as the change of the seal's geometry might be difficult to verify.

When replacing the gaskets the hatch cover bearing pads should also be checked or repaired as worn bearing pads can cause over-compression of the gaskets resulting in a shortened lifetime.
