**Canal &
River Trust**

Heritage Report

2017–19

September 2019

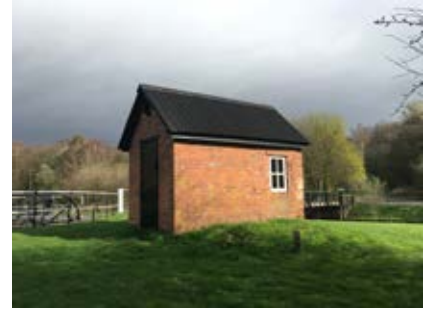
One of the Partnership's projects involved repairs to a former bridge-keeper's hut at Newbridge on the River Weaver near Winsford. It was built in the early 1900s as a small store and shelter for staff operating the swing bridge.

Above: Bridge-keeper's hut restored

Work to the hut included roof repairs, carried out via the Trust's framework contract, graffiti removal by the Trust's local team and brickwork repairs and repointing by two volunteers who received heritage skills training in the use of lime mortars.

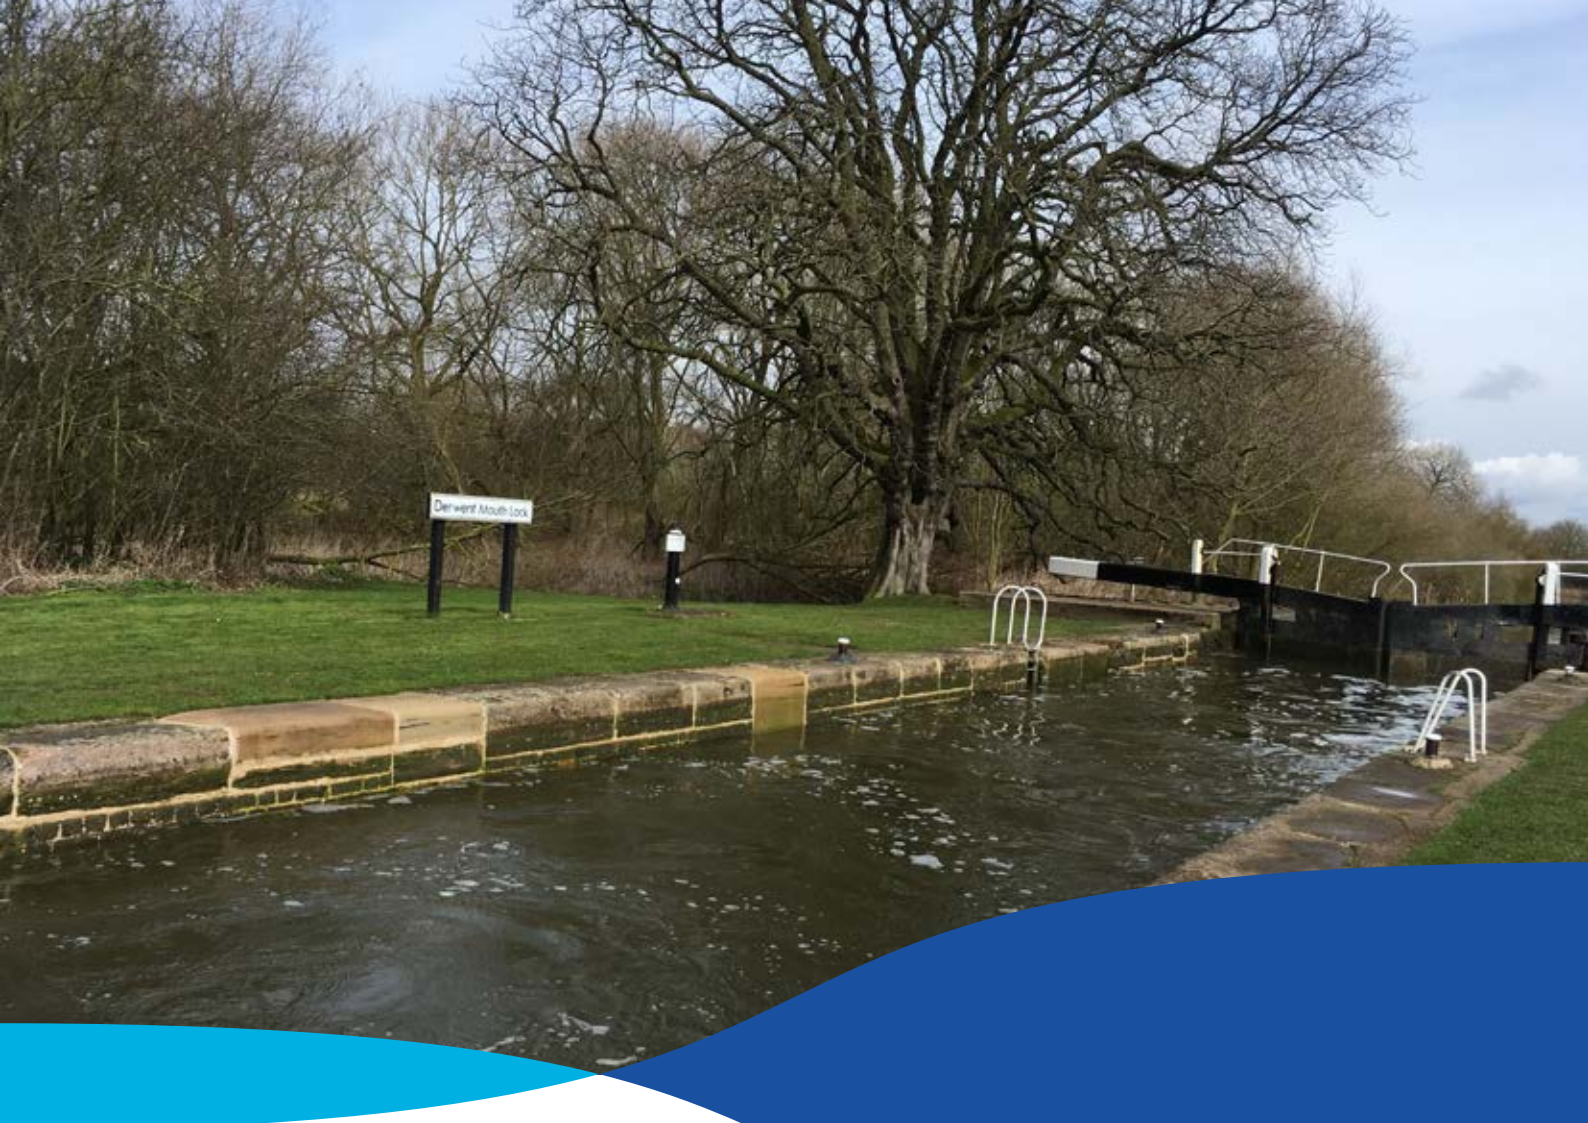
Derwent Mouth is the first lock on the Trent & Mersey Canal. It is Grade II listed and in a conservation area. In December 2017, extensive repairs to the lock chamber were carried out by the Trust's direct services, working closely with a conservation stonemason and the local conservation officer.

Once the lock was dewatered it was found that one anchor stone had delaminated over time and was preventing the gates from sealing when closed. This was replaced with a new piece of sandstone.

Above: Derwent Mouth Lock after repairs

Repairs to the lock chamber were carried out in matching brick and lime mortar. Worn copings were replaced with a matching sandstone. The stone was cut and delivered to site, then dressed in situ to ensure that the profile of the new stones matched the existing.

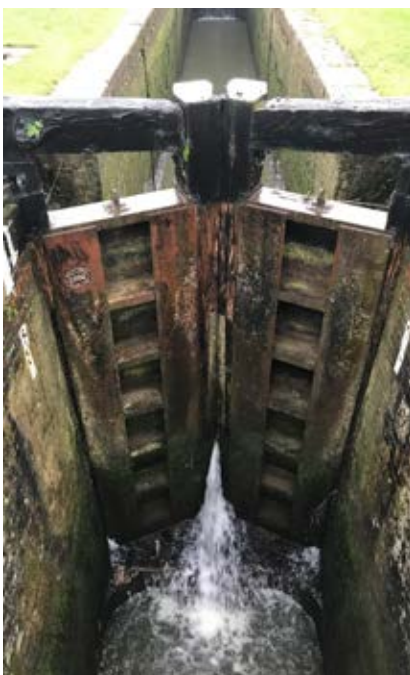
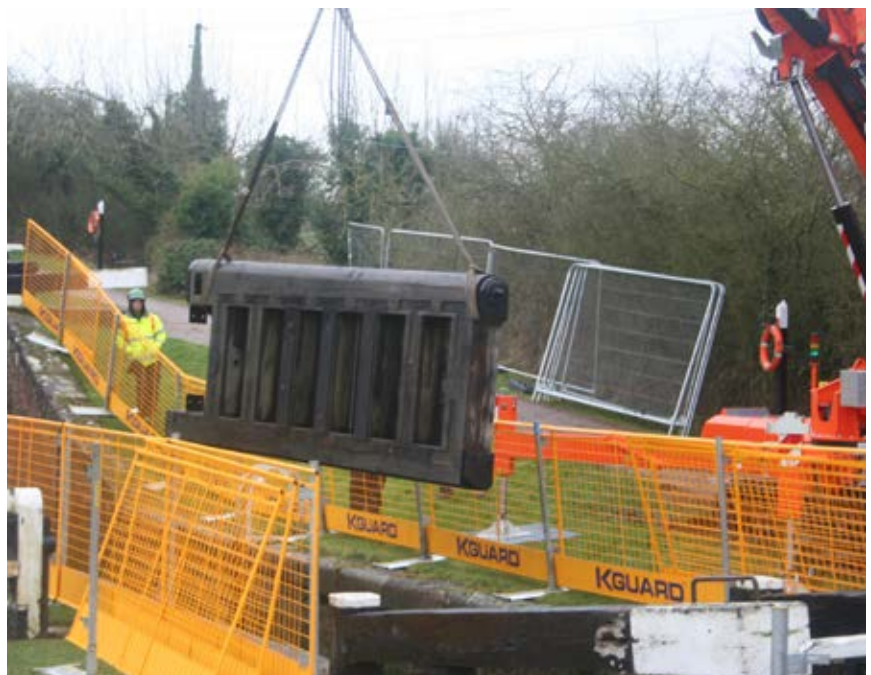
Left: Lock 16, Foxton Locks, 1992 composite gates

Right: Lock 16, new wooden gates being installed, 2018

Twenty-five years later in the winter of 2018, as part of other repairs to the lock flight, the composite gates of Lock 16 were removed and replaced with an authentic wooden set by the Canal & River Trust.

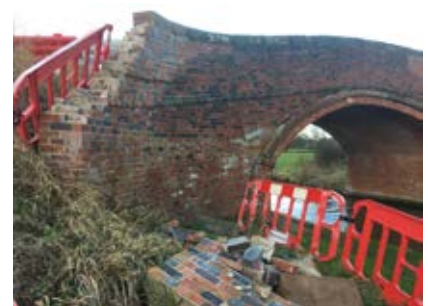
Cheshire West & Chester Council and the Trust have been working together to address the issue of frequent vehicle damage to Golden Nook Bridge near the village of Huxley, south of Chester. Since 2011, at least five vehicle strikes have been recorded, incurring costs of £125,000. The bridge is unlisted but was constructed in the late 18th century and is an important feature on this part of the former Chester Canal.

Above: Golden Nook Bridge vehicle damage

After careful consideration and planning, traffic lights have now been installed at the bridge, with costs shared between the Council and the Trust. This will help to reduce the risk of further incidents and safeguard the historic bridge for the future.

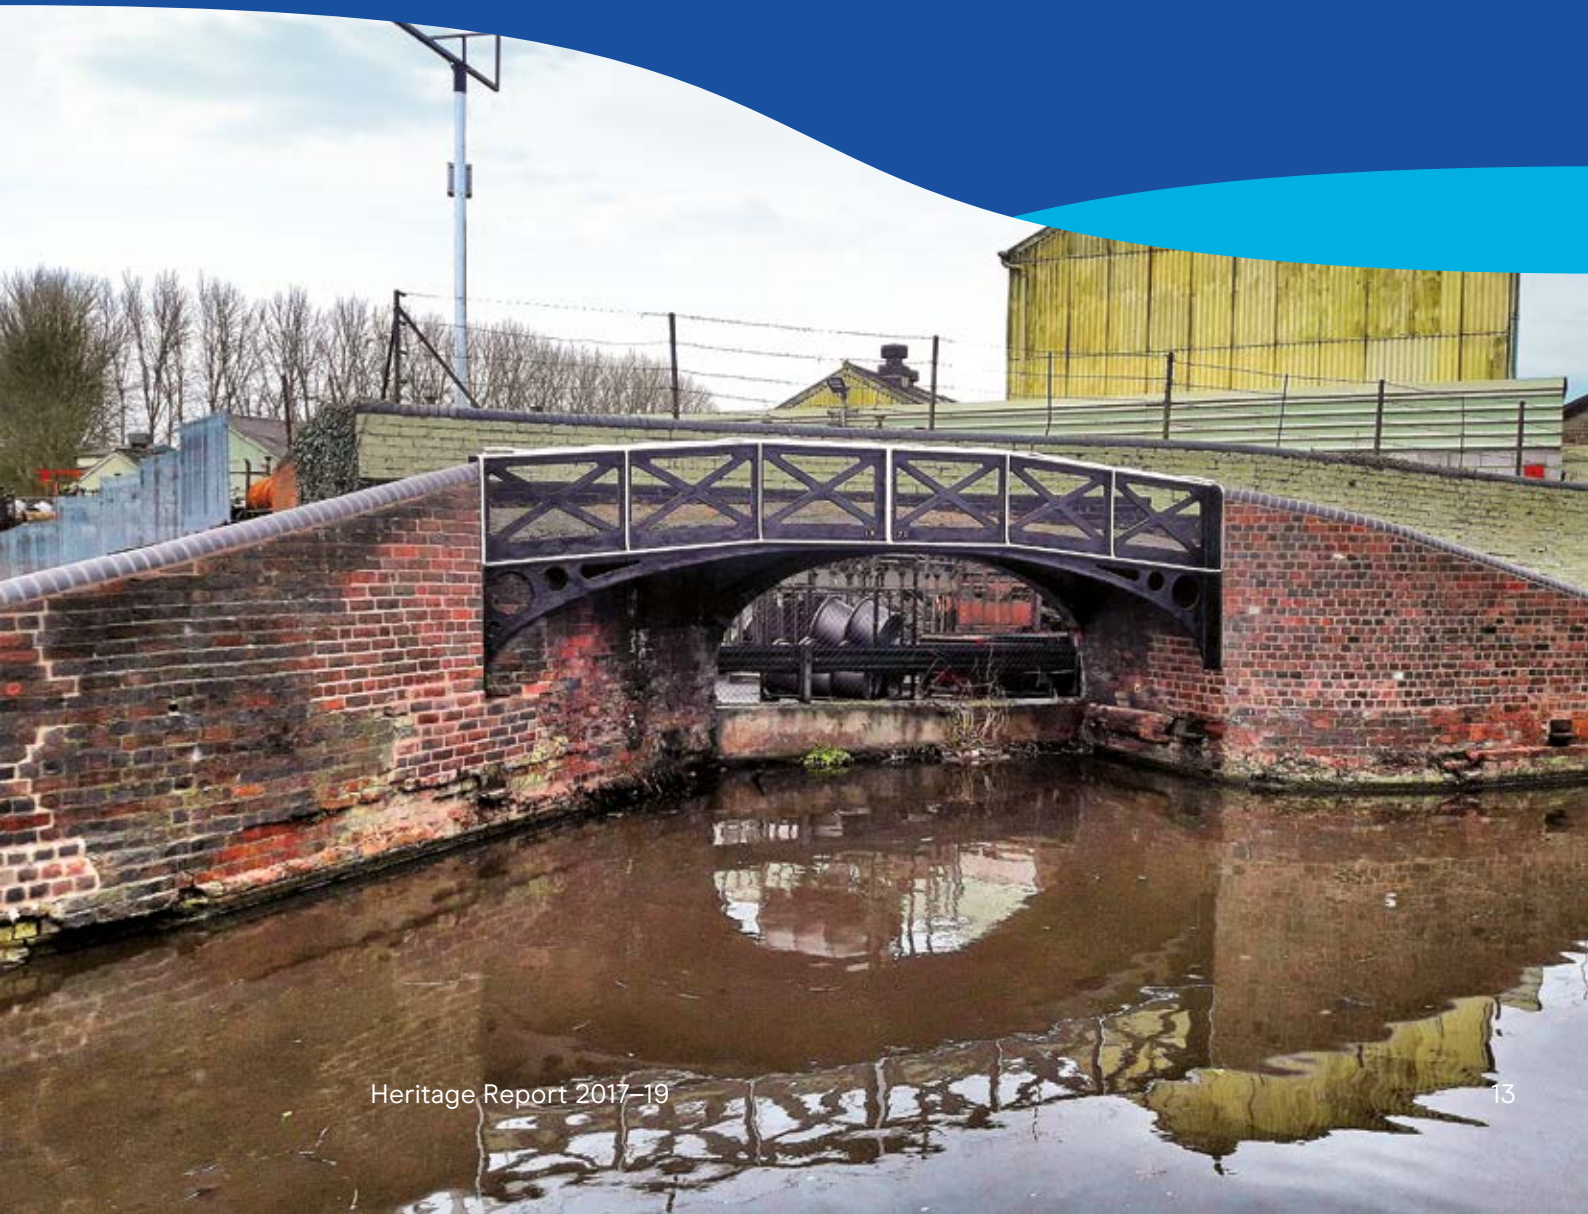
This towpath bridge spans a now disused canal branch into the former Cookley Forge Basin. Although unlisted, it is an excellent example of a cast iron decked basin bridge built in 1871. Over time its parapets had fallen into serious disrepair, posing a risk to towpath users and to the structure itself. In 2017/18 the bridge was repaired by the combined efforts of the Trust's direct services, customer services and volunteers. The repairs were carried out using traditional materials, including lime mortar and locally sourced reclaimed bricks for patch repairs.

Below: Cookley Forge Basin Bridge

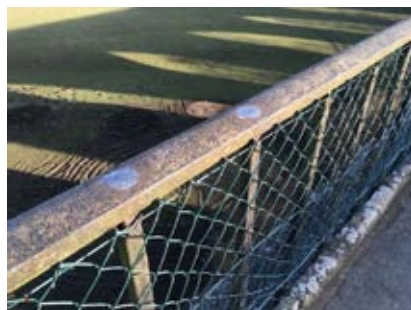
The work included repairs to missing, loose and cracked parapet uprights, casting defects in handrails and missing or failed rivet connections between the handrails and parapet uprights.

Above: Repairs to ironwork, Chirk Aqueduct

Large holes in the handrails were filled with molten lead. Replacement uprights were discreetly date marked and loose uprights were re-caulked into the surrounding masonry. Failed rivets were replaced with new wrought iron fixings. Defective rails were repaired and retained rather than renewed, and where uprights were missing, they were recast to match the originals.

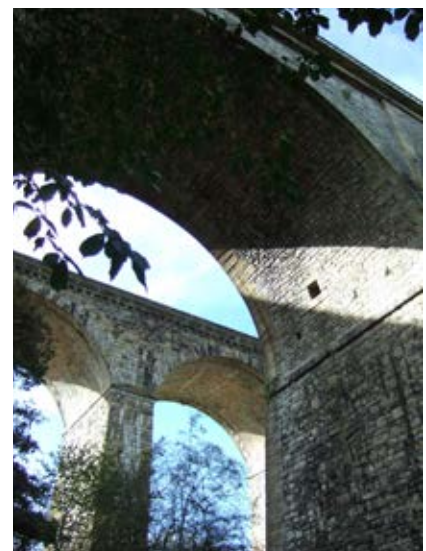
Right: Chirk Aqueduct, view from below

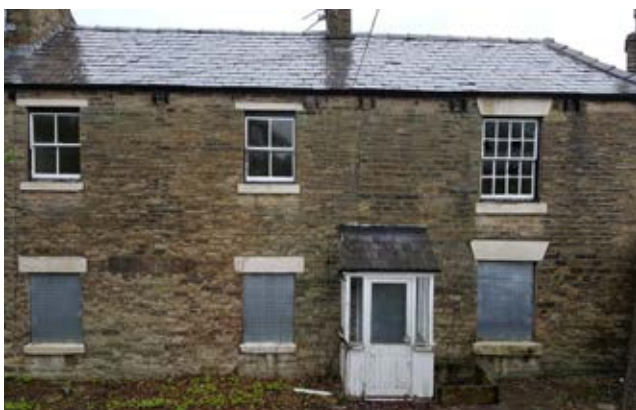
Left: Marple Cottages before refurbishment

Works included re-roofing the properties, including repairs with matching Welsh slate, replacing areas of gypsum plaster with a natural lime plaster and undertaking conservation repairs to sliding sash windows. Loft spaces were given natural sheep's wool insulation to reduce heat loss and in Cottage 1 a timber stud wall was removed from one of the bedrooms to return it to its original plan form. The modern lean-to porch was also removed from Cottage 2. New kitchens and bathrooms were installed, along with extract ventilation, to improve tenant comfort and reduce the build-up of condensation internally.

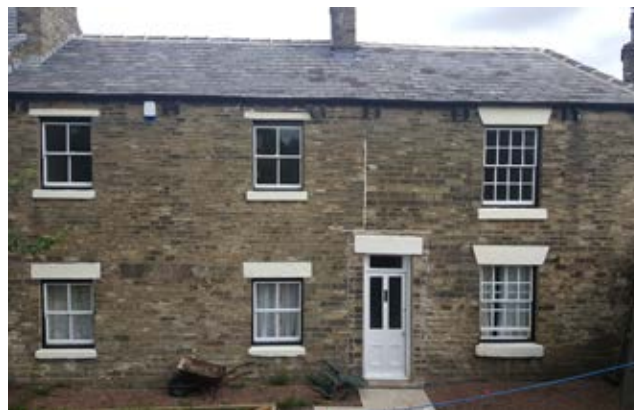
Right: After refurbishment

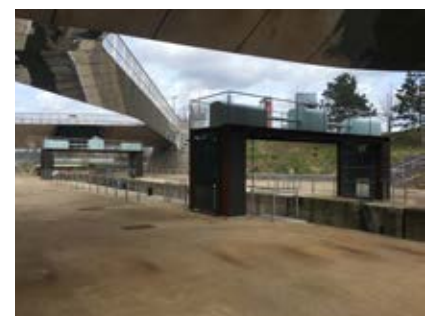
Essential repairs were carried out to the bridge in 2018/19 when the parapets were replaced with modern steel replicas. The original plates were cracked, fragile and unsafe. Two were carefully removed however and will be incorporated into interpretation that will tell the story of the bridge.

Below: Bedford Street Bridge, before repairs

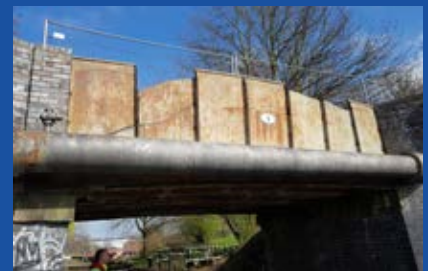
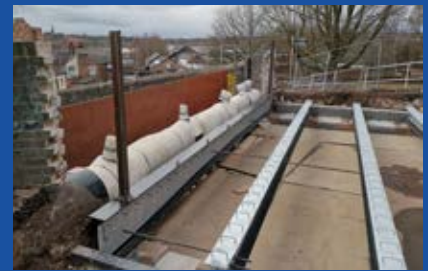
Middle: Bedford Street Bridge, repairs in progress

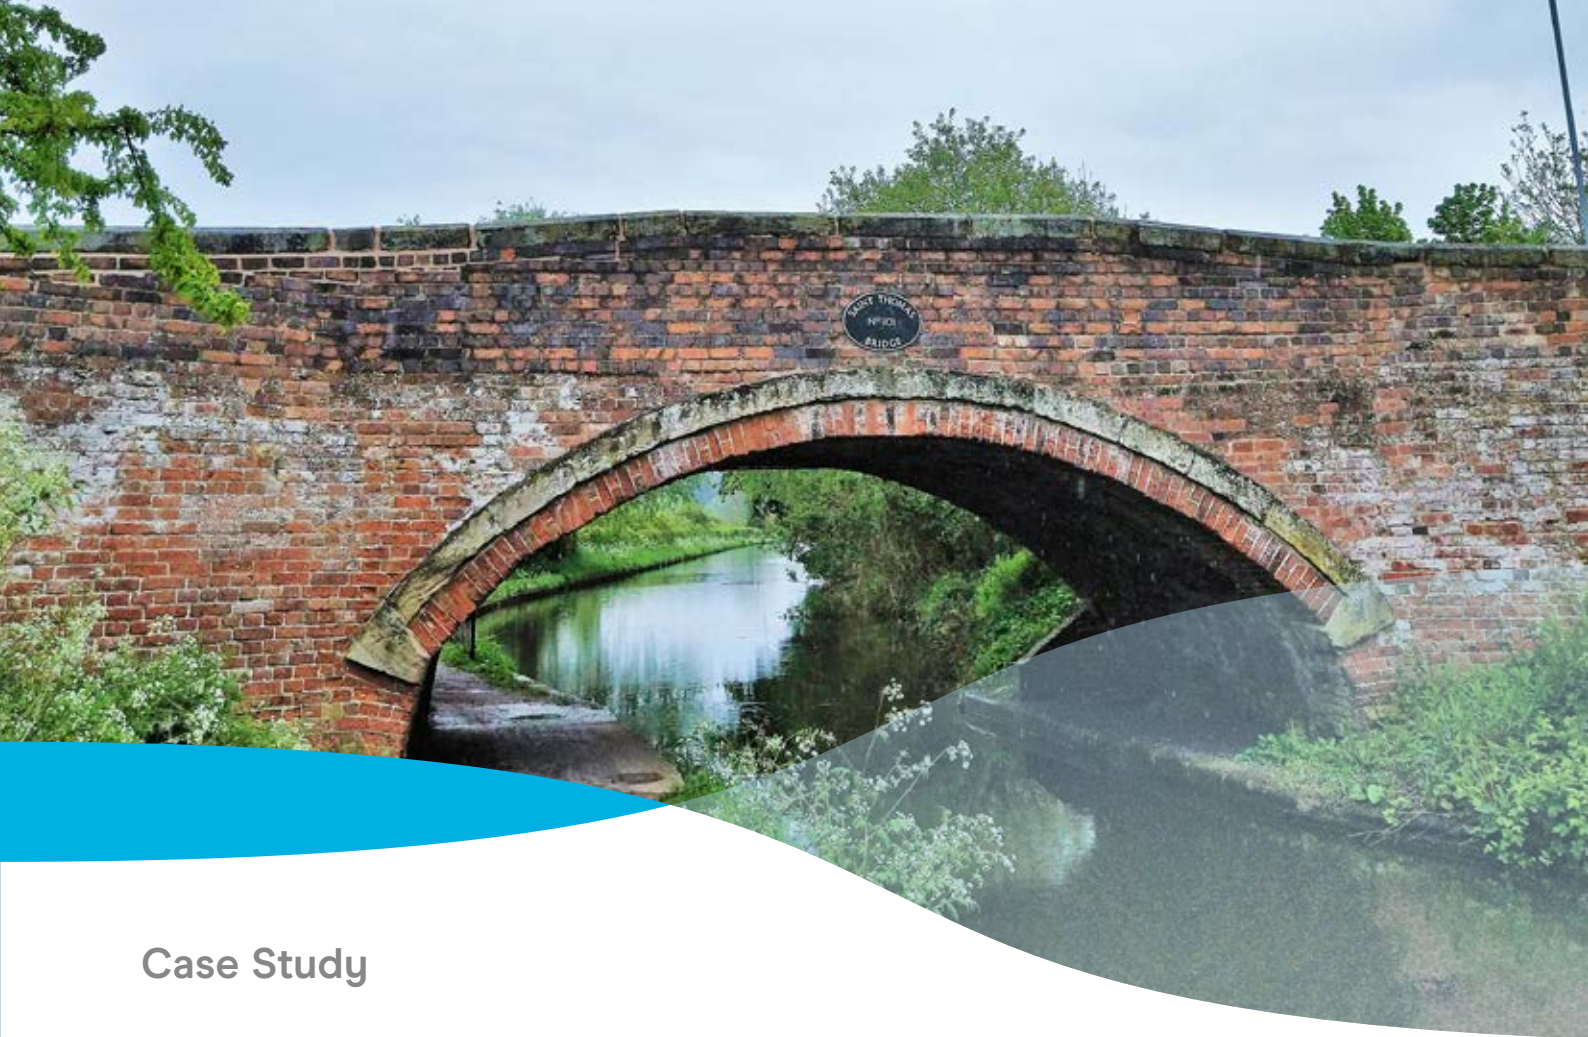
The bridge carries modern traffic loads and following inspection its brickwork was found to be heavily saturated. Saturated brickwork has typically 40% less strength than dry brickwork, and freeze/thaw cycles leads to further degradation and loss of material. The state of the bridge had reduced its load capacity and it had become a potential safety risk.

Above: Saint Thomas Bridge after repairs

Proposed repairs were invasive but necessary and listed building consent was applied for and granted by the local authority. Works began in autumn 2018 and involved removing the backfill of the arch and constructing a new reinforced concrete saddle to improve load capacity and safety. The original brick soffit remained in place.

Localised brickwork repair and repointing were also carried out using conservation-led methods and materials and preserving as much historic fabric as possible. Visually, the bridge is barely altered and it is now equipped to take the traffic of the day.

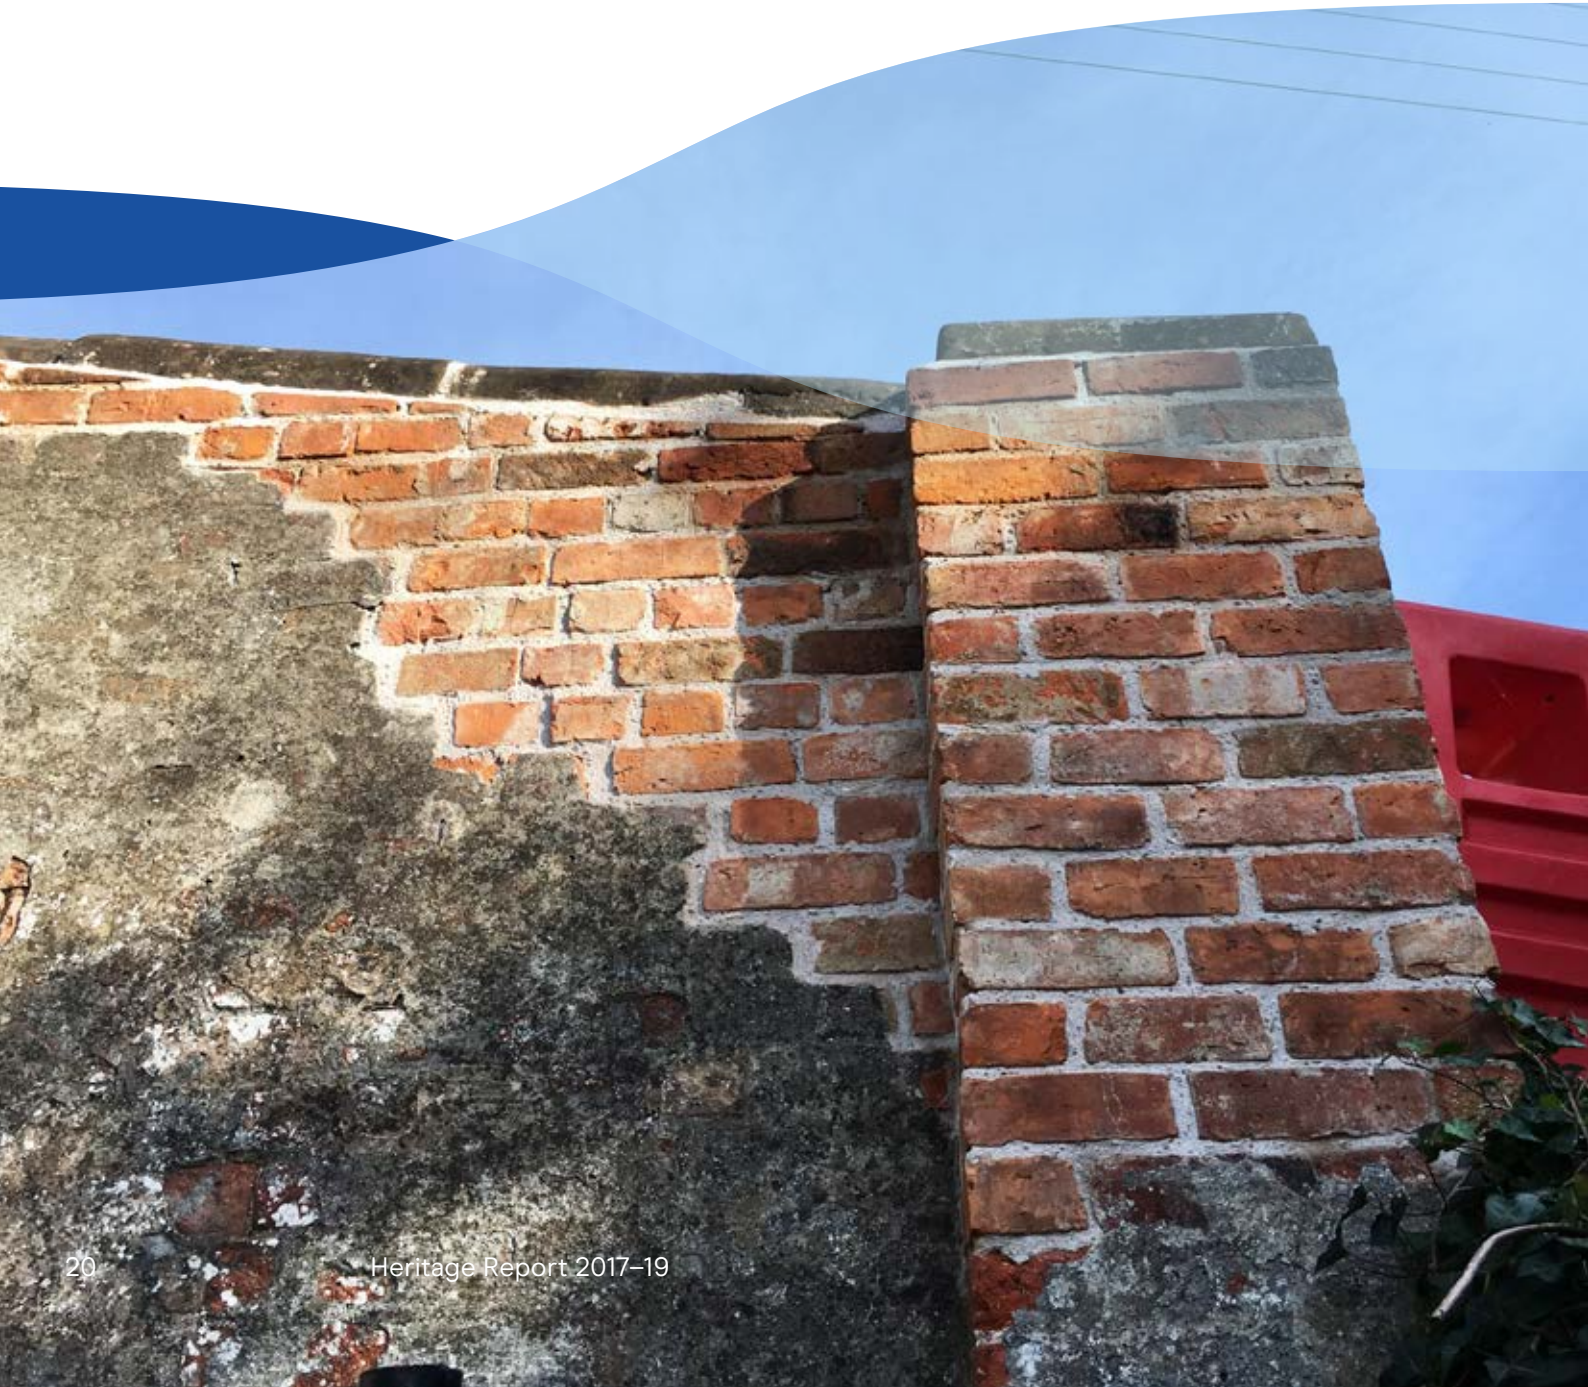
Curdworth Bridge is an historic brick road bridge in Warwickshire on the Birmingham & Fazeley Canal and dates from the late 18th century. In August 2018 the bridge was struck by a vehicle, causing damage to its parapet and requiring works to repair it.

Below: Curdworth Bridge after repairs

Although the vehicle strike resulted in the loss of some historic brickwork, as many bricks as possible were salvaged and re-used in the repairs. New bricks were carefully matched in colour and size against old. The stone parapet copings were all saved. At some point in its history the bridge was given a cementitious render but this was not replaced, due to its harmful nature especially when applied to soft bricks. Bedding and repointing was completed using a lime-based mortar and the repairs were carried out to a high standard.

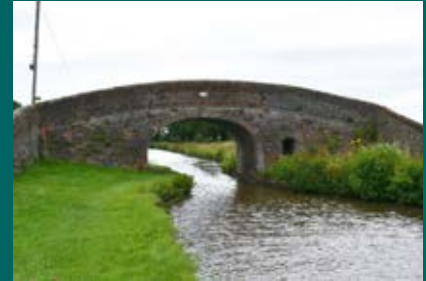
Above: Roundthorn Bridge before repairs

Following a vehicle strike, works including vegetation removal, brickwork repairs and reinstatement of missing copings were carried out to the Grade II listed Roundthorn Bridge.

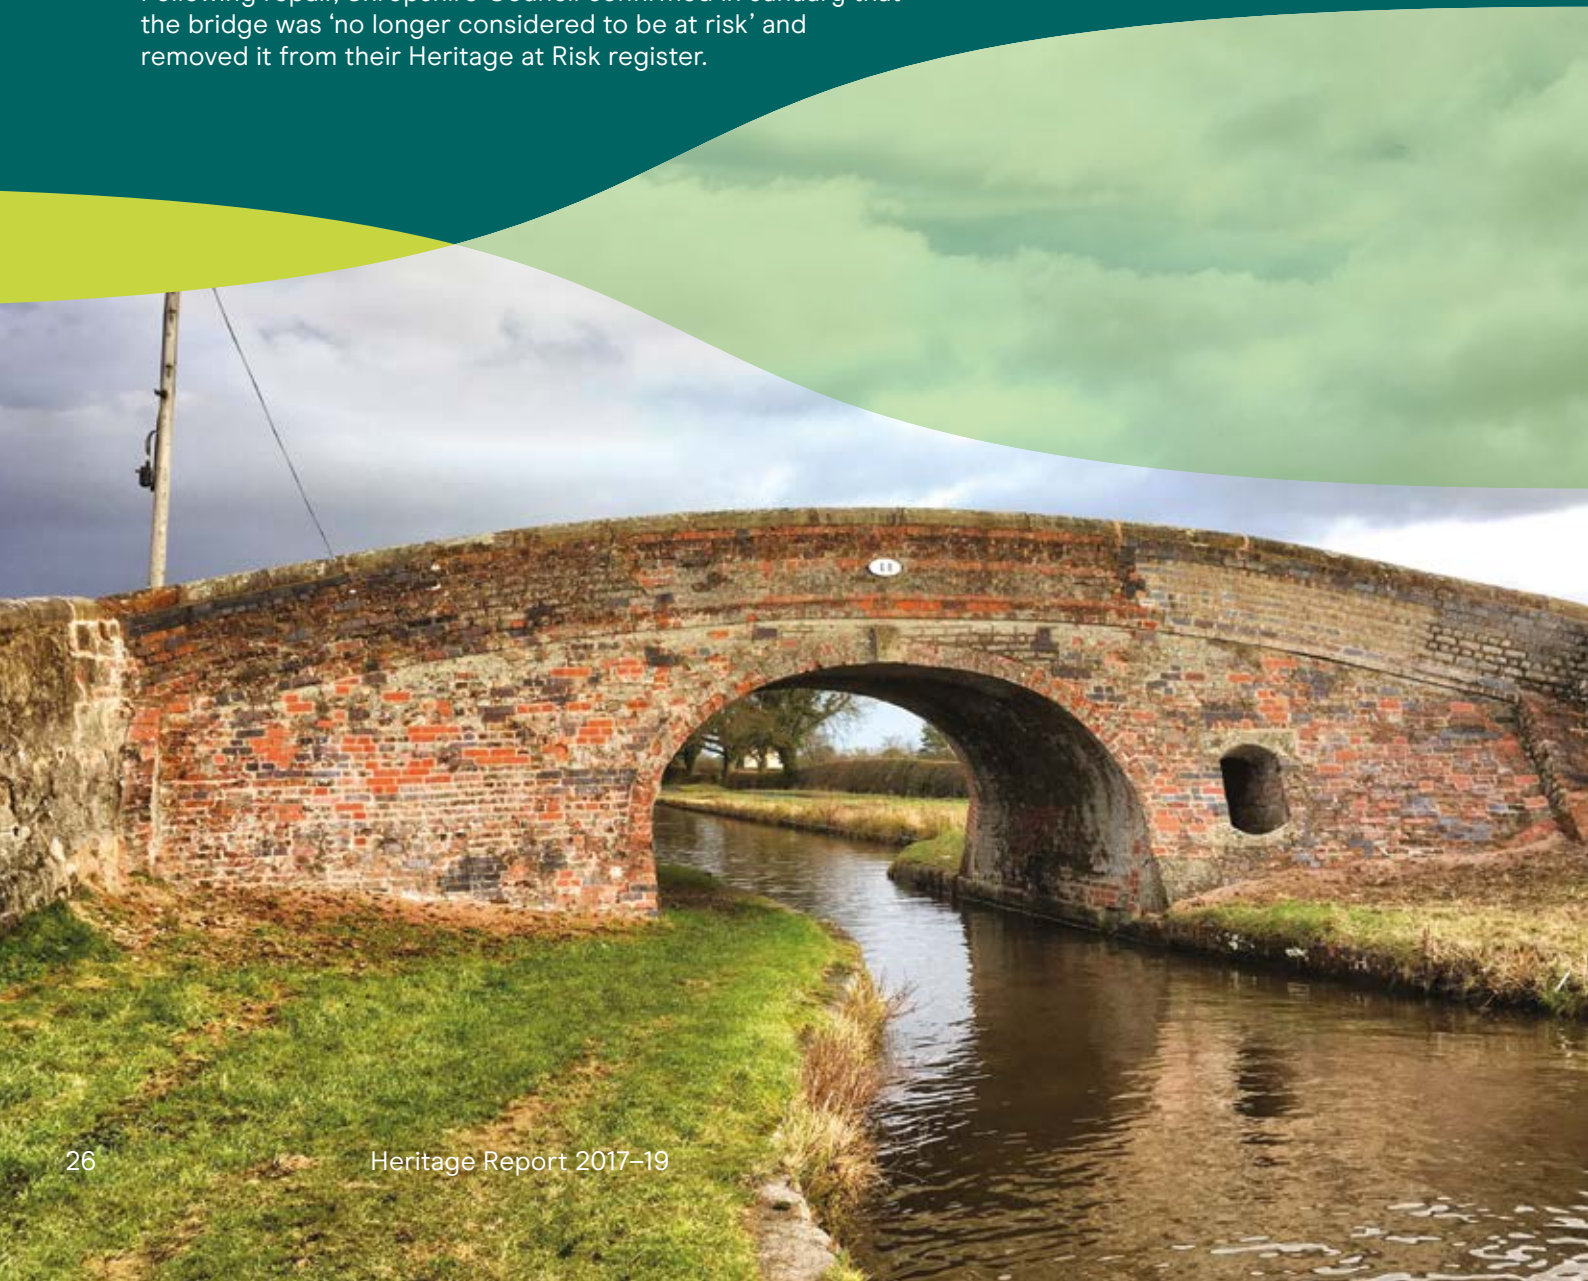
Below: Roundthorn Bridge after repairs

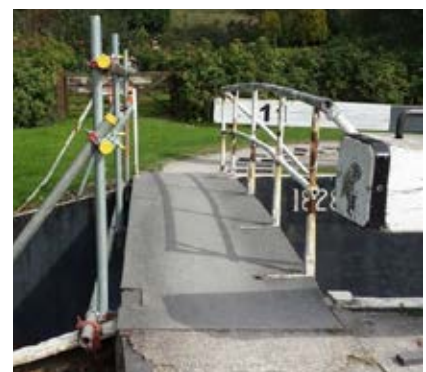
Above: Beeston Iron Lock footbridge after alterations

In 2018/19 work was carried out to remove the temporary scaffold arrangement, repair the existing railings and provide the footbridge with two elegantly designed iron parapets with curving rope guides. Following scheduled monument consent, this work was completed to the highest standard by an ironwork conservation specialist and the bridge deck was renewed in timber by the Trust's in-house carpenters.

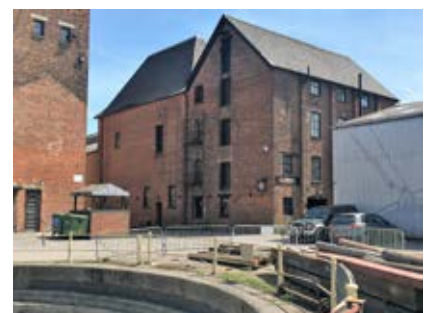
Below: Soulbury Pump House after restoration

Restoration of the pump house was completed in 2019 with the support of a grant from the National Lottery Heritage Fund. Working as part of a direct services construction team, the Trust's Heritage Apprentices restored the roof and brick walls and fitted new doors and windows in keeping with the original character of this historic building.

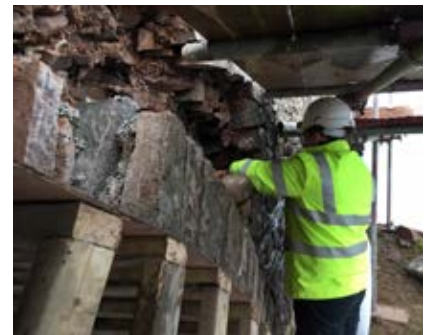
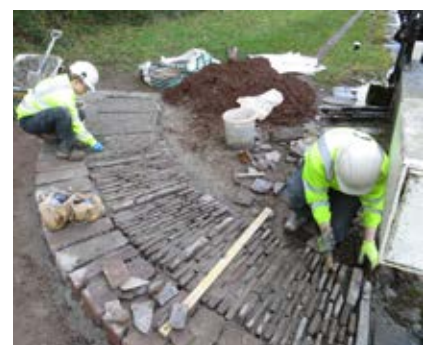
Below Right: Bridge 130, after repairs

Below: Repairing Bridge 130

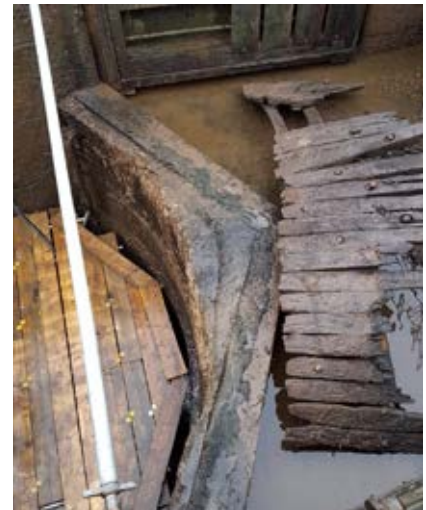
Archaeological recording was carried out at both locks in advance of repairs. This included illustrative drawings and a photographic record of the lock cills, cill buffers and lock gates.

Above: Beeston Stone Lock, historic cill area

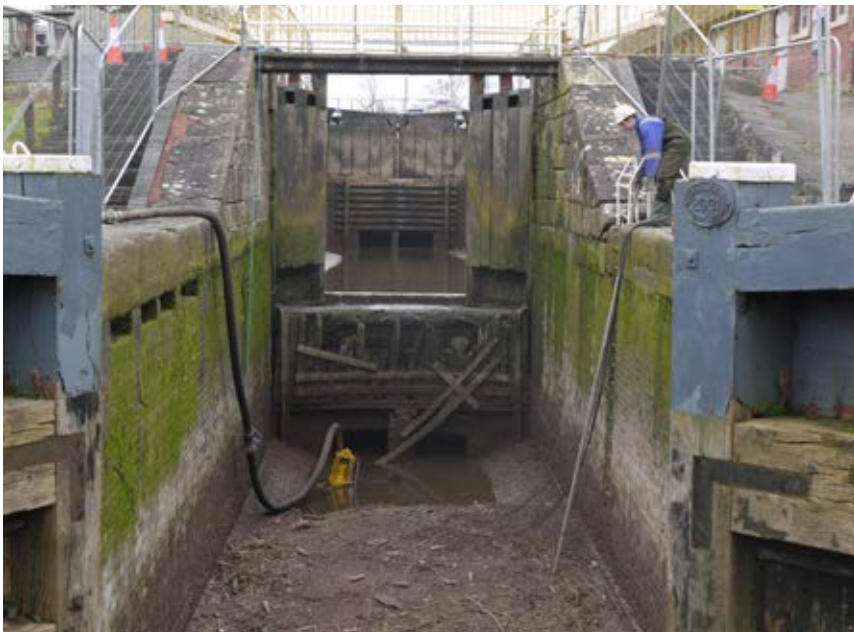
Left: Bunbury Locks, lower chamber

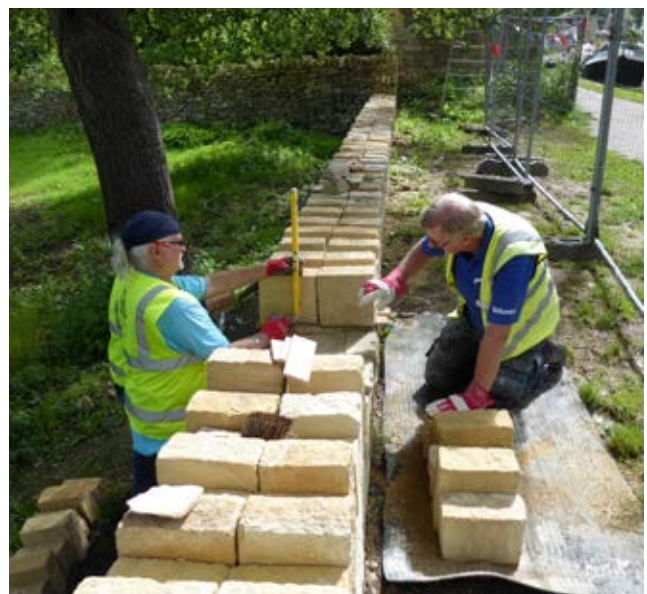
Above: Volunteers rebuilding drystone wall, Bradford on Avon

The three-year project involved dismantling the old masonry, salvaging as much of it as possible and rebuilding the wall with carefully selected matching stone. Repairs were entirely undertaken by the dedicated team of volunteers, led by a specialist trainer and involved learning traditional masonry and lime mortar skills.

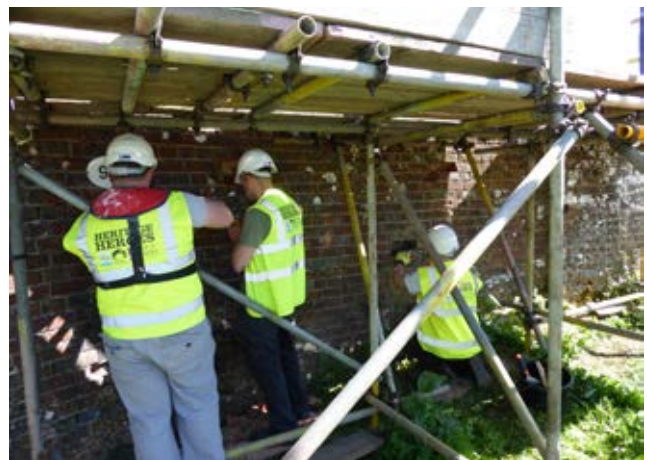
Above: Heritage Heroes repairing Bridge 99

During restoration, the original design was largely replicated by studying photographs from the early 1960s when the parapets were still extant. The restoration required some 16,000 new Furness bricks, sourced to make a good match with those found in the arch and abutments. Enough of the original masonry copings were recovered from the undergrowth to cover one of the parapets with the other side receiving new matching limestone copings. An interpretation board on top tells the story.
