# Safe container transport north of the Wadden Islands

Lessons learned following the loss of  
containers from MSC ZOE

*The Hague, June 2020*

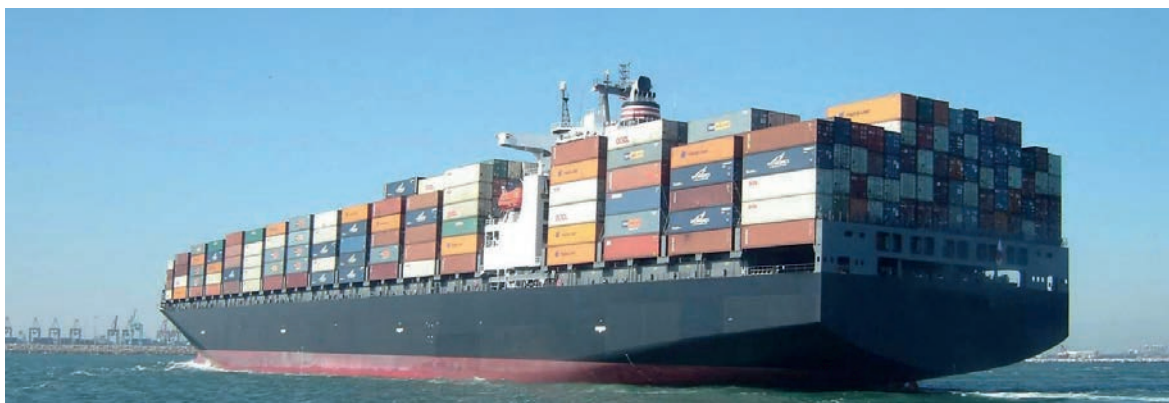
Figure 2: Photograph of a container ship. (Source: <https://www.mvvlaanderen.be/inspiratie/hoe-milieuvriendelijk-zeevaart>)

The majority of container ships secure their containers by placing them in guide rails below deck. Containers can also be placed on deck, and stacked on top of each other. There are attachment points at each corner of a container (corner castings), via which the containers can be connected to the underlying container using a system known as twistlocks. Twistlock foundations are placed on the deck hatches to secure the first tier of containers so these can not slide. A series of steel structures are placed on the deck between the bays known as lashing bridges. Using lashing rods, the stacked containers are attached to the lashing bridge or to the deck, starting from the bottom layer.

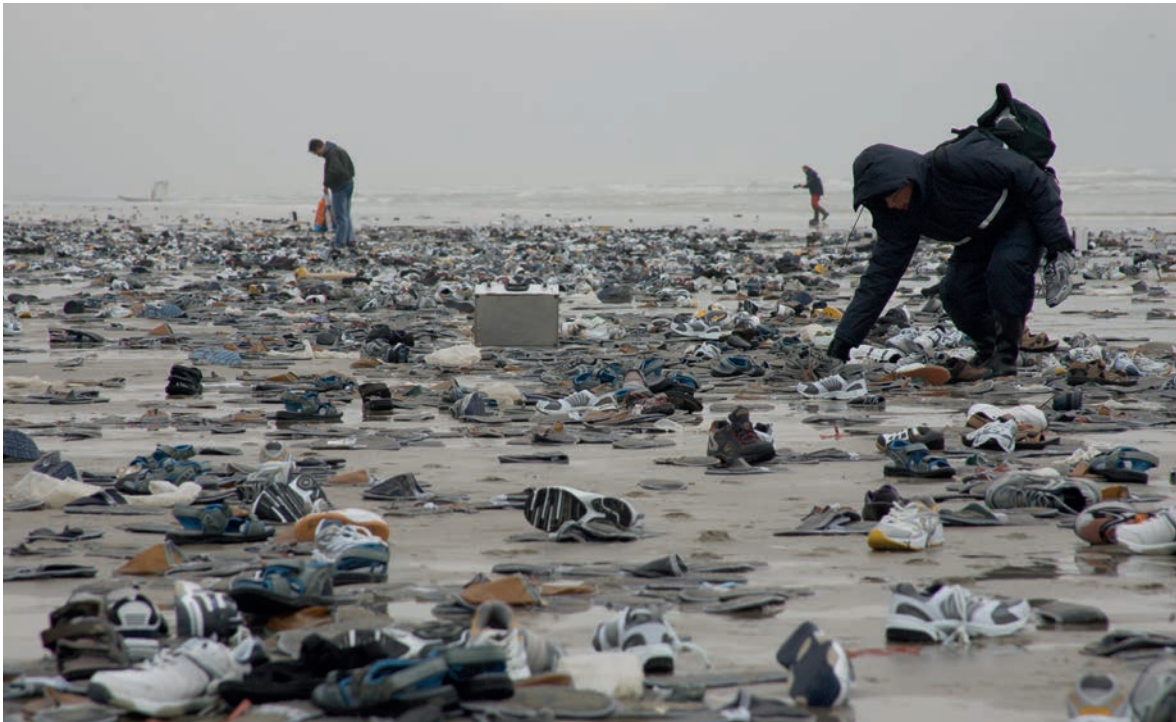
Figure 7: Photograph of a beach on Terschelling following the incident involving the container ship the *Mondriaan*. (Source: Arie Ouwerkerk - ANP)

In addition to pollution and potential environmental damage, the loss of containers can also represent a serious hazard to shipping. Floating containers generate a risk of collisions, and sunk containers can form a hazard if they become entangled with the nets of fishing boats.

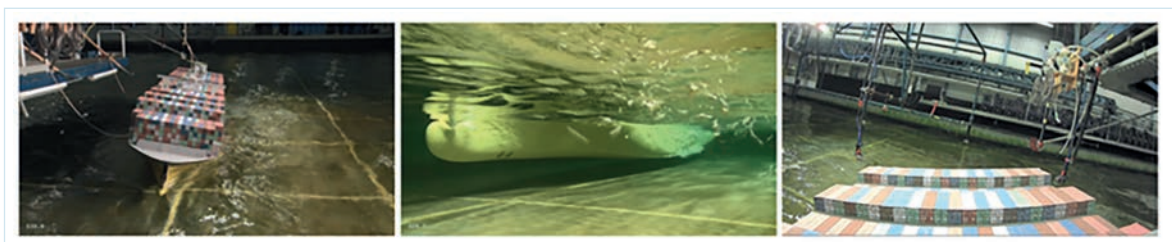
Figure 15: Images of the ship model in the MARIN test basin, respectively with images of the ship, under water and from the bridge of the ship.

The ship model used for the basin tests is a container ship of a comparable shape and size to the MSC ZOE. The ship model with measuring equipment is made according to international standards<sup>78</sup>, whereby the containers are modelled as one block with a container photo print. The wooden ship model is stiffer than a steel ship as the MSC ZOE. In addition, the basin has a concrete bed and the shipping route a sandy bed. Figure 15 shows pictures of the basin tests.

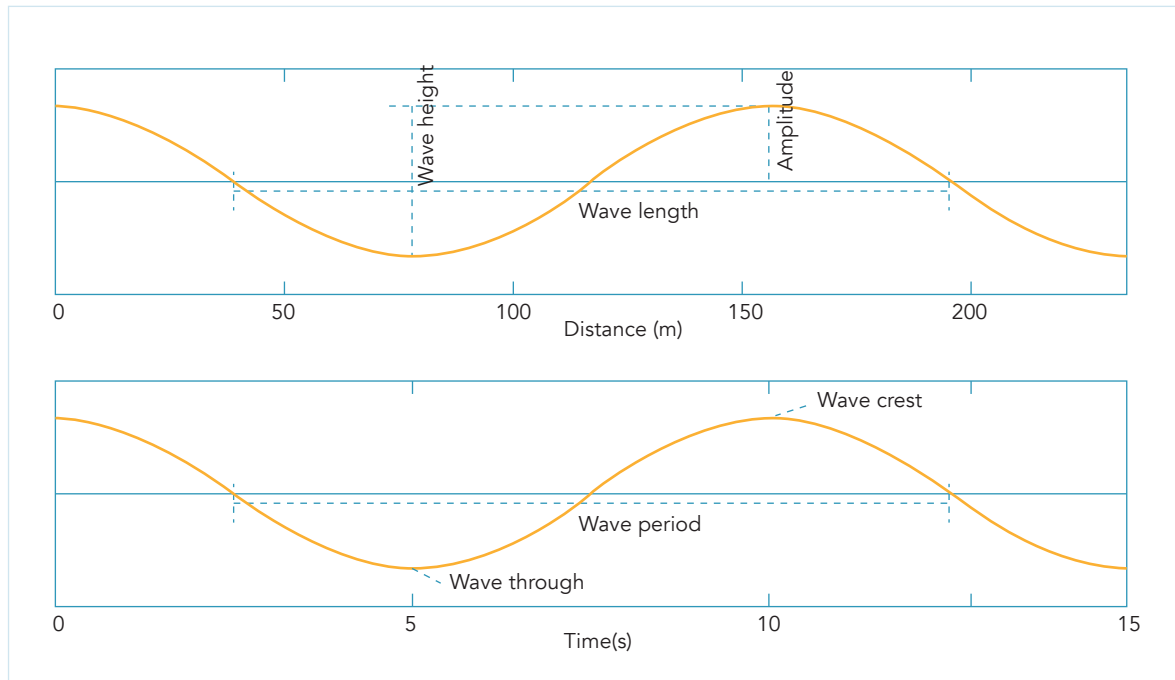
Figure 16: Diagrammatic representation of waves as a sine wave with the parameters wave height, wave length and wave period. (Source: Deltares)

Waves are formed by the local wind (known as the seaway) and the swell, the waves that are created elsewhere and which ran out at that location. A wave in deep water can be simplified reproduced as a sine shape wave. The wave has the following characteristics: the wave height (from wave crest to wave trough), the wave length (distance between two wave crests) and the wave period (the time between the passing of two wave crests).

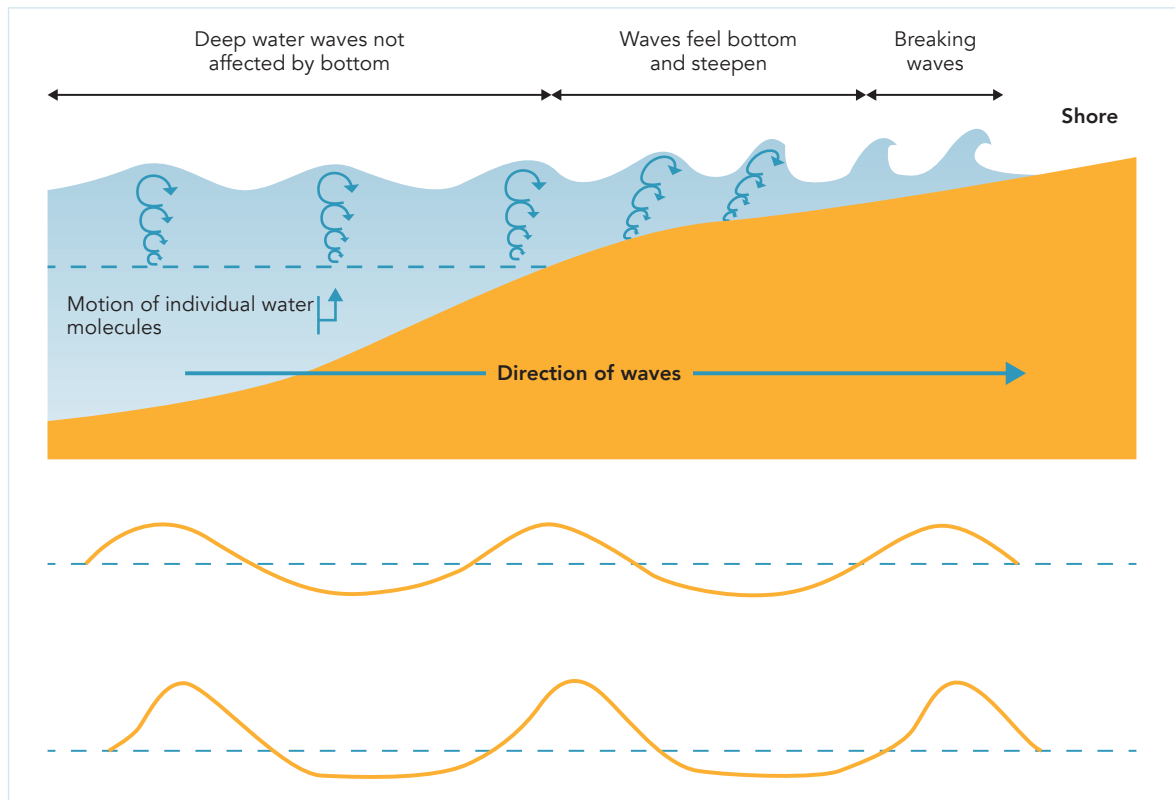
Figure 17: Reproduction of waves approaching the coastline (top) and the shallow water effect (below): the sine shape wave in open sea (above) changes in shallow water to a wave pattern with high, steep wave crests and flat, wide wave troughs (below). (Source: Deltares)

As a wave approaches the coastline, the shape of the wave changes into a wave pattern with higher, shorter and therefore steeper waves. In the case of high waves in shallow water, the wave crests and wave troughs become (more) asymmetric: the height of the wave crest is greater than the depth of the wave trough, and flatter, broader wave troughs occur (see Figure 17). These short, steep waves in shallow water can break more easily. In that process, the higher crest of the wave tumbles forward at greater speed.

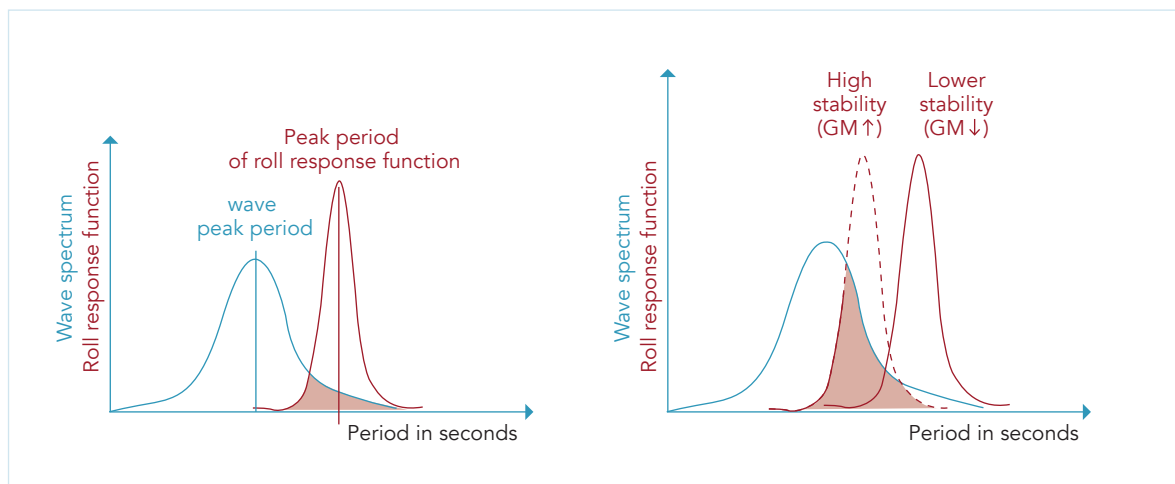
Figure 21: Figure with peak period of wave spectrum and natural roll period of a ship (a) with transfer function, the shaded area (b) with two different ships with a low and a high GM-value. (source: MARIN)

For waves with a wave period close to the natural roll period of the ship, the ship reacts strongly to the wave; less with other wave periods. This can be expressed by a transfer function, as depicted in Figure 21 (a). This transfer function indicates how strong the wave motion is being transferred to the motion of the ship. There is a high resonance peak at the natural roll period. The shaded overlap between the wave spectrum and the transfer function determines the reaction of the ship to the present wave spectrum.

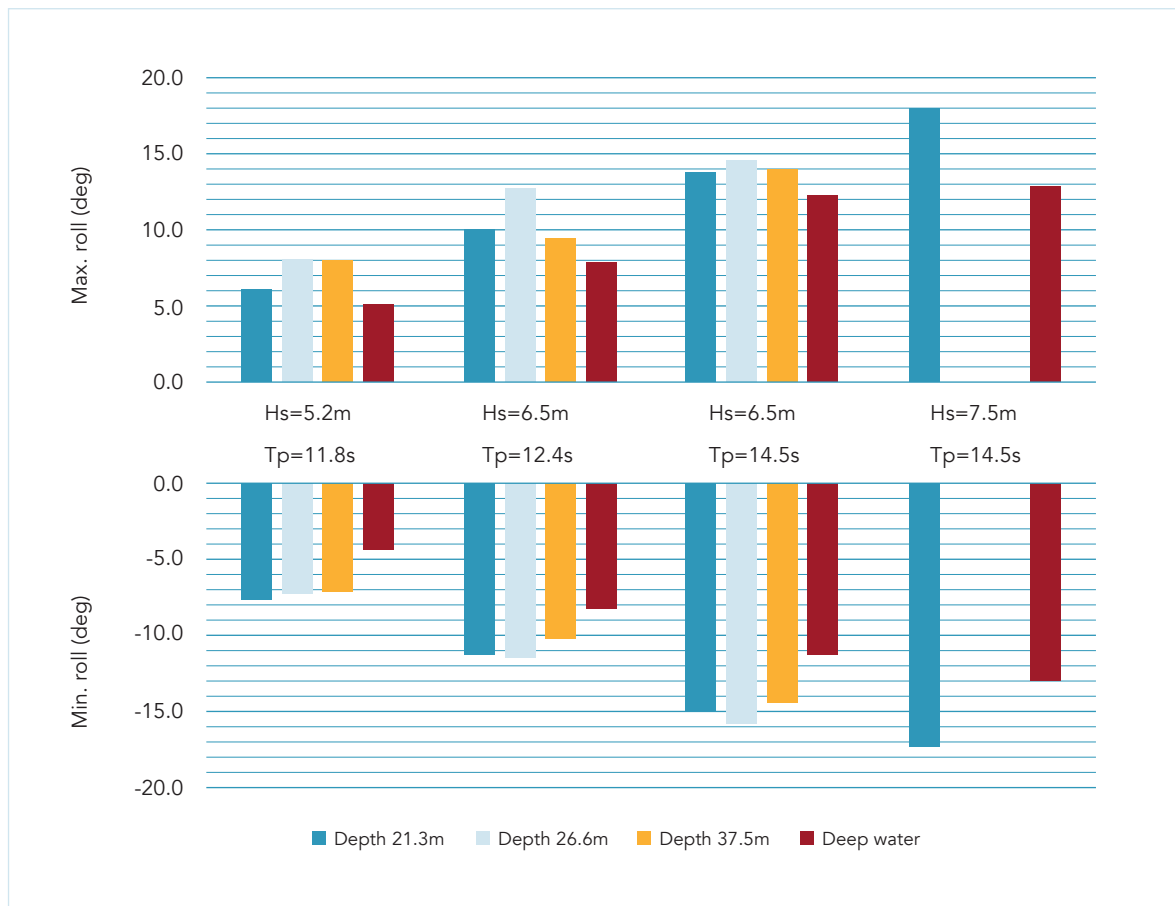
Figure 22: Maximum roll motion at the tested water depths and environmental conditions. A positive roll angle is to starboard and a negative roll angle to port. (Source: MARIN)

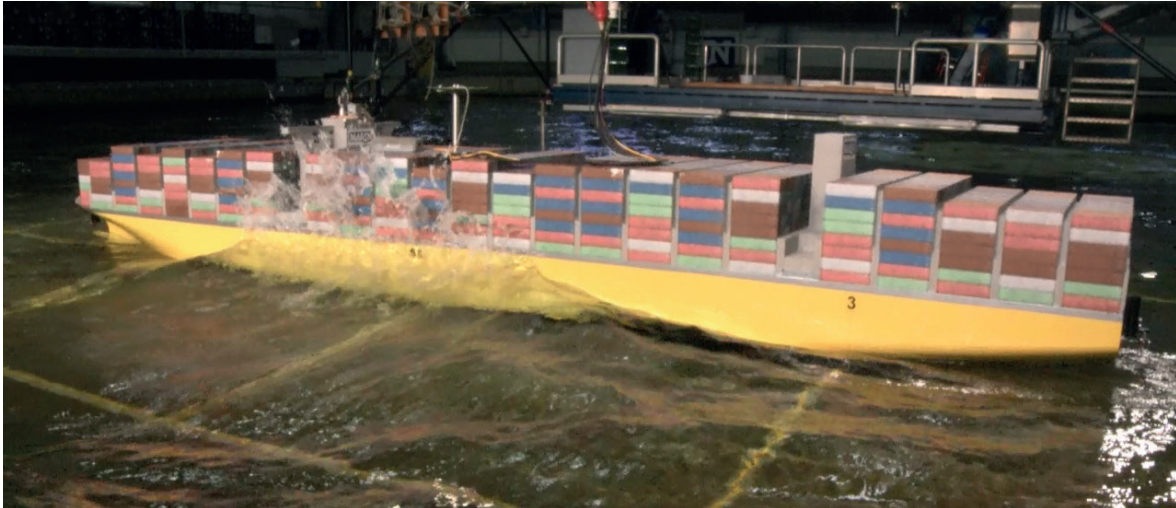
Figure 26: Images of the ship model at the moment of occurrence of the green water phenomenon. (Source: MARIN)

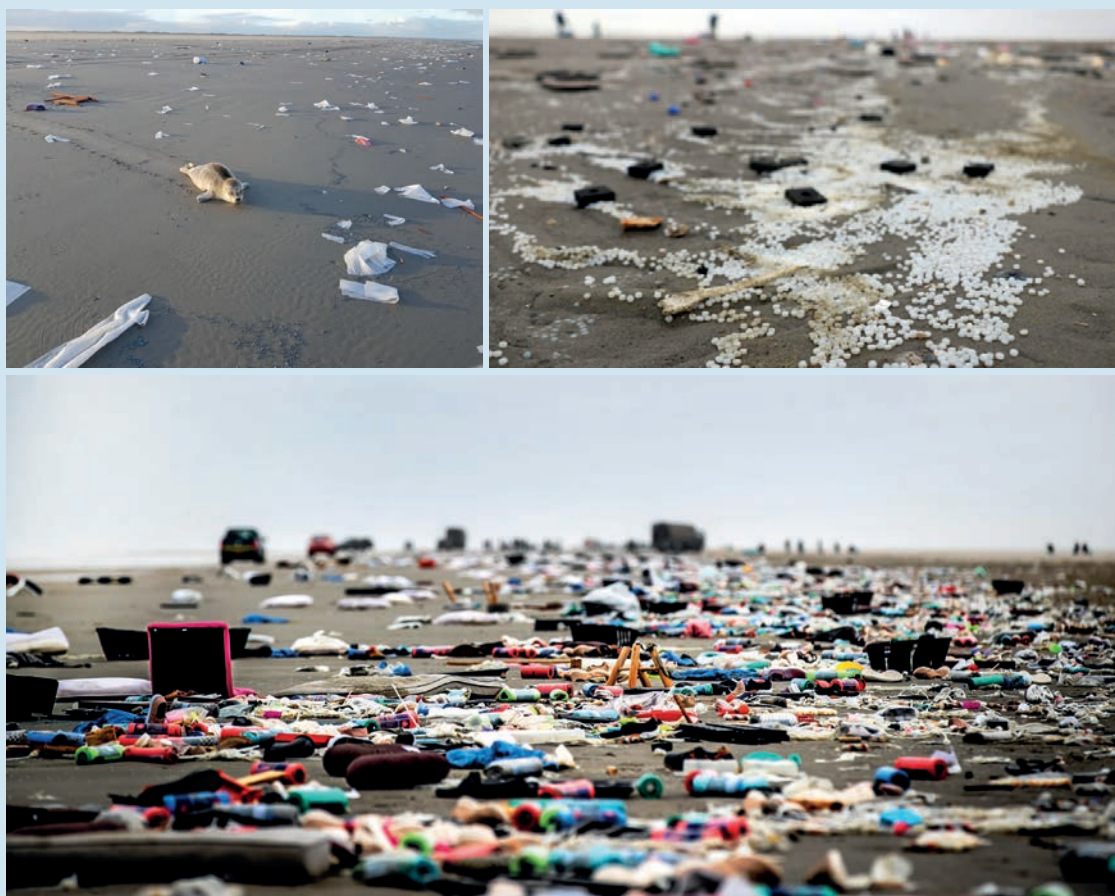
Figure 29: Photographs of objects from the MSC ZOE washed ashore. (Source from left to right: Arnold van der Wal – Natuurmonumenten, Jeroen Berkenbosch – RTV Noord, Remko de Waal - ANP)
