Report on the investigation of the
explosion of gas released from a cargo
of unprocessed incinerator bottom ash on

Nortrader

at anchorage in Plymouth Sound

on 13 January 2017

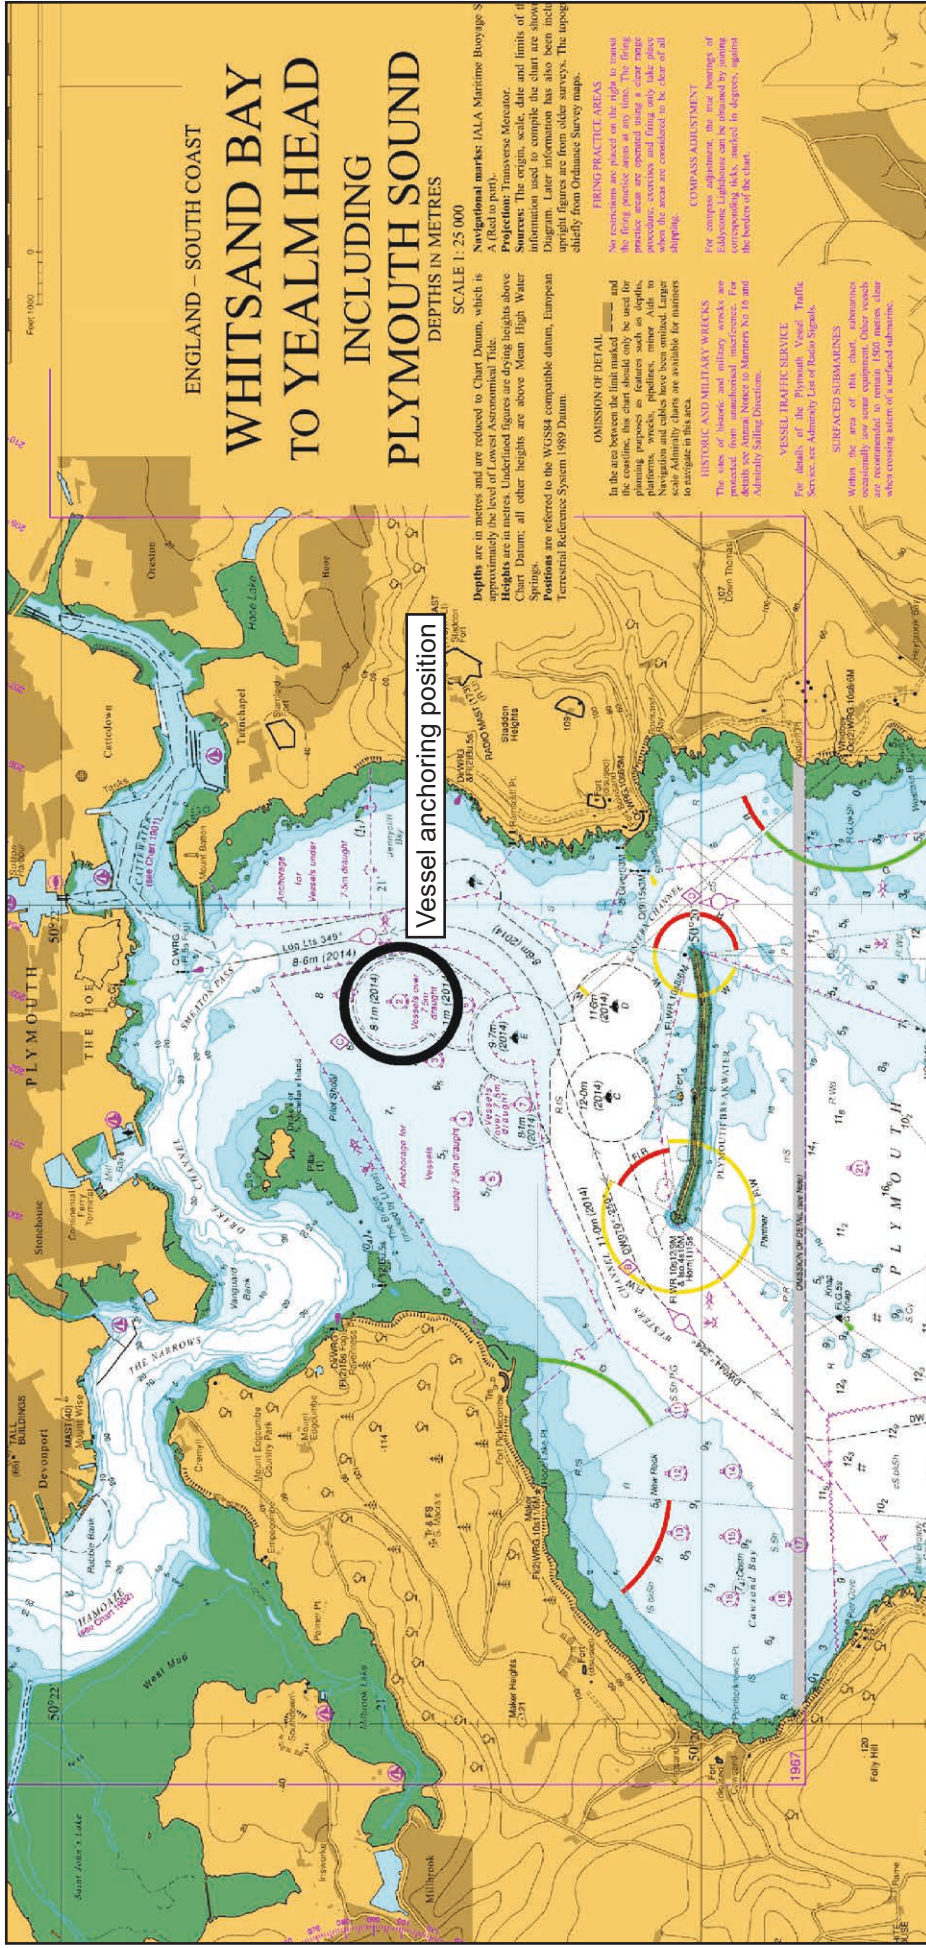
Figure 2: Location of the accident

Nortrader berthed at Victoria Wharf, Plymouth, at 0655 on 12 January. Loading commenced at 0815, and by 1600 that day 2333t of U-IBA had been loaded in heavy and persistent rain (**Figure 1**). After completion of the final draught survey, the master checked the weather forecast and decided to anchor off Plymouth and wait for the imminent bad weather to pass. At 1900, the vessel left the berth and anchored 30 minutes later in Plymouth Sound (**Figure 2**).
