## MARINE TRANSPORTATION SAFETY INVESTIGATION REPORT M18A0001

### **BOTTOM CONTACT**

Passenger ferry *Deer Island Princess II*  
Little Letete Passage, New Brunswick  
02 February 2018

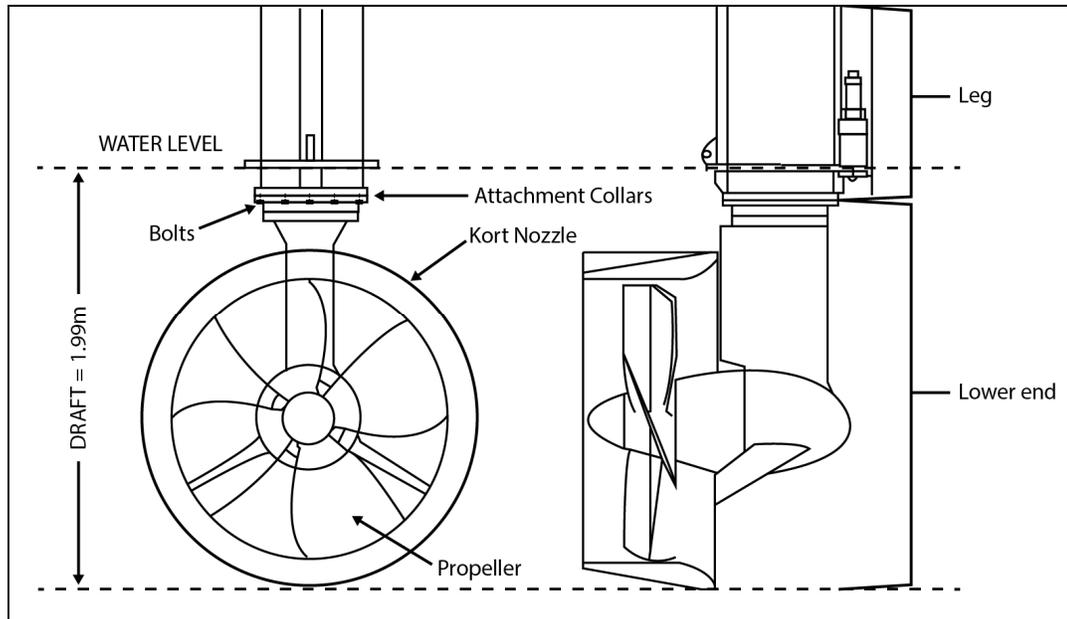
Figure 4. Diagram of a Z-drive thruster unit (Source: Coastal Transport Limited, with TSB annotations)

Each Z-drive thruster unit is made up of a horizontal shaft, a vertical leg, and a lower end. The lower end of the vessel's Z-drive thruster unit includes the propeller, kort nozzle, and an attachment collar. It is secured to the leg's attachment collar by 14 bolts (Figure 4). When the Z-drive thruster unit on the Deer Island end of the vessel made contact with the bottom, these securing bolts were sheared off when the lower end detached from the leg. The attachment collar on the leg was also pushed up and deformed. When the Z-drive thruster unit on the Letete end of the vessel made contact with the bottom, those securing bolts were also sheared off when the lower end detached from the leg. The lower ends of both Z-drive thruster units were later recovered by divers. There was superficial damage to the paint coating on the lower end units and there was no damage to the vessel's hull.
