# SAFER SEAS Digest 2020

Lessons Learned from  
Marine Accident Investigations

NTSB/SPC-21-01

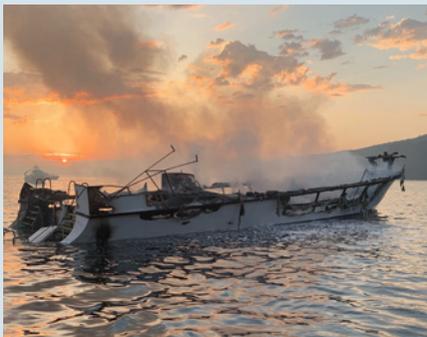
On the cover: The *Conception* after the fire (see page 68).

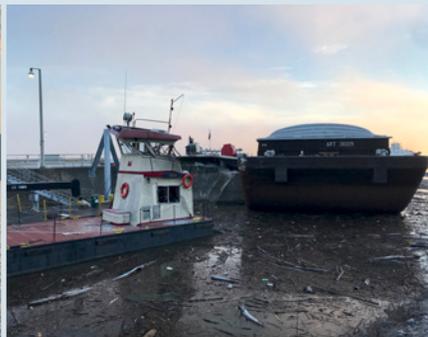
Back cover: Damage to the workboat *Gibson* (see page 54).

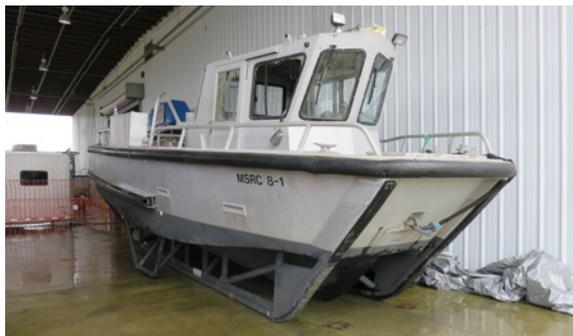
Figure 1. *MSRC 8-1* after salvage postaccident.

About 1038 local time on January 16, 2019, the workboat *MSRC 8-1*, which operated from the OSRV *Louisiana Responder*, capsized during an oil spill boom deployment exercise in the Lower Mississippi River near Boothville, Louisiana (mile 18), trapping both of its crew inside. While the OSRV's crew and the Coast Guard worked to rescue the trapped *MSRC 8-1* crew, the boat sank. One crewmember died in the sinking; the other crewmember was not found and is presumed dead. The *MSRC 8-1* was declared a constructive total loss with damage estimated at \$250,000. A sheen of oil was sighted on the water after the vessel sank; no other pollution was reported.

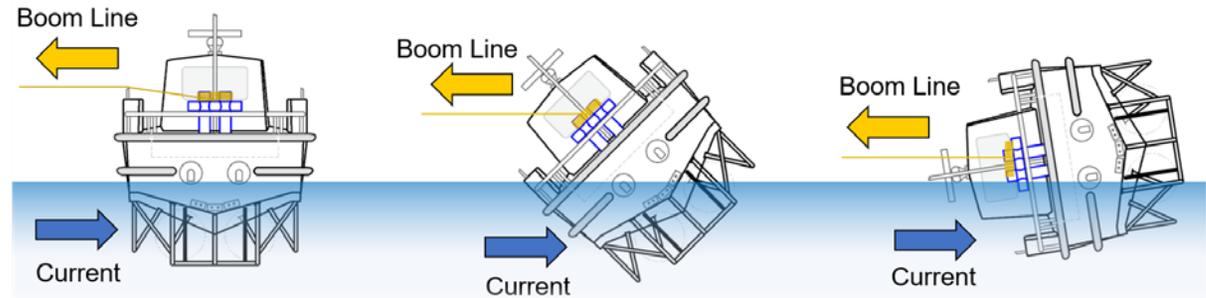
The towline was tending directly off the boat's port side from the top of the H-bitt with tension on it. The static force that the towline exerted on the H-bitt, combined with the force of the current broadside to the *MSRC 8-1*'s underwater hull, attached framework, and large rudders, created a heeling moment, which rolled the boat to port quickly (tripped it), overcoming its inherent stability and capsizing it. Although the towline was rigged for ease of release, the speed of the capsizing and the line tension prevented this.

**Figure 6.** The forces of the current and boom towline acting to capsize the *MSRC 8-1*.

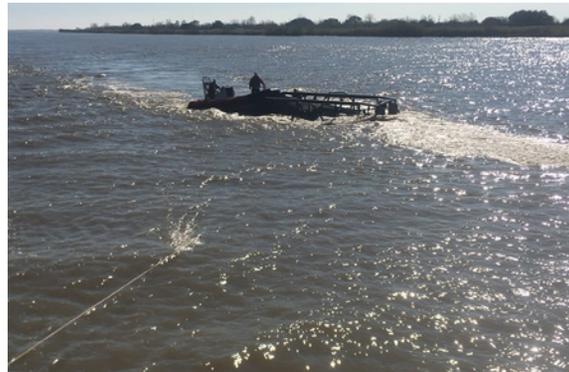
**Figure 7.** Waterwash from the *CG 45707* and the combined current flow over the stern of the *MSRC 8-1*.

The crew of the OSRV retrieved the boom to pull the *MSRC 8-1* to the OSRV's stern. The *CG 45707* attempted to assist, but the strength, direction and effects of the river current, combined with the boat's waterwash, caused very dynamic conditions that made it difficult.

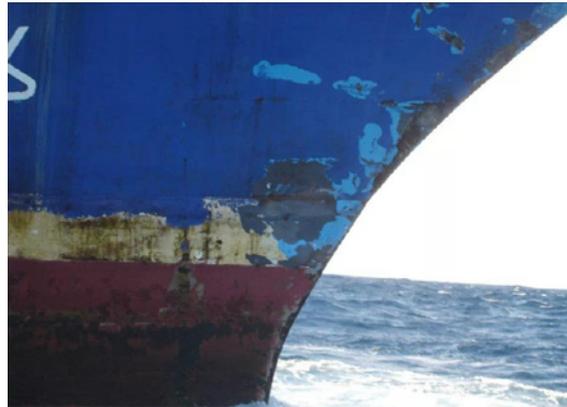
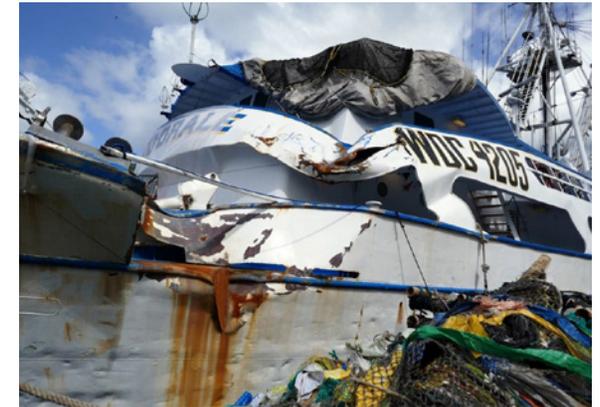
**Figure 11.** Damage sustained to both vessels. Bow of *American Eagle* (left) and *Koorale* (right). SOURCE: AMERICAN EAGLE FISHING, LLC.

On June 17, 2019, about 1704 local time, the commercial fishing vessels *American Eagle* and *Koorale* were fishing in the eastern Pacific Ocean, 1,475 miles northeast of American Samoa. While pursuing the same school of tuna, the two vessels collided. Both vessels sustained damages but were able to return to port. No pollution or injuries to the 33 crewmembers aboard the *American Eagle* or the 19 aboard the *Koorale* were reported. Damage to the vessels was estimated at \$8.3 million.

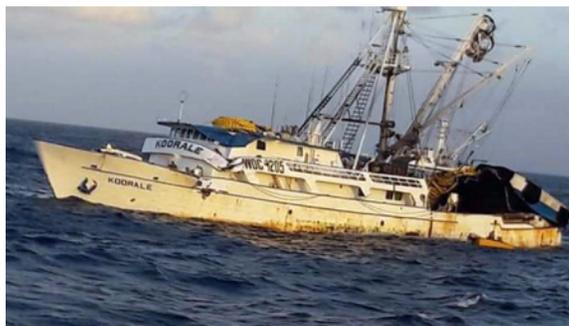
**Figure 13.** *Koorale* after collision. SOURCE: COAST GUARD.

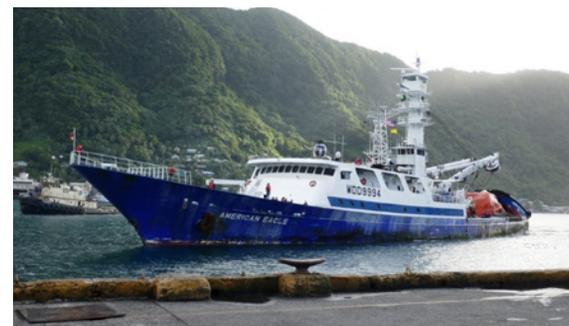
**Figure 14.** *American Eagle* approaching berth in Pago Pago, American Samoa, after collision.

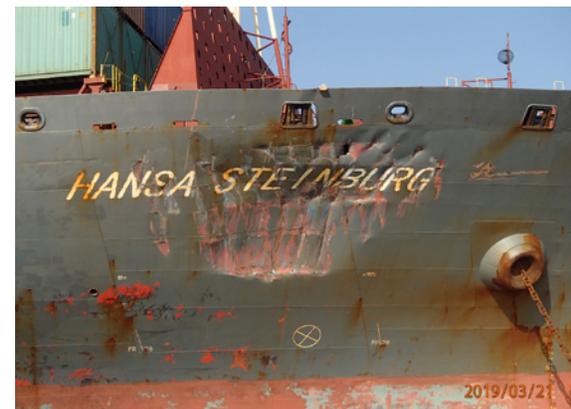
**Figure 18.** Damage to *Hansa Steinburg* starboard-side bow. SOURCE: COAST GUARD.

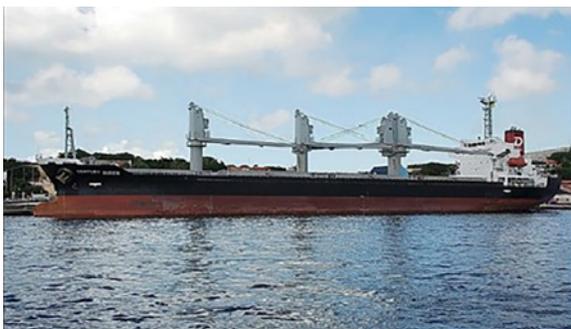
Figure 21. Both vessels shortly after the collision. SOURCE: COAST GUARD.

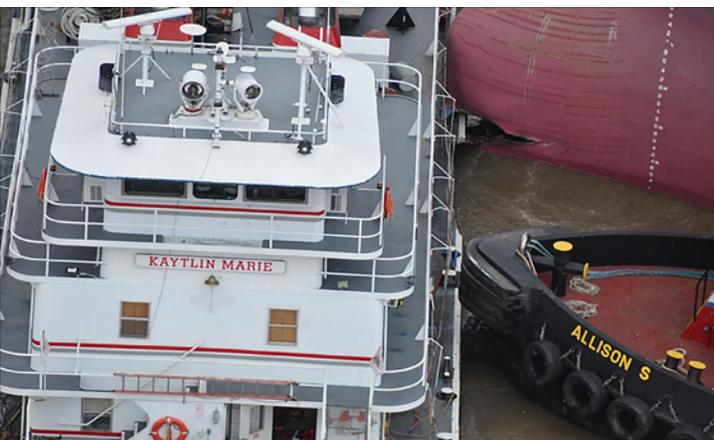
**Figure 22.** *Kaytlin Marie* embedded in the *Century Queen*'s bulbous bow. SOURCE: COAST GUARD.

At 1215:08, the *Century Queen*'s bulbous bow struck the *Kaytlin Marie* amidships at about a 90-degree angle, and the towboat was pushed sideways up-current. The bulker's bow was torn open for about 6 feet, and the void space was filled with some of the diesel fuel released from the towboat's punctured fuel tanks. The *Kaytlin Marie*'s pilot was pinned by furniture that had come loose, and refrigerators in the galley that broke free pinned two deckhands, one of whom suffered internal injuries; the other had a minor injury.

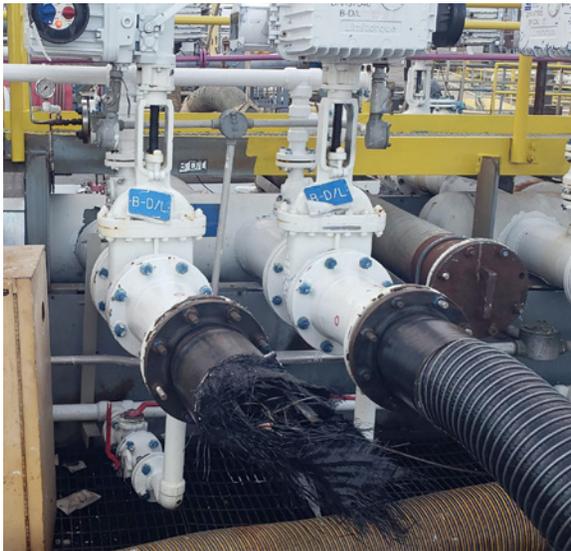
**Figure 24.** Damaged shoreside cargo hose and deformed piping at the manifold at the Kinder Morgan facility.

**Figure 25. Right:** Damage to the *Trinity's* starboard side from the impact of barge *Kirby 29751*.

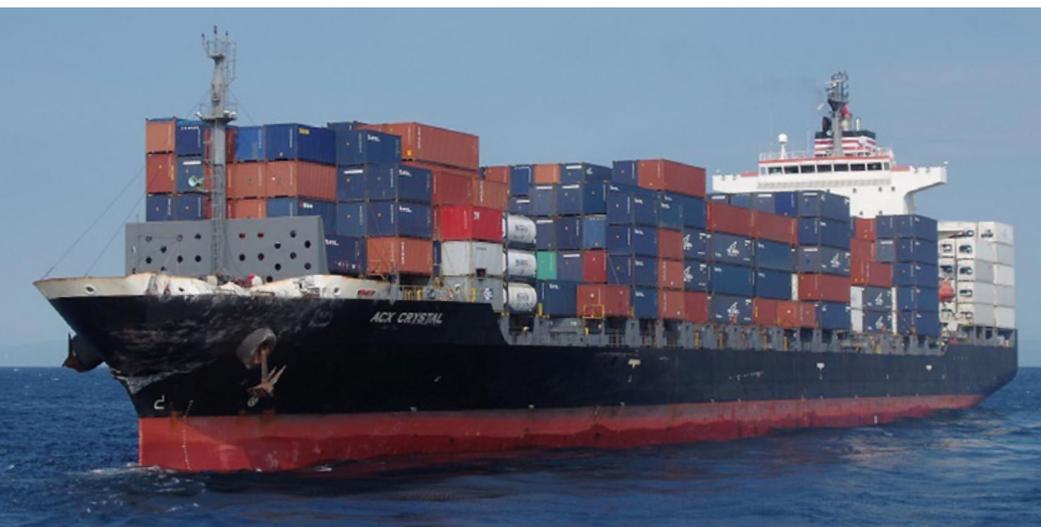
**Figure 30.** Containership *ACX Crystal*, post-collision. SOURCE: SEA QUEST MANAGEMENT.

The *ACX Crystal's* bow penetrated the *Fitzgerald's* hull and superstructure, trapping numerous crewmembers aboard the destroyer, and the vessel took on a 7-degree starboard list. Seven crewmembers, trapped in their berthing compartment, perished. The destroyer sustained damage in excess of \$300 million. No one was injured on board the *ACX Crystal*, but the container ship sustained damage to its bow and forward compartments. The cost to repair the *ACX Crystal* was not reported to investigators.

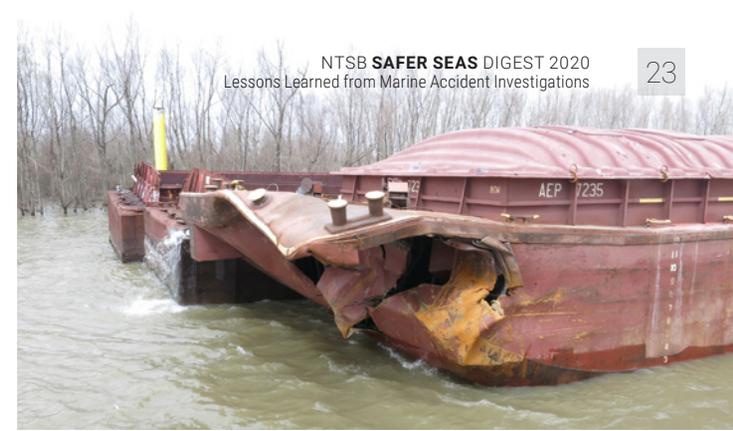
Figure 40. Damage to port bow of the AEP 7235.

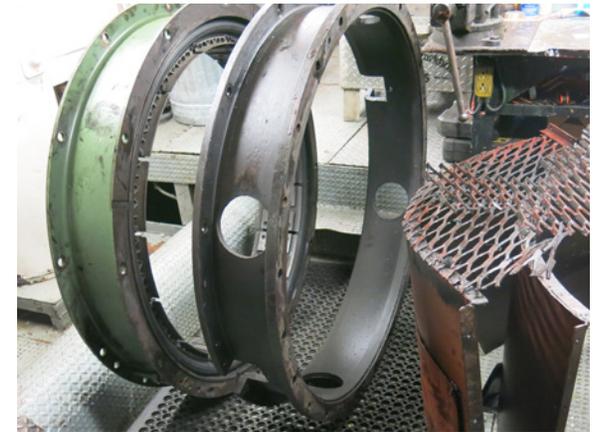
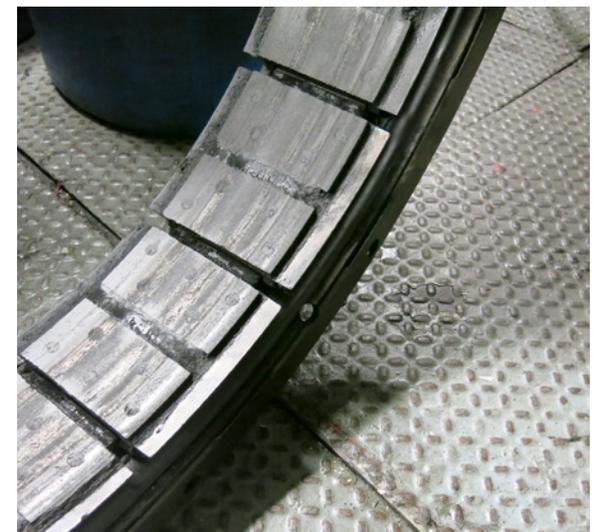
A postaccident inspection by a service representative found that the port clutch had excessive wear, would slip, and was only 40% operational. The air-actuated clutch was designed to transfer torque from the engine to the

The probable cause of the collision between the tows of the towing vessels *Miss Dixie* and *D. & R. Boney* was the lack of an effective maintenance program aboard the *Miss Dixie*, resulting in excessive and undetected wear of the port clutch, which compromised the vessel's maneuverability.

Figure 41. Above: Port clutch assembly steel rings removed from the *Miss Dixie* during postaccident inspection. Below: Condition of the port engine clutch friction pads aboard the *Miss Dixie* after the accident.

**Owners and operators should ensure that all critical equipment associated with propulsion systems, such as clutches, are included in preventative maintenance systems and that they follow the manufacturer's maintenance and inspection interval recommendations.**

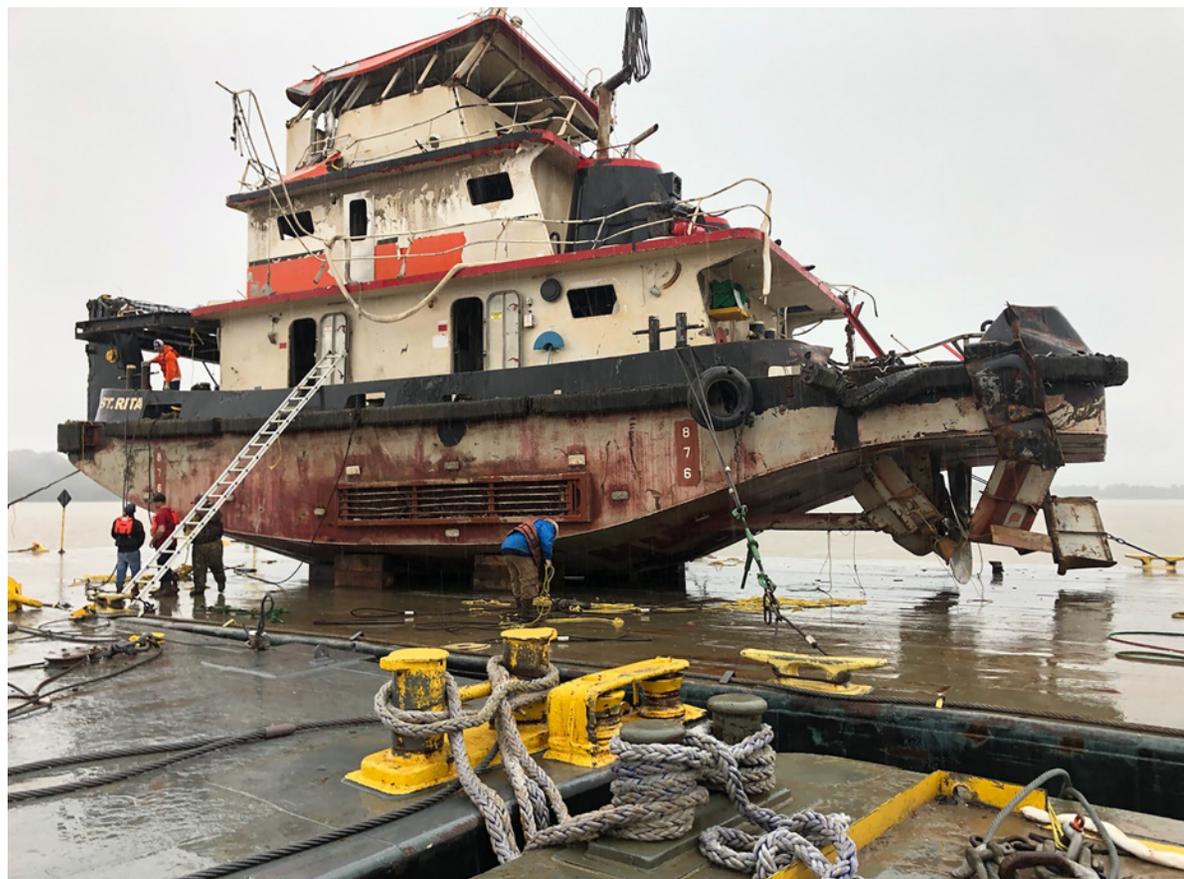
Figure 43. Below: The *St. Rita*, post-salvage, sitting atop a barge. SOURCE: COAST GUARD.

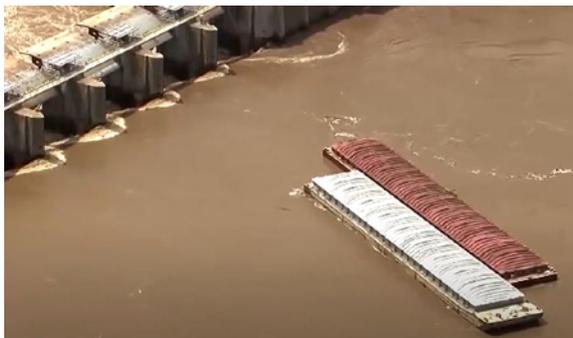
**Figure 52.** Barges *MTC 7256* and *LTD 1140* shortly before striking Webbers Falls Dam. SOURCE: KJRH-TV.

The port captain for the Muskogee Oakley Terminal caught the barges with the towboat *Legacy* and secured them to trees on the bank across from the terminal. About 7 hours later, with the river stage at 39.94 feet, the *MTC 7256* and *LTD 1140* broke away a second time, carrying the mooring lines and trees down the Arkansas River. At 1200 on May 23, the barges struck the Webbers Falls Lock and Dam 16. Both barges were pinned against four of the dam gates, and the rushing river forced the upriver sides of the hopper barges downward, filling them with water until each sank.

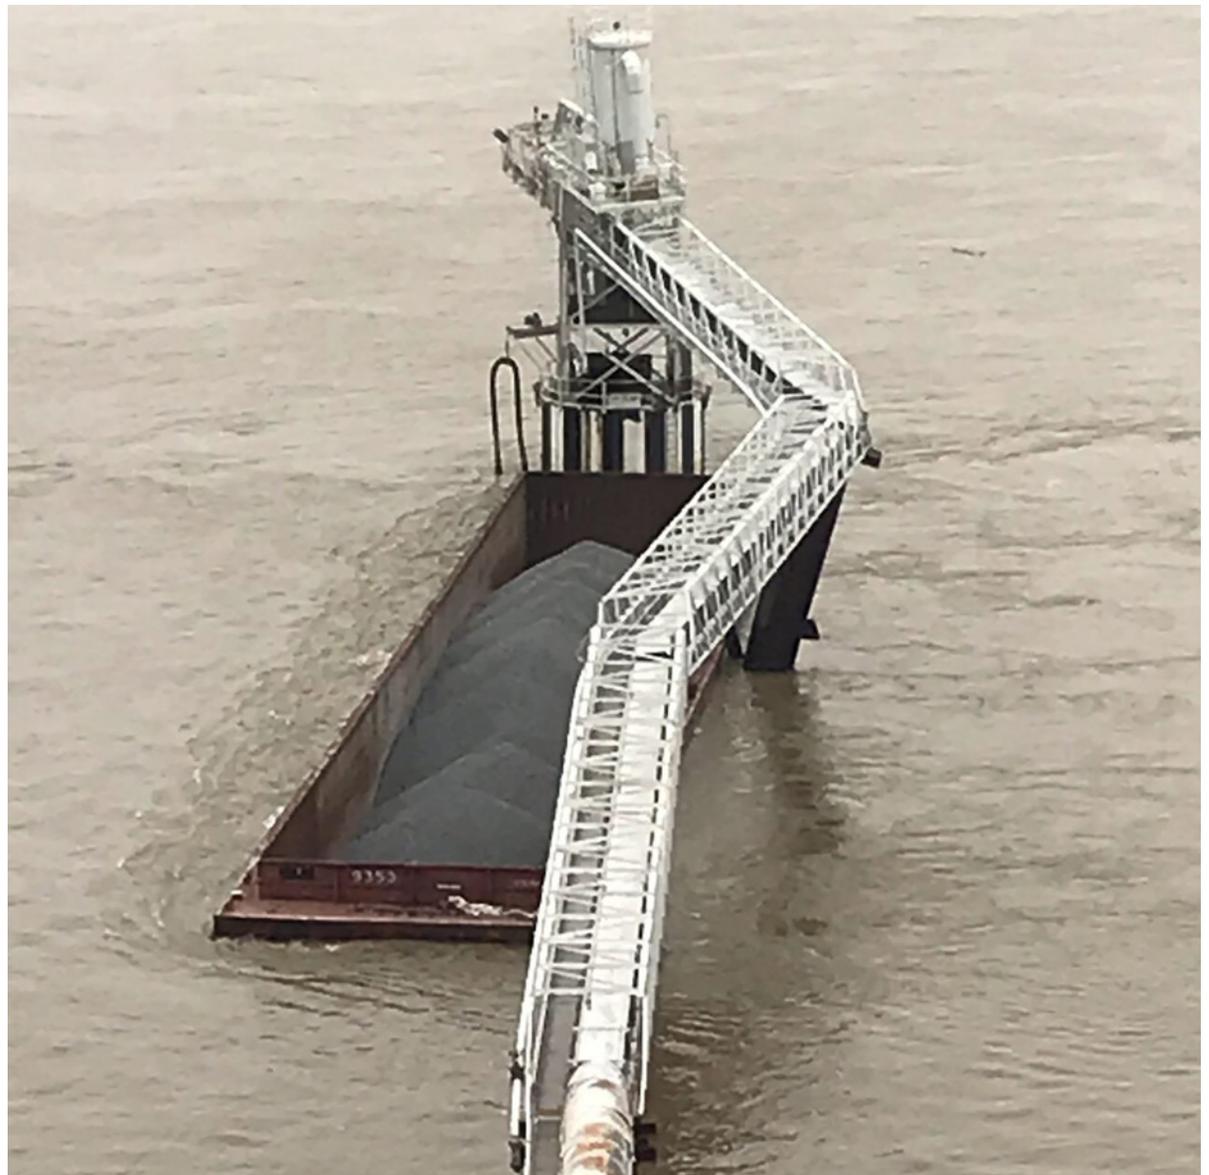
**Figure 55. Right:** The damaged Bunge grain conveyor and barge T9353, four days after contact.

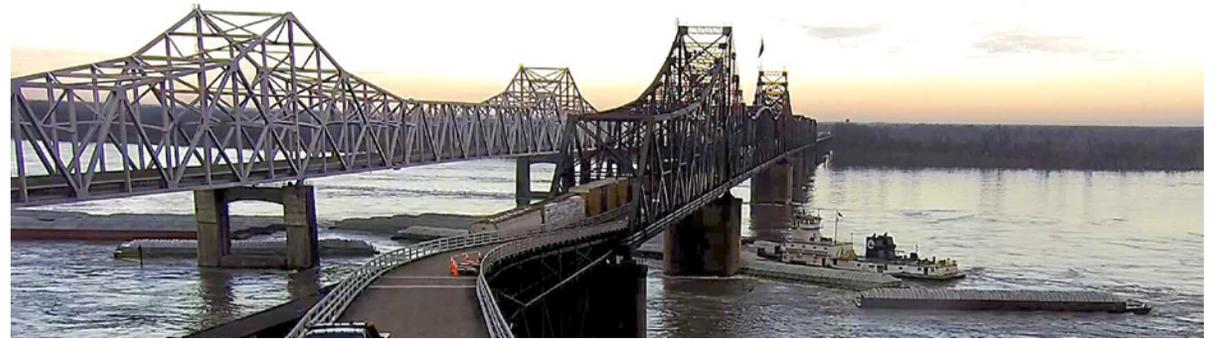
**Figure 59.** Barges broke away from the *Chad Pregracke* after the tow struck pier 3 of the Old Highway 80 bridge.

One barge sank immediately, and another's bow was submerged. Two other barges were damaged but remained afloat. The Coast Guard closed the river to traffic. A total of 26 towboats and 354 barges were delayed until the morning of March 1, when the Coast Guard re-opened the area for vessel traffic.

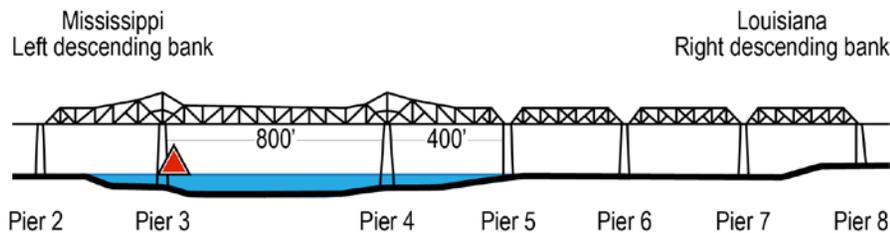
**Figure 60.** A drawing of the Old Highway 80 Bridge looking down river. The red triangle indicates the location of the bridge strike.

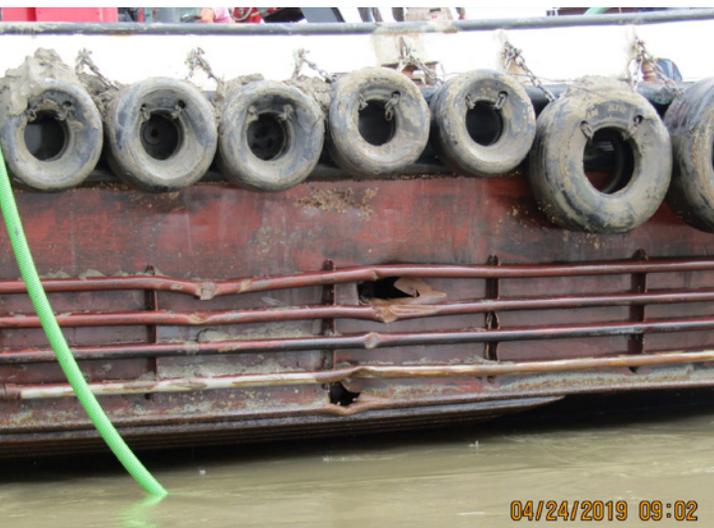
On April 15, at 0044, the *DeJeanne Maria* struck the end of a submerged dredge pipeline on the Mississippi River in Pass A Loutre, 2 miles south of Pilottown, Louisiana, while pushing two spud barges to the Gulf of Mexico. Following the contact, the three crewmembers abandoned the vessel to its barges and were rescued by a Good Samaritan vessel. The *DeJeanne Maria* later sank. There were no reported injuries, but 70 gallons of diesel fuel were discharged, and damage to the vessel was estimated at \$650,000.

**Figure 68.** Punctures to the vessel's hull are visible.

The captain experienced a strike on the starboard side and then found flooding in the engine room. With the vessel listing to starboard, the captain and the two deckhands abandoned the vessel to one of the barges. The *DeJeanne Maria* sank after about 10 minutes, except for its bow, which was held above the water by the port cable connected to the barge.

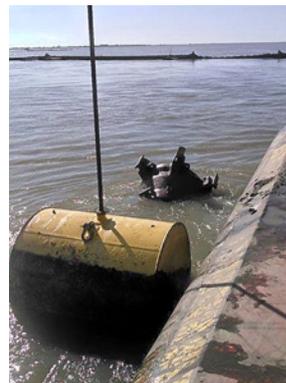
The submerged object that damaged the *DeJeanne Maria* was not discovered until 3 weeks later, when, on the afternoon of May 6, 2019, a Weeks Marine towing vessel struck what was identified a few hours later as the end of the submerged pipeline. The end of the pipe was located only 5 feet beneath the river's surface and 1,035 feet from where the *DeJeanne Maria* was recovered from the bottom of the river. The buoy marking the end of the submerged pipe was floating 75 feet downstream.

The probable cause of the contact between the towing vessel *DeJeanne Maria* and a submerged dredge pipeline end was the last bathymetric survey not detecting the hazard, which had been brought to just below the surface due to an unsuccessful lift the day before.

**Figure 69. Left and below:** End of the submerged pipeline and its buoy. SOURCE: WEEKS MARINE.

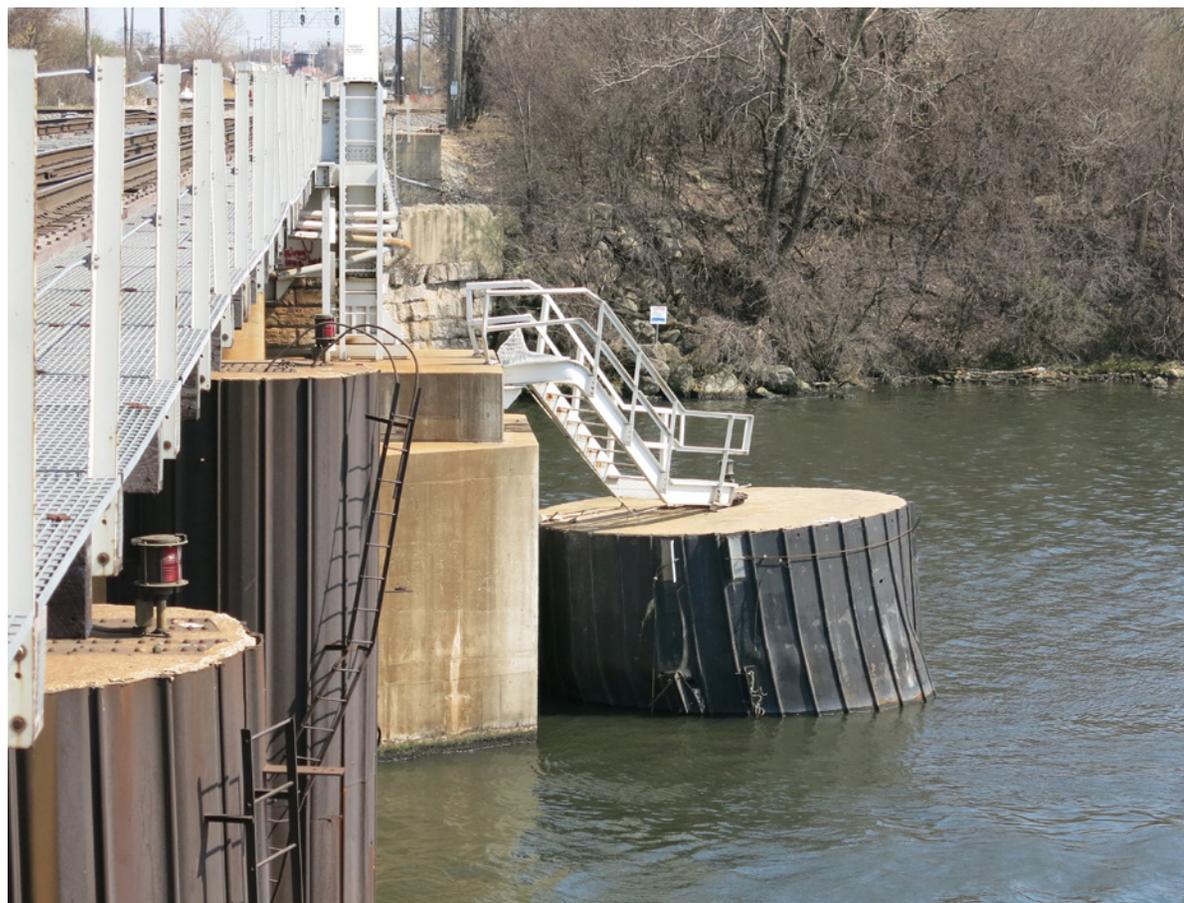
**Figure 71. Below:** Postaccident condition of the south side of the CSX Railroad Bridge.

At 0123, the bow of the lead barge struck the protection cell on the south side of the bridge at a speed of 5.75 mph. The southern protection cell was displaced over 4 feet in the direction of the pier, and several pieces of its fendering system had been dislodged and were no longer in place. The south corner of the bridge's concrete pier was also damaged.

The probable cause of the contact of the *Dewey R's* lead barge with the south-side protection cell for the CSX Railroad Bridge was the pilot's departure from the centerline of the channel as the tow approached the bridge without a forward look-out to monitor the transit.

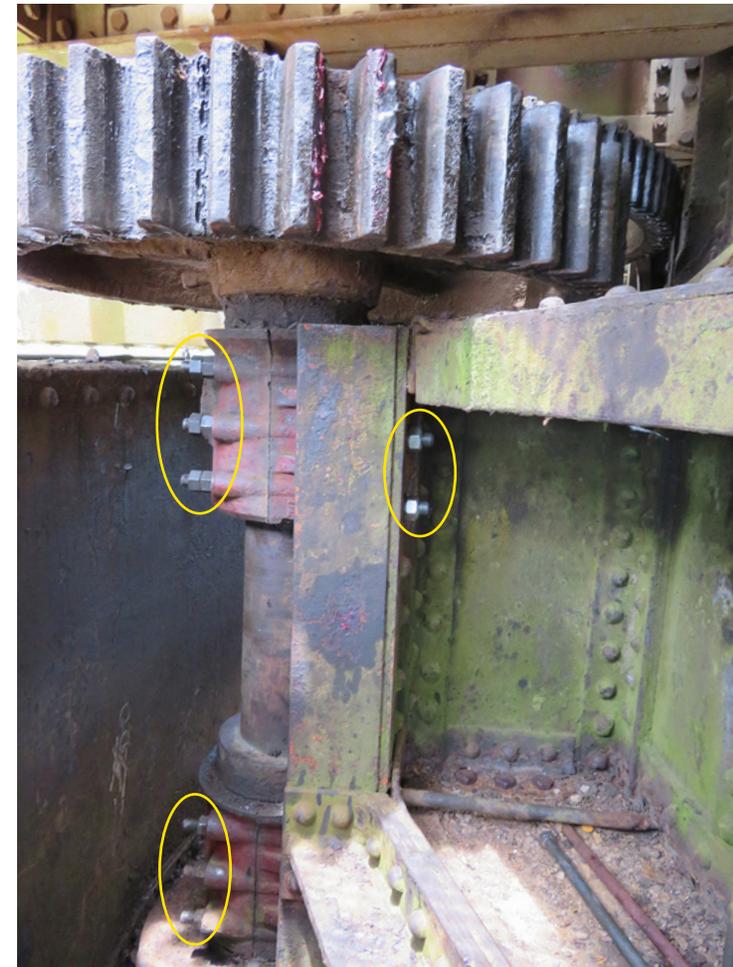
At 2348, the starboard quarter of the barge hit the bridge pier, then bounced to port. The port bow of the *Edna T. Gattle* hit the swing span pedestal. As the barge was swept under the bridge, the spud and excavator struck the swing span. The tow forced the bridge to move in a counterclockwise motion, almost back to its closed position. Damage to the bridge closed it to train traffic until temporary repairs were completed on April 27, allowing trains to pass at a reduced speed.

**Figure 79. Below:** A repaired gear within the pedestal. The new bolts are shown circled in yellow.

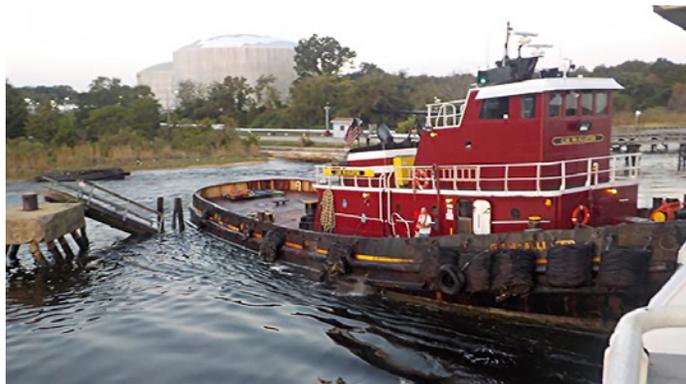
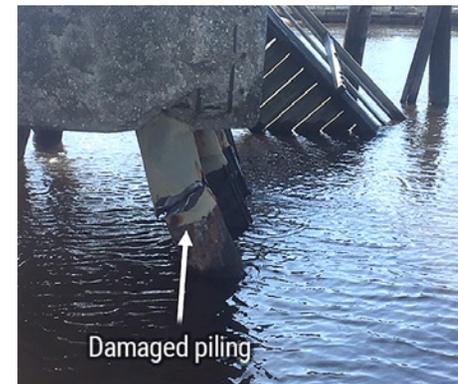
Figure 81. Left: *G.M. McAllister* at the NGL Energy Partners berth immediately after the accident.

SOURCE: MASTER, *IJSSEL CONFIDENCE*. Right: Damaged piling and walkway.

On September 23, 2019, about 0657 local time, the tugboats *G.M. McAllister* and *Nancy McAllister* were assisting the bulk carrier *Ijssel Confidence* on the Southern Branch of the Elizabeth River, in Chesapeake, Virginia. While engaged in turning the bulk carrier, the *G.M. McAllister* contacted the NGL Energy Partners wharf. There were four crewmembers on board the tugboat. The vessel was not damaged and therefore continued the turning maneuver. No pollution or injuries were reported. Damage to the wharf was estimated at \$1.47 million.

The probable cause of the contact of the *G.M. McAllister* with the NGL Energy Partners berth was the docking pilot backing down the river toward the turning basin at a speed at which the assist tugboats could not be effectively used. Contributing to the accident was insufficient communication, before and during the maneuver, between the docking pilot and the *G.M. McAllister* captain.

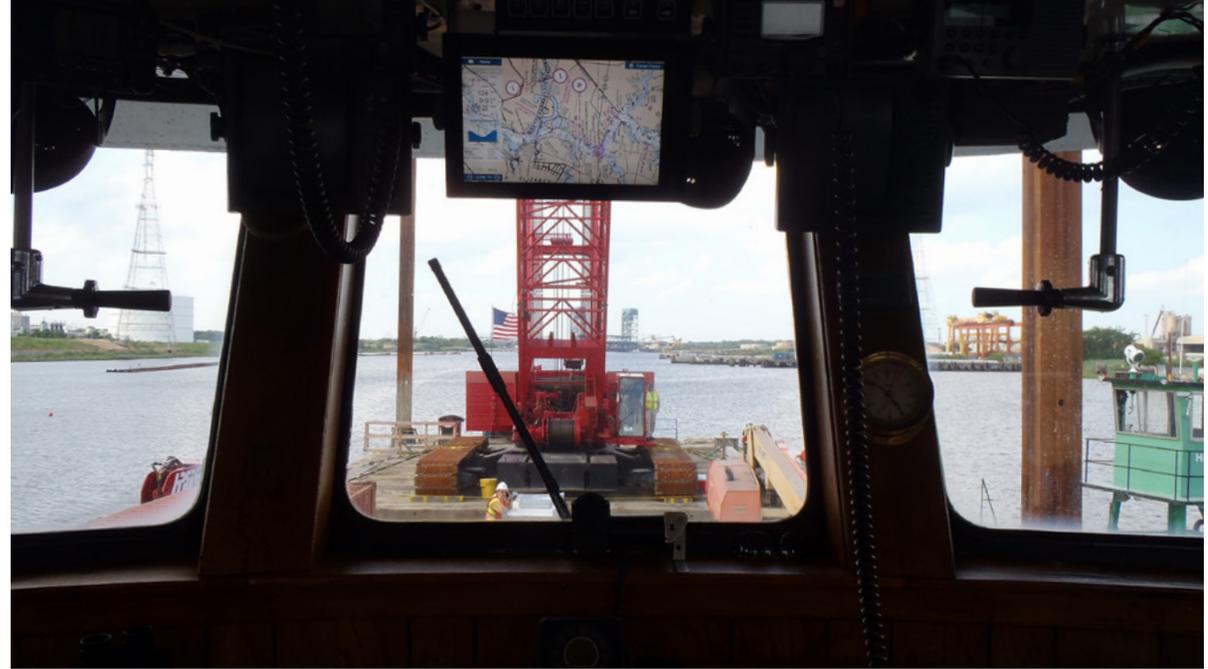
**Figure 85.** View from *Goose Creek*'s wheelhouse after the accident facing north towards Gilmerton Bridge and no. 120 transmission tower on the left (west) with the Manitowoc crane (centered) and *Heidi C* (right) moored to crane barge *U1510*. SOURCE: COAST GUARD.

At 1134 local time on June 20, 2019, the crane barge *U1510* (with three persons on board), being pushed by the towing vessel *Goose Creek* (with three crewmembers on board), struck three overhead power transmission lines while transiting to Precon Marine on the southern branch of the Elizabeth River in Chesapeake, Virginia. No pollution or injuries were reported. Damage to the powerlines and crane barge was estimated at \$226,204.

The crane operator announced over the radio that he had "200 feet of stick out." The crane boom's angle indicator read 67 degrees postaccident, indicating the air draft was approximately 195 feet at the time of the accident, which exceeded the charted 152-foot vertical clearance of lines no. 120 by 43 feet. Although aware that the construction workers intended to raise a spud and warned of the nearby powerlines, the captain allowed the workers to raise the crane boom. About 1134, the crane's boom contacted lines no. 120, and arc flashes and "cannon like-booms" were observed. All three transmission lines subsequently parted and fell into the river. There were no reported injuries, and the tow safely moored outside of the channel.

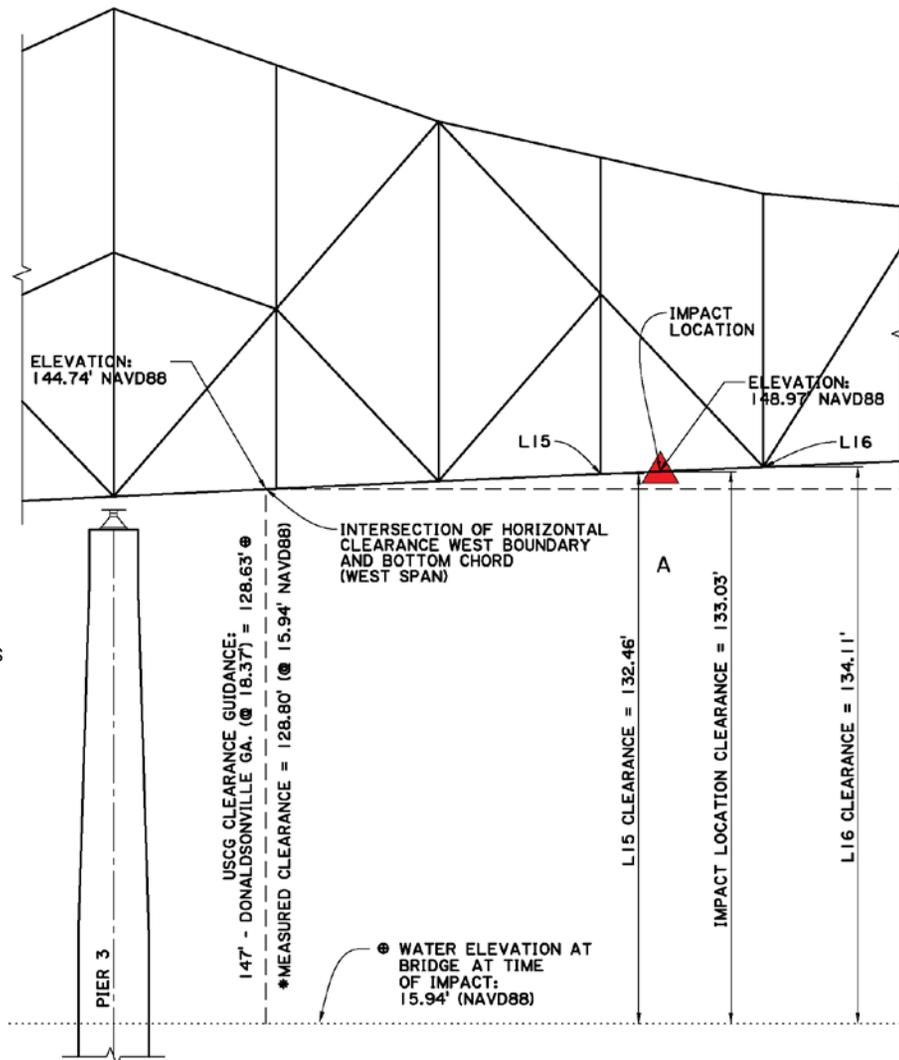
On October 12, 2018, about 0141 local time, the towing vessel *Kristin Alexis* was transiting with the crane barge *Mr Ervin* upbound on the Lower Mississippi River near St. James, Louisiana, when the crane struck the deck of the Sunshine Bridge while passing under the west channel span. No pollution or injuries to the six crewmembers on board the *Kristin Alexis* were reported. The bridge was completely closed to vehicular traffic for 49 days while repairs were made, which resulted in significant traffic impacts. Damage to the bridge was \$6.7 million, while crane damage was estimated at \$8,500.

The probable cause of the *Mr Ervin* crane barge striking the Sunshine Bridge was the inadequate voyage planning and watch turnover between the captain and pilot, resulting in the pilot transiting beneath the bridge's west span instead of its channel span. Contributing to the accident was the lack of company oversight. Also contributing to the accident was the charted information for the bridge used by the pilot, which did not reflect the actual vertical clearance of the west span.

**Figure 95.** Vertical clearances of the Sunshine Bridge's west span measured shortly after the accident. The impact location is marked with a red triangle.

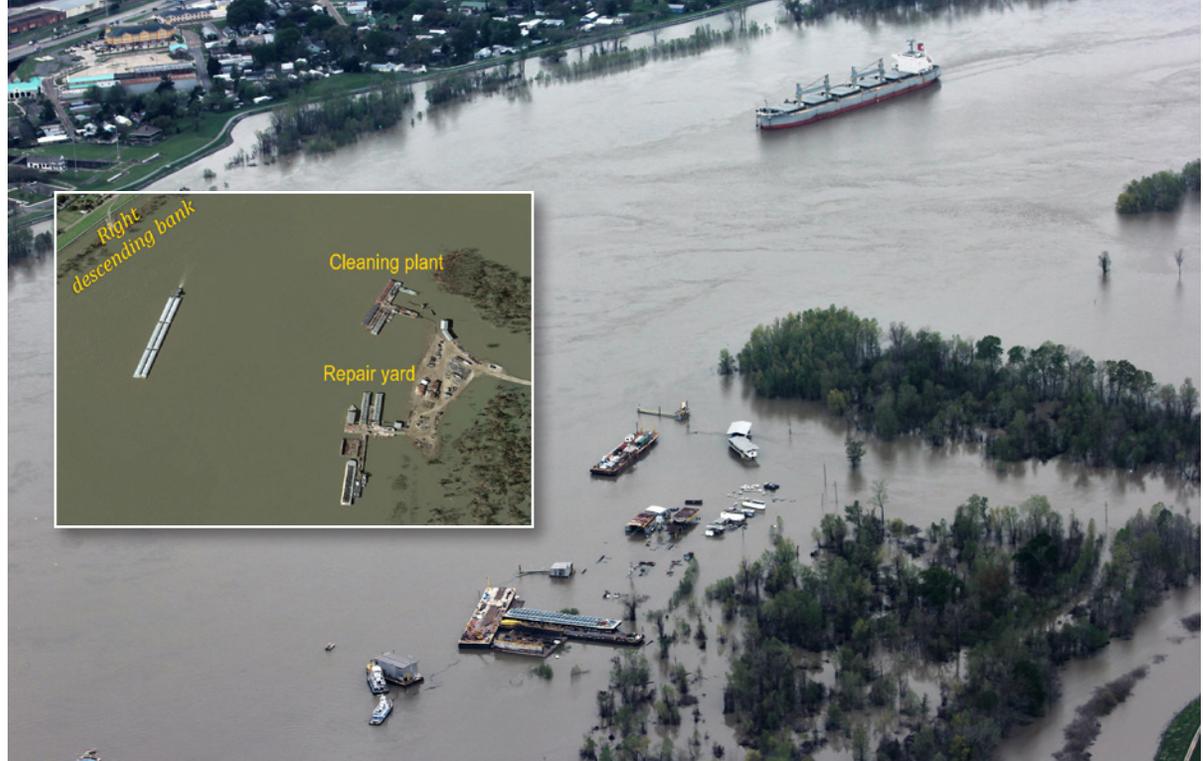
**Figure 97.** Plaquemine Point Shipyard immediately after the accident during major flood stage; inset shows the same area in January 2019. SOURCE: COAST GUARD. INSET: GOOGLE EARTH; ANNOTATED BY NTSB.

On March 7, 2019, at 1020 local time, the towing vessel *Leviticus* was pushing six barges downbound on the Lower Mississippi River at mile 208.5 near Sunshine, Louisiana, with a crew of eight on board. While transiting through a river bend, the lead barges of the tow contacted barges moored at the Plaquemine Point Shipyard, breaking free a total of 11 barges. The 27 shipyard workers on board the barges were able to evacuate before contact; 10 sustained minor injuries. All barges were later recovered, and no pollution was reported. Damage to the shipyard (\$520,000) and the tow (\$19,500) amounted to an estimated \$539,500.

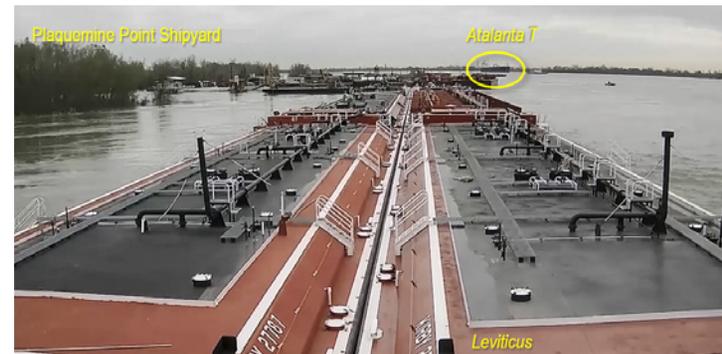
Despite the captain's efforts, at 1020, the tow's port lead barge struck a barge at the cleaning plant. Less than a minute later, the tow's starboard lead barge struck another barge. As a result, all six of the cleaning plant's barges were knocked free from their moorings, and the tow pushed them down river toward the repair yard. At 1021, the cleaning plant barges hit the repair yard. Five of the repair yard's barges broke away. About 1025, two of the barges knocked loose from the cleaning plant struck the no. 1 barge anchor buoy at the Banta Mile 208 Fleet.

The probable cause of the contact of the *Leviticus* tow with the Plaquemine Point Shipyard was the captain's decision to continue the training of an apprentice mate/steersman while navigating a challenging river bend downbound and meeting upbound traffic in high-water conditions.

**Figure 99.** Screen capture from the *Leviticus*' video recorder at 1020 looking forward shows initial impact with the moored barges at the shipyard's cleaning plant.

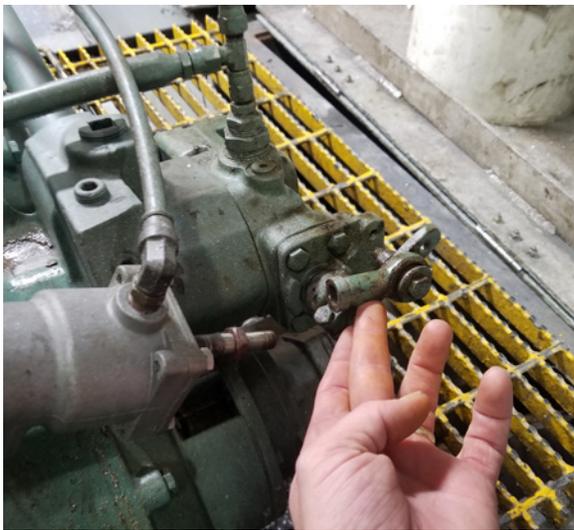
**Figure 101.** Starboard engine pneumatic gear clutch actuator linkage disconnected aboard the *Lindberg Crosby* as found after the accident.

Postaccident tests indicated that there was not a material failure of the pneumatic cylinder or its

components. The design of the piston within the cylinder allowed it to rotate to account for misalignment in various applications. Testing showed that during repeated operation, the piston rod rotated in a direction that would unscrew a threaded connection. To prevent cylinder shaft rotation as it was fitted on the *Lindberg Crosby's* transmission, a jam nut was provided to tighten down against the shift lever threaded connector. The most likely cause of the separation of the linkage between the cylinder and the transmission lever was the jam nut becoming loose over time, therefore allowing rotation of the piston rod, resulting in the rod unthreading from the shifting lever connector piece.

The probable cause of the towing vessel *Lindberg Crosby* contacting a pier column of the Interstate 10 bridge was the undetected loss of starboard engine directional control due to a separation of the control system mechanical linkage to the pneumatic gear clutch, resulting in the engine not shifting in response to the operator's commands.

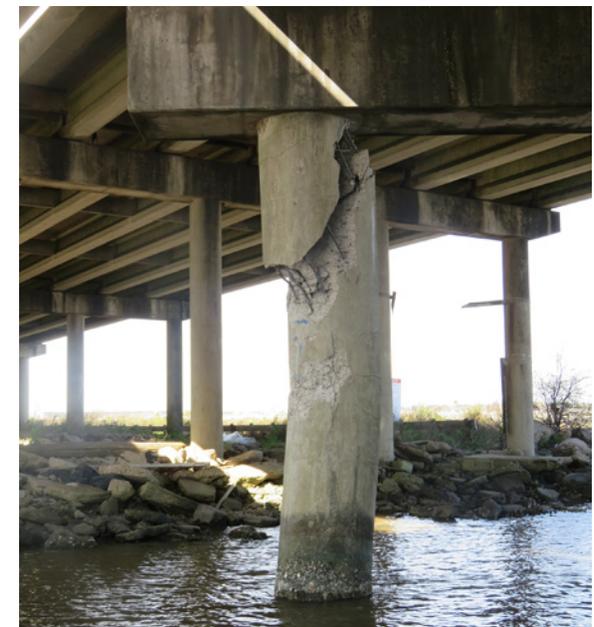
**Figure 105. Below:** Damaged section of struck pier column under westbound lanes of I-10 bridge.

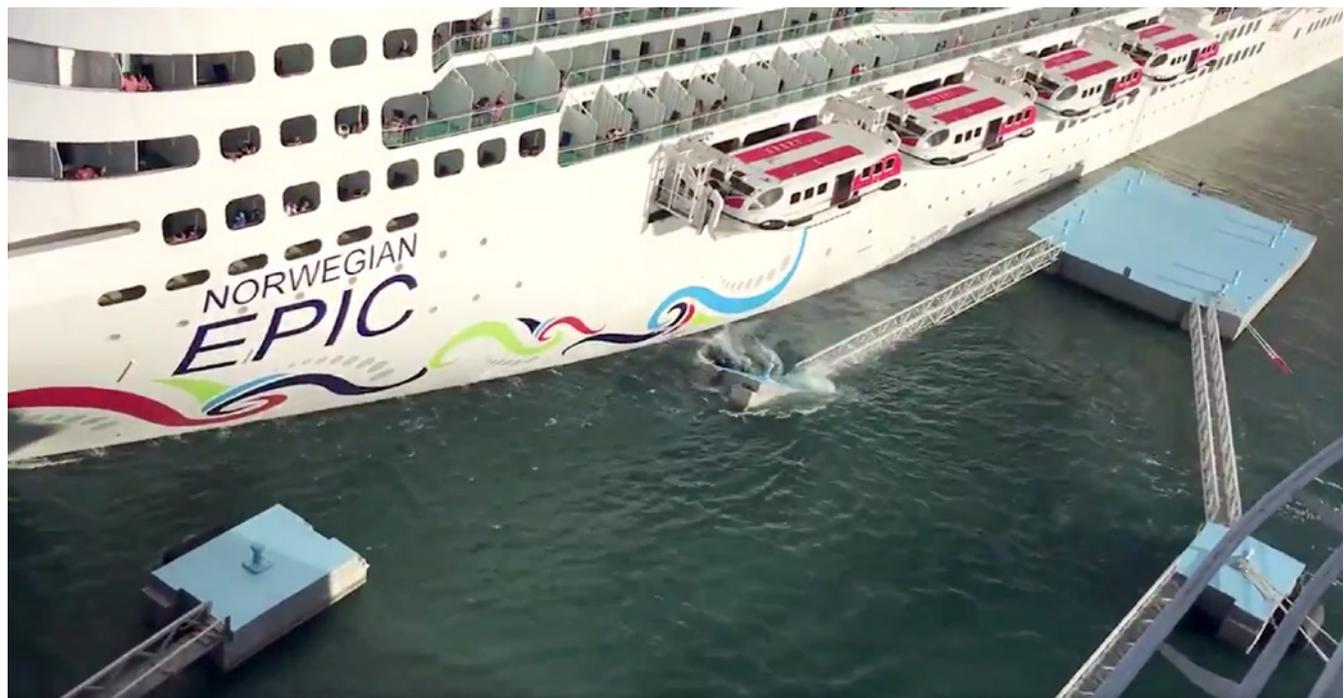
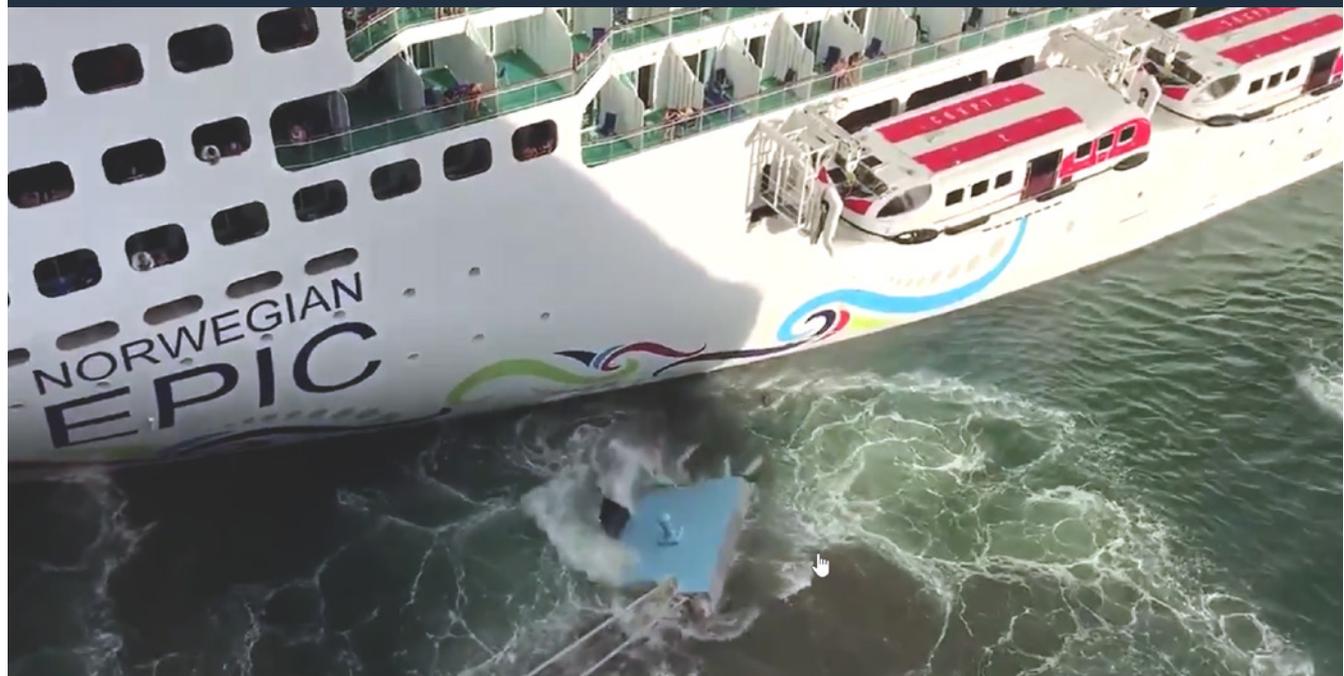
**Figure 111. Above:** The *Norwegian Epic* as it struck the first mooring dolphin and catwalk, which collapsed. **Below:** The second dolphin and catwalk as it collapsed after being struck. SOURCE: TWEETSWITHTITO@DUNARD2.

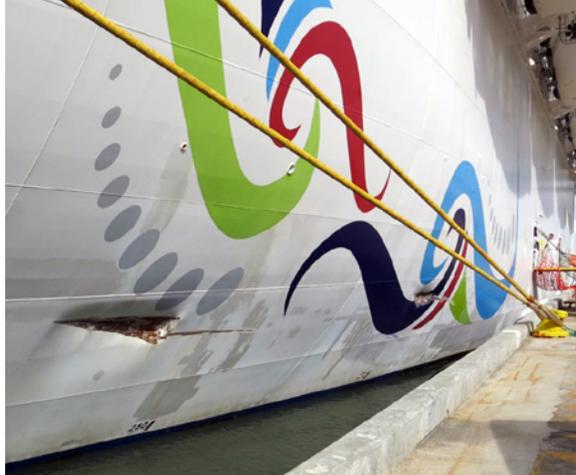
**Figure 112.** Damage to the *Norwegian Epic's* hull.

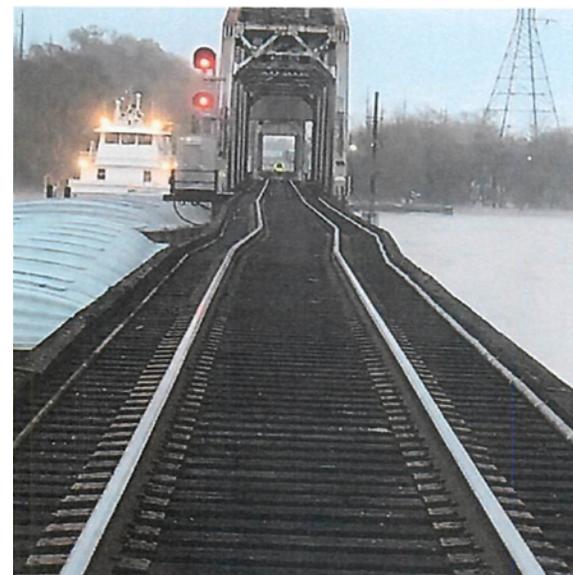
At 0058, the port aft barge contacted the bridge pillar (pier 3), and the whole tow pivoted to port. The port aft barge went partially under the bridge, ripping open the barge covers. The lead barge also contacted a pier and was damaged. The *Rivers Wilson* laid up against pier 3 of the bridge and was unable to extract itself or the barges from the bridge. The pilot sounded the general alarm, and the captain and the bridge tender called the Coast Guard.

**Figure 117.** Rail displacement of the Norfolk Southern railway bridge, looking east, with the *Rivers Wilson* and two barges alongside. SOURCE: COAST GUARD.

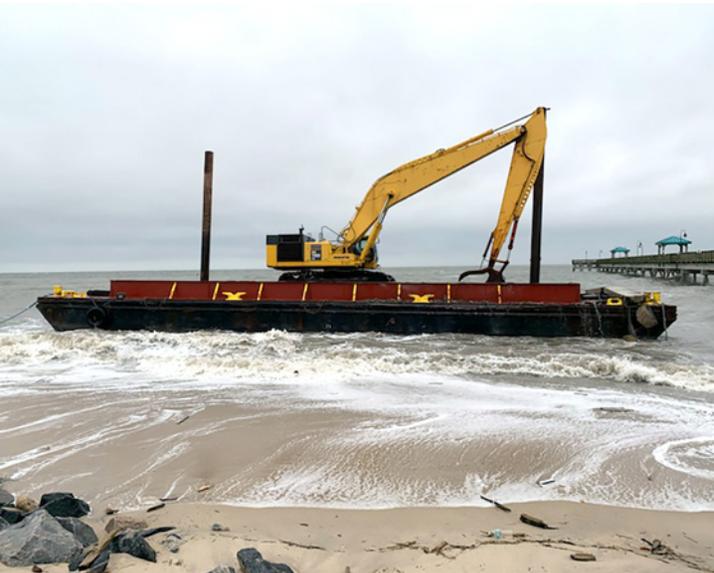
**Figure 123.** The *YD 71* aground after breaking free from its mooring and prior to striking the pier.
