# SAFER SEAS Digest 2020

Lessons Learned from  
Marine Accident Investigations

NTSB/SPC-21-01

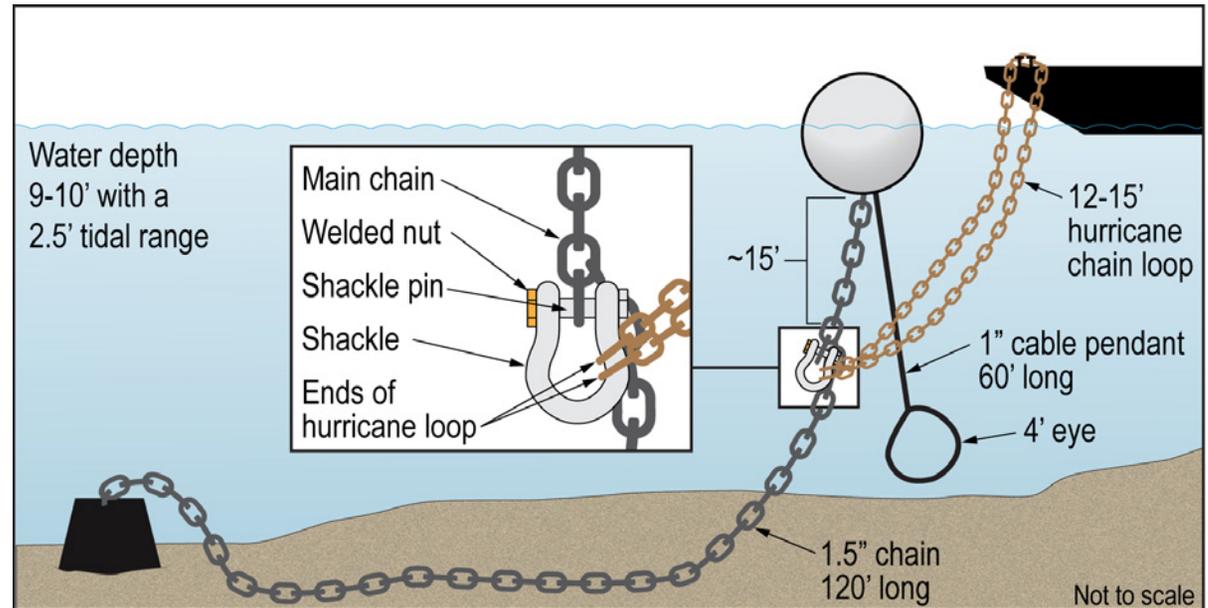
The mooring's chain and hurricane loop were found intact. Neither the shackle nor its pin connecting the hurricane loop to the chain were found. Therefore, the barge could only slip its mooring if the shackle failed, or if the pin backed out after the weld attaching the nut to the pin failed. It is more likely the weld failed than material failure of the shackle bow or pin occurred. This likely would have occurred over a period of time, with the strain of the 4-foot storm wave action, near gale winds, and/or high tide breaking it free.

The probable cause of the contact between the barge YD 71 and the James T. Wilson Fishing Pier was a shackle pin in the mooring arrangement working itself free in heavy weather, leading to the barge's uncontrolled drift.

Figure 126. A representation of the arrangement of the YD 71's mooring at the time of the accident.

Moorings for vessels can be single-point failures that can lead to losses for both vessels and nearby infrastructure. Operators should identify failure modes of mooring arrangements and implement controls, including more frequent inspections if necessary, to avoid accidents.

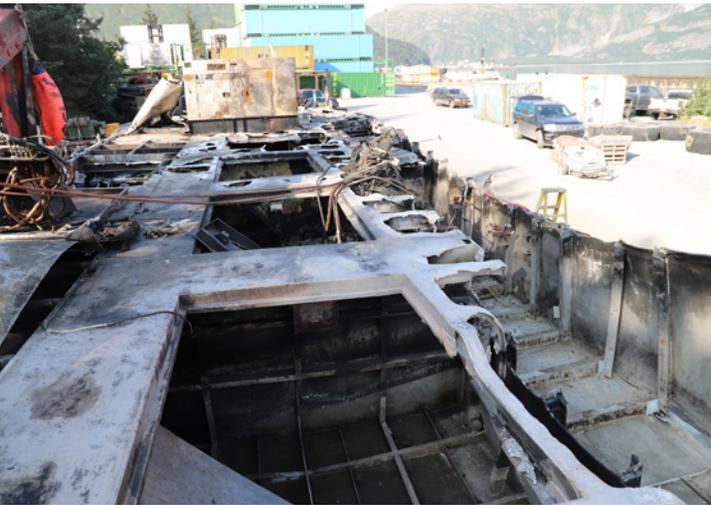
**Figure 127.** Bent and deformed deck plating forward on the *Alaganik*'s starboard pontoon after the fire.

Evidence suggests that the initial explosion occurred in the vicinity of the cargo tank that was carrying gasoline. Gasoline is more volatile and has a lower flashpoint than diesel fuel, making it far more dangerous to store, particularly in confined spaces. With a flashpoint of -45 degrees, gasoline forms an ignitable vapor at normal ambient temperatures. By comparison, the flashpoint of diesel fuel is 125 degrees. Further, the vapor density of gasoline is three to four times that of air, and thus the vapor tends to gather in low areas and enclosed spaces. Prior to the evening of the accident, only diesel fuel had been stored in the four fuel cargo tanks on the *Alaganik*. Following the onload of gasoline, it is likely that escaping gasoline vapor gathered around the portside forward fuel cargo tank. When this vapor ignited, the explosion occurred.

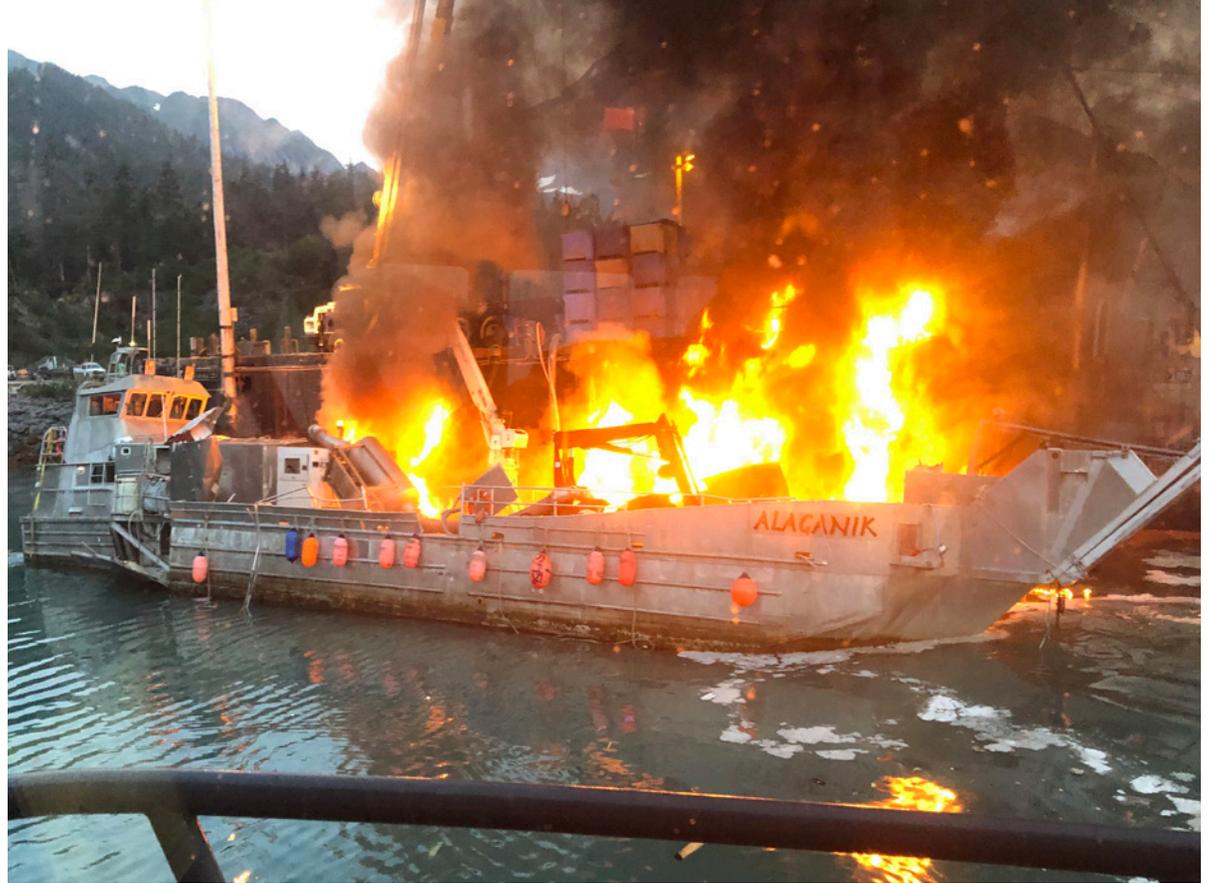
**Figure 128.** *Alaganik* on fire after the explosion. SOURCE: COAST GUARD.

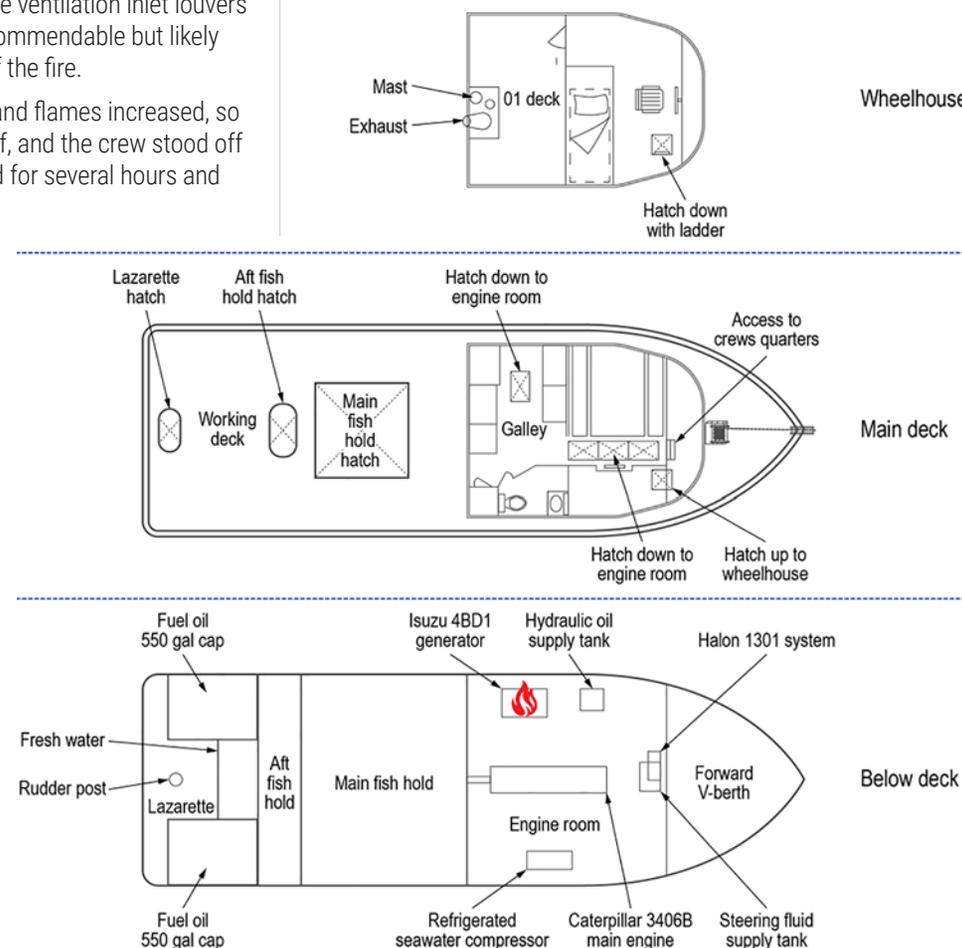
The probable cause of the fire aboard the fishing vessel *Ariel* was the ignition of fuel leaking from the generator fuel supply line in the engine room. Contributing to the severity of the fire and the eventual loss of the vessel were the fixed-open inlets for the engine room ventilation, which allowed fire-extinguishing agent to escape and air to enter the space.

Figure 133. Below: General arrangement of the *Ariel*, with the area where the fire was first reported indicated by the red flame icon.

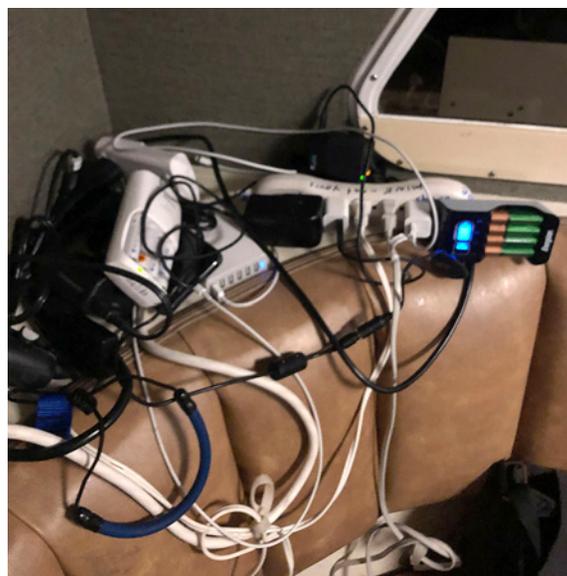
After a night dive on Sunday, September 1, the *Conception* anchored in Platts Harbor about 2300 for the night. Flashlights, cameras, and flashes that the divers used during the dive were stowed on two aft tables in the salon on the main deck, and some electronics that needed recharging were plugged into nearby 120-volt receptacle outlets. At least one passenger-owned power strip was used to recharge the electronics.

**Figure 137.** Photo taken August 31, 2019, of devices plugged in to charge at the port side aft corner of the salon on the *Conception*. SOURCE: J. DIGNAM.

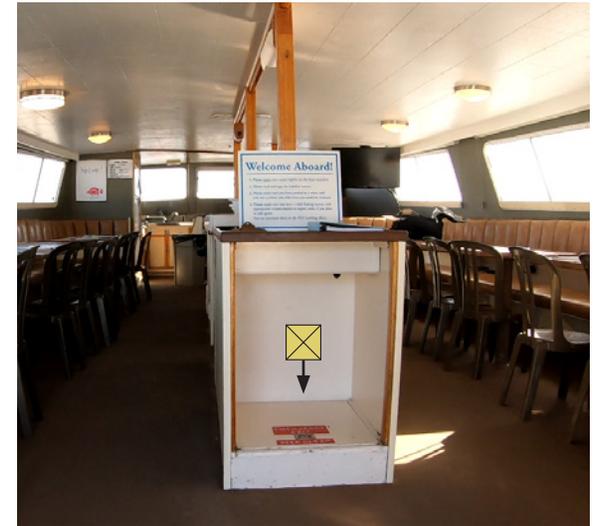
**Figure 139.** The bunkroom escape hatch, viewed from aft in the salon on the main deck.

**Means of escape.** The *Conception* was designed in accordance with the regulations in Subchapter T at the time of construction. As such, the vessel was required to have at least two emergency egress pathways from all areas accessible to passengers. The *Conception* had two means of escape from the bunkroom: spiral stairs forward and an escape hatch aft, accessible from either port or starboard aisles by climbing into one of the top aftermost inboard bunks. However, both paths led to the salon, which was filled with heavy smoke and fire, and the salon compartment was the only escape path to exterior (weather) decks. Therefore, because there was fire in the salon, the passengers were trapped, and the crew was not able to reach them. If regulations had required the escape hatch to exit to a space other than the salon, optimally directly to the weather deck, the passengers and crewmember in the bunkroom would have likely been able to escape.

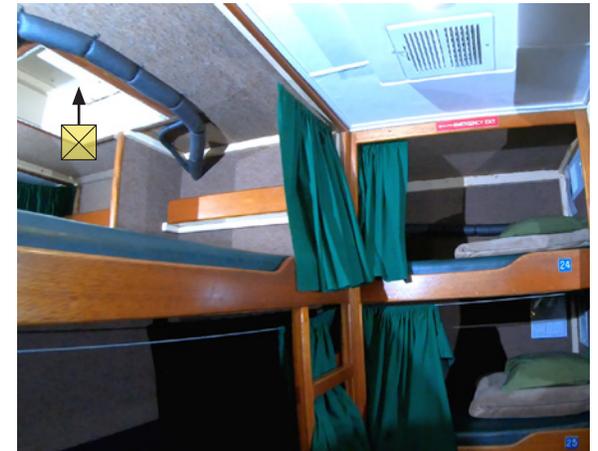
**Figure 140.** The escape hatch, viewed from the bunkroom below deck. SOURCE: R. CLEVINGER, ANNOTATED BY NTSB.

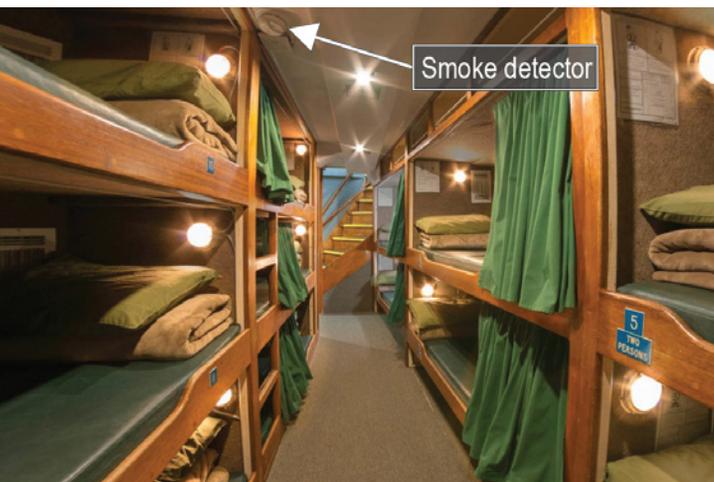
**Figure 142.** Interior view of *Conception* bunkroom.

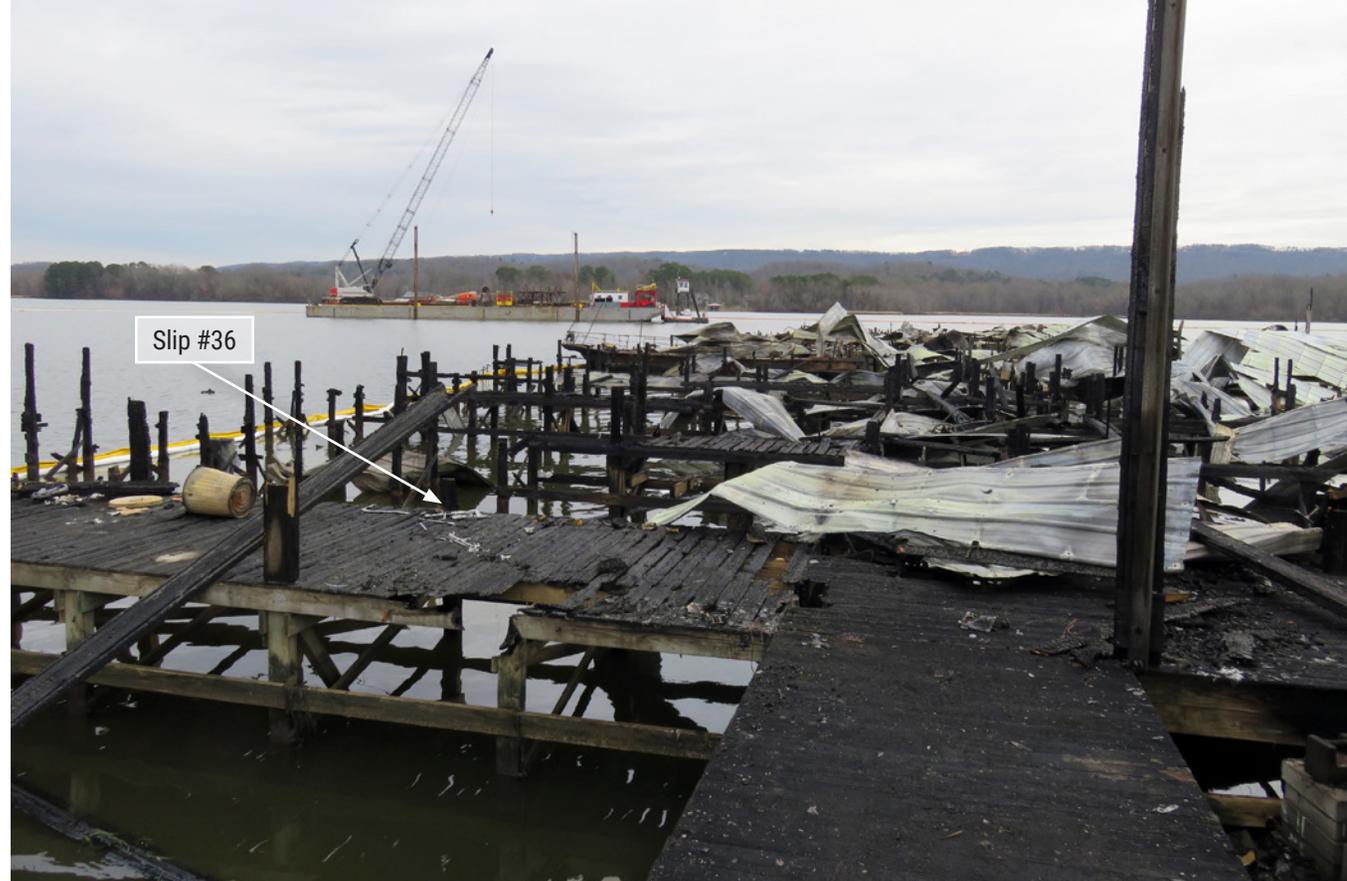
**Figure 145.** Dock B the day after the fire. The remains of the *Dixie Delight* are submerged in slip #36.

The probable cause of the fire aboard the *Dixie Delight* and subsequent fire at Dock B was a fire of unknown source, originating aboard the *Dixie Delight* in the vicinity of the vessel's electrical panel. Contributing to the severity of the fire and loss of life were the County and marina's limited fire safety practices.

**The close proximity of vessels in marinas can cause fires to spread quickly, preventing evacuation. Marina owners should assess their own operations, consult relevant fire safety guidance, and review fire plans in concert with local fire departments. Marina boat owners should familiarize themselves with their marina's fire plan and review their vessels' potential fire hazards and firefighting equipment.**

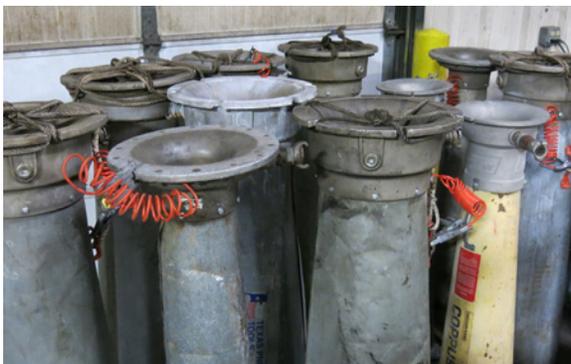
**Figure 149. Below:** Types of air movers from IMT's shop used aboard the barge *IB1940* on the morning of the explosion. (Photo taken after the explosion and after new bonding straps were attached to air movers.)

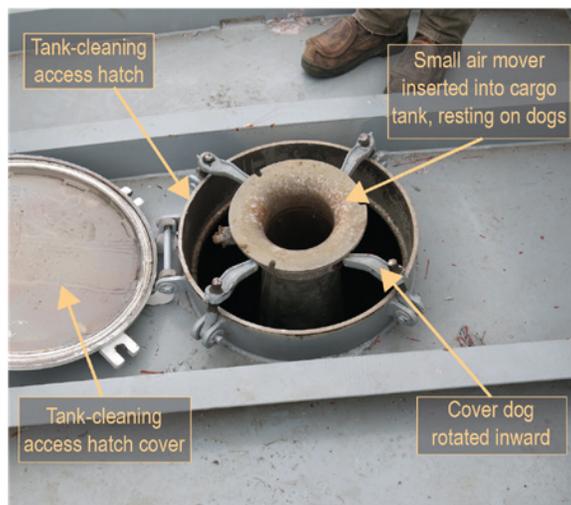
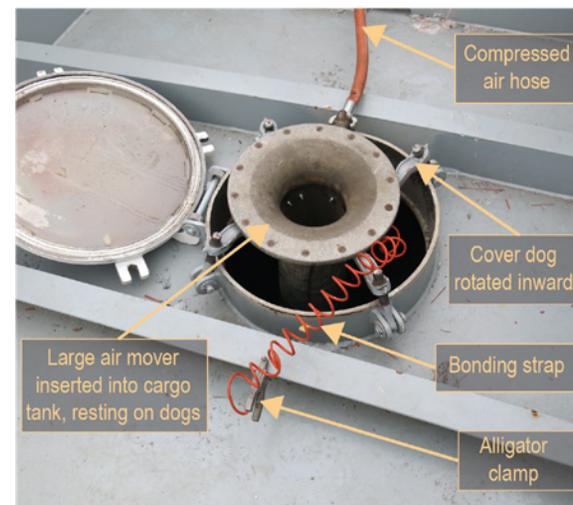
**Figure 151.** Demonstration of air-mover-installation methods reconstructed after the accident. **Left:** Smaller (6-inch diameter) air mover without compressed air hose and bonding wire. **Right:** Larger (11-inch-diameter) air mover connected with compressed air hose and bonding wire with clamp.

At 0929, within minutes of the compressed air supply to the air movers being applied, an explosion occurred. Cargo tank 2 was the likely location of the initial explosion. The source of ignition was most likely a static electrical discharge from the air mover that was resting on the painted dogs of cargo tank 2's tank-cleaning access hatch. Postaccident testing indicated that resting the air mover on the dogs did not provide a good electrical bond between the air mover housing and the barge. An inadequately bonded air mover would have allowed the accumulation of electrostatic charge generated by the flow of the compressed air stream with water droplets and rust particles. Without a proper bonding connection, a static electrical charge would

likely not safely dissipate to the grounded barge, but could instead accumulate, causing a potential spark hazard.

**Hazardous cargos with flammable vapors are subject to the risk of explosion. Shipboard and shoreside personnel working aboard vessels and barges carrying such cargos should establish and follow procedures for the bonding of all air-moving equipment when venting tanks.**

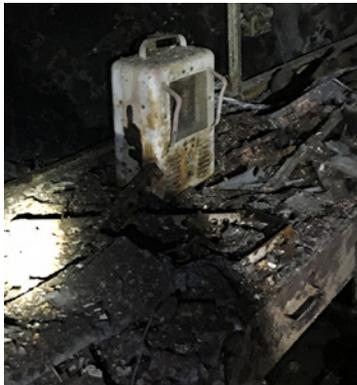
**Figure 153. Right:**

A space heater on the workshop bench located in the engine room break area following the fire.

The probable cause of the fire aboard the bulk carrier *St. Clair* was the ignition of combustible material in the vicinity of an engine room workshop likely due to the use of portable space heaters or smoldering smoking materials, which spread to other areas of the vessel. Contributing to the extent of the fire damage was the lack of operating procedures for continuous active monitoring of the vessel in lay-up status.

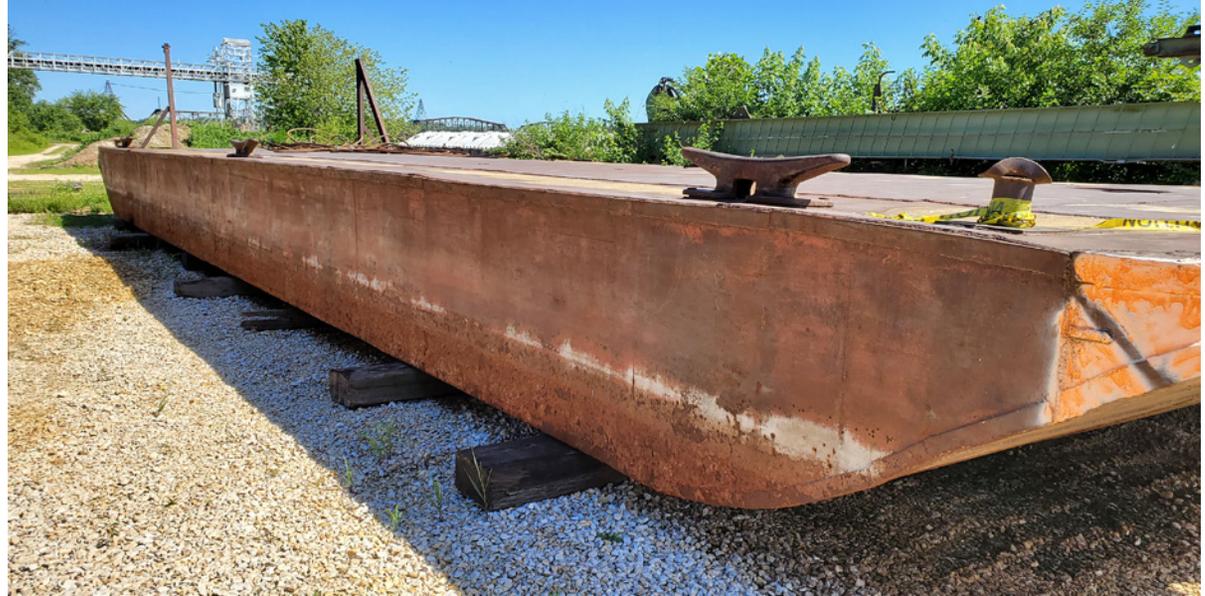
**Figure 158.** The unnamed deck barge after the accident. SOURCE: HEX STONE.

A post-salvage inspection of the deck barge revealed that there were several small holes on the deck that could have allowed rainwater to collect and enter the interior compartments. Additionally, holes found on the sides and bottom of the hull could have allowed continuous flooding. Based on a review of its condition, the holes likely had been present for a significant amount of time and were the source of the barge flooding.

Monitoring the frequency of the bilge pump operation and developing a trend of the volume of water being removed would have indicated the rate of water ingress and assisted in detecting hull leaks not easily visible.

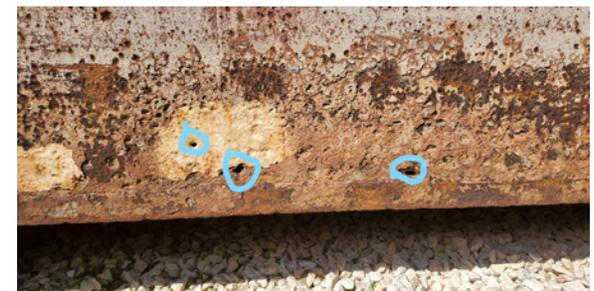
**Figure 159.** An annotated photo from the vessel company identifies holes on the side shell of the barge near the bottom plating. SOURCE: HEX STONE.

**To protect vessels and the environment, it is good marine practice for owners and operators to conduct regular oversight and maintenance of vessel and barges, even during lay-up periods. Oversight should include periodic testing and maintenance of dewatering equipment.**

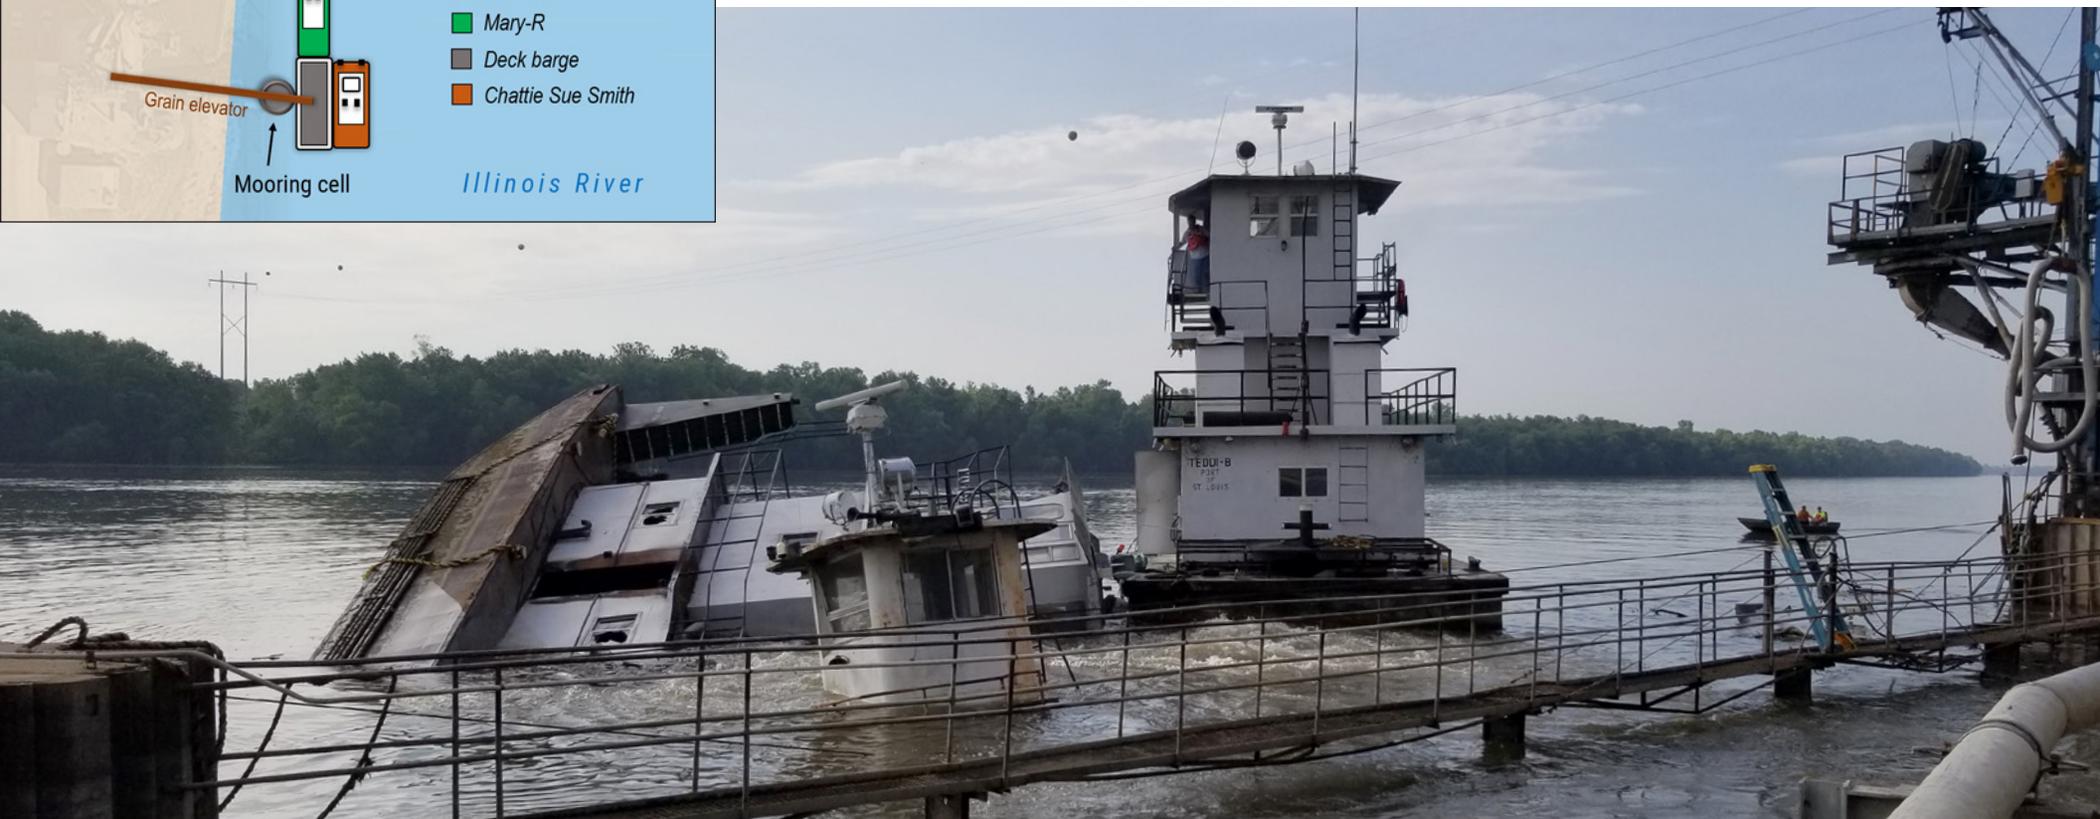
**Figure 161. Below:** *Mary Fern* (capsized on left), *Chattie Sue Smith* (sunken in center), and *Teddi B* (upright on right) about 0800 on the morning of the sinking. SOURCE: HARDIN FIRE PROTECTION DISTRICT.

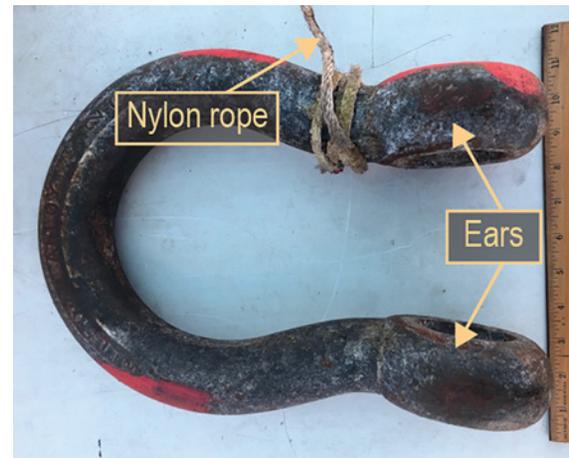
At 0440, the captain called the crew on deck to retrieve and secure the tow wire. The wire and the 14-inch tow pendant came aboard, but the shackle closest to the *Mangilao* was bent and missing its pin. It is likely that the chain from the bitt on the foredeck was not long enough for the attached 50-ton shackle to clear the fendering on the bow. In heavy seas, as the vessel pitched and the bow of the vessel lifted up over the waves, the shackle likely made repeated contact with the fendering and opened, causing the *Chamorro's* towline to drop from the *Mangilao*. At some point, the shackle's securing cotter pin broke or worked loose, thereby likely allowing the shackle bolt's securing nut to work loose. Had the chain been longer and the shackle extended out beyond the bow fender, the chain, rather than the shackle, would have contacted the bow, thereby likely preventing the shackle pin securing mechanism from failing.

The probable cause of the sinking of the *Mangilao* was the failure of the *Chamorro's* towing arrangement due to the loss of a towline shackle pin, which left the *Mangilao* adrift and resulted in the ingress of water from boarding seas in a developing typhoon.

**Figure 164.** Recovered 50-ton shackle with nylon rope, bent ear, and missing pin.

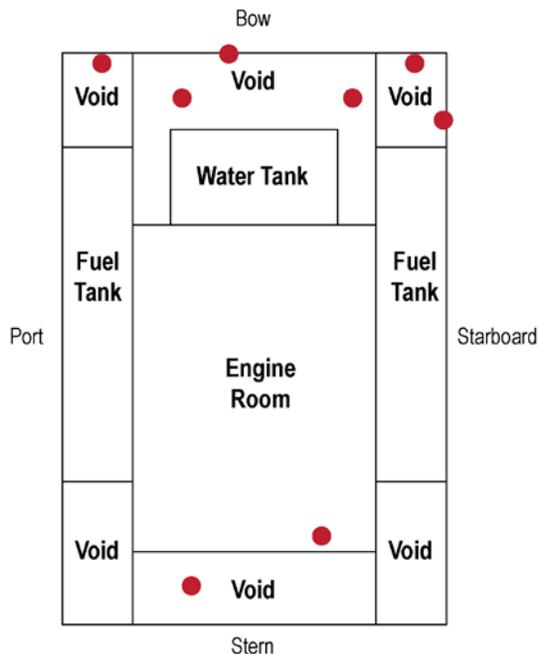
**Figure 167. Below:** Simplified layout of the *Tom Bussler*'s voids and fuel tanks. Pre-existing damage is marked with red circles.

There were seven pre-existing hull fractures in the vessel's hull found during a postaccident survey. The vessel had last been drydocked in January 2018, but no hull repairs related to watertight integrity were scheduled or completed. Throughout 2018, multiple issues with the hull were reported by crewmembers. However, attempts to find the leaks were unsuccessful, and the reported issues were not resolved. Instead, portable pumps were used to control the water ingress.

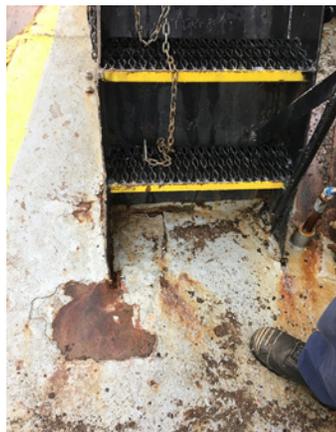
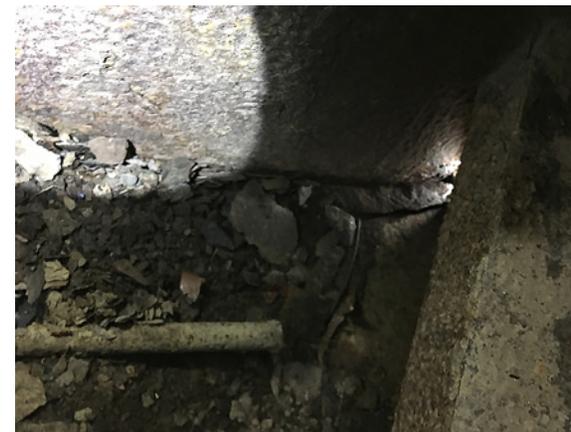
**Figure 170.** Pre-existing damage on the *Tom Bussler*. **Right:** Severely corroded deck on the bow inboard of the port townee. **Far right:** Corroded hole in the hull from within the bow void.

The probable cause of the flooding and sinking of the tugboat *Tom Bussler* was the company's lack of an effective hull maintenance and repair program, which resulted in flooding into the bow voids and engine room through fractures in the hull.

**To protect vessels and the environment, it is good marine practice for owners to conduct regular oversight and maintenance of hulls, including between drydock periods. Regardless of inspection requirements, owners are obligated to ensure vessels are properly maintained, equipped, and operated in a safe condition. Issues with watertight integrity and wastage should be addressed immediately.**

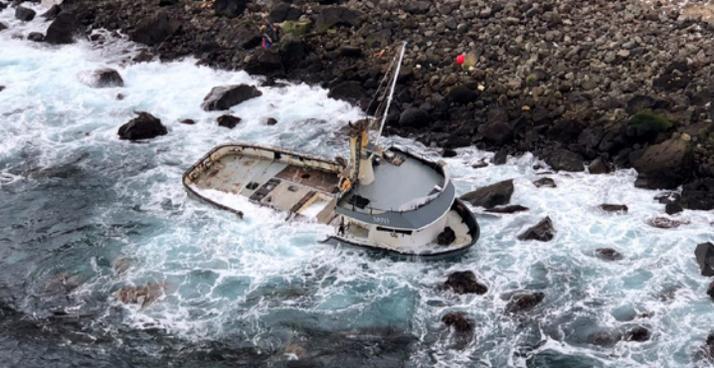
**Figure 173.** *Freyja* postaccident. SOURCE: COAST GUARD.

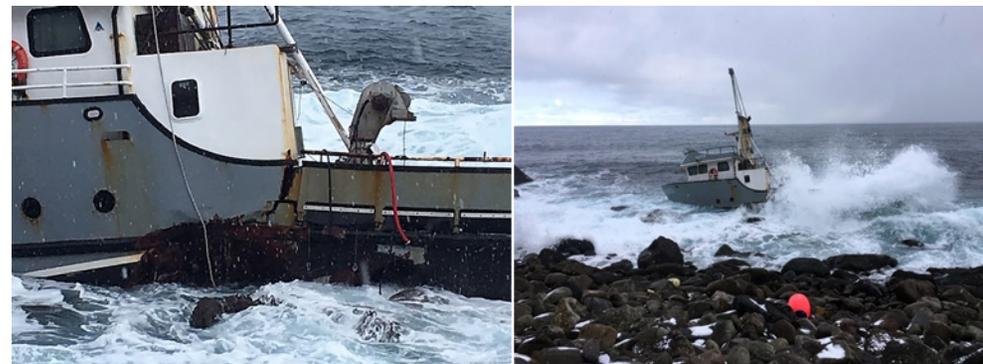
**Figure 174. Right:** The *Freyja*’s starboard side, showing structural damage due to grounding.

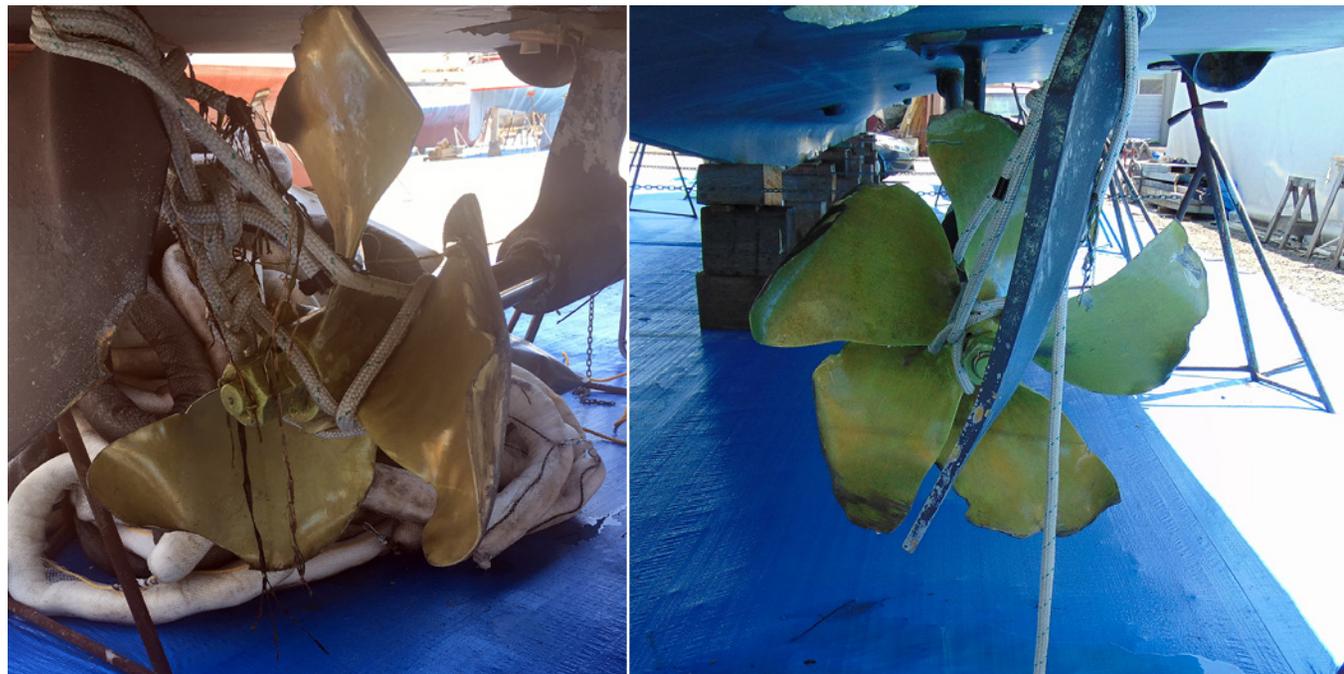
Figure 177. Below: Damage sustained to the port propeller and rudder (left) and starboard propeller and rudder (right) of the *Silver Lining* following the accident.

The vessel had significant damage to the aft section of the keel and hull, and the rudders and propellers were also extensively damaged. The damage would have resulted in flooding of the vessel.

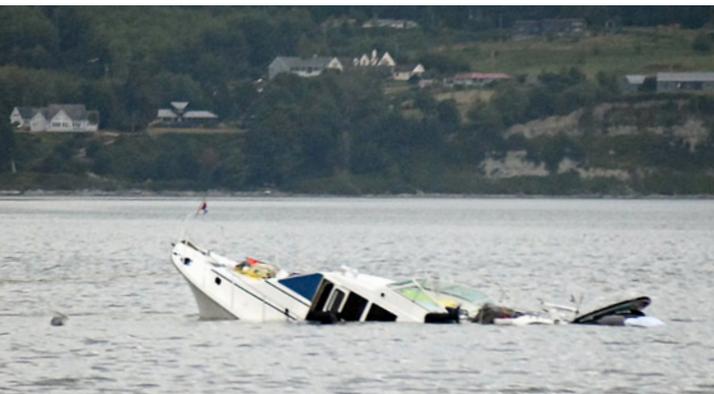
**Figure 178.** *Silver Lining* following the accident.

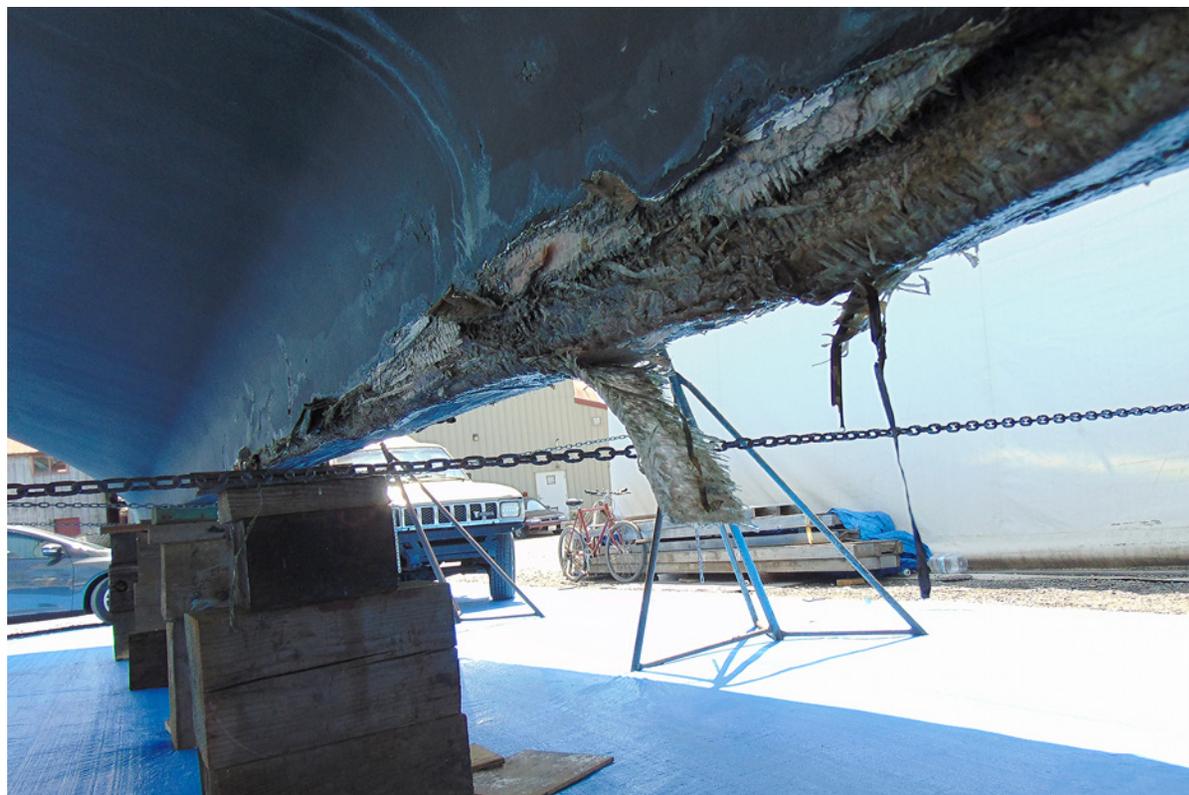
**Figure 179. Below:** Damage to the keel of the *Silver Lining* postaccident.

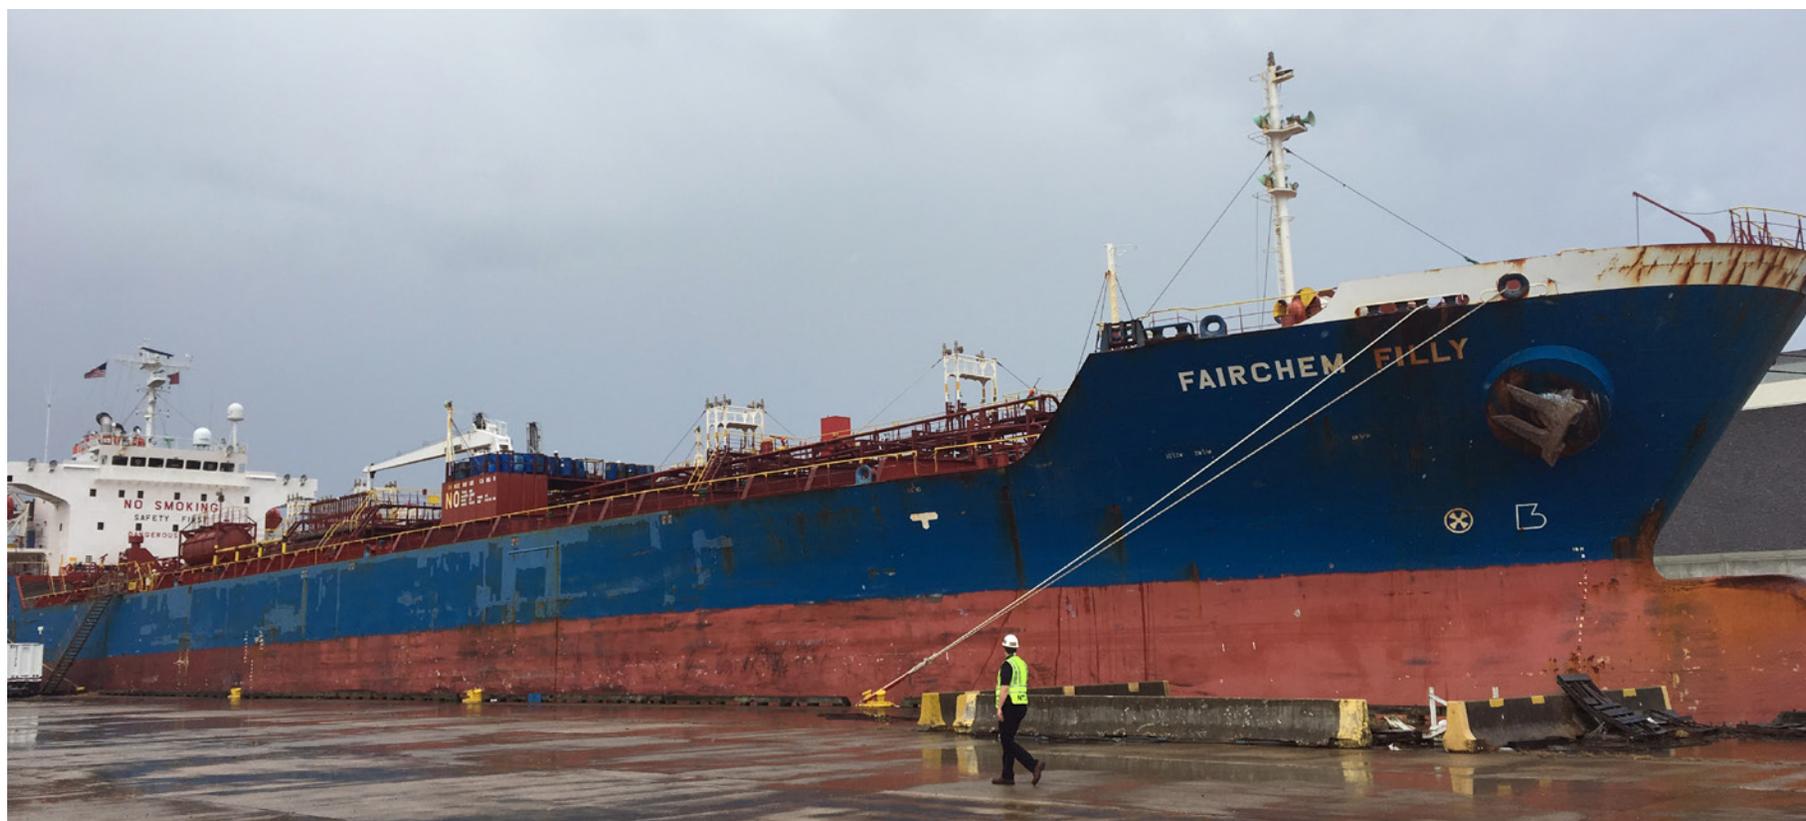
**Figure 181. Below:** Chemical tanker *Fairchem Filly* after the accident in Galveston, Texas.

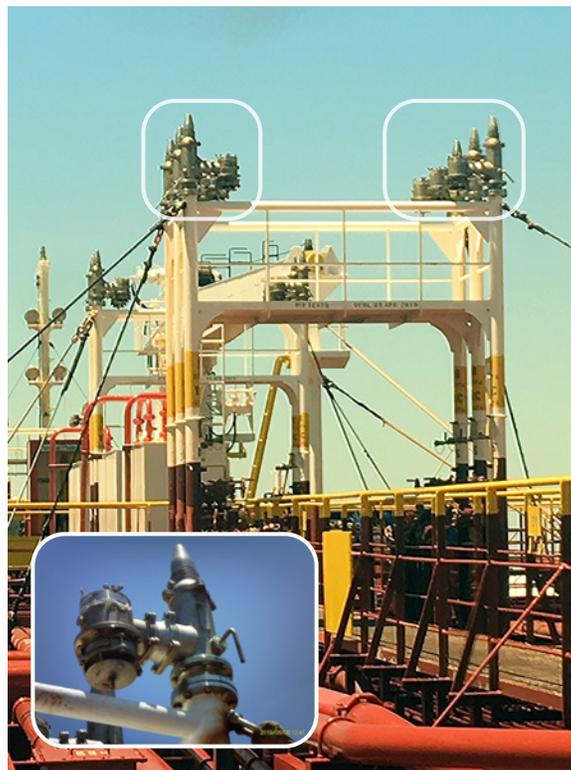
**Figure 183.** PV valves on board the main deck of the *Fairchem Filly*.

Unable to contact the Vopak PIC, the chief officer had the pumpman open the ship's nitrogen valve fully. At 0748, the 3P and 3S tanks registered an "ERROR" alarm, indicating a pressure of over 3.2 psi. About the same time, both the 3P and 3S cargo tanks protective PV valves, which were set to open at 2.9 psi, opened. It was later determined that rapid pressurization of the cargo tanks occurred, exceeding the PV valve capacity and overpressurizing the tanks to 15.8 psi. At 0749, the ship's crew turned off the cargo pumps, the terminal and the vessel closed their respective valves, and cargo transfer operations ceased.

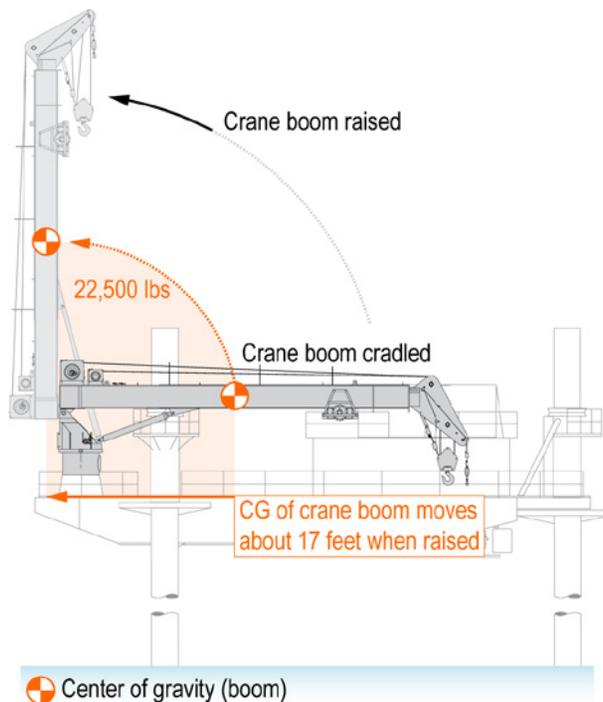
**Figure 184.** When the captain raised the *Kristin Faye*'s port crane boom, its center of gravity shifted about 17 feet.

The probable cause of the overturning of the liftboat *Kristin Faye* was the company's inadequate preload procedure that did not account for crane movements or the planned loads (weights) to be lifted, resulting in a "punch through" of one of the vessel's three legs.

**Liftboat Preload Tests**  
Prior to jacking up to expected operating height and commencing operations, liftboat operators should conduct preload tests, with the hull close to the water, that simulate all planned operational loads.

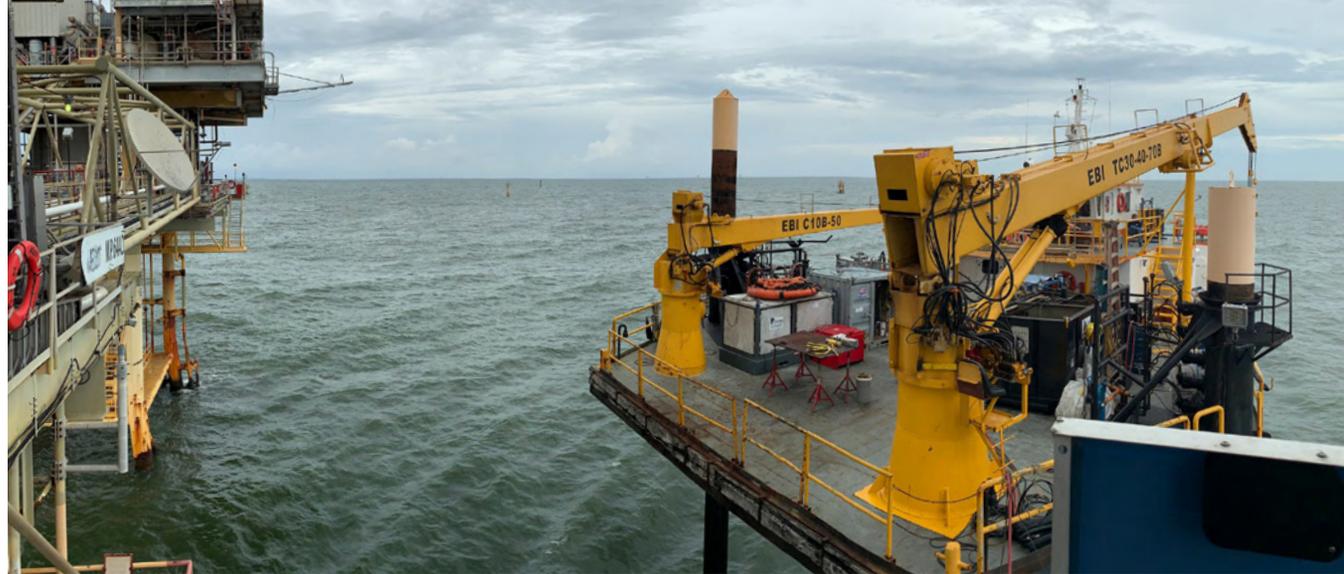
**Figure 185.** *Kristin Faye* (right) in an elevated position alongside Platform AQ (left) before the accident.

The morning of the accident, the *Kristin Faye* headed toward Platform AQ to receive and transfer the repaired 17,000-pound tank it had offloaded several days earlier. The captain maneuvered the liftboat slightly closer to Platform AQ than it had been a few days earlier, so the liftboat could extend a walkway to it. The captain said he was confident that a bottom survey used for the *Kristin Faye*'s operations at the platform five days earlier still verified the sea bottom clear of hazards or obstructions.

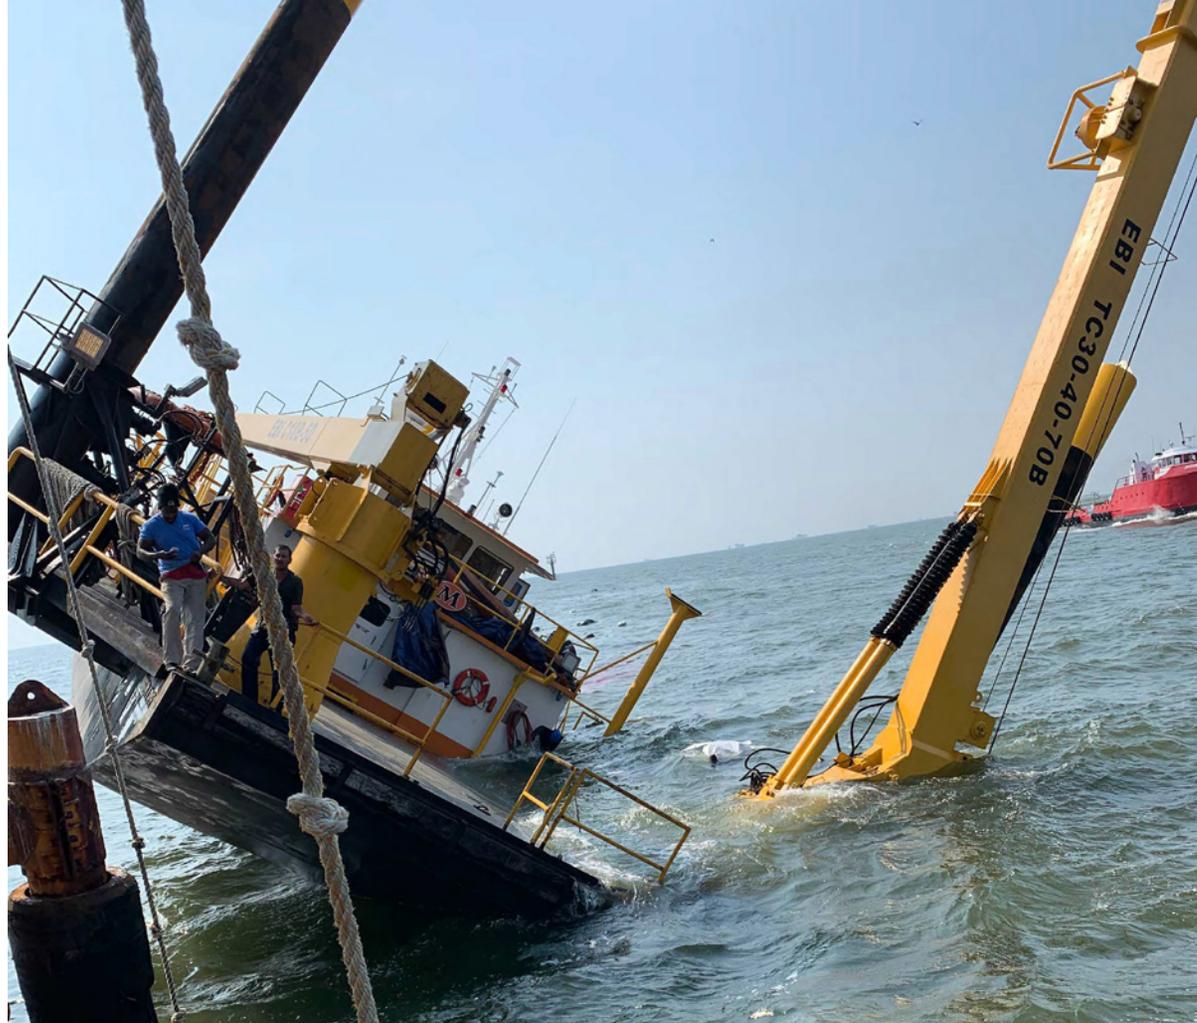
**Figure 186.** The toppled *Kristin Faye* after abandonment.  
SOURCE: SANARE ENERGY PARTNERS, LLC.
