Capsizing of Roll-on/Roll-off
Vehicle Carrier *Golden Ray*
St. Simons Sound, Brunswick River,
near Brunswick, Georgia
September 8, 2019

Marine Accident Report

NTSB/MAR-21/03
PB2021-100930

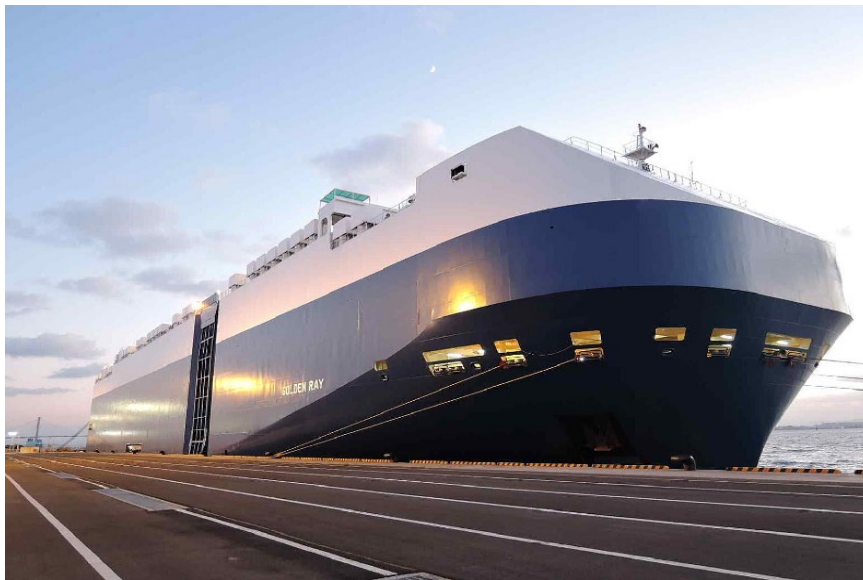
Figure 1. Roll-on/roll-off vehicle carrier *Golden Ray* before the accident.

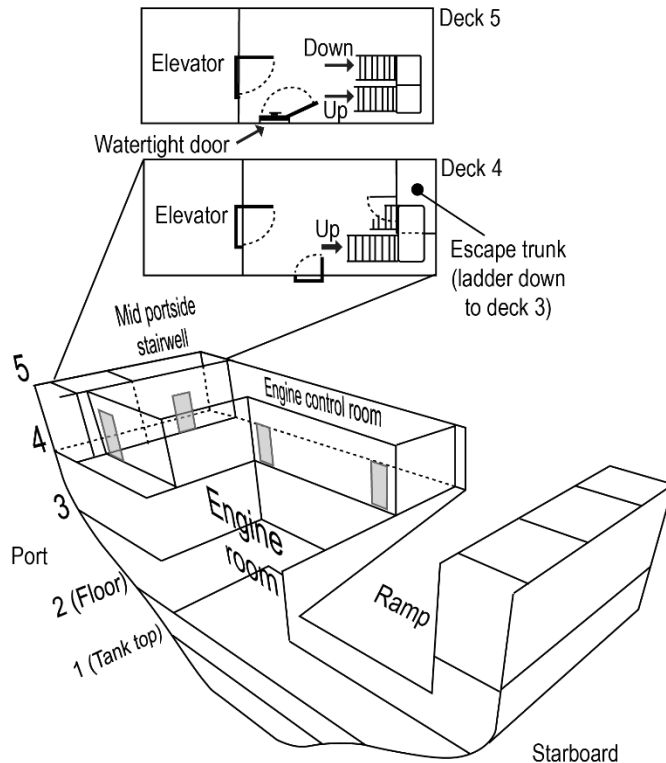
Figure 6. Simplified diagram showing a portion of the engine room and engine control room exits. Doors shaded gray.

the mid-portside stairwell—the primary stairwell serving the engine control room and engine room—but were blocked by incoming water, which was entering the stairwell from an open watertight door on deck 5. The engine control room also had three other doors facing aft that accessed the engine room directly (see figure 6).

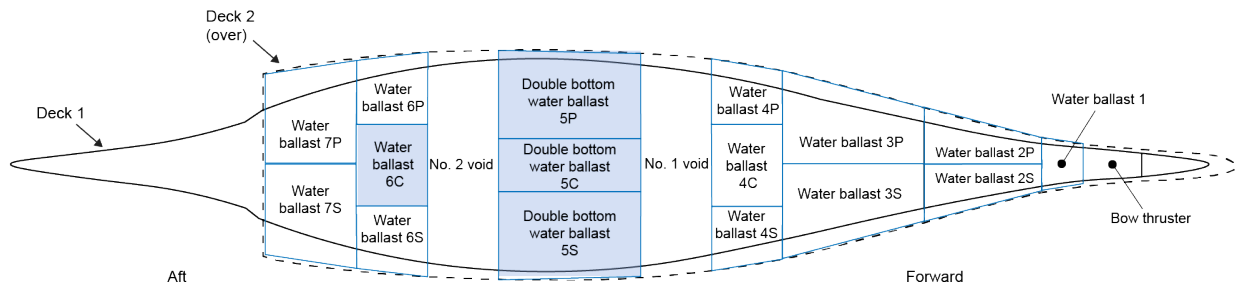
The vessel had 22 ballast tanks, comprised of 18 water ballast tanks, a fore peak tank, and 3 aft peak tanks (see figure 9). The total volume of the tanks was 9,842 cubic meters, and, when the tanks were completely full of salt water, the total capacity was 10,088 MT. Three water ballast tanks did not extend above the lowest cargo deck (deck 1) and were designated double bottom tanks (no. 5 starboard, centerline, and port water ballast tanks). (See [Appendix D](#) for water ballast tank levels at the time of the accident.)

Figure 9. Simplified plan of water ballast tanks on *Golden Ray*. Blue lines show water ballast tanks, and blue highlights show water ballast tanks used to transfer ballast prior to the accident voyage. Note: the solid line is deck 1, and the dashed line shows deck 2 above. Fore and aft peak tanks are not indicated for clarity.

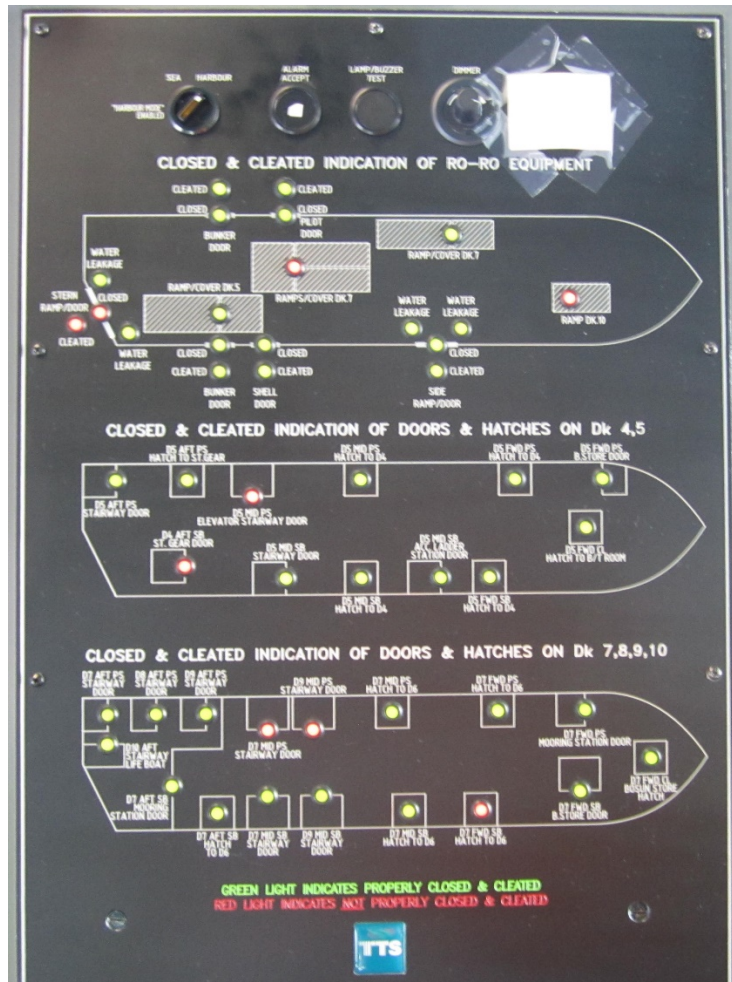
Figure 10. Watertight door indicator panel located on the bridge of the *Silver Ray*, a vessel of the same class as the *Golden Ray*.

The IMACS data showed that in addition to the portside pilot door, the watertight doors to both the aft and mid portside deck 5 stairwells were open at the time of the accident and had been open since 2341 on September 7 before the vessel departed the Colonel’s Island Terminal. The mid portside stairwell, about 75 feet (22.9 feet) aft of the pilot door, served as the primary access to the engine room and the engine control room on deck 4; the escape trunk stairwell serving the lower engine room exited to this stairwell at deck 4 (see figure 11).

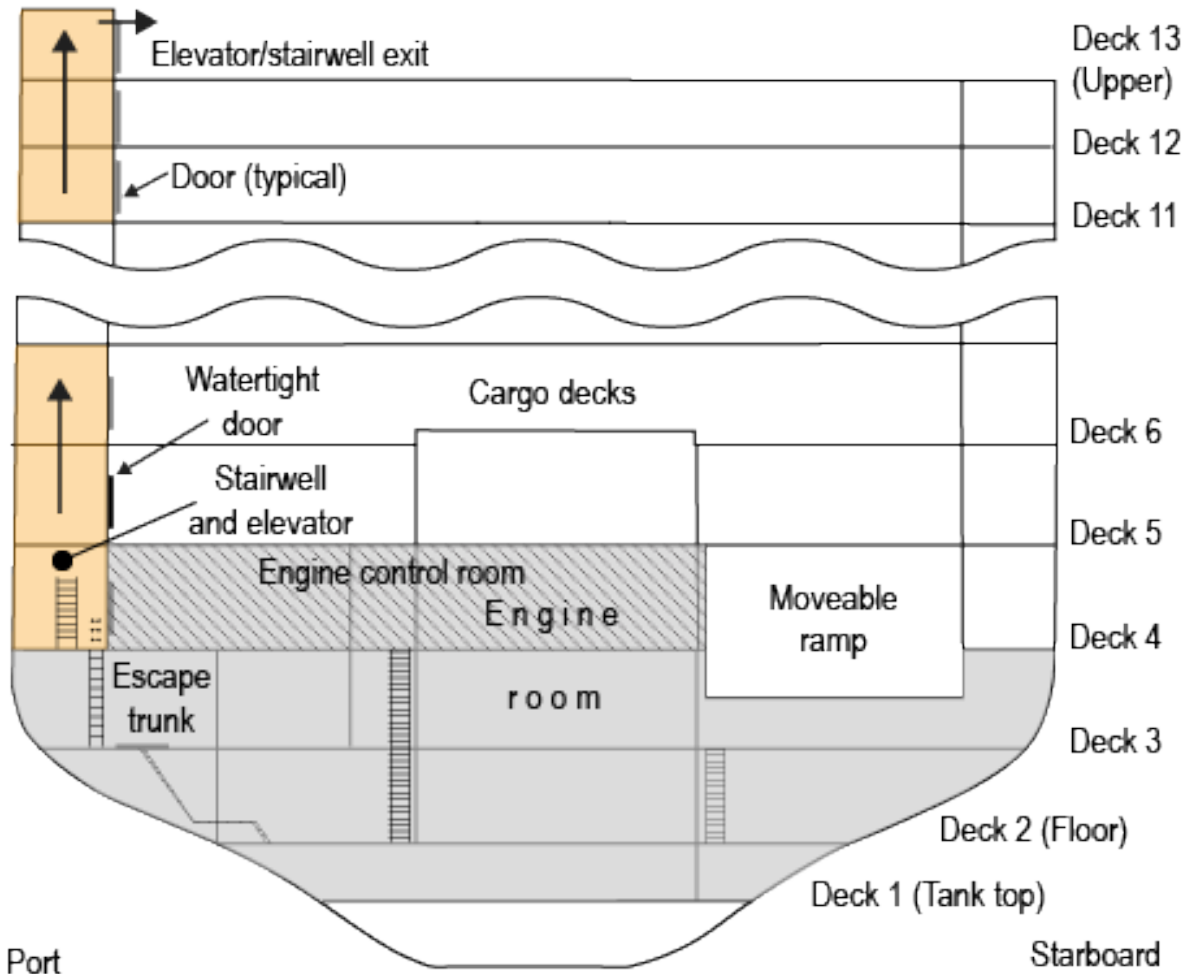
The aft portside stairwell at the stern served as access to the steering gear room on deck 4 (the engine room and steering gear room were separated by a watertight transverse bulkhead and connected to each other on deck 4 by a watertight door). Both the aft and mid stairwells were “towers”—isolated spaces with fire-protected bulkheads that ran vertically up to deck 13, with doors serving car decks in between (see figure 12). On deck 13, the upper deck, the doors allowed exit to the weather deck (outside). There was also an exit from the engine room on the port side from deck 4 by a series of vertical ladders that led up through the engine casing to the upper deck.

Figure 12. Simplified section view of the escape trunk and mid portside stairwell exit from the engine room and engine control room.

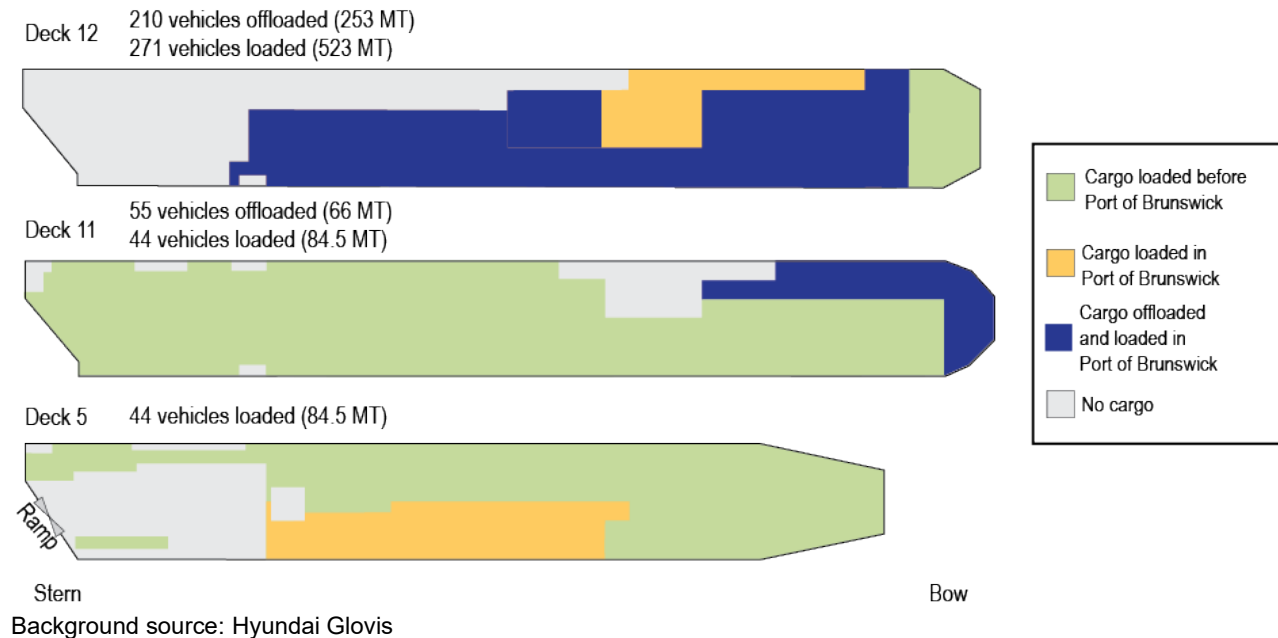
Figure 13. Preload plan (top view of decks 5, 12, and 13) for the *Golden Ray* at the Colonel's Island Terminal.

The chief officer stated that the preload plan that he received only contained the number and type of vehicles but did not contain the weight of each type of vehicle. (A postaccident review of the plan confirmed that the plan contained the number of vehicles and the total weight to be loaded in each loading location). Based on his experience, he estimated that each small vehicle being offloaded weighed 1.3 MT and each mid-sized vehicle being loaded weighed 2 MT, and he determined the total weight of the vehicles “based on the average weight of the given number of cars.” Using the stowage locations of the cargo provided in the preload plan and the estimated weight based on his calculations, the chief officer used the LOADCOM stability calculation program to determine the effect the cargo change would have on the vessel's stability. He concluded that the vessel would be able to accommodate the vehicles and meet stability requirements. He emailed the ship's agent to accept the preload plan before the vessel's arrival at the Port of Brunswick.

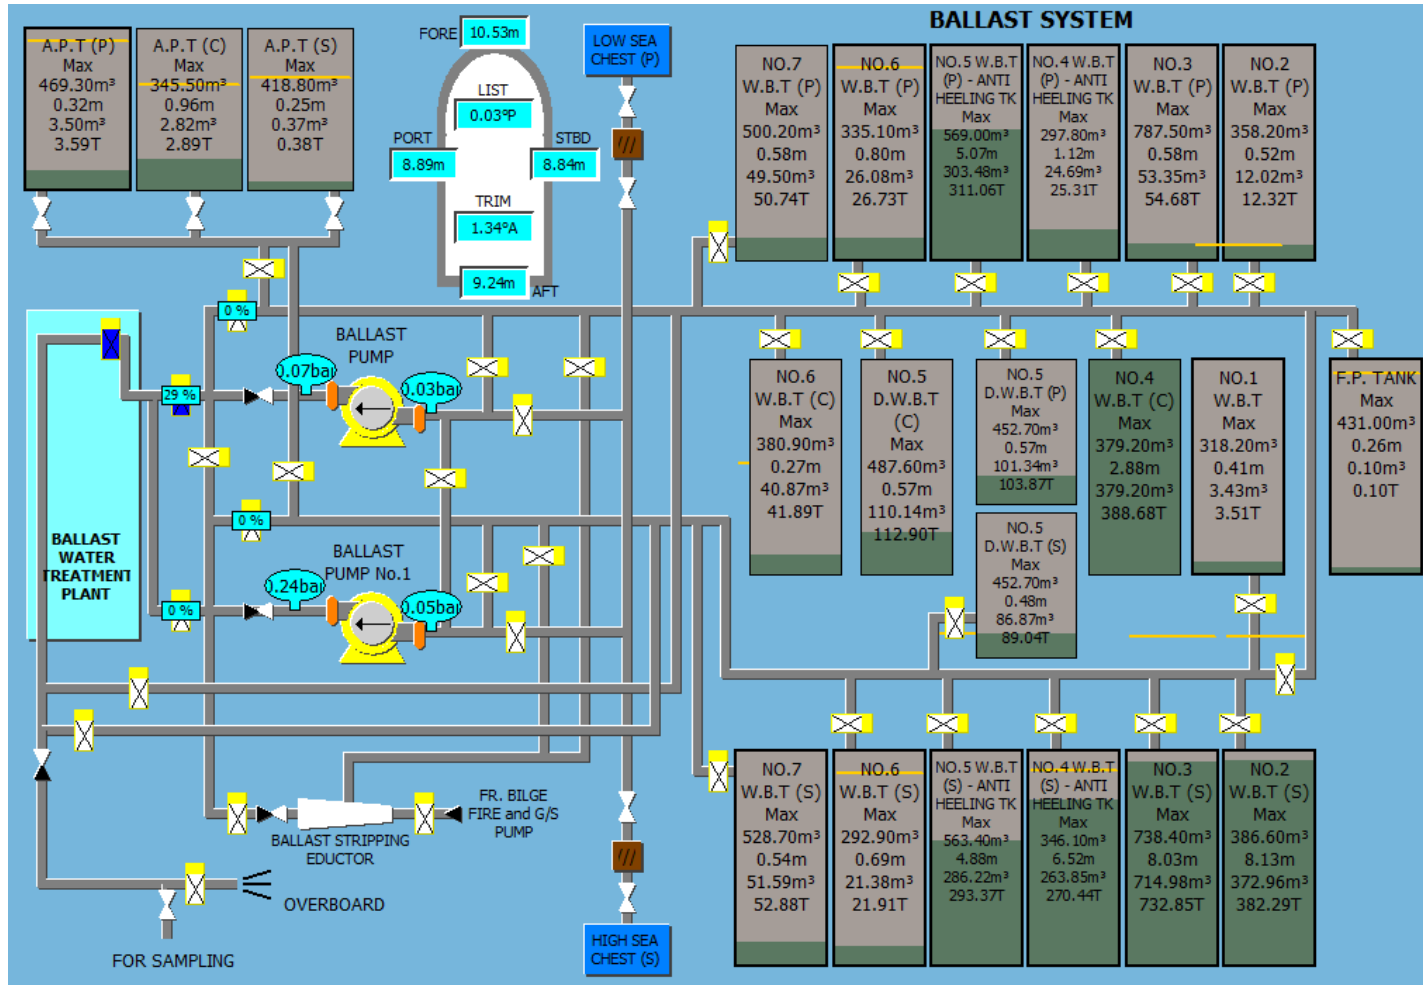
Figure D-1. IMACS water ballast system data before the *Golden Ray's* departure from the Colonel's Island Terminal.
