Fire aboard Roll-on/Roll-off Vehicle Carrier *Höegh Xiamen*

Pier 20, Blount Island

Jacksonville, Florida

June 4, 2020

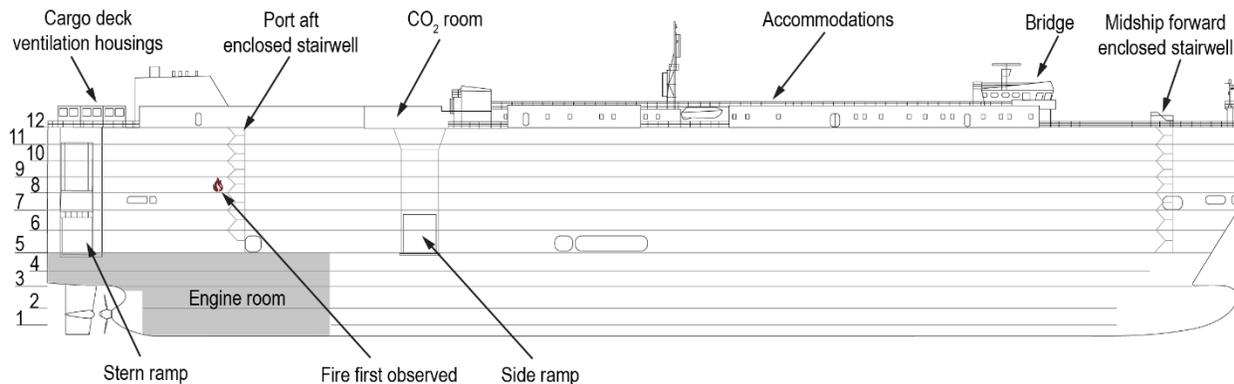
The chief mate sent an ordinary seaman and an able seafarer to decks 7 and 8 to investigate while he secured the cargo deck fans.⁴ The chief mate also sent the vessel's electrician to close the remotely controlled ventilation dampers.⁵ The chief mate stated that closing these dampers slowed but did not stop the smoke (the ventilation system's manually operated dampers remained open). At this time, he saw other crewmembers leaving their staterooms and donning firefighting equipment. About the same time, the chief engineer went to cargo deck 11 and began searching for smoke on the cargo decks, working his way to deck 7, by going down the port aft enclosed stairwell and checking each deck from the stairwell (the vessel had two stairwells: one located portside aft and one located on the centerline forward) (see figure 3).

Figure 3. *Höegh Xiamen* inboard profile. (Background source: Höegh Technical Management)

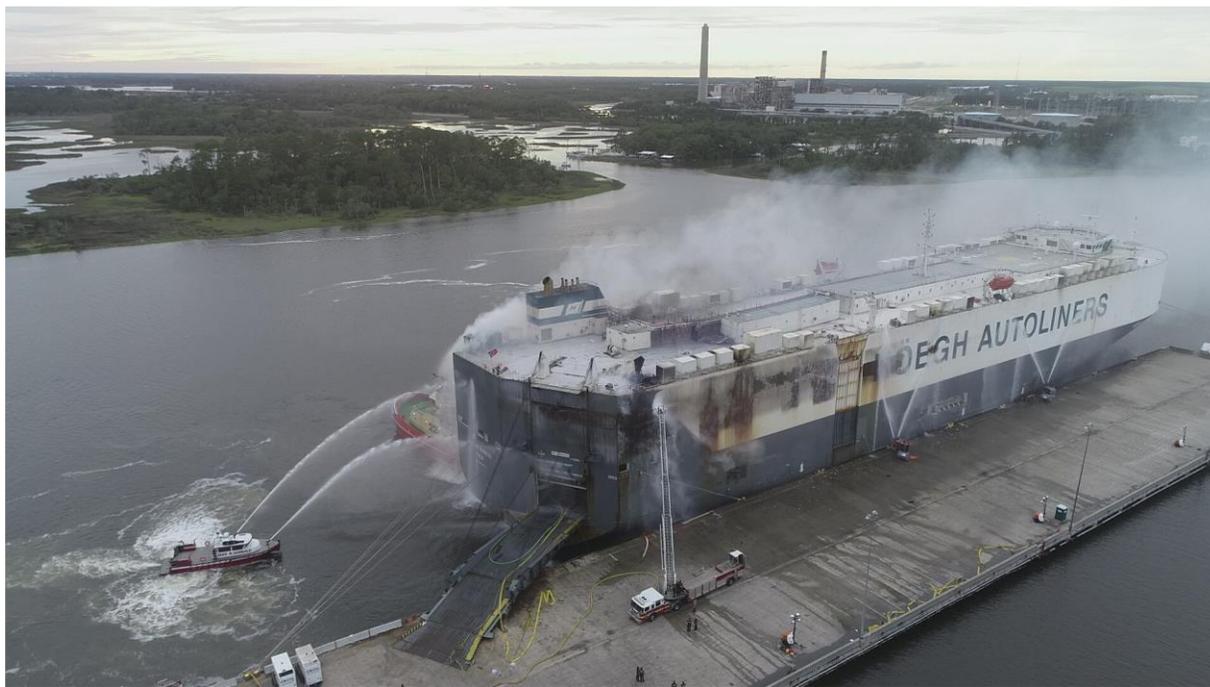
Following the explosion, the firefighters, assisted by the Coast Guard, transitioned to a defensive strategy where they focused on boundary-cooling to avoid flooding the higher decks and affecting the vessel's stability until personnel, including a naval architect, and equipment from the commercial salvor (Resolve Marine) identified in *Höegh Xiamen's* Coast Guard-approved non-tank vessel response plan arrived about 0130 on June 5 (see figure 6).⁸ Personnel from Resolve Marine continued to arrive over the next week to assist with boundary-cooling while the Coast Guard and personnel from the Port of Jacksonville worked on security and oil spill containment. The fire continued to burn for 8 days, destroying the interior of cargo decks 7 through 11 and deck 12, including the accommodations.

Figure 6. Firefighters conducting exterior boundary-cooling on June 5, 2021, the day after the fire was discovered. (Source: JFRD)

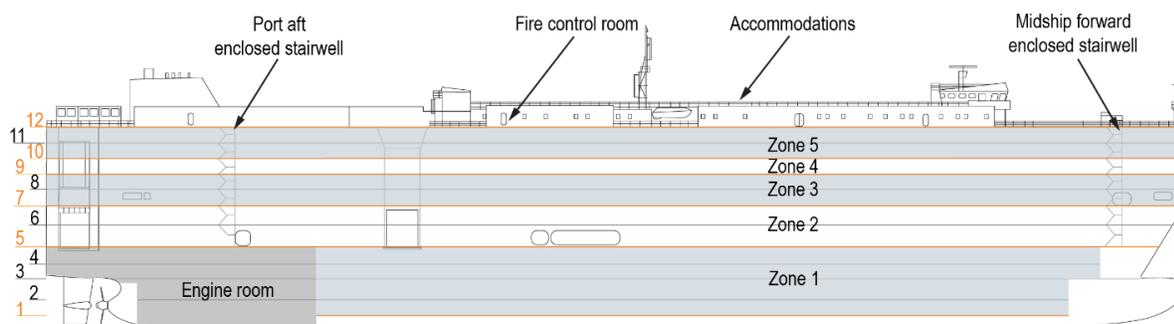
Of the vessel’s 11 decks used for cargo stowage, decks 3, 5, and 7 were stronger and intended to carry high and heavy rolling units, as well as static cargo, while the rest of the decks were intended to carry cars and other light-wheeled cargo. The cargo decks were open along the entire length of the vessel (bow to stern) but were divided vertically by retractable ramps between decks into five horizontal gastight fire zones: decks 1–4 comprised zone 1; decks 5 and 6 comprised zone 2; decks 7 and 8 comprised zone 3; deck 9 comprised zone 4; and decks 10 and 11 comprised zone 5 (see figure 8).

Figure 8. *Höegh Xiamen* fire zones. The vessel’s gastight decks, which separate fire zones, are highlighted orange. (Background source: Höegh)

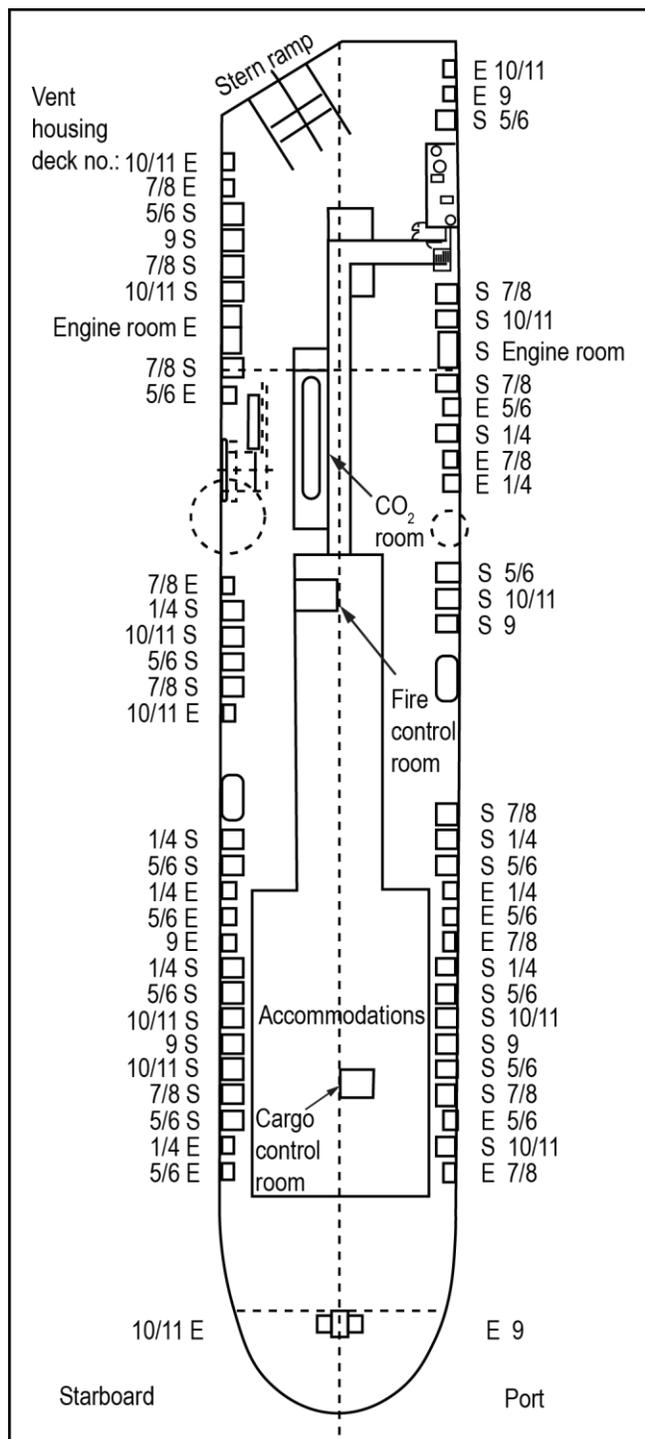
Fresh air was drawn into and expelled from the cargo holds through a system of closable dampers, fans, and large ventilation shafts, known as trunks (see figure 9). The vessel's cargo deck supply and exhaust ventilation trunks were located along both sides of the vessel and ran from each cargo deck to deck 12. The supply and exhaust trunks provided fresh air through vent grilles to ventilate the cargo decks during vehicle loading. The trunks were independent of each other. However, since decks within the same fire zone were not gastight from each other, for fire zones that encompassed two decks (such as decks 7 and 8), the ventilation was mixed in the cargo area, and, therefore, the independent trunk served both decks (figure 10 shows a portion of the portside aft ventilation trunks). The exhaust and supply fans for these ventilation trunks were also located on deck 12 along the periphery of the ship from bow to stern in ventilation housings.

Figure 9. Diagram of deck 12 showing ventilation housings. Each exhaust is marked with an "E," and each supply is marked with an "S."

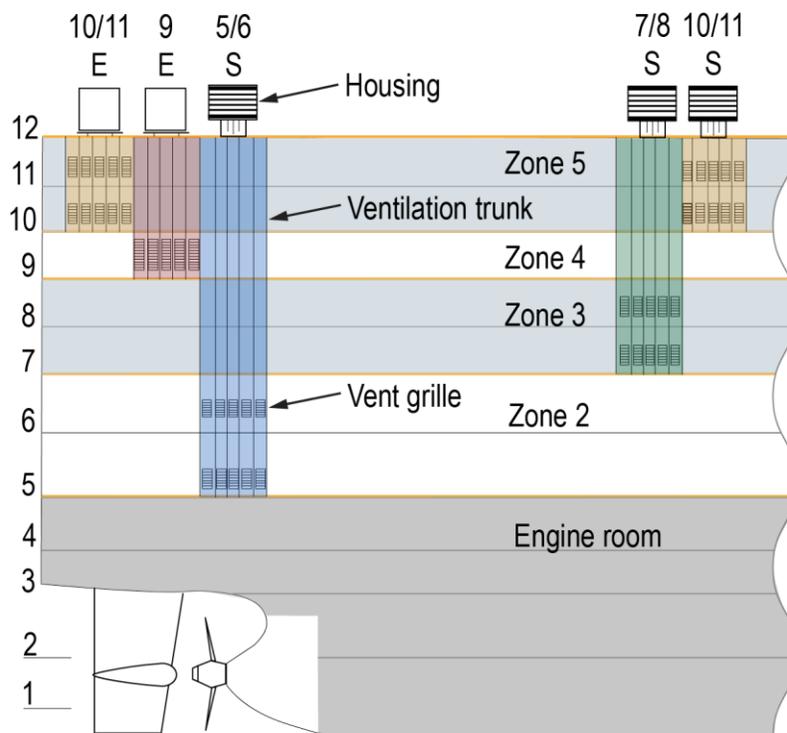
Figure 10. Arrangement of portside aft cargo ventilation trunks on deck 12. Each exhaust is marked with an "E," and each supply is marked with an "S." This only represents a portion of the exhaust and supply ventilation trunks.

Each supply and exhaust trunk was fitted with a fire damper that could be closed (in conjunction with stopping the supply fans) to cut off the air to a fire zone in case of fire. The dampers were gravity sealed. The Fire Control and Safety Plan listed 58 manual dampers for cargo spaces. The plan did not list remotely controlled dampers, but crewmembers reported that modifications had been made to the ship since the plan's creation in 2010, and some remotely controlled dampers were replaced with manually operated dampers. The plan was not updated with the manually operated dampers. The remotely controlled dampers could be secured from the cargo office, while the manually operated dampers required a crewmember

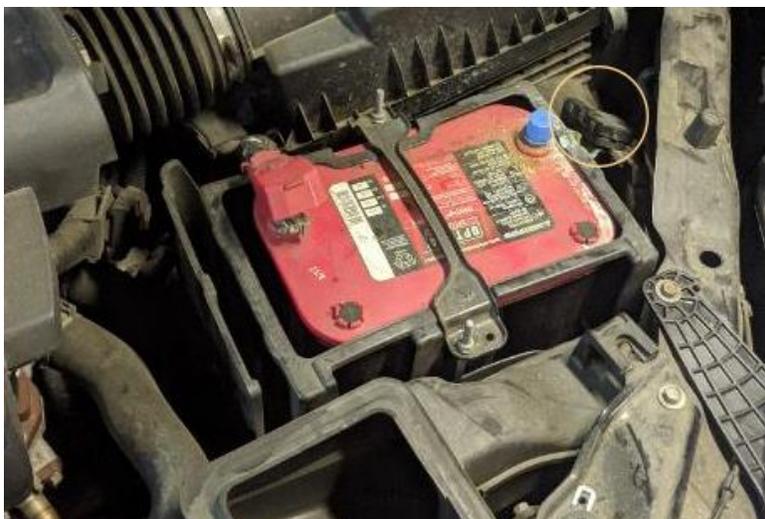
Grimaldi instructed SSA to create a "battery brigade" of ILA longshoremen who would be solely responsible for following behind vehicles as they were loaded and parked in order to disconnect the batteries. The brigade was required to disconnect the negative cable from the battery, tuck the cable away from the battery terminal, and cover the battery post with the battery cap (see figure 12). Once the cable was disconnected and the hood was shut, the brigade would mark the unit with grease marker to identify the vehicle as having a disconnected battery. Before loading, on May 22, 2020, the Grimaldi port captain emailed the company's written procedure to SSA and instructed, "Please note that I can't stress enough the importance of battery disconnect. Please ensure to have battery caps and adequate mechanics ordered to keep up with production."

Figure 12. Excerpt from Grimaldi battery disconnect procedure showing a vehicle battery secured with a blue plastic negative terminal cap and disconnected cable (*circled*) tucked inside. (Source: Grimaldi)
