# **SAFETY DIGEST**

**Lessons from Marine  
Accident Reports  
2/2020**

**SAFETY DIGEST**  
**Lessons from Marine Accident Reports**  
**No 2/2020**

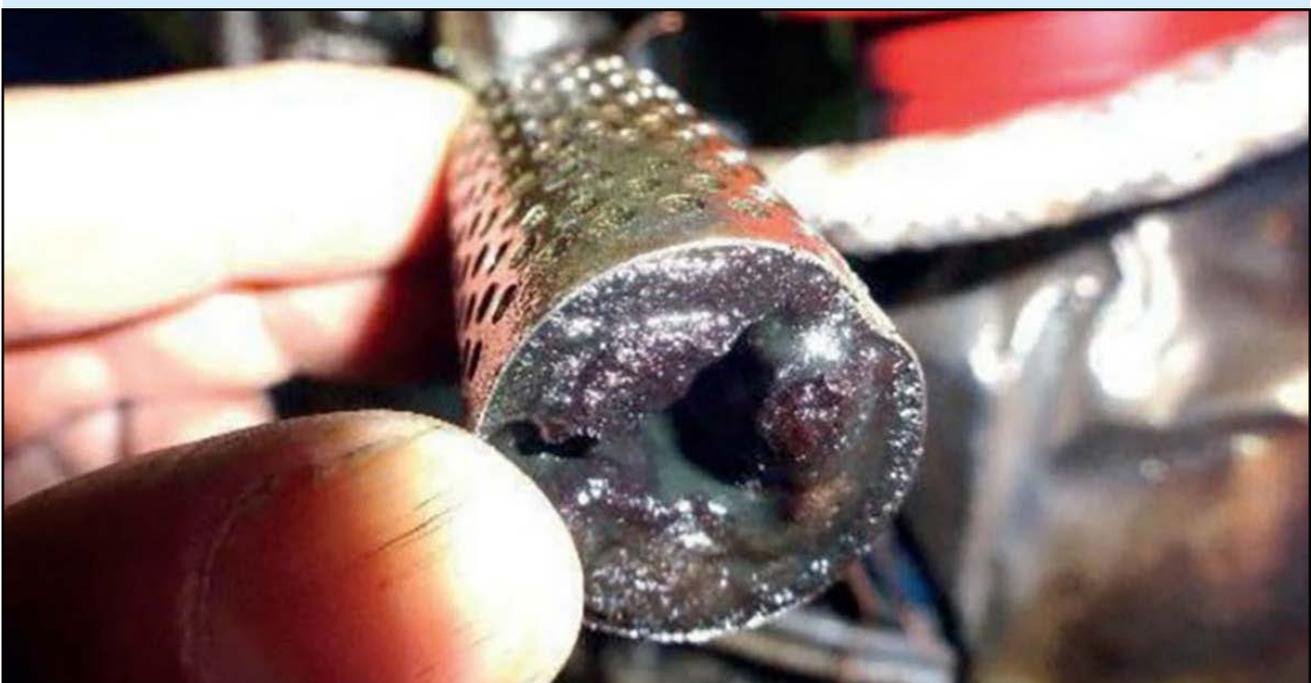
In this case, the ship had been operating in Arctic waters where the air temperature had dropped to minus 14°C and the sea temperature was between 3°C and 5°C. In these conditions, the ship's engine room ventilation system allowed the ambient temperature to drop to very low levels, resulting in significant cooling of the MGO pipework. This created the environment for the crystals to form in the MGO fuel lying dormant in the supply pipework, which blocked the filters soon after the MGO fuel supply was selected. A number of actions could have been in place to minimise this risk, specifically: pipework insulation, pipework heating, circulation of the fuel back to the service tanks or the use of a fuel additive.

Figure 2: An example of waxy deposits formed in a fuel line (library image, not from this incident)

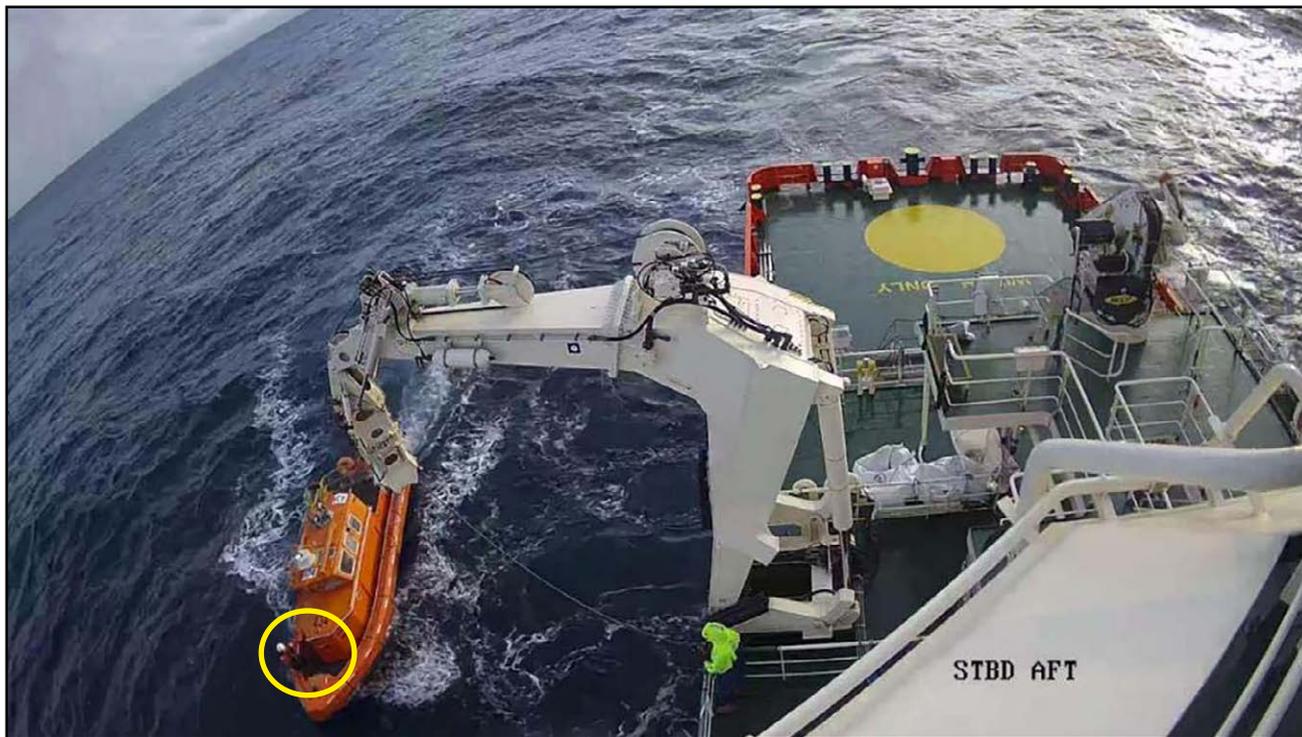
Figure 1: The bowman moves forward as the daughter craft approaches the falls

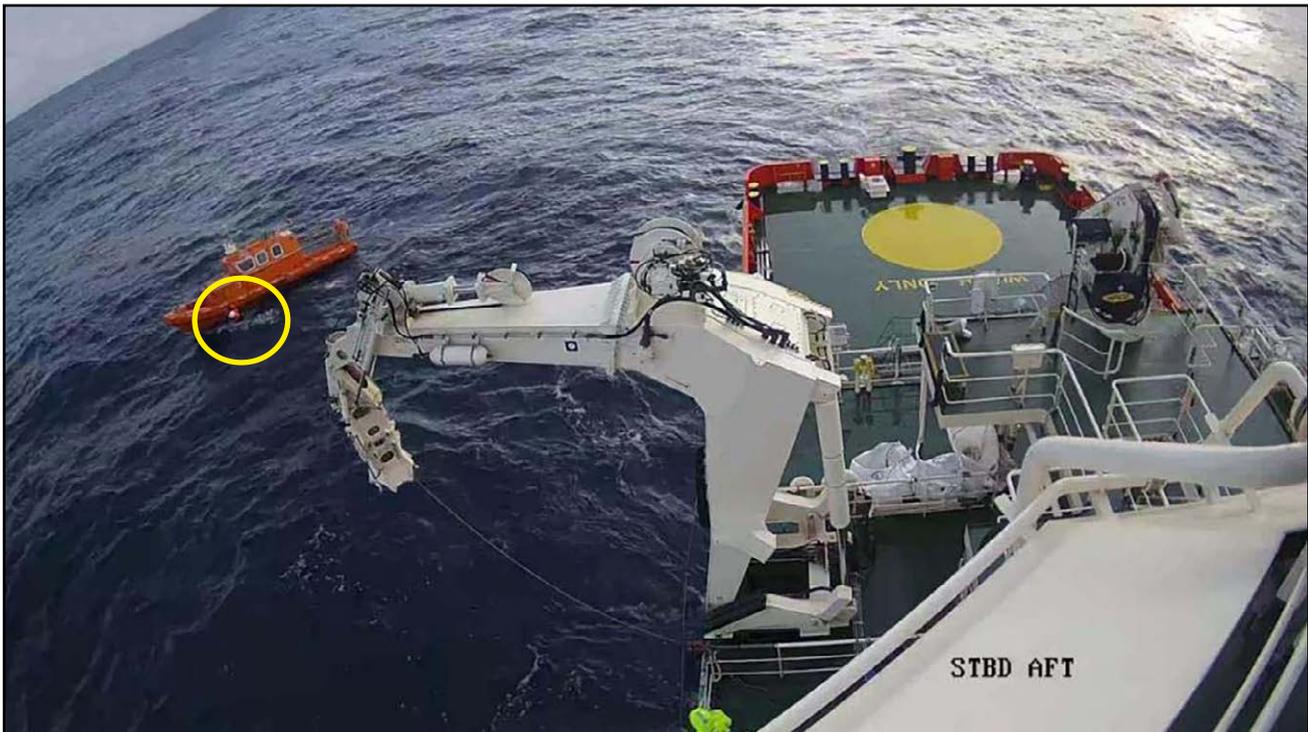
The bowman was wearing a safety tether, which prevented him from being separated from the daughter craft. The coxswain could see what had happened and immediately manoeuvred the daughter craft away from the support vessel to eliminate the risk of crushing the bowman.

Figure 2: The daughter craft manoeuvres away from the mother ship as the bowman, secured by his lifeline, holds onto the grabline

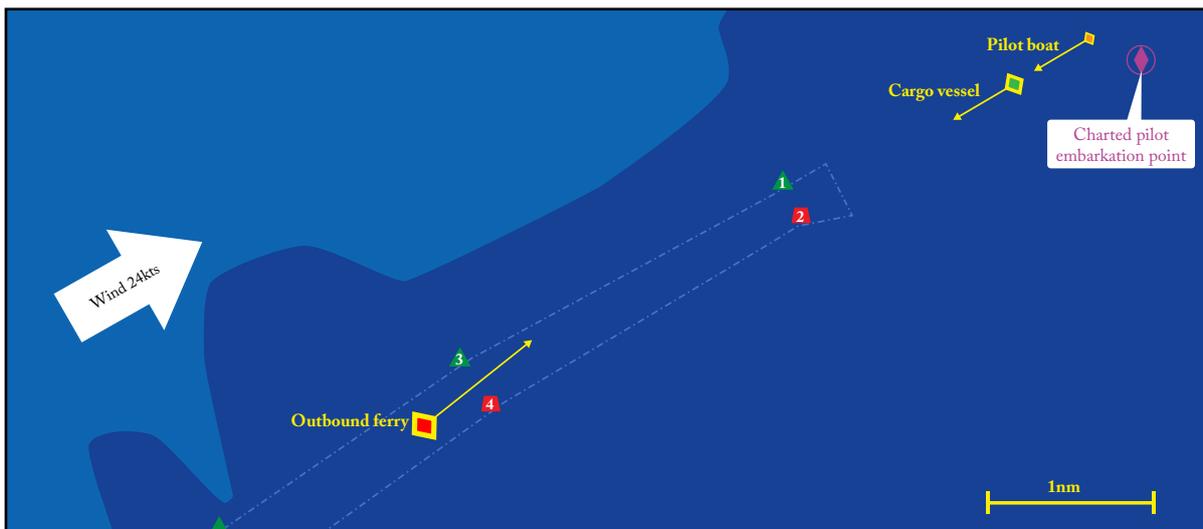
Figure 1: The outbound ferry and the inbound cargo vessel prior to the pilot transfer

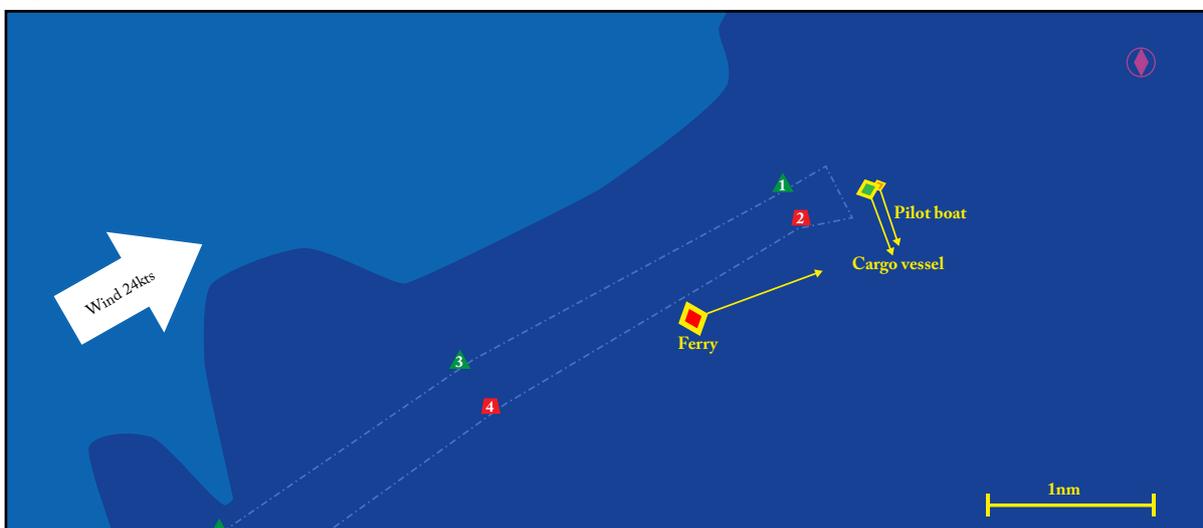
and that he hoped the cargo vessel would not proceed too far in his direction. As the cargo vessel started its turn to port, the vessels were just over a mile apart (Figure 2).

Figure 2: The situation during the pilot transfer

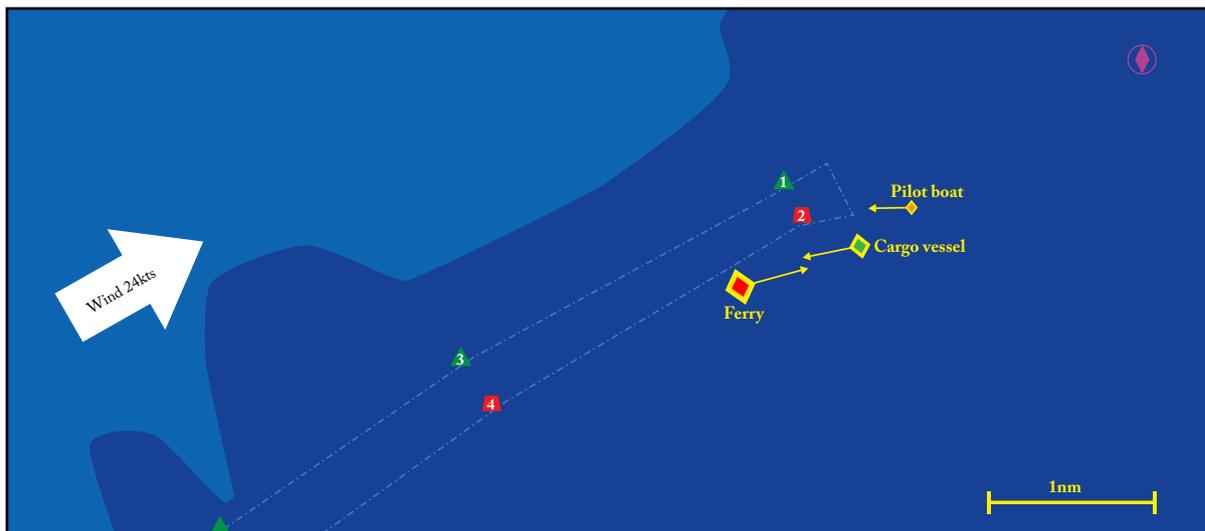
As soon as the pilot arrived on the cargo vessel's bridge after the transfer, it was immediately apparent that urgent action was required to avoid collision. The pilot informed the ferry's master that he was altering course hard to starboard and, at the same time, the ferry's master had applied astern power to stop the vessel (Figure 3). Both these actions prevented collision and, after passing, the vessels continued their passages without further incident.

Figure 3: The close pass after the cargo vessel had been altered back to starboard

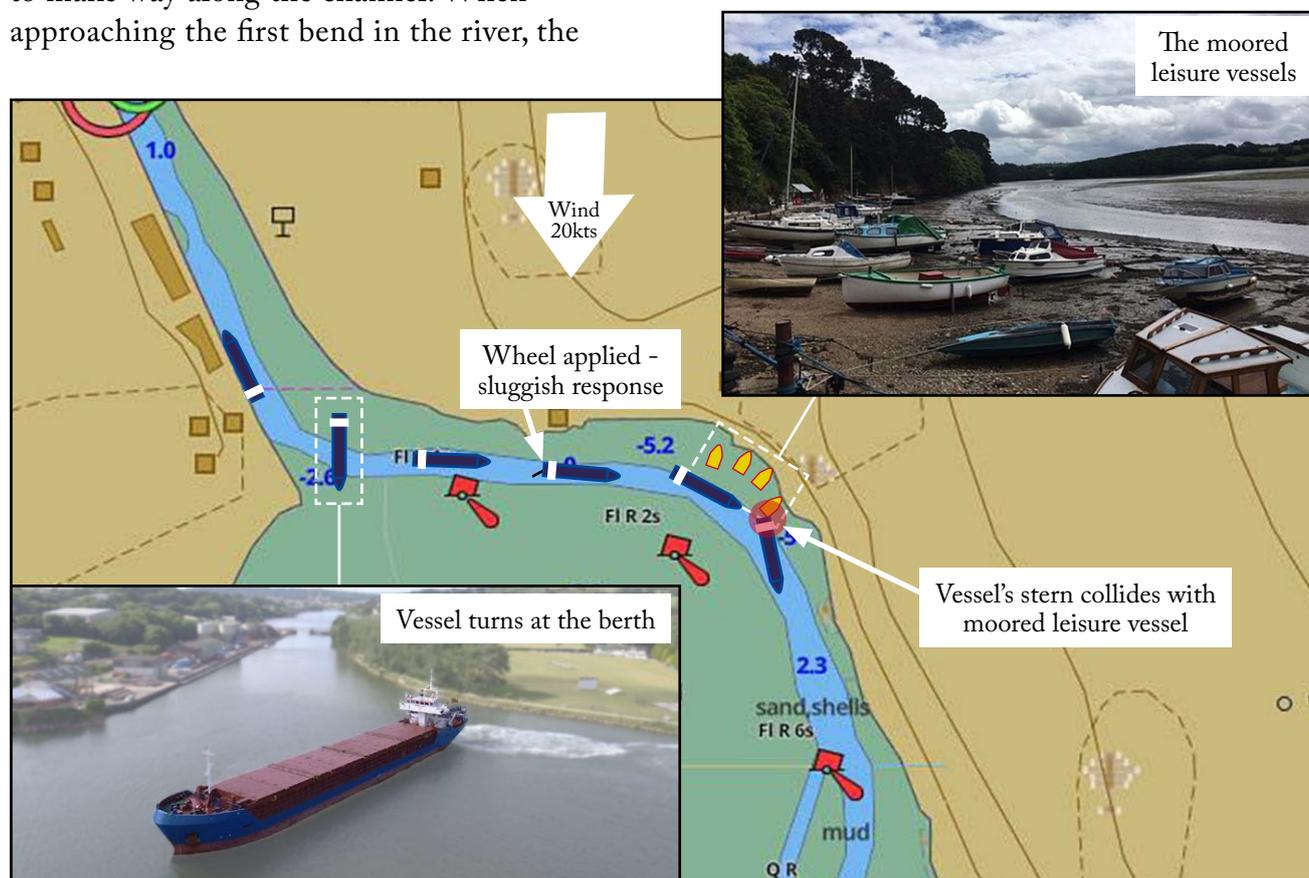
pilot applied starboard wheel, but the vessel did not respond. More wheel was soon applied and the vessel started to turn slowly to starboard. However, by this time, the vessel was on the port side of the channel and its stern struck a small, moored leisure vessel during the turn. There were three people on board the leisure vessel at the time of the collision; thankfully, none were injured.

Figure: Overview of accident

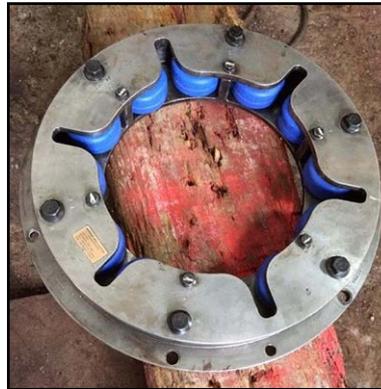
A gearbox inspection revealed that all 12 of the coupling pads had disintegrated to varying degrees (see figure). As the vessel carried no spare coupling pads, the vessel's engineer was unable to restart propulsion. The skipper called the coastguard for assistance. An hour and a half later a lifeboat was on scene to tow them to the nearest harbour.

The coupling pads were subsequently examined by the gearbox manufacturer and it was established that they were of the wrong type. They were not designed for varying torque applications such as a propulsion shaft gearbox

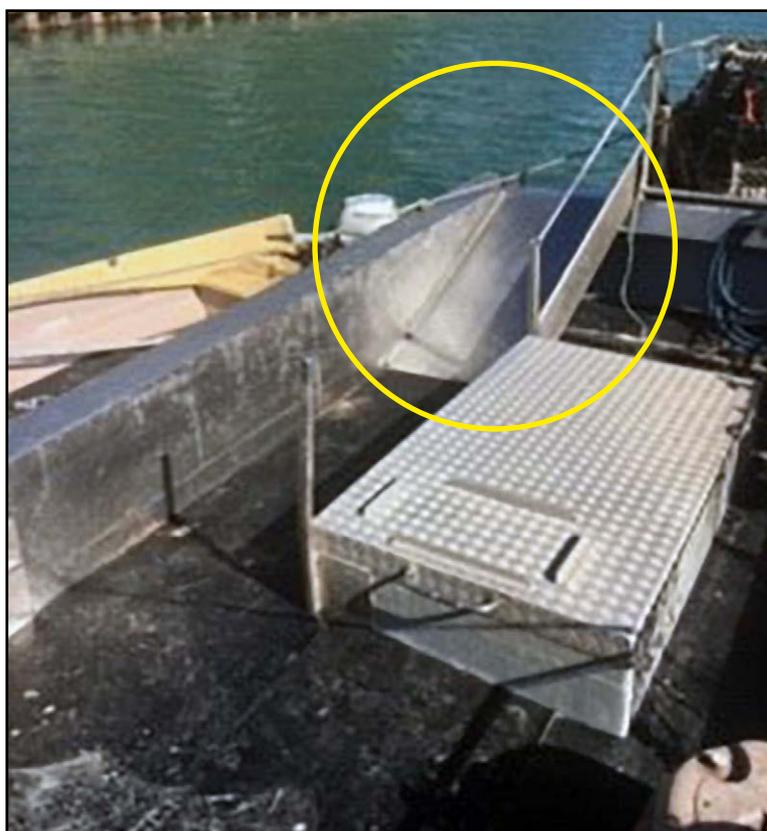
Figure 1: Stern ramp on starboard side

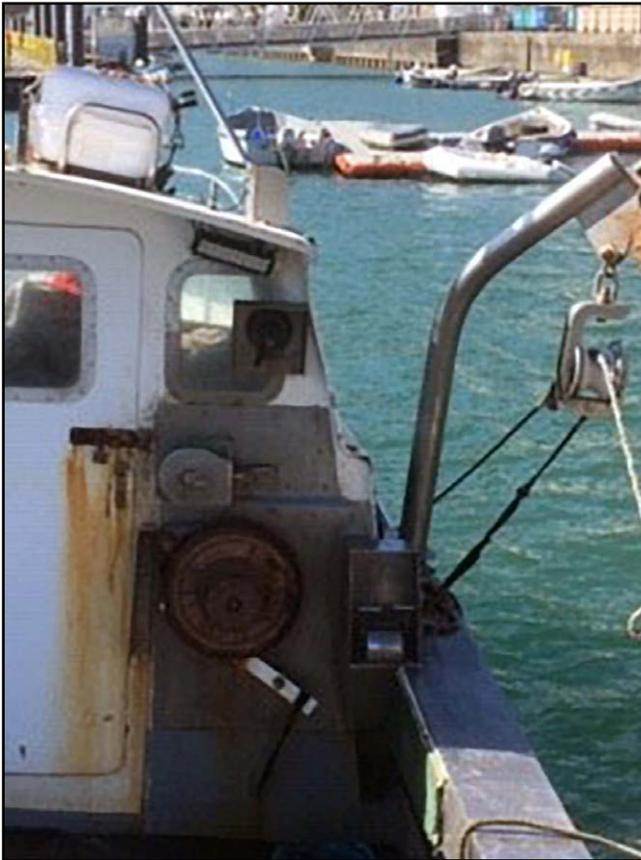
The skipper quickly stopped the boat and put the back rope from the string of pots on to the hauler (Figure 2). He was able to successfully lift the crewman to the surface. The crewman's lifejacket (Figure 3) had automatically inflated and this assisted in bringing him to the surface. The skipper tied off the rope and was able to swing the crewman back on board. The skipper then headed into port, where the crewman was taken to hospital. On examination it was found that the crewman had broken his forearm where he had wrapped the rope around his arm, and he was suffering from mild hypothermia.

Figure 2: The hauler

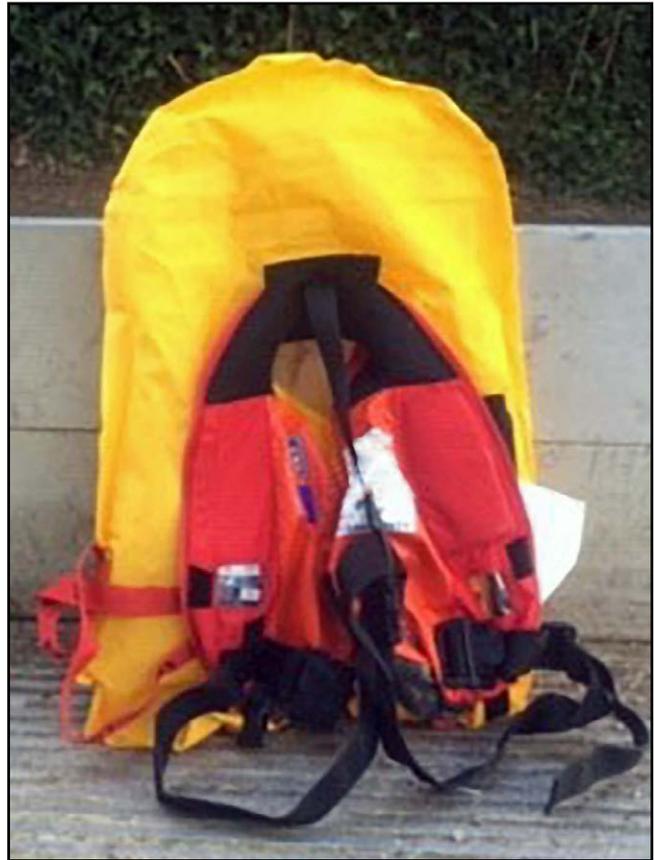
Figure 3: The crewman's lifejacket

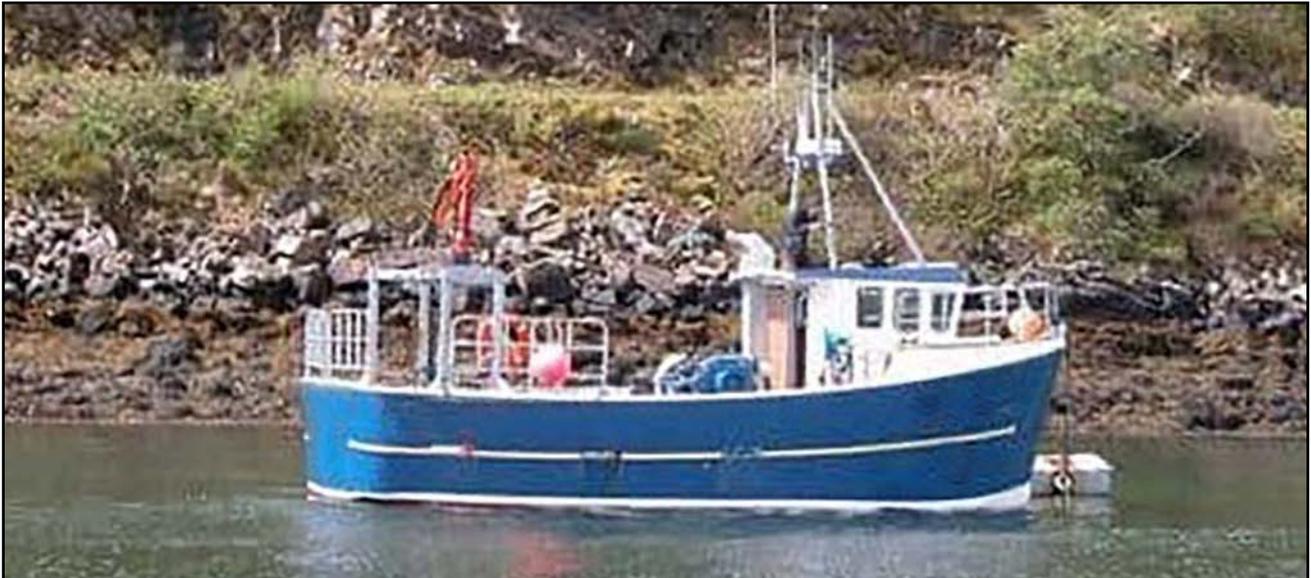
This fishing vessel had been extensively modified from its original design. Modifications made prior to the change of ownership included: the addition of a shelter deck, which extended almost the full length of the vessel; a hydraulic hauler, which weighed 400kg and was fitted 2 metres above the deck; and a vivier tank for storing live catch. Figures 1 and 2 show the vessel before and after the modifications. No checks on the vessel's stability had been made by the previous owner and the new owner assumed that it was safe. When heading to sea on the day of the accident, the boat was heavily loaded with strings of creels ready to lay for the first time. The combined effects of the modifications and the excessive loading high up created the unstable situation, resulting in capsizing and placing the lives of the crew in immediate danger.

Figure 1: The vessel prior to modification

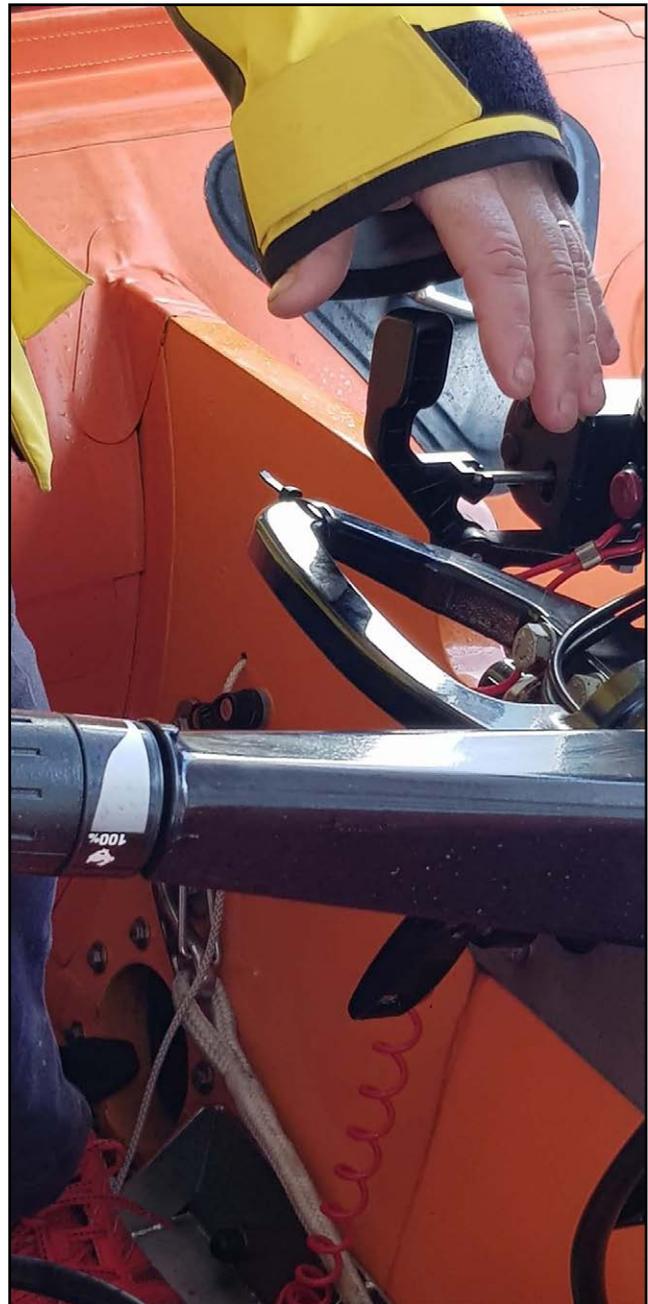
The helmsman moved his left hand forward towards the tiller arm of the outboard to centre the engine. In doing so his left jacket cuff became caught on the gear selector, putting the engine into ahead gear. The boat started moving forward, surprising all on board. It unbalanced the crew member holding on to the moored boat, who bumped into the - also unbalanced - second crew member preparing to board, who then bumped into the third crew member. Both the second and third crew members fell over the port side of the inflatable boat and into the water, where their lifejackets automatically inflated. Reacting quickly, the helmsman pulled his arm away from the engine while stopping it by disconnecting the kill cord.

Figure: Loose cuffs can catch controls!

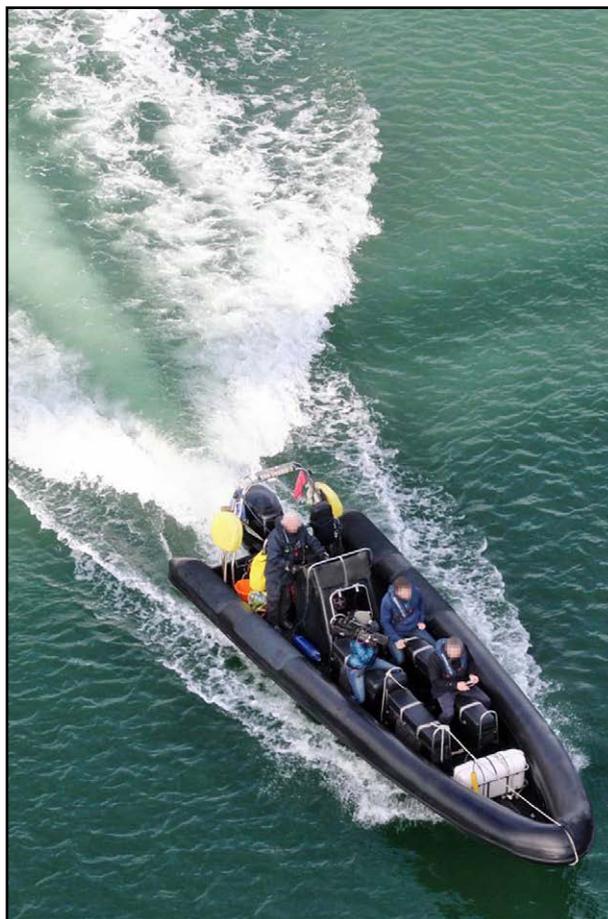
Soon after these turns, the skipper became aware of a passing merchant vessel that was creating a significant wake, so he reduced speed and altered course to approach the wake at an angle. After crossing the wake, the RIB slammed back down on to the water, and a female passenger, who was sitting in the seat closest to the bow on the port side, indicated that she was in pain. The RIB was returned to the pier and the casualty was assisted ashore by her partner (who was also on board) and the skipper before being taken to hospital by ambulance.

Figure: The powerful RIB (not at the time of the accident)

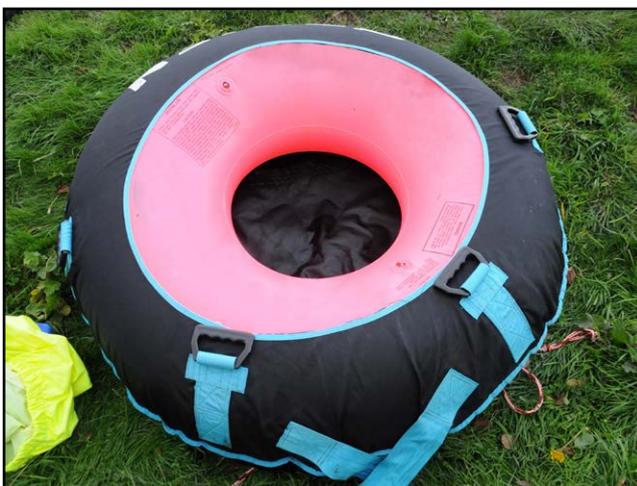
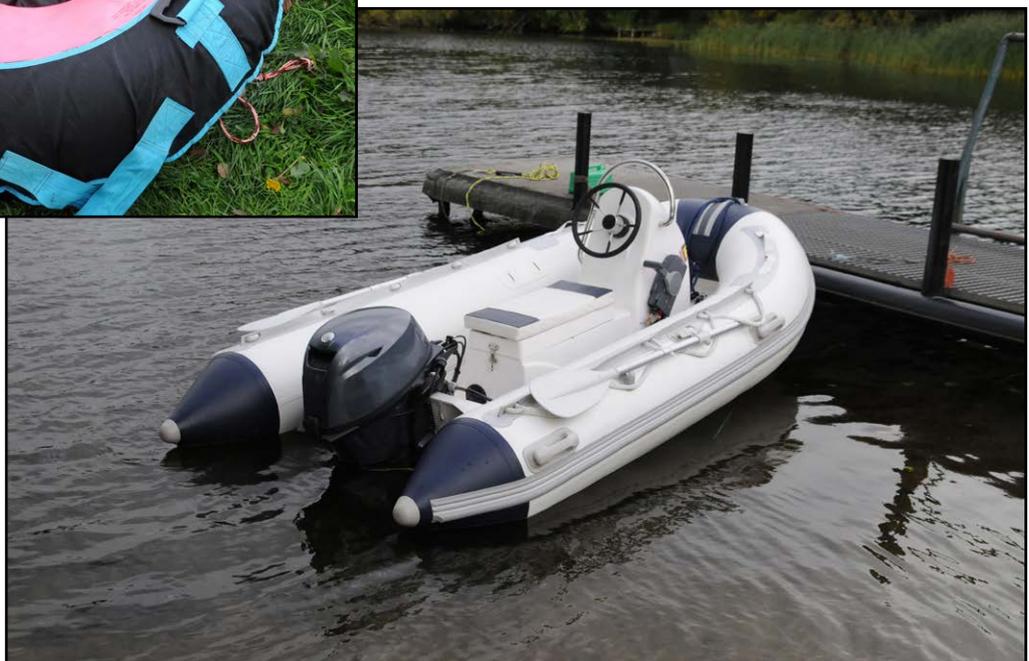
Figure 1: The towing boat (inset: the towable ring)

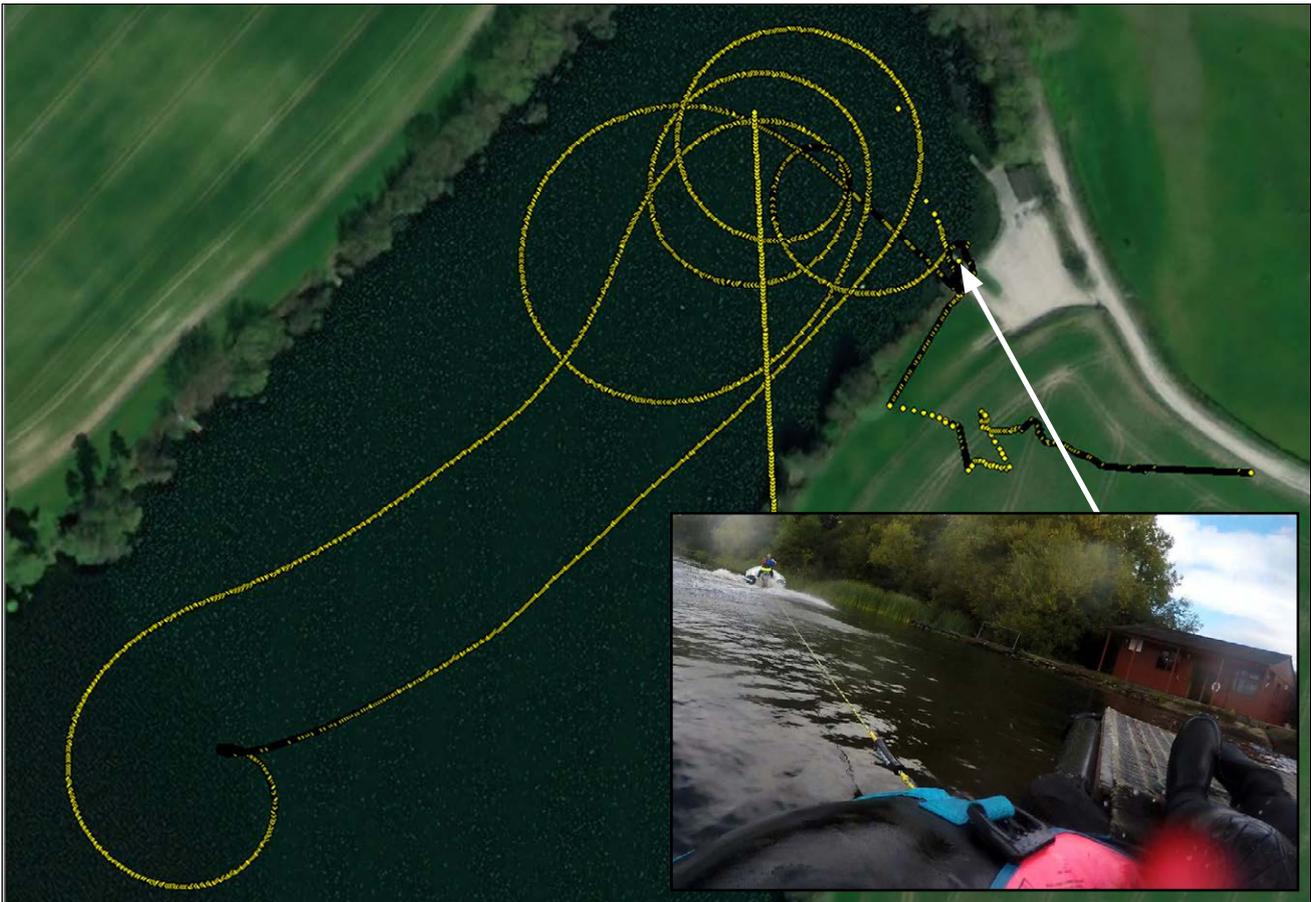
A few circuits were made of different sections of the lake (Figure 2), but when the boat's helmsman decided to make a few tight left-hand turns the resulting pendulum effect forced the ring and its adult occupant to accelerate outward towards the side of the lake. After a couple of turns, the boat became too close to the side of the lake in front of the rest of the family, and resulted in the ring and its occupant hitting the jetty, which jutted into the lake, at a speed of about 20mph.

Figure 2: The action cam track from around the lake (inset: the moment of impact, captured on action cam)

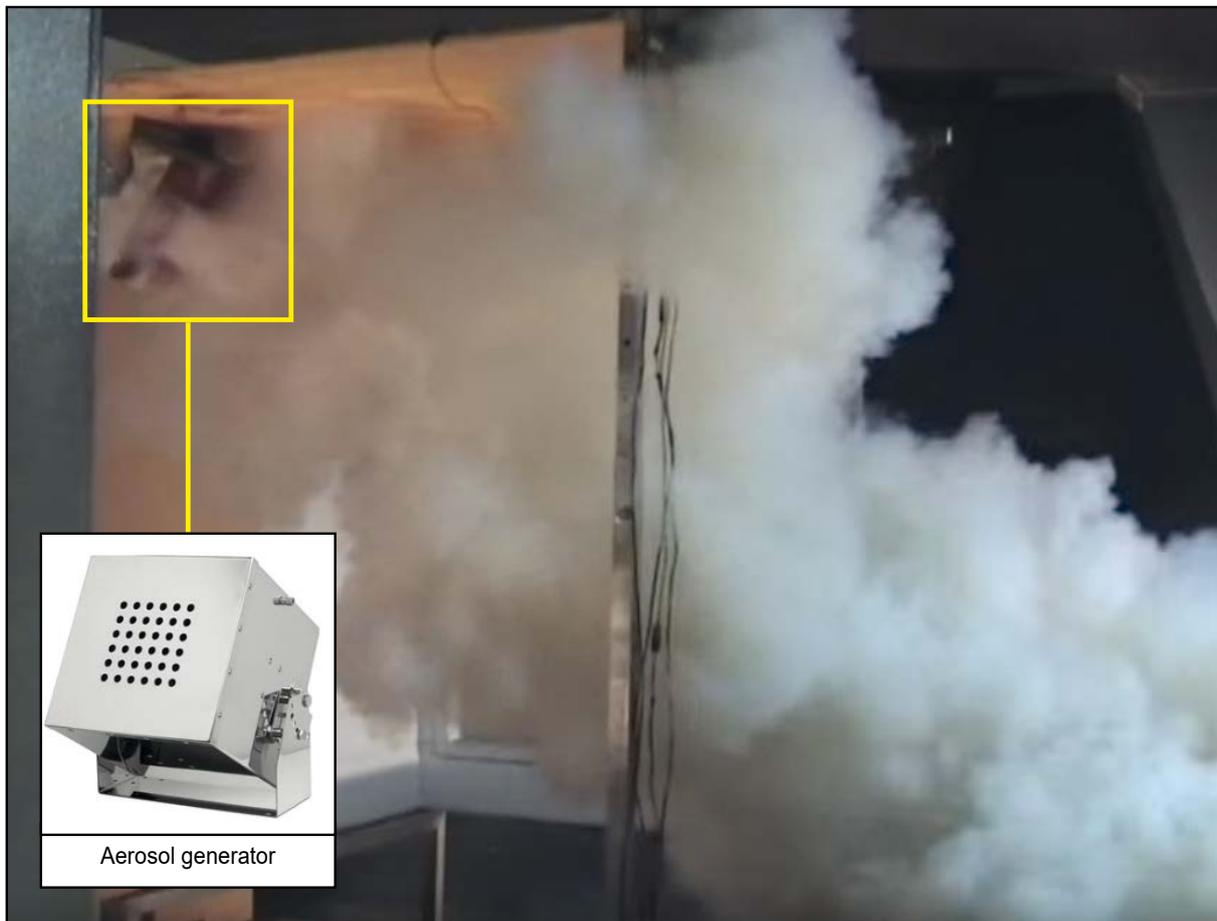
During the installation and without warning, the fire extinguishing system partially and inadvertently discharged, filling the engine room with a dense cloud of aerosol fire suppressing particles (**Figure 1**). Both installation contractors and the company's engineer managed to evacuate, but the apprentice collapsed in the engine room. He was later recovered by the local fire and rescue service but was found not breathing and could not be resuscitated.

**Figure 1:** Typical discharge of a condensed aerosol fire suppressant (not at time of accident)
