# MARITIME FEEDBACK

Issue 66  
February 2022

An independent and confidential reporting system for the maritime industry

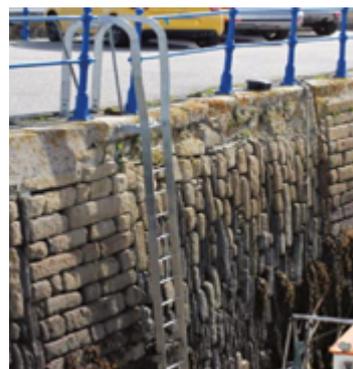
A fisher returned to their vessel with a guest in the late evening after they had met ashore. Both had drunk alcohol. It was low tide, and the vessel was approximately 6m below the quay edge due to the tidal range in that port.

As they climbed down the vertical quayside ladder, the guest fell off the ladder and hit the vessel's hull before falling, injured, into the water. The sea temperature was approximately 10° C (50° F).

**Design (latent factor)** – Vertical ladders are exposed to the elements and prone to damage by vessels berthed alongside. There is no fall protection inherent within the design and unless regularly maintained they are prone to rusting and marine growth

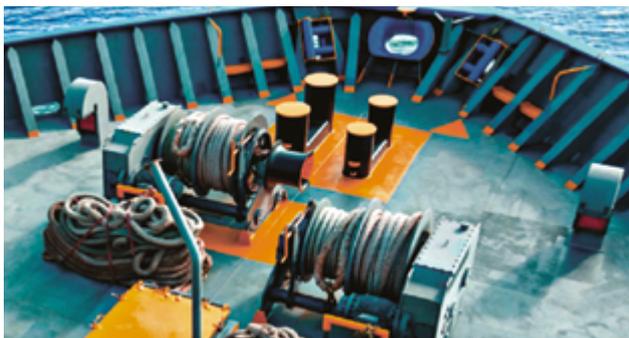
An ordinary seaman (OS) eased the tug's mooring rope out through the closed chock (Panama lead) and had taken a turn of the messenger rope around the bitts. As the tanker turned to starboard to align itself with the berth the tug's line was in the water and as the separation between the tanker's bow and the tug increased, the messenger line paid out at an increased speed which was not anticipated by the line handlers.

The officer in charge of the mooring operation warned the OS to step clear from the messenger rope. The OS attempted to do so but slipped on the deck and became entangled with the rope which dragged him overboard through the Panama chock. The OS was recovered from the water by the tug and resuscitation and first aid was immediately administered until the ambulance took them to hospital. Tragically the OS died the next day.
