Annual Digest
Reports and Insight Articles

2021

Annual Digest of Reports and Insight Articles 2021

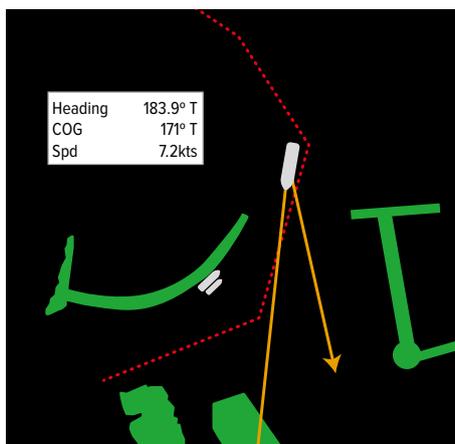
The vessel's speed was still above 5 knots, so the pilot ordered that both anchors be let go. The vessel speed had reduced to 4.5 knots when it contacted a barge that had been berthed outboard of another.

A detailed inspection was carried out by the ship's staff, followed later by an inspection by class. Non-penetrating

hull damage was identified, with significant indents and minor deformation to internal strength members that required repairs.

The investigation revealed that maintenance work conducted 6 days before on the engine control system had not been properly completed nor had it been inspected afterwards. The red locking pin (see photos below) had not been correctly secured back into position and during manoeuvring it had shaken loose due to vibration. This activated the emergency manoeuvring system which over-rode both the bridge and engine room control systems.

The emergency manoeuvring system located on the side of the engine is fitted with a locking arrangement which under normal conditions rests firmly inside the groove indicated in the photos below.

The investigation revealed that the direct cause of this incident was the disengagement of the emergency manoeuvring system's locking arrangement.

The root causes for this incident were found to be a lack of understanding of the risks by the engineering officers carrying out the checks, which were not overseen by a supervising officer – a procedural requirement that is stated in the SMS procedures for working on critical equipment. It is likely therefore that the engineering officers failed to appreciate the criticality and impact of the locking system.

Critical equipment defined in the company SMS must be inspected on completion of any maintenance by a supervising officer. Crucially, single points of failure must also be checked as part of routine pre-arrival and pre-departure checks.

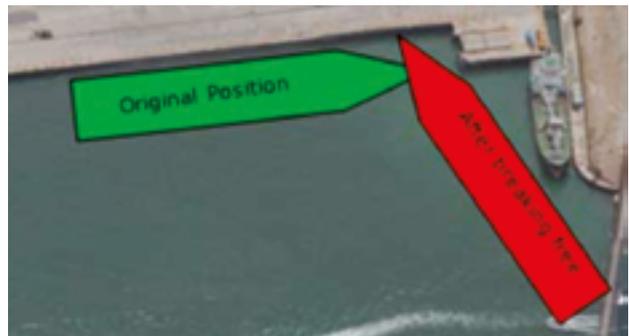
The vessel was now attached to the dock with just 2 headlines and one fore spring, and as it continued to swing it hit a berthed bunker barge and a railway bridge, sustaining damage to the starboard side amidships as well as on the starboard quarter. A piece of cargo was also discovered to be hanging over the starboard side.

While not an exact science, it is possible to estimate the likely forces generated by high winds on a high-sided vessel so long as the windage area is known

An investigation revealed that the mooring bollard to which the stern lines of both vessels were attached had been pulled completely out of its foundations due to the wind loading on the side of the vessels. It also concluded that the crew could not have prevented the incident.

Placing all the stern ropes onto one bollard created a single point of failure which was aggravated when the second vessel secured to the same bollard. Either vessel could have identified this latent risk, as could the supervisor of the line-handling party. It is possible that neither the port authority nor the master understood the risk which had been created. There is no evidence of a discussion regarding the possibility of the vessel moving to an alternative berth, either before or after the strong wind warning was issued, and no additional lines were put ashore after the warning had been received. Similarly, the vessel could have brought its engine(s) to immediate notice as a prudent contingency measure.

While not an exact science, it is possible to estimate the likely forces generated by high winds on a high-sided vessel so long as the windage area is known. Many vessels keep a 'ready reckoner' on the bridge for quick reference, and some port authorities that regularly berth high-sided vessels have similarly developed a guide to assist them in calculating the likely 'pull' forces that the bollards must accommodate. The use of auto-tensioners can cause dynamic loading of lines that potentially exceed bollard holding limits so this should be considered as well.

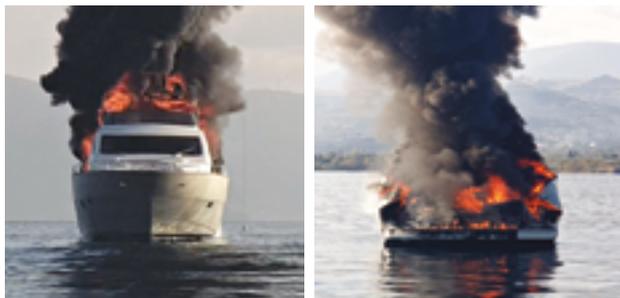
Figures 1 and 2

Shortly after weighing anchor following an overnight stop, the vessel suffered a catastrophic engine room fire which spread rapidly throughout the vessel.

The two crew abandoned the vessel using a tender and liferaft combination and were unharmed.

The vessel subsequently sank in deep water whilst a firefighting vessel was attempting to extinguish the blaze.
