Report on the investigation of
the capsizing and sinking of the fishing vessel

Joanna C (BM 265)

5 nautical miles south of Newhaven, England
on 21 November 2020

REPORT NO 7/2022

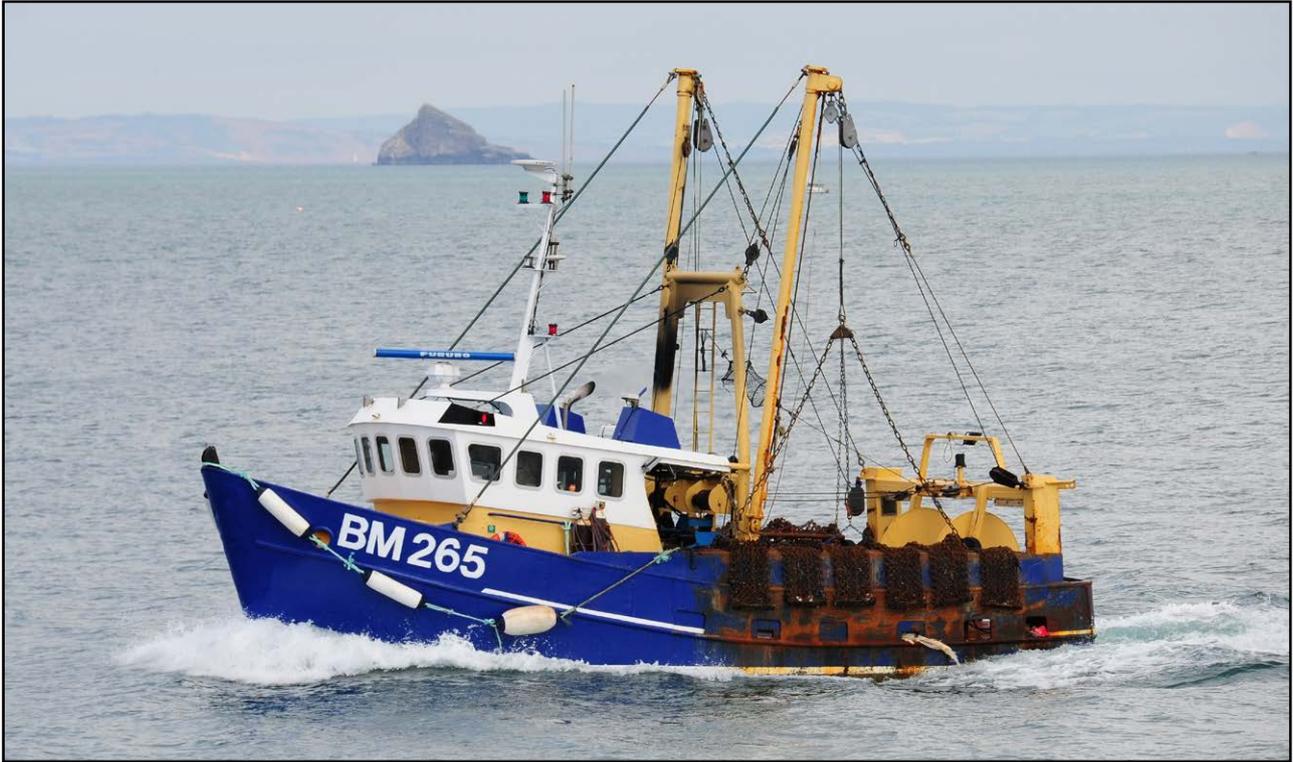
Figure 9a: *Joanna C* before the 2019 modifications

In 2019, *Joanna C* underwent another series of modifications (**Figures 9a and 9b**), which included:

- Extension of the wheelhouse
- Renewal and improvement of accommodation areas
- Replacement of the refrigeration system and installation of fish room insulation
- Replacement of fishing gear

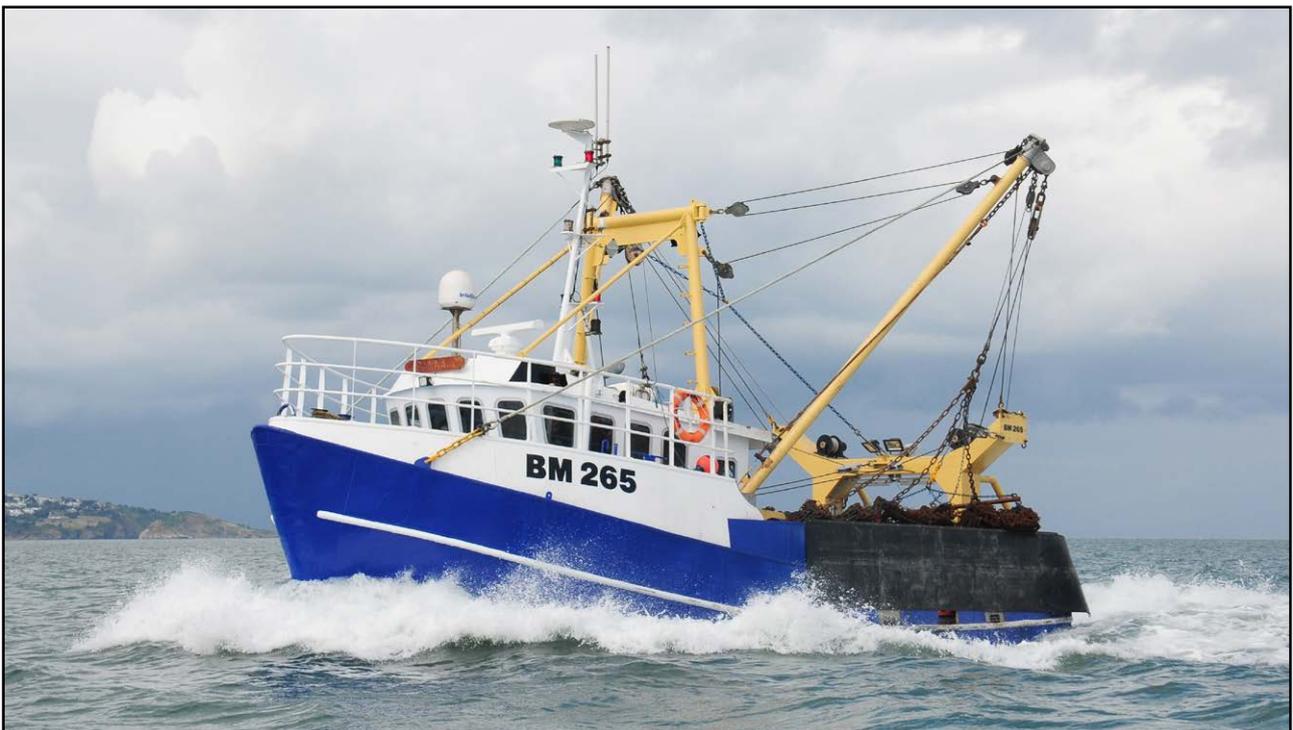
Figure 9b: *Joanna C* after the 2019 modifications

The 2019 modifications also included moving the derrick attachment points and main gantry from on top of the main winch housing to the sides and roof of the wheelhouse respectively (**Figure 10**). The MCA was not notified of the start of the 2019 modification work and became aware that the alterations had been carried out after completion.
