REPORT MARINE 2022/08

*Fire on board 'MS Brim' in the outer
Oslofjord on 11 March 2021*

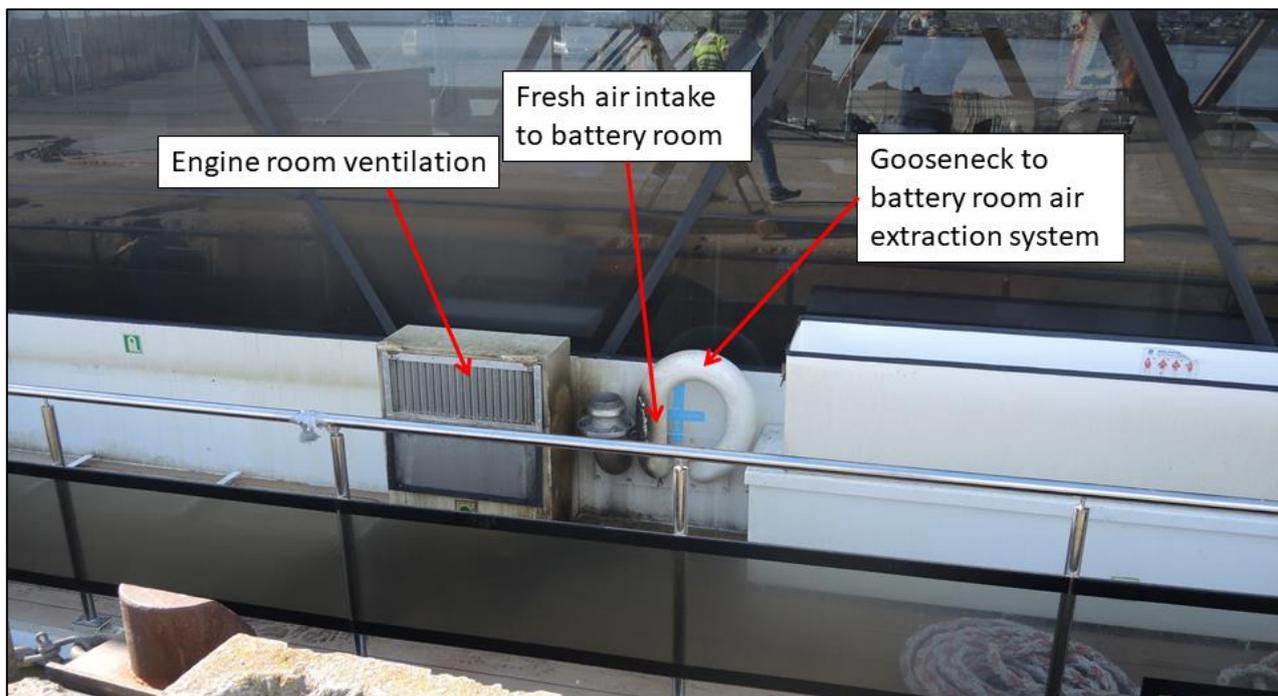
Figure 4: Ventilation for engine room and battery room on starboard side of 'Brim'. Photo: NSIA

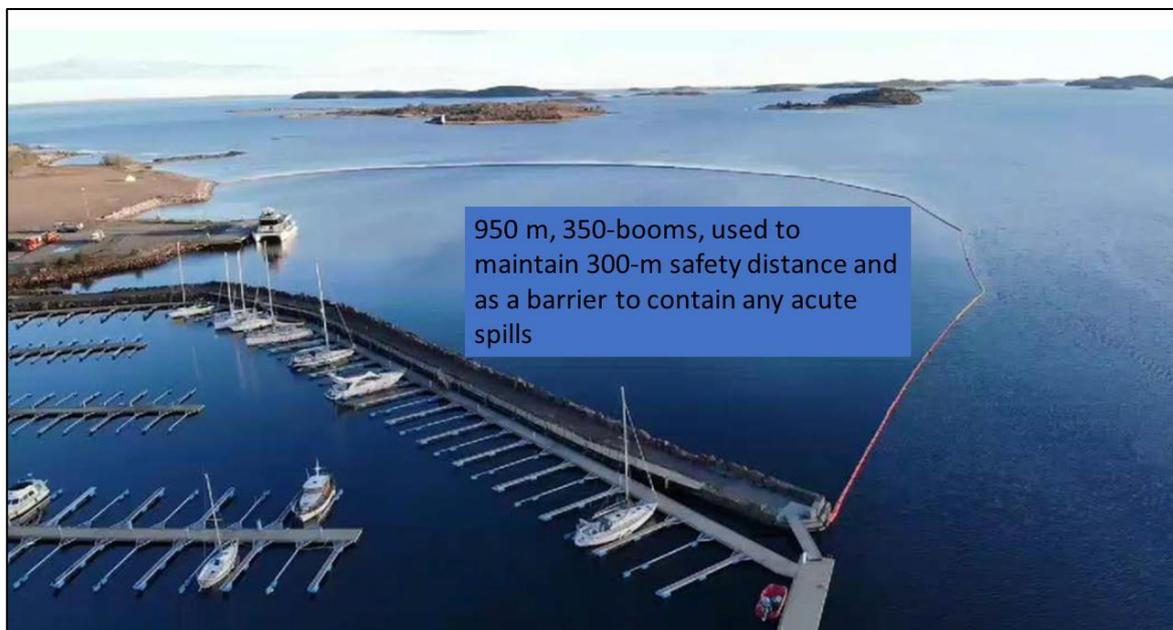
the Norwegian Defence Research Establishment (FFI), the shipping company, the battery contractor, the insurance company and consultants from Oslo Fire and Rescue Service participated in the meeting. At the time, the risk of explosion was seen as the greatest risk. A 300-metre safety zone was established (see Figure 5) and booms were deployed to reduce the possibility of polluting the fairway.

Figure 5: The area in the vicinity of 'Brim'. Photo: Vestfold Intermunicipal Fire Service

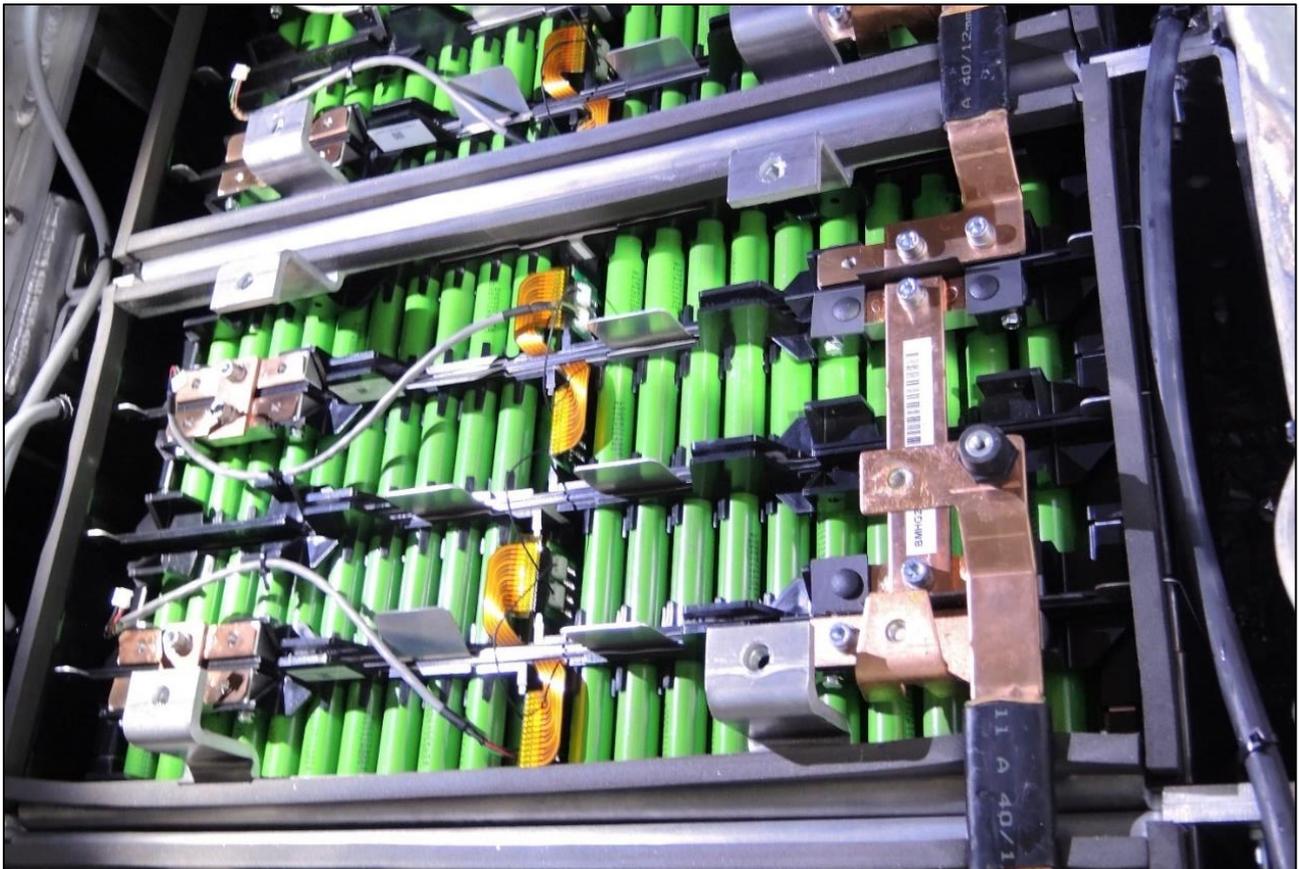
Figure 18: Battery module with battery cells, from the port battery room. Photo: NSIA

The battery modules installed in the vessel were designed and tested to IP44 on all sides, except for the front (rated IP23), and the back (rated IP2X). IP2X meant no protection against the ingress of water. In the battery's production certificate, it was rated as IP23 by DNV, which the investigation subsequently found to be an error; it should have been rated as IP2X.

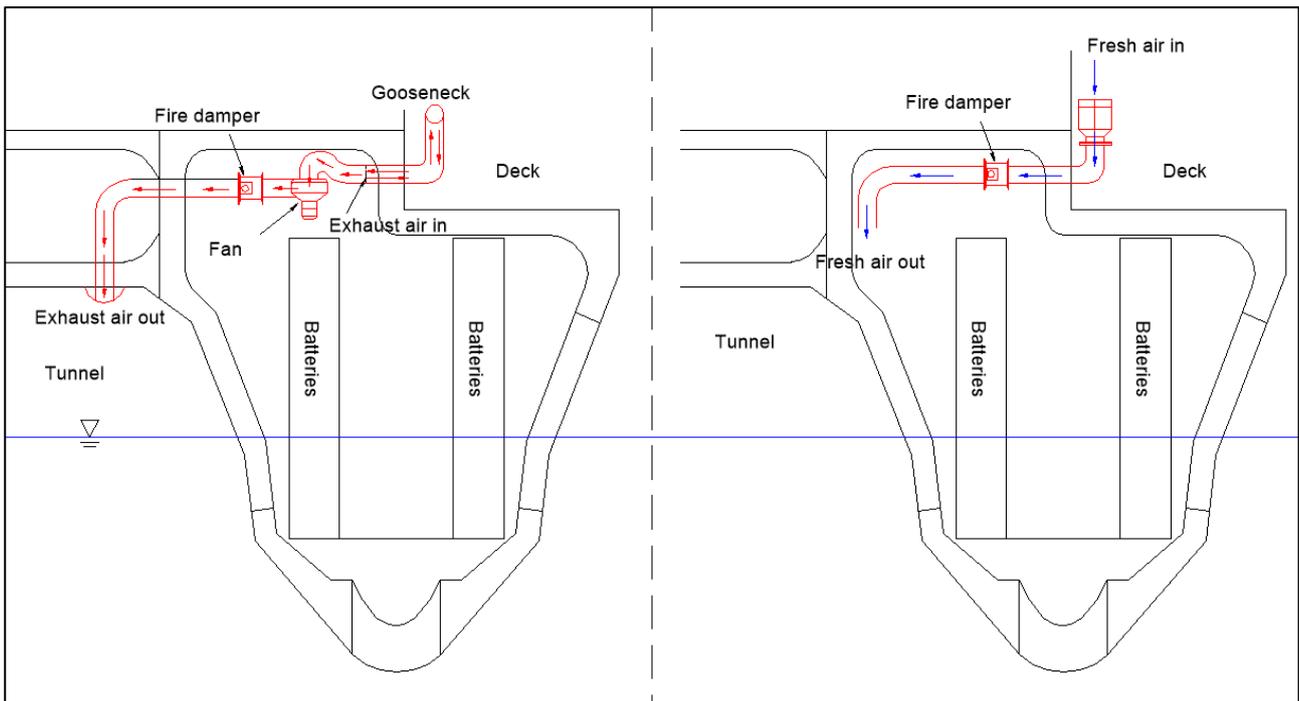
The outlet air from the battery room was routed via a gooseneck to deck, back to the battery room and into the tunnel. The outlet was equipped with a centrifugal fan and a fire damper; see Figure 19 and Figure 20. The design with location of the outlet in the tunnel was chosen on the basis of

requirements relating to fire safety and emission of hazardous gases from the battery room. In the interest of crew and passenger safety, it was decided to route the outlet to the tunnel rather than to install a 3.5-metre high vent pipe on deck.

Figure 19: Arrangement drawing of battery room ventilation. Illustration: The shipyard/NSIA

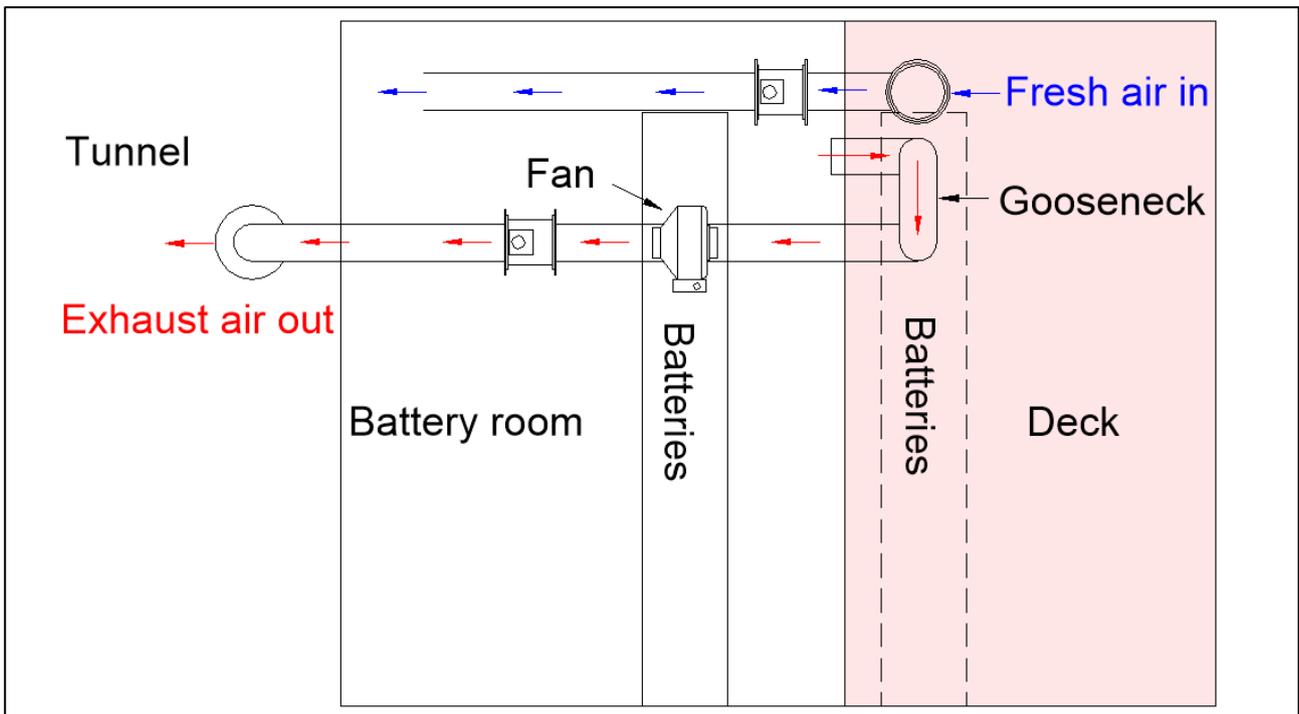
Figure 20: Arrangement drawing of the ventilation system seen from above. Illustration: The shipyard/NSIA

Each fan discharged air via a gooseneck on the outside of the hull (see Figure 20) to the top of the tunnel; see Figure 21. The gooseneck design had been chosen to ensure sufficient freeboard.

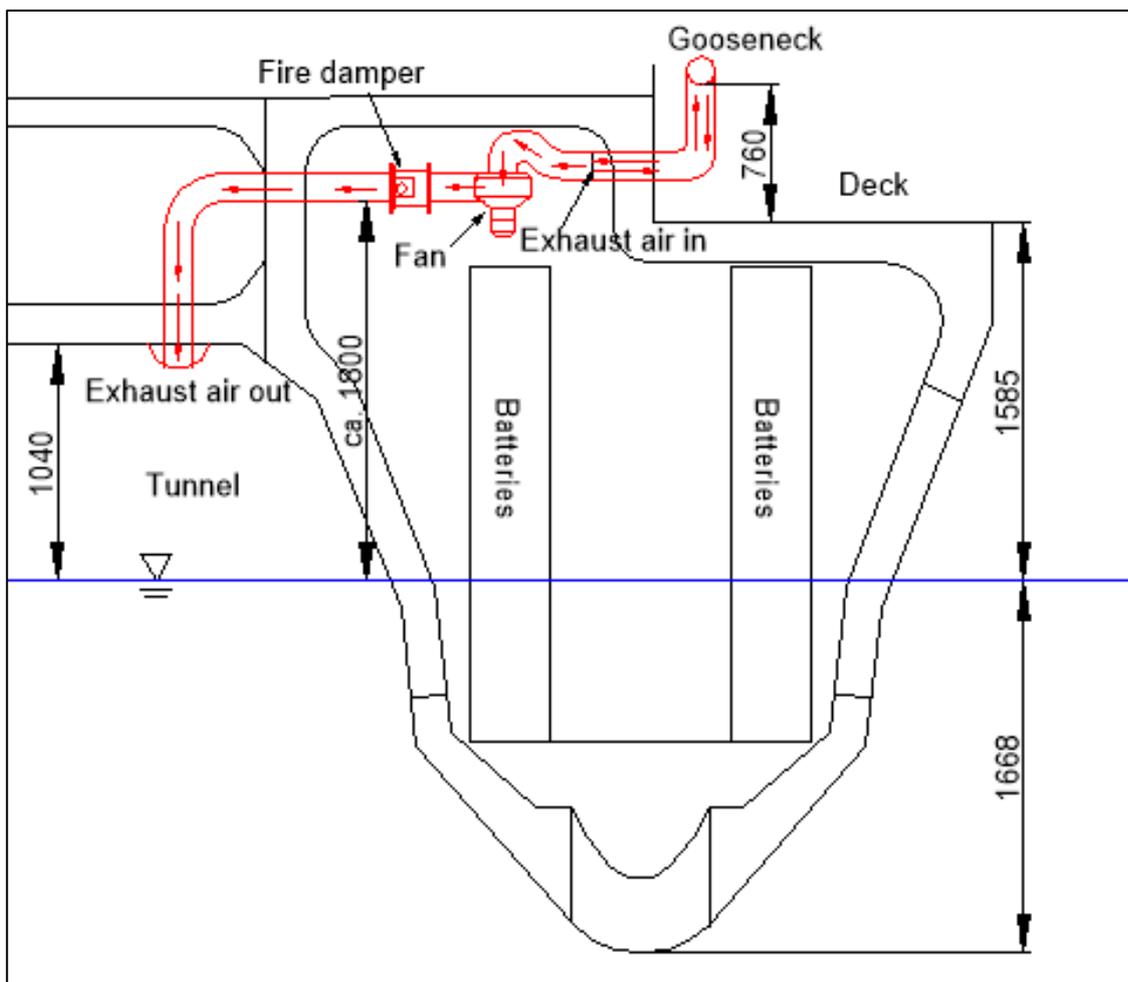
In fully loaded condition, the distance from the waterline to the ventilation fan was approximately 1.8 m and from the ventilation opening in the tunnel top to the waterline approximately 1.04 m. Figure 22 is an illustration of the air extraction system showing distances to the waterline.

Figure 22: Freeboard measurements (mm) relating to the air extraction system. Illustration: The shipyard/NSIA

The ventilation system for each battery room has two possible flooding points: the ventilation intake located by the superstructure just above the main deck and the ventilation outlet located in the tunnel top.

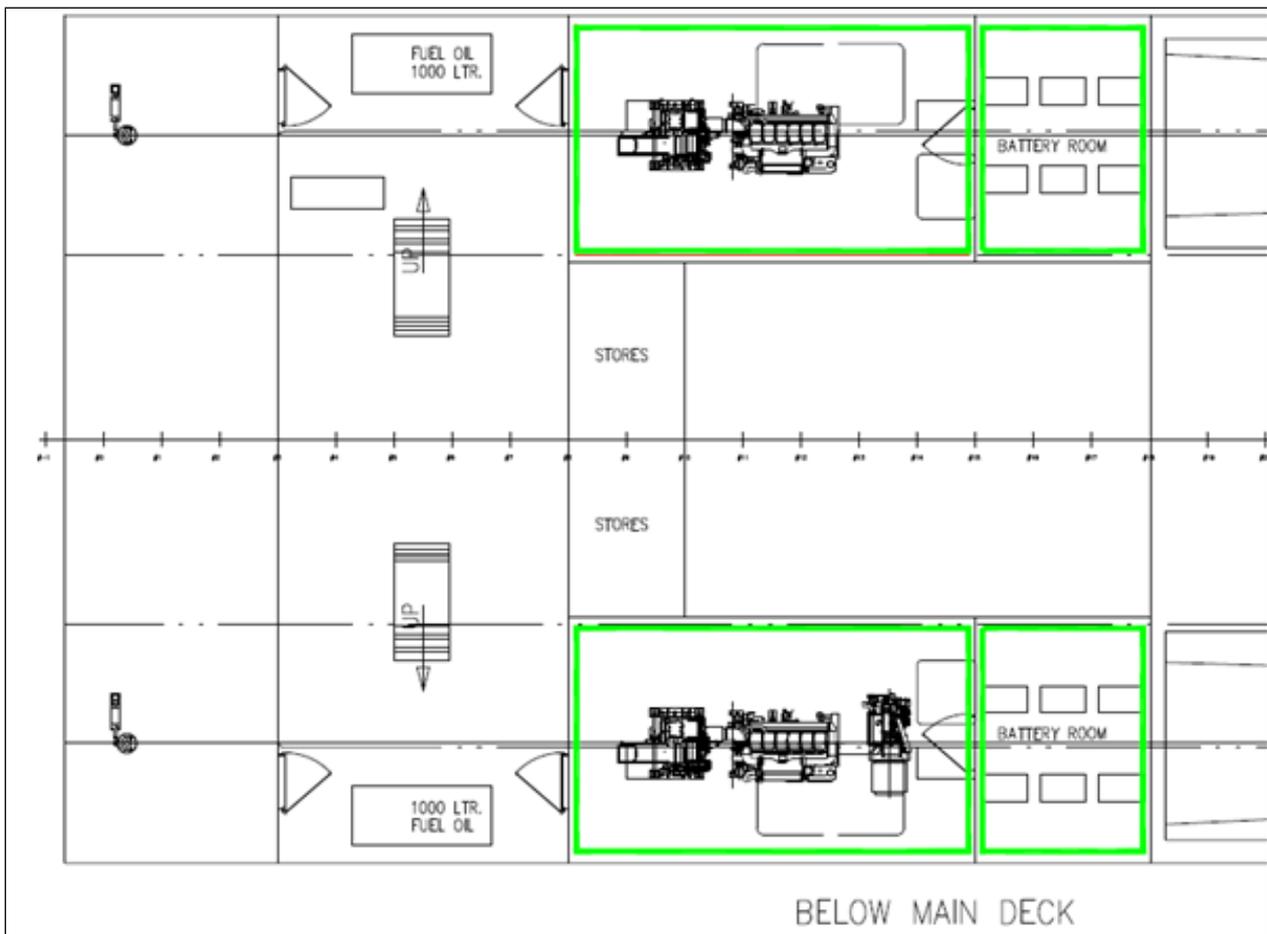
previously. The repair yard had installed insulation almost all the way down to the bottom of the vessel. The regulations¹⁰ permitted leaving 100 mm immediately above deck level without insulation for drainage purposes, but the bulkhead had to be smoke-tight. Fire insulation shall be from deck to deck, except along the ship sides; see sections 1.9.2 and 1.9.4.5. Figure 24 shows the fire integrity plan and where fire insulation was to be installed.

Figure 24: Fire insulation of the engine and battery rooms as presented in the fire integrity plan. Technical drawing: The shipyard

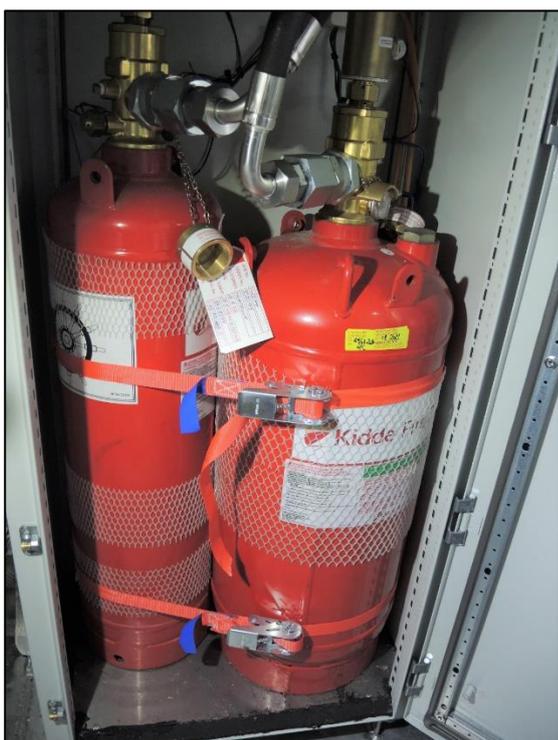
Figure 26: Novec cylinders in the port technical room. The smallest cylinder on the left is for the battery room while the cylinder on the right is for the engine room. Gas from both cylinders was released. Photo: NSIA

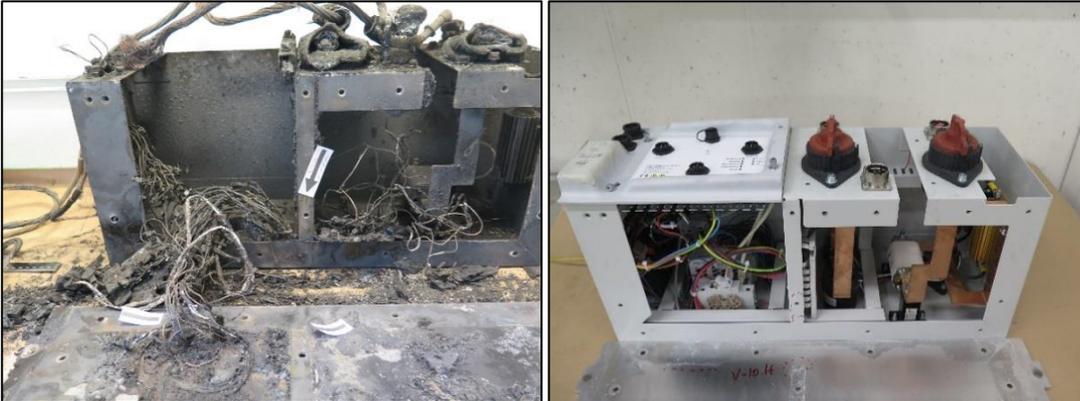
The stack controllers for battery stacks 6 and 12, below the fan motors, were taken down and examined.

Figure 39: The photo on the right shows the module from the starboard side. The photo on the left shows the module from the port side. Photo: NSIA

The module from the starboard side was examined for traces of short-circuiting, along with the circuit board and fuses found inside the module. The main fuse was intact.

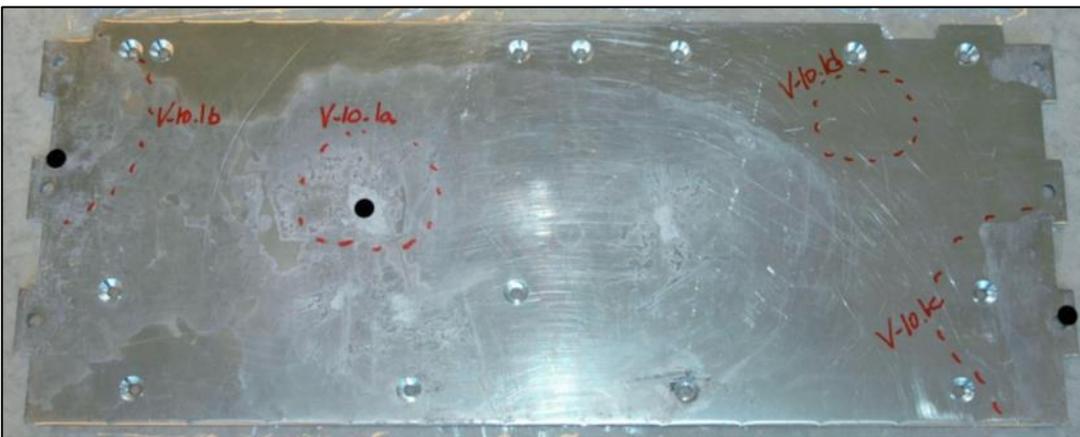
Figure 40: The stack controller's bottom plate. Scraped-off material from the marked areas was sent for analysis. Photo: NSIA

Salt was found to have been deposited in several places of the stack controller's bottom plate, on the port side. The bottom plate on the starboard side was not sent for analysis.

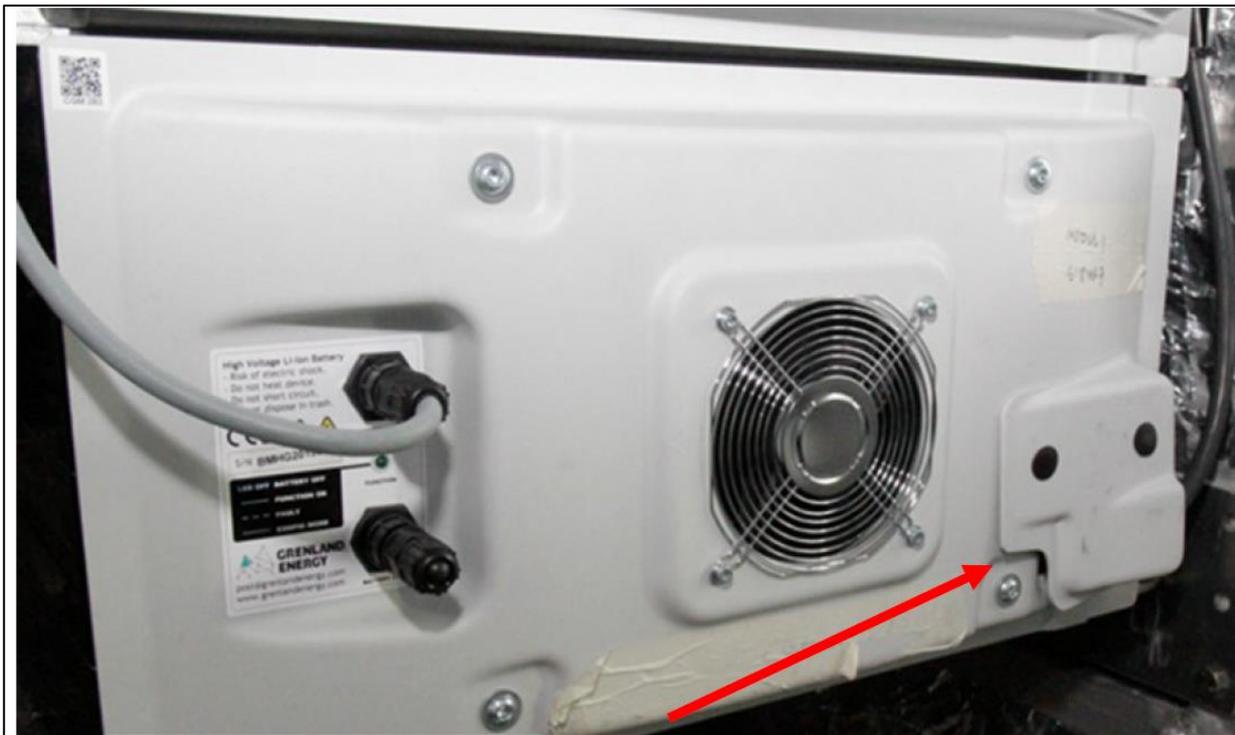
Figure 43 shows how seawater can enter battery module 1 through an open protective cover.

Figure 43: Module 1 in a battery stack from the port side. Note that the protective cover on the right is open.
Photo: NSIA/FFI

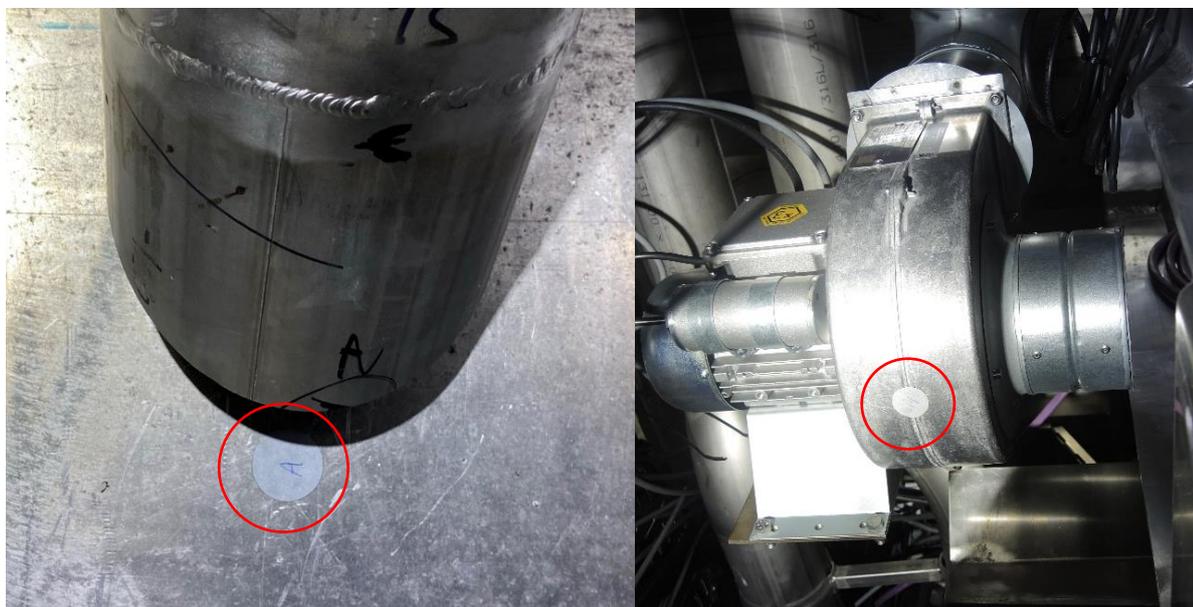
Six samples were taken from the port battery room and two from the starboard battery room. The samples were taken from different places in both battery rooms, from both new and old components. The particle samples included samples taken from the inside of the hull at the ventilation intake in both battery rooms, and from the bottom of the new fan in the starboard battery room; see Figure 46.

Figure 46: Particle samples from the hull at the ventilation intake (left) and from the bottom of the ventilation fan on the port side (right). The red circles mark the areas from which the samples were taken. Photo: NSIA

Traces of chlorine and salts were found in all eight samples. In addition to chlorine, other elements that may be present in a maritime environment were also found, including magnesium, sulphur,
