Collision between the motor yacht *Vision* and the anchored motor yacht *Minx*, resulting in one fatality at Île Sainte-Marguerite, near Cannes, France on 25 May 2019

SUMMARY

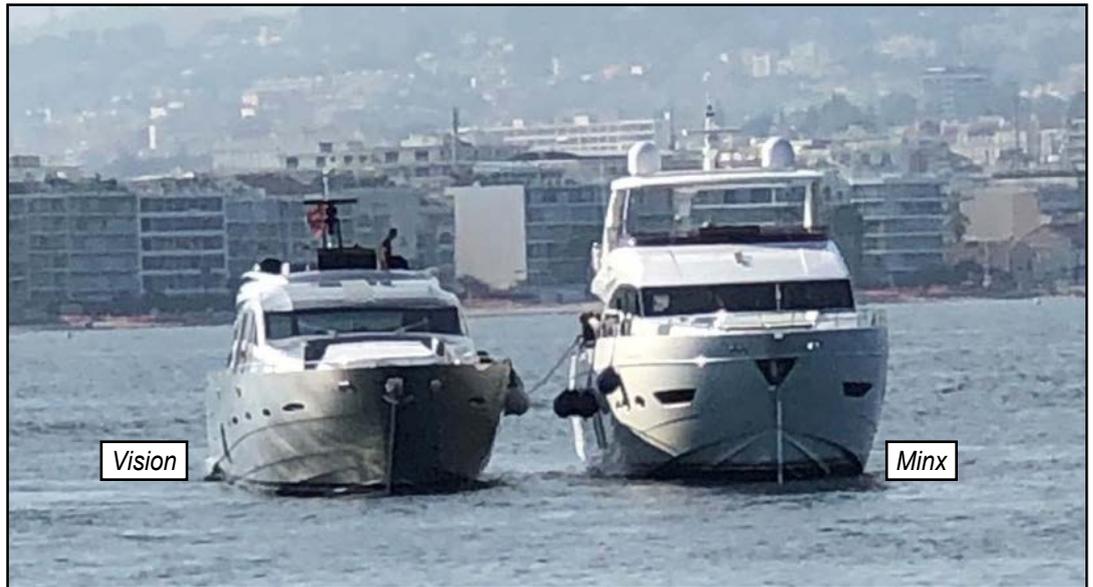
During their meal, the guests agreed to continue the party back on board, and *Vision's* charterer called the skipper and asked him to raft up with *Minx*. *Vision's* skipper contacted *Minx's* skipper and discussed the plan, then let out more anchor chain and manoeuvred the yacht alongside *Minx* (**Figure 1**). By about 1830, everyone was back on board and the drinking and partying continued with most of the guests on board *Vision*.

Figure 1: *Vision* and *Minx* at anchor and rafted together near Île Sainte-Marguerite

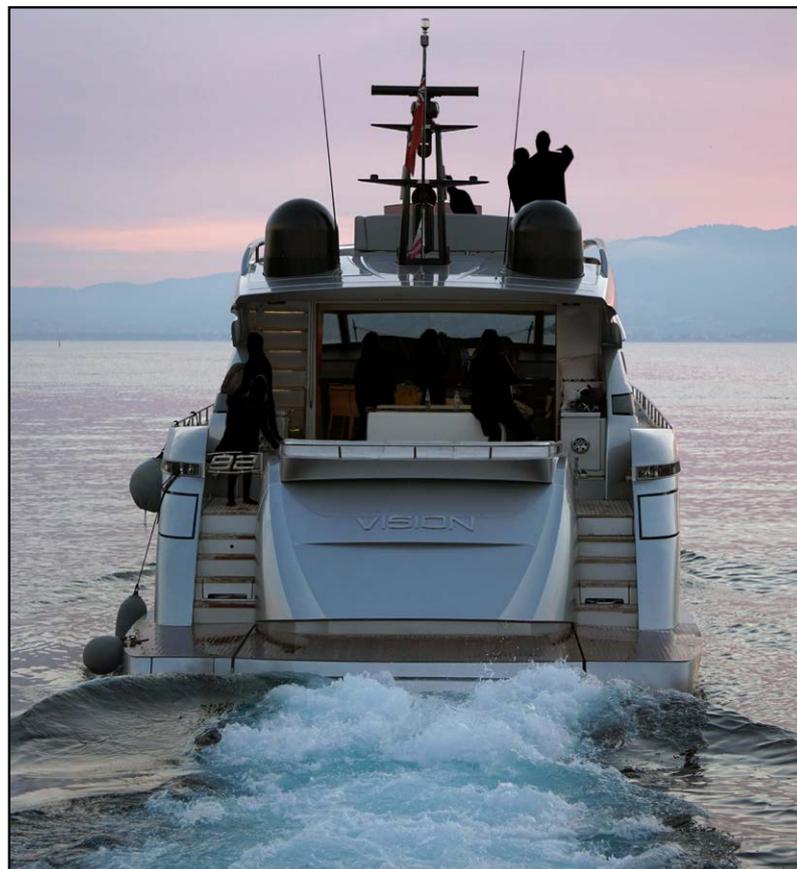
Figure 2: *Vision*, seen from *Minx*, initially opening to the west

After *Vision* had been manoeuvred clear of *Minx*, it was discovered that a guest's mobile phone had been left on board. *Vision's* skipper then manoeuvred the yacht back close to *Minx* so the mobile phone could be returned, then *Vision* started opening away on a westerly heading (**Figure 2**). Having opened to a distance of 750 metres (m) from *Minx* (**Figure 3**), *Vision's* skipper turned the yacht to an easterly heading, moved down from the flybridge to the internal wheelhouse, then began to accelerate ahead. The skipper's intention was to conduct a fast slalom-type manoeuvre close down the port side of the anchored *Minx*. As its speed increased, *Vision* started planing and its propellers were creating a 'rooster tail' water spray astern (**Figure 4**). As the distance between the two yachts rapidly decreased, *Vision's*
