**Lessons from Marine
Accident Reports
1/2016**

SAFETY DIGEST
Lessons from Marine Accidents
No 1/2016

April 2016

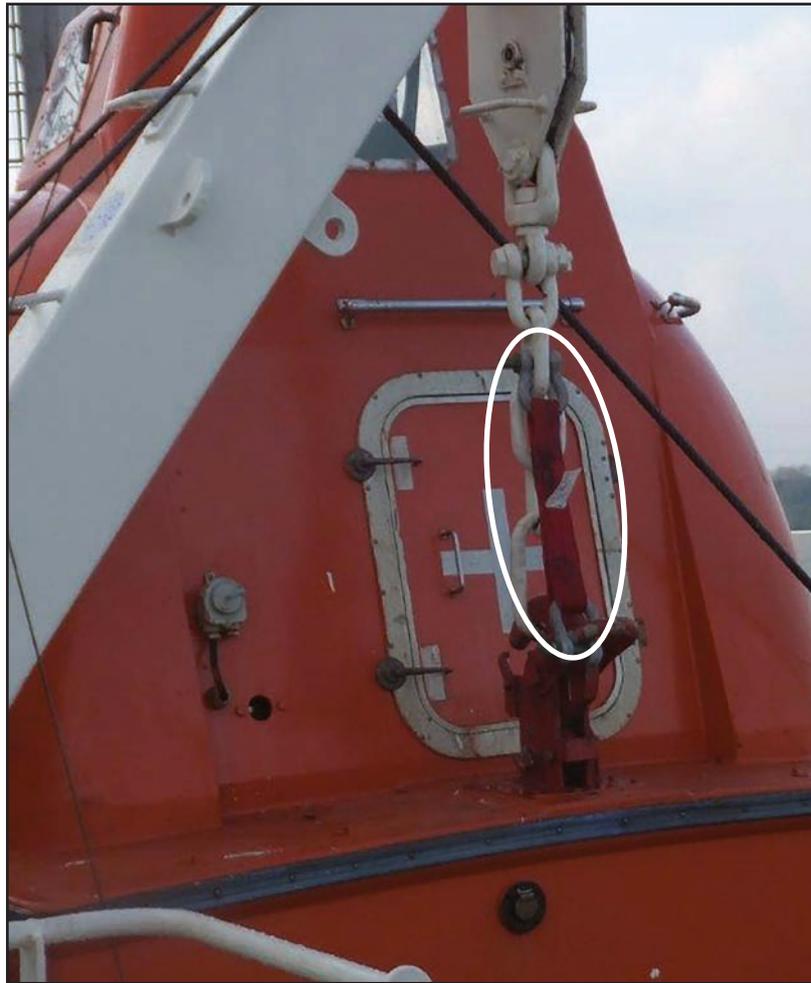
Figure 1: Fall preventer device

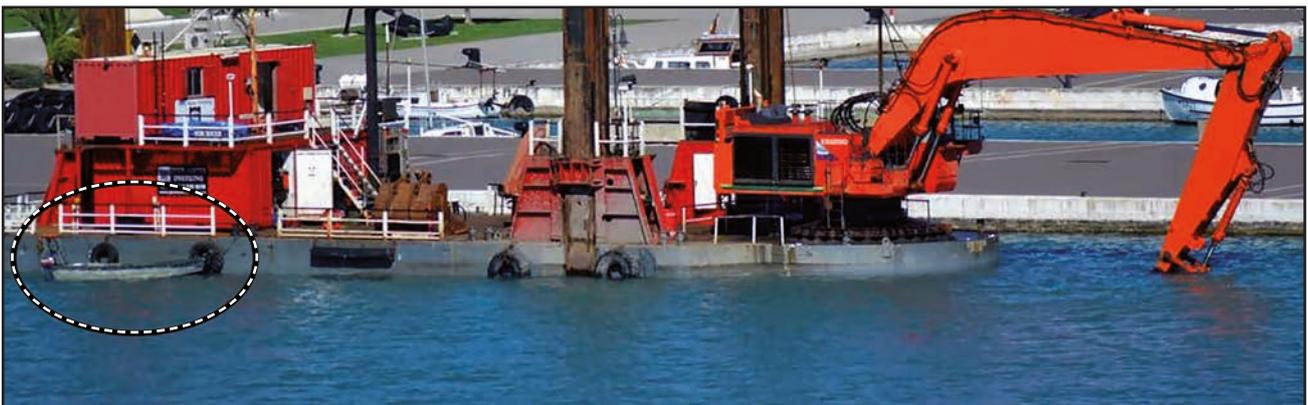
However, when the dinghy was turned again into sea about 100m from the workboat, it was quickly overwhelmed in the choppy seas. The dinghy flooded rapidly and started to submerge. The crew remaining on board the workboat saw what had happened and quickly collected two lifejackets, a life-ring and line. One of the crew then climbed into the life-ring, jumped into the sea with the two lifejackets and swam towards the men in the water. Unfortunately, one of the men in the water had lost consciousness and could not be revived.

Figure 1: The dinghy (circled)

1. The operating limits of small open boats can be easily exceeded when used in open and exposed waterways. Although conditions might look good when setting off, they can change for the worse very quickly. Don't take chances. Know the limitations of small boats and tenders, and carefully plan all trips taking into account the potential effects of changing weather, tide and visibility. Where necessary, delay, postpone or cancel.

2. It is always safer to wear a lifejacket when travelling in an open boat than not to. The effects of shock, injury or lack of fitness have the potential to reduce a person's chances of survival no matter how good a swimmer they are, how warm or calm the water is or how close they are to the shore. Lifejackets might not be a fashion accessory when going ashore – but they are not meant to be.

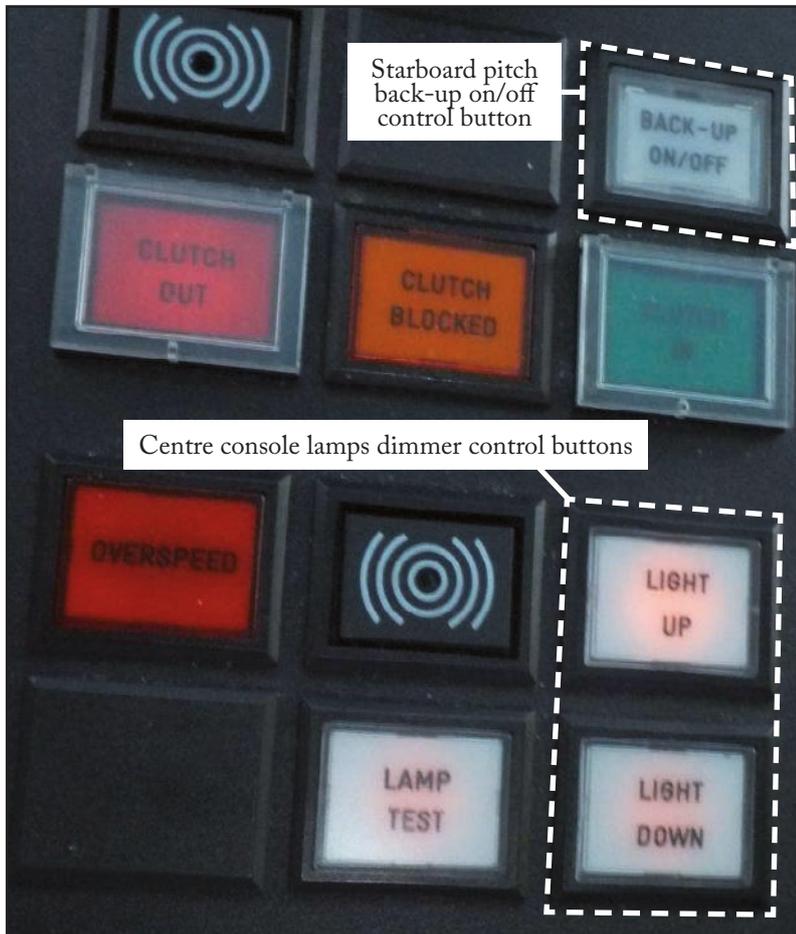
The investigation found that when the starboard CPP back-up control mode was inadvertently selected, the master lost bridge control of that propeller. The starboard

Figure 1: Part of bridge centre console indicator lamps

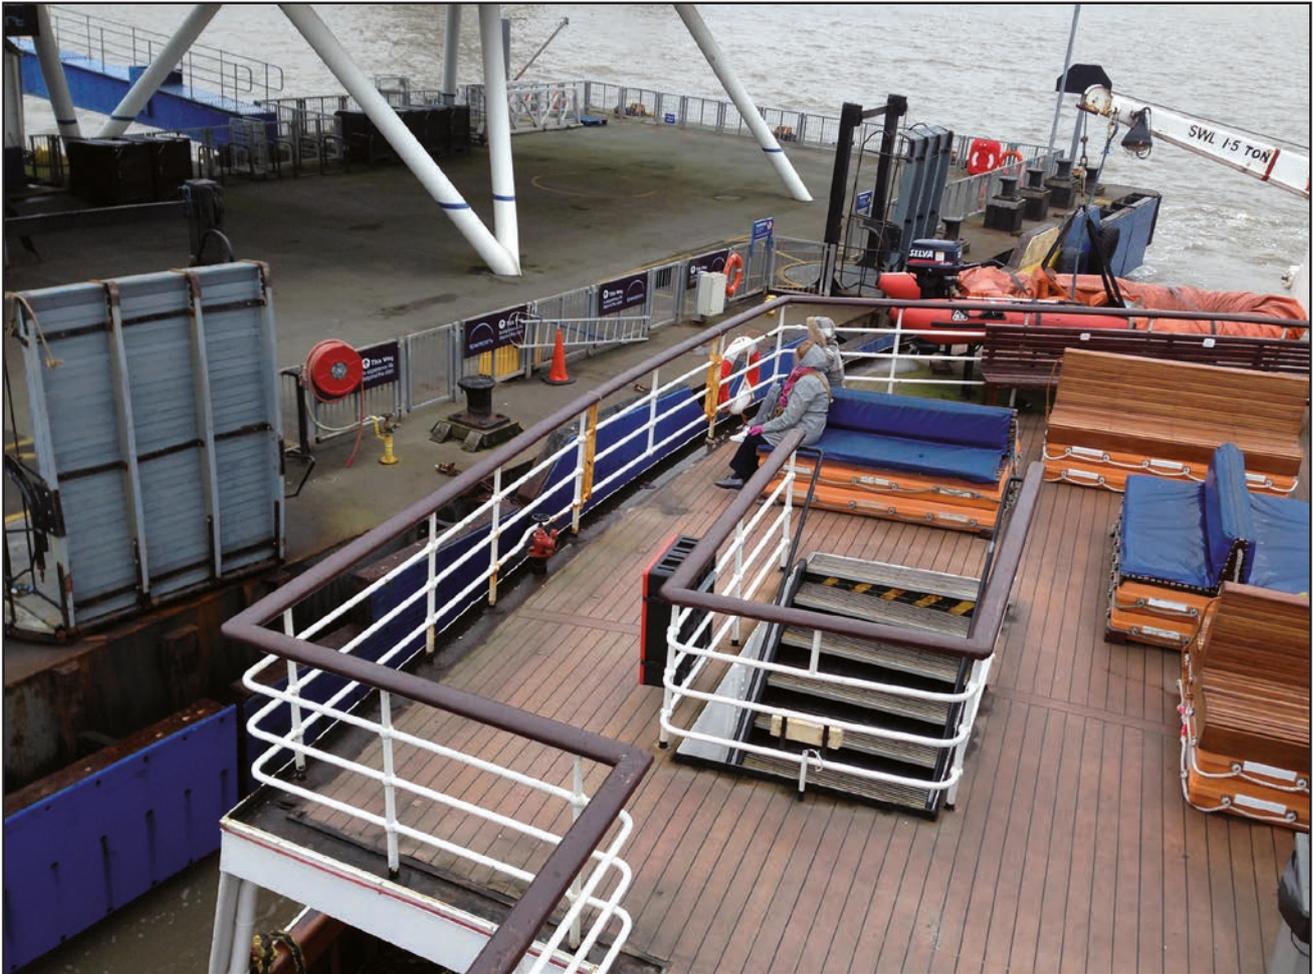
Ships' side rails are installed to protect individuals and reduce their chance of accidentally falling overboard. On this particular vessel the side rails were 1100mm high, which was higher than the mandated minimum. However, seating was arranged next to the side rails, which meant that if someone stood on the seating, the effective height of the rail from the seat to the top was reduced to approximately 635mm. This then introduced a hazard, which had been recognised by the management through its

The warnings provided by the safety announcement and on the safety notice attached to the seats proved to be insufficient to prevent the passengers from standing on them occasionally.

Figure 2: Promenade deck with guard rail seating removed

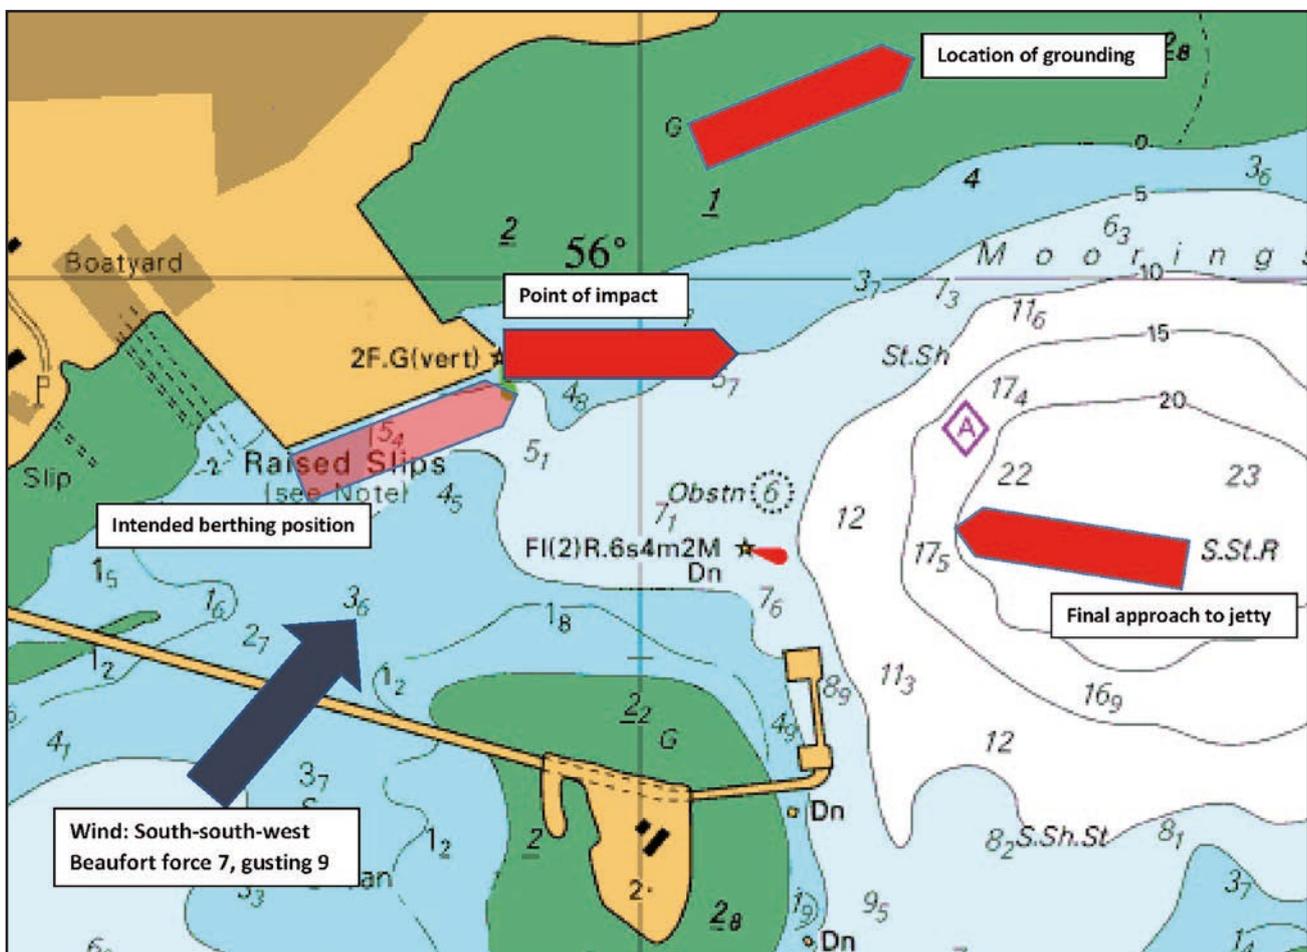
In order to avoid further damage the master decided to abort the berthing operation, but he was unable to regain control of the vessel before it grounded, approximately 60m from the berth (Figure 1). Despite attempts to refloat the vessel, it was hard aground and, as the tide fell, ended up high and dry (Figure 2).

Figure 1: Chart showing intended berthing position, point of contact and location of grounding

1. Passage planning is 'berth-to-berth' for good reason: to ensure that every aspect of the voyage is properly assessed. In this case, the berthing plan did not take into account the predicted environmental conditions, especially the likely effect of the strong to gale force wind. Had this been taken into account, an alternative course of action could have been considered such as anchoring to wait for better conditions.

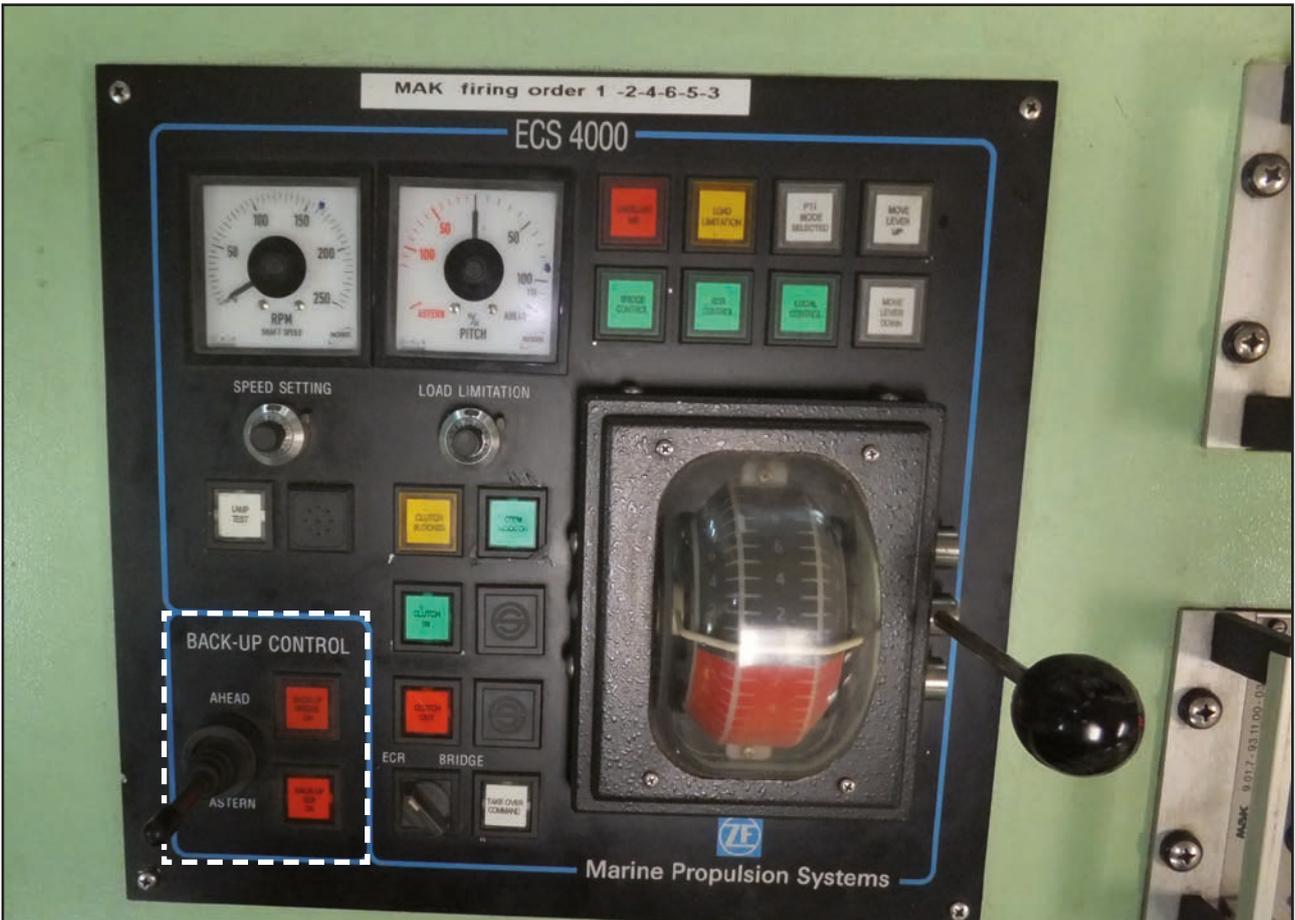
Figure 2: Bridge control panel of CPP system showing back-up controls

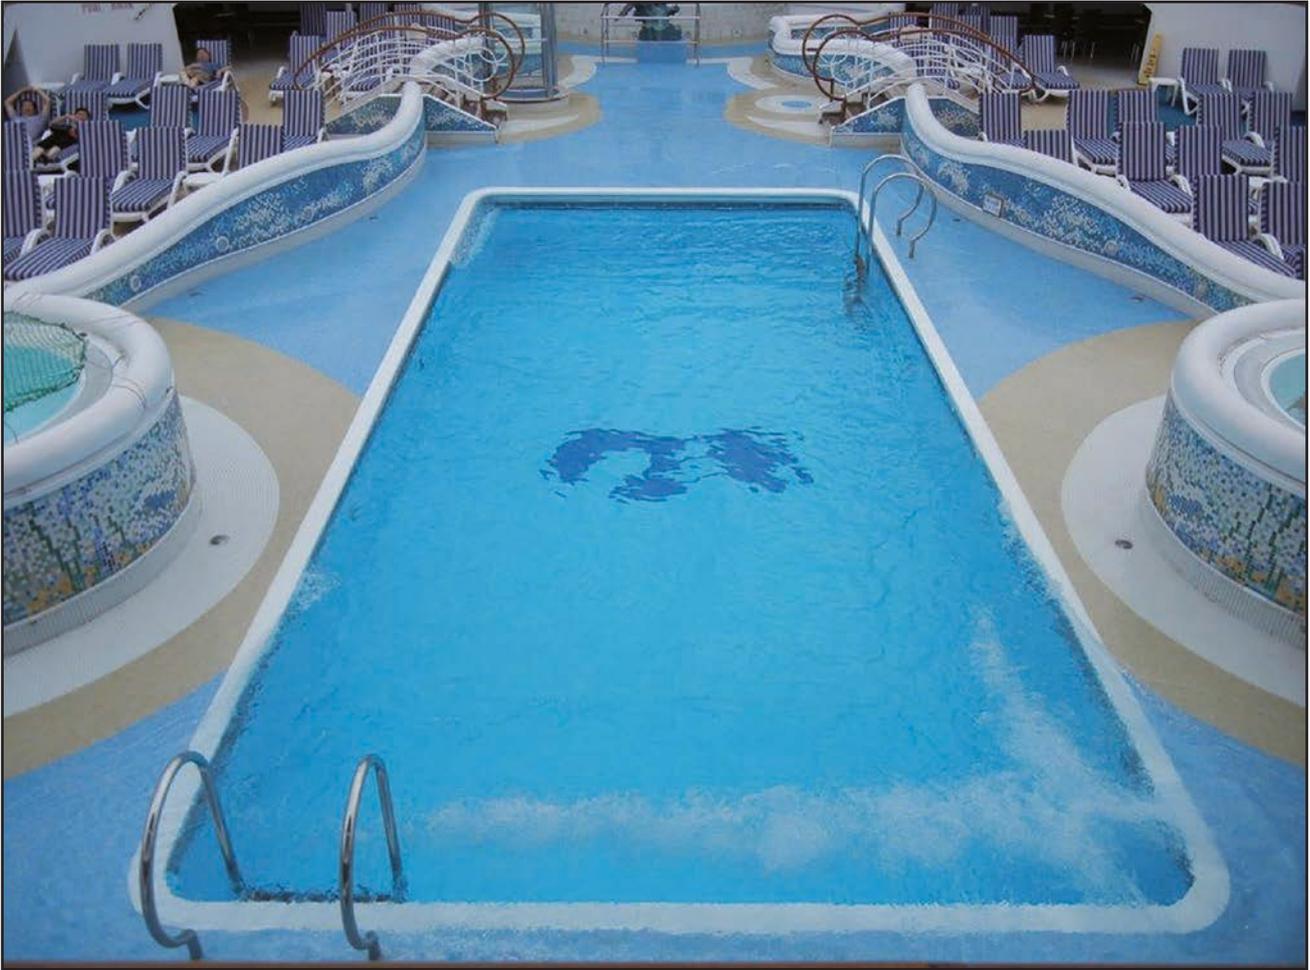
The pool was approximately 5m long by 2.5m wide, with a depth of 2m at its deepest point and 1.6m at its shallowest point. There was a large tiled area at one end, which is where the recovery took place. Forward of this was an area with food outlets and a bar. The pool was enclosed by a low wall with seating and sun loungers on the adjacent deck area (Figure 1).

No documented risk assessment relating to hazards involved in the use of swimming pools was available to the ship's crew. There were no designated attendants present or CCTV coverage of the pool areas. A parental advisory notice warned passengers with children that there were no lifeguards on duty and that use of the pool was at their own risk. Health and safety notices to this effect were displayed adjacent to the pool.

Figure 1: Ship's swimming pool aft to forward

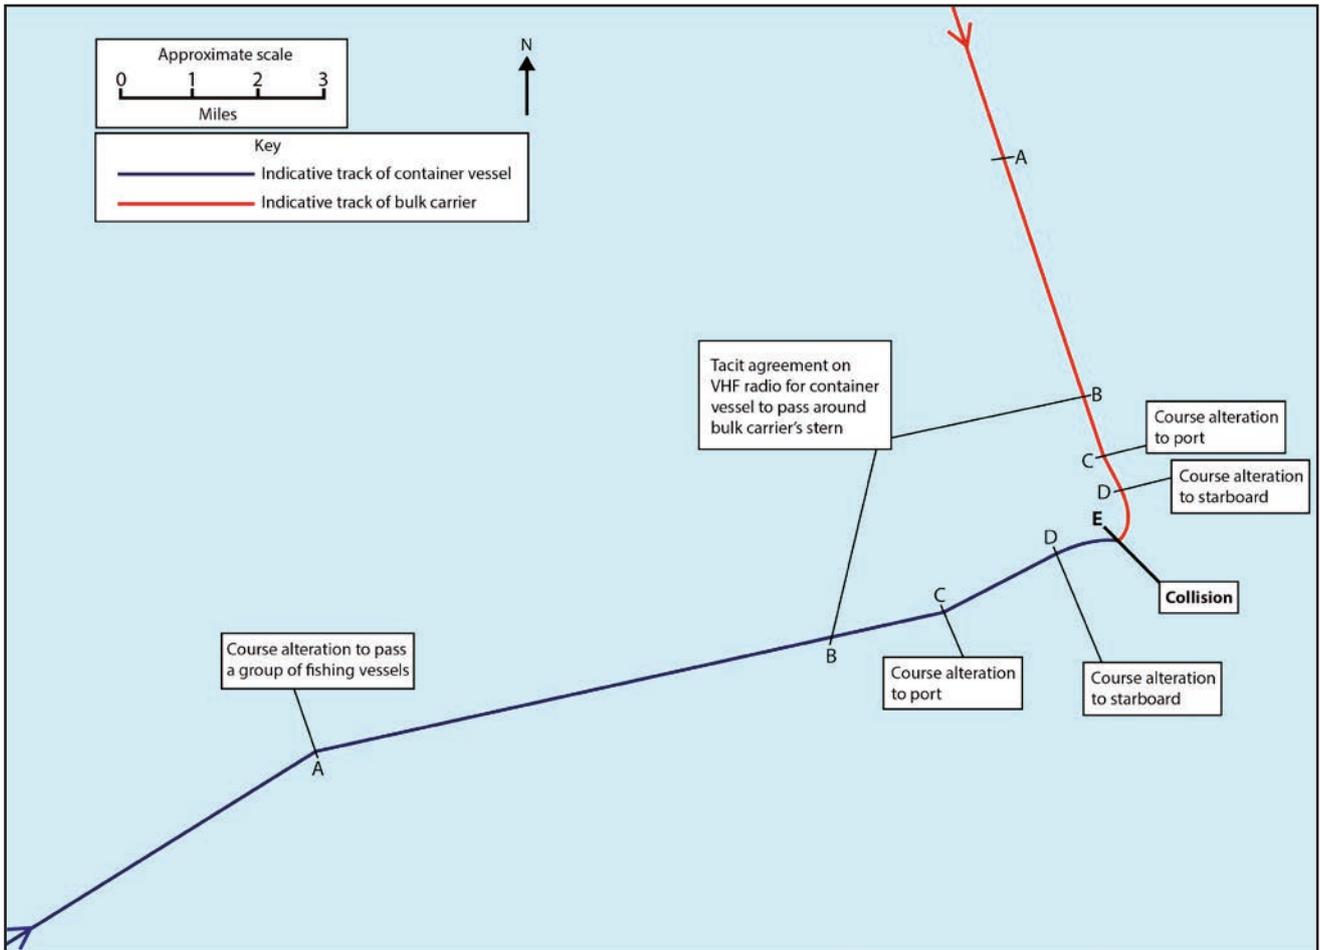
Although the bulk carrier's OOW had also altered course to starboard, the avoiding action taken on both vessels was insufficient and taken too late to prevent them from colliding (Figure 1, point E).

Figure 1: Indicative vessel tracks

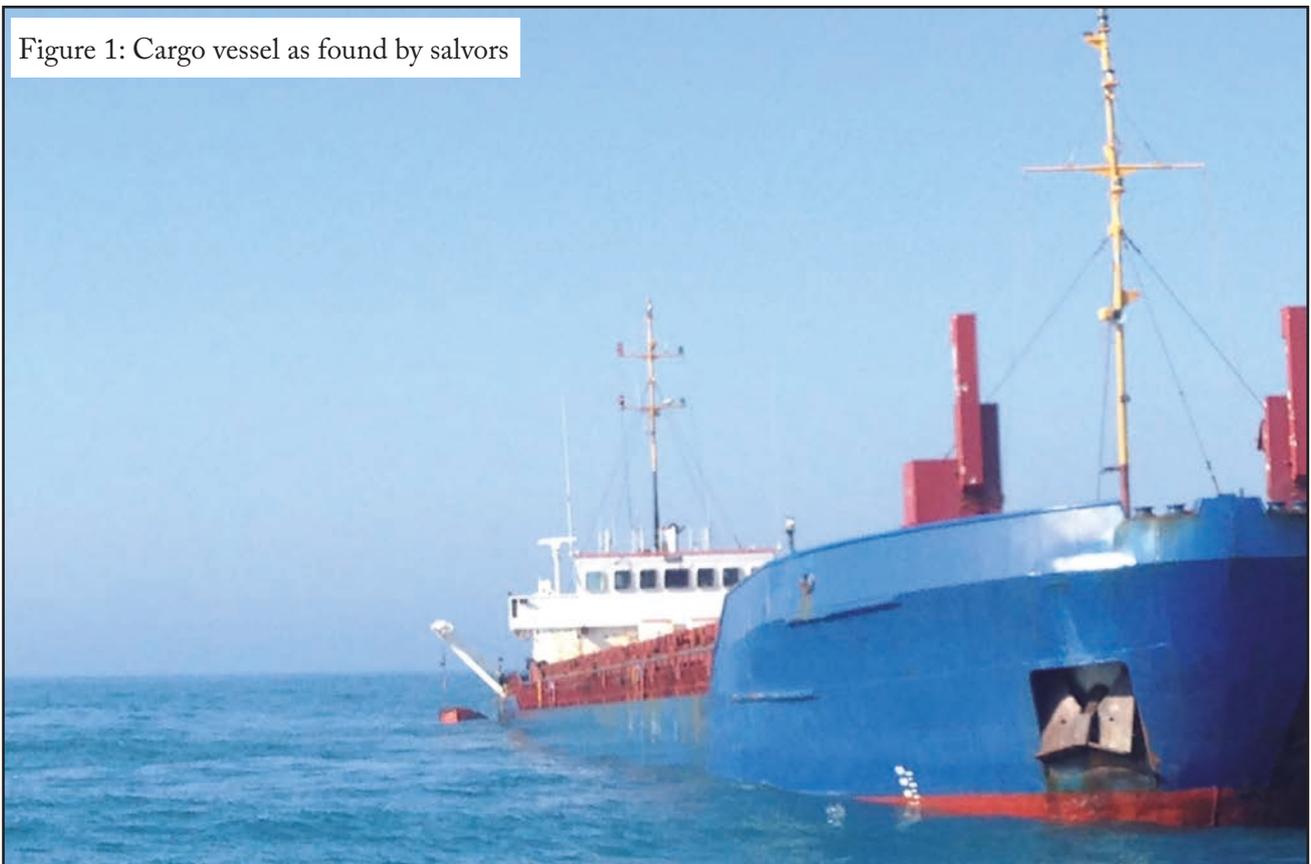
Figure 1: Cargo vessel as found by salvors

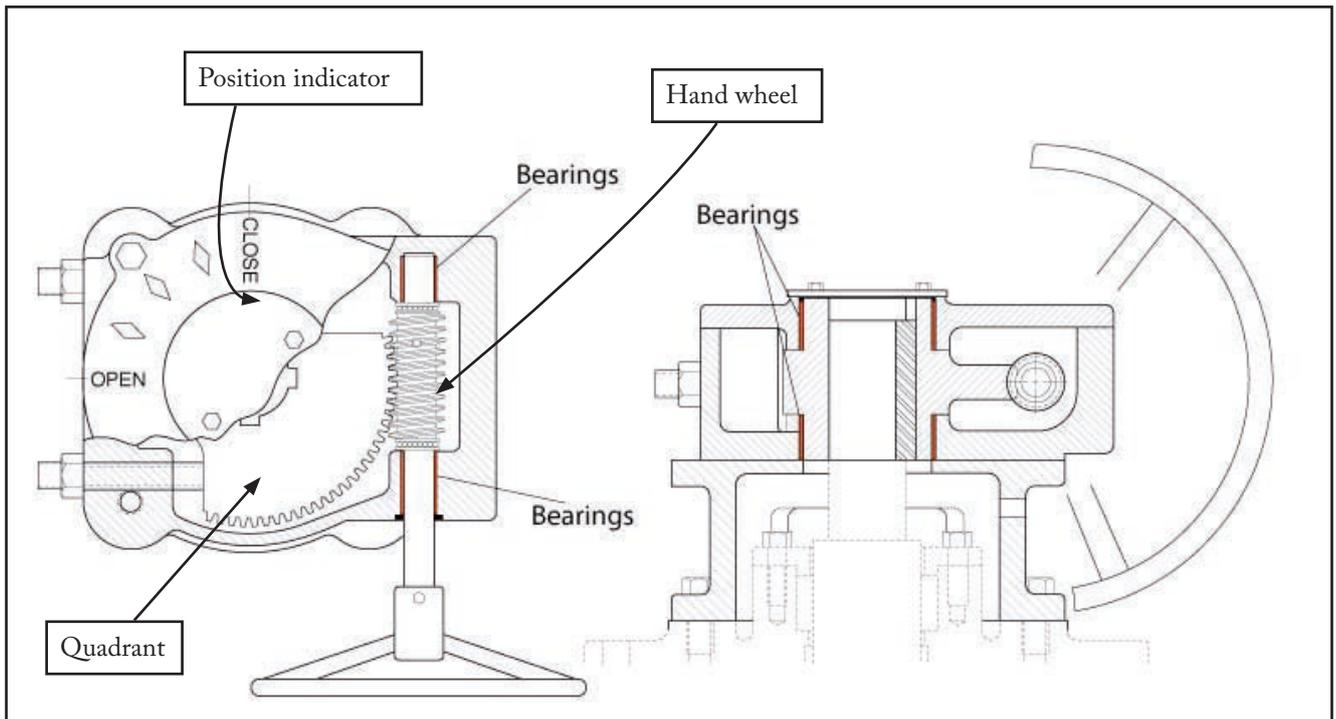
3. Examination of the isolating valve following the accident identified that the valve actuator had been defective, giving an impression that the valve was fully closed when it was not. Although there was a visual indicator located on the side of the actuator, this was not checked to confirm that the valve was closed prior to removal of the flange bolts. The actuator had previously been repaired. However, the chief engineer, who had only recently joined the vessel, was unaware of the actuator's poor internal condition (Figures 2 and 3).

Figure 2: Arrangement of actuator gearbox for valve A104 port

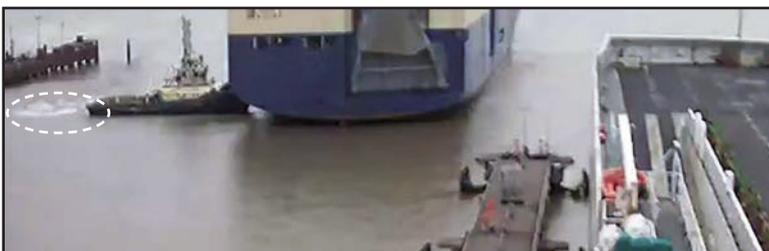
Figure 2: Vessel making approach astern toward berth – tug pushing

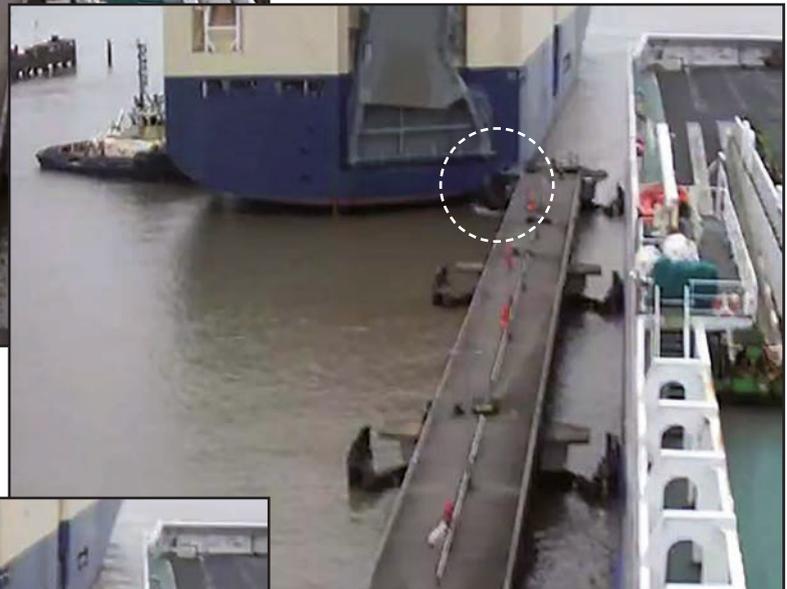
It was fortunate that the damage to this vessel was above the waterline and into a ballast tank. Had this been below the waterline, there could have been serious flooding. Had the damage been in way of a bunker tank, this could have resulted in a pollution incident. It was clear that the lead pilot had lost situational awareness; once he lost his electronic aid he did not properly utilise the resources available to him.

Figure 3: Contact with the end of the jetty

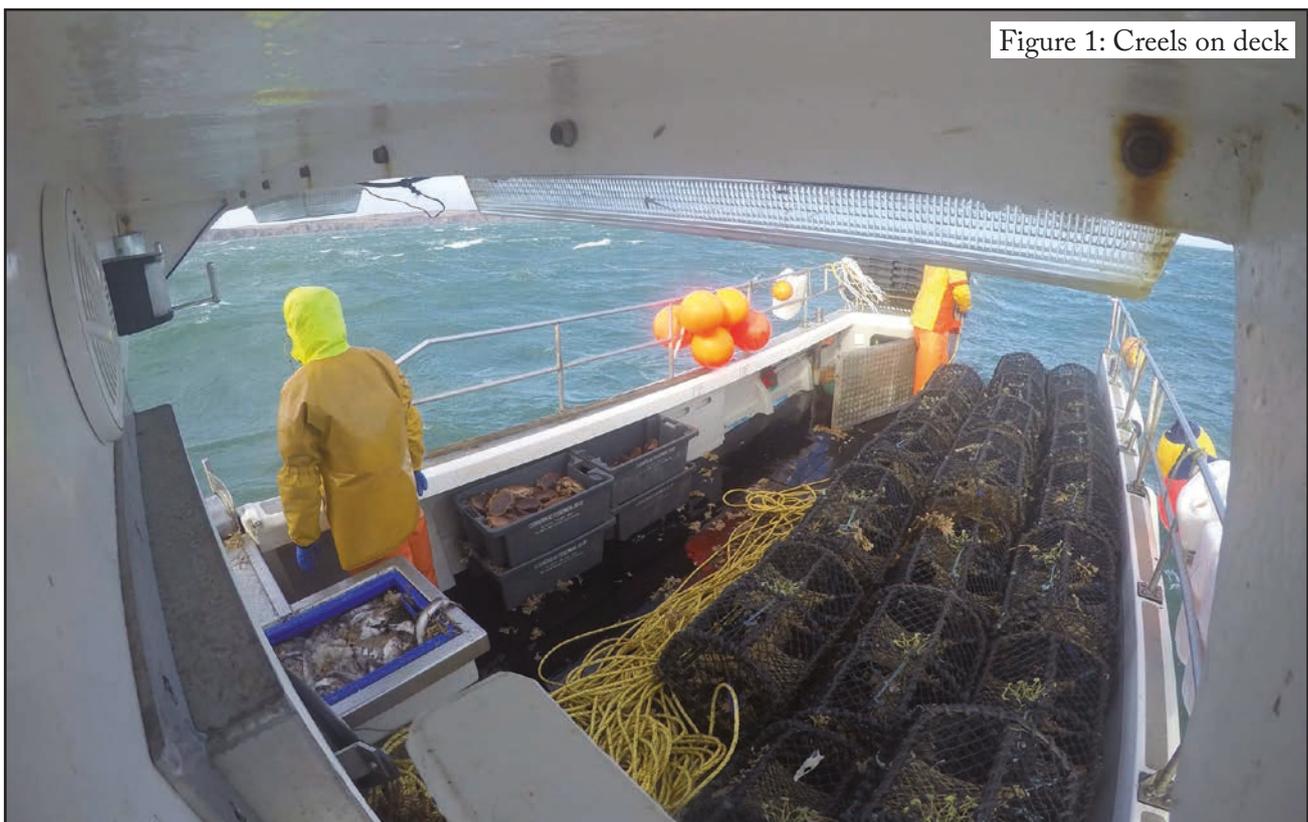
Figure 1: Creels on deck

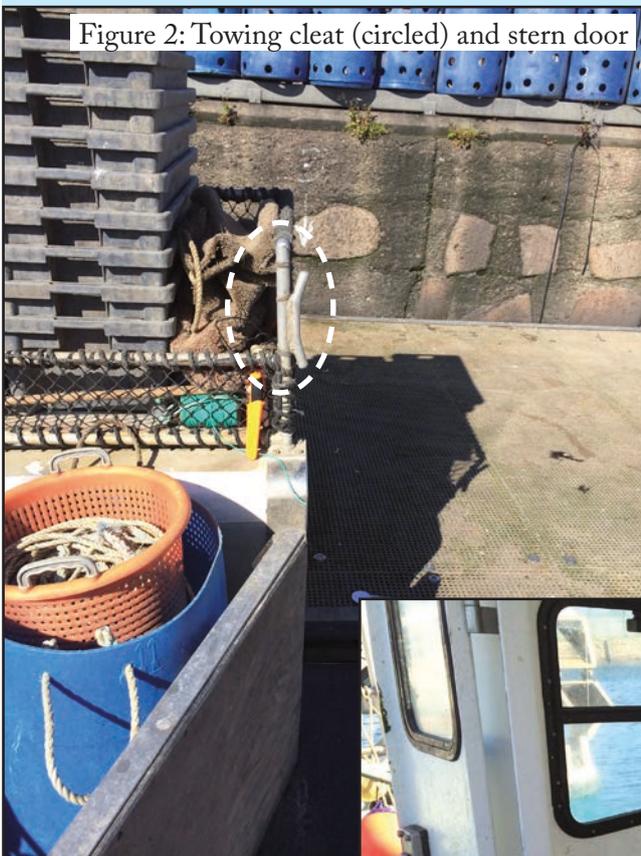
Figure 2: Towing cleat (circled) and stern door

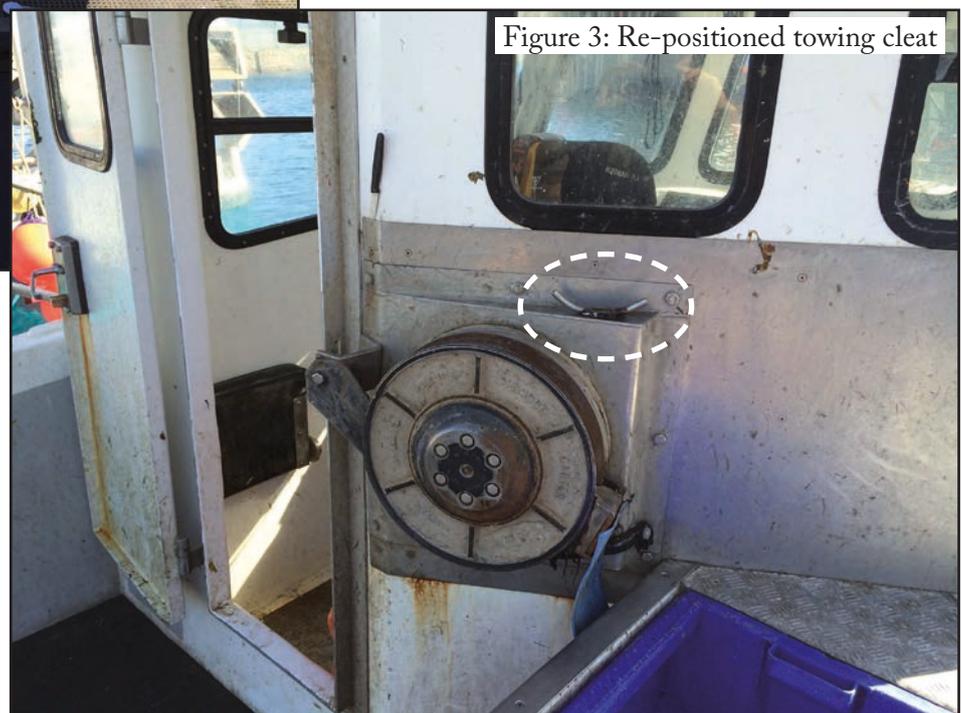
Figure 3: Re-positioned towing cleat

1. The working decks on fishing vessels are hazardous, particularly when shooting and hauling gear. However, where possible, keeping fishermen and moving nets, wires, pots, ropes and associated fishing gear apart significantly helps to prevent serious injury or worse. Following his accident, the skipper moved the towing cleat from the stern to the back of the wheelhouse (Figure 3) so that he can now release the end buoy without walking across the deck. The risk of entanglement when first shooting the creels has been eliminated.

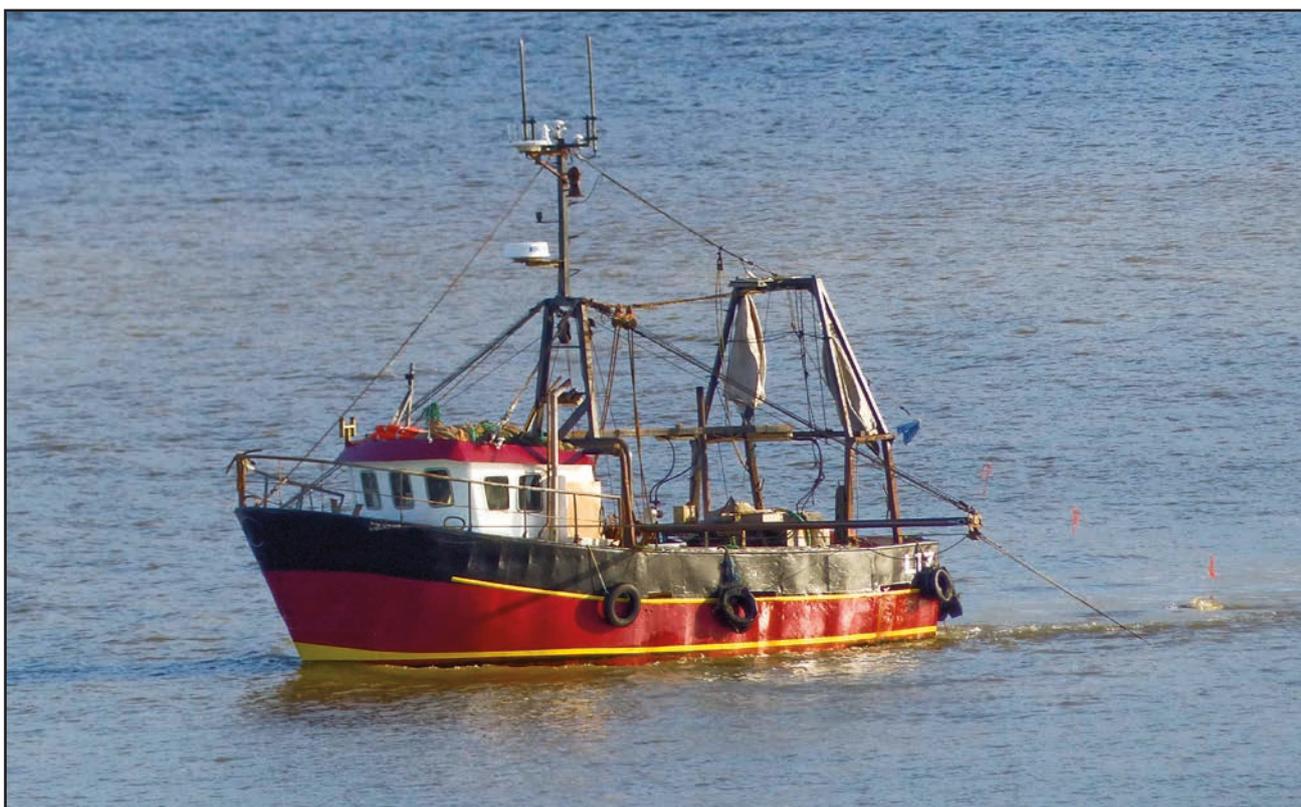
Figure 1: 10.8m steel beam trawler

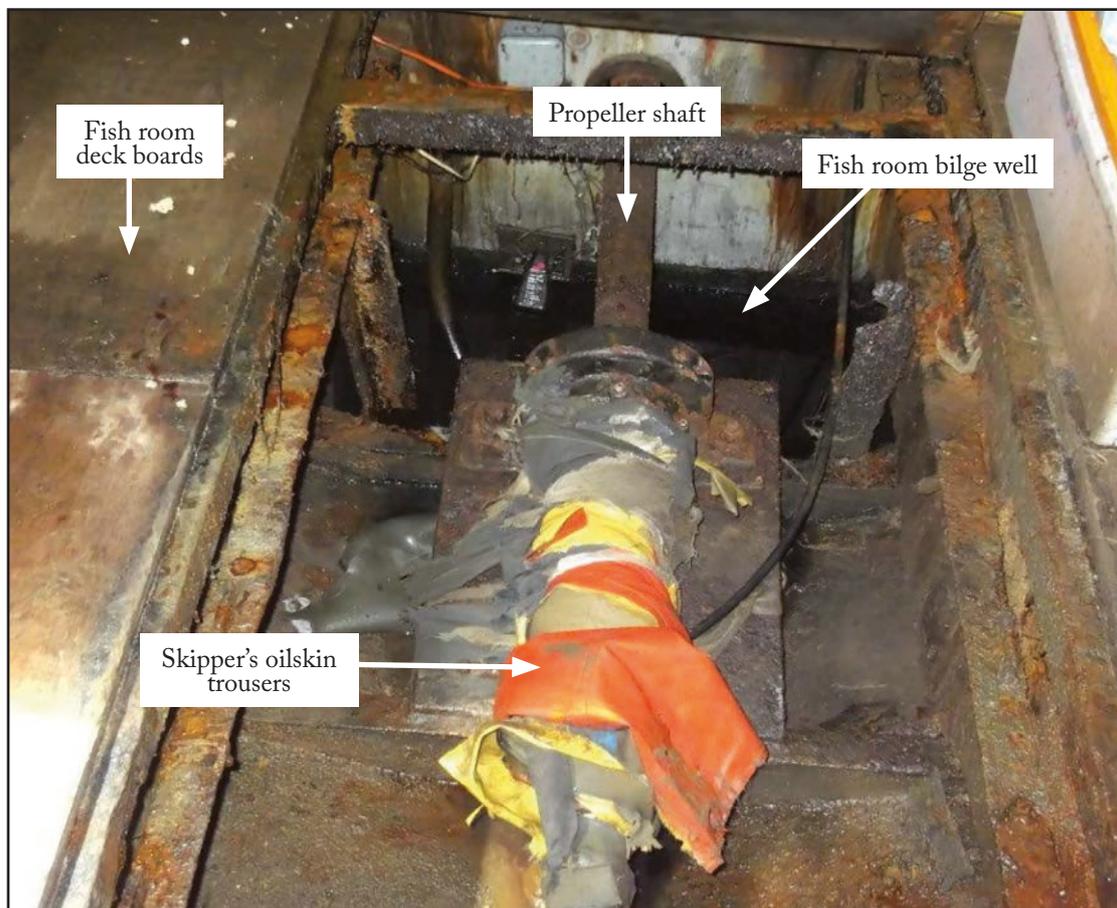
3. It took incredible strength of will and desire to survive for the skipper to free himself from the rotating propeller shaft and climb out of the fish hold. Once in the wheelhouse he could not reach the VHF radio. Fortunately he had a mobile telephone to hand, it had battery power and the boat was within range to pick up a signal. The ability to raise the alarm and communicate is vital in these circumstances. Options that should be considered include the carriage of PLBs.

Figure 2: Propeller shaft and fish room bilge well

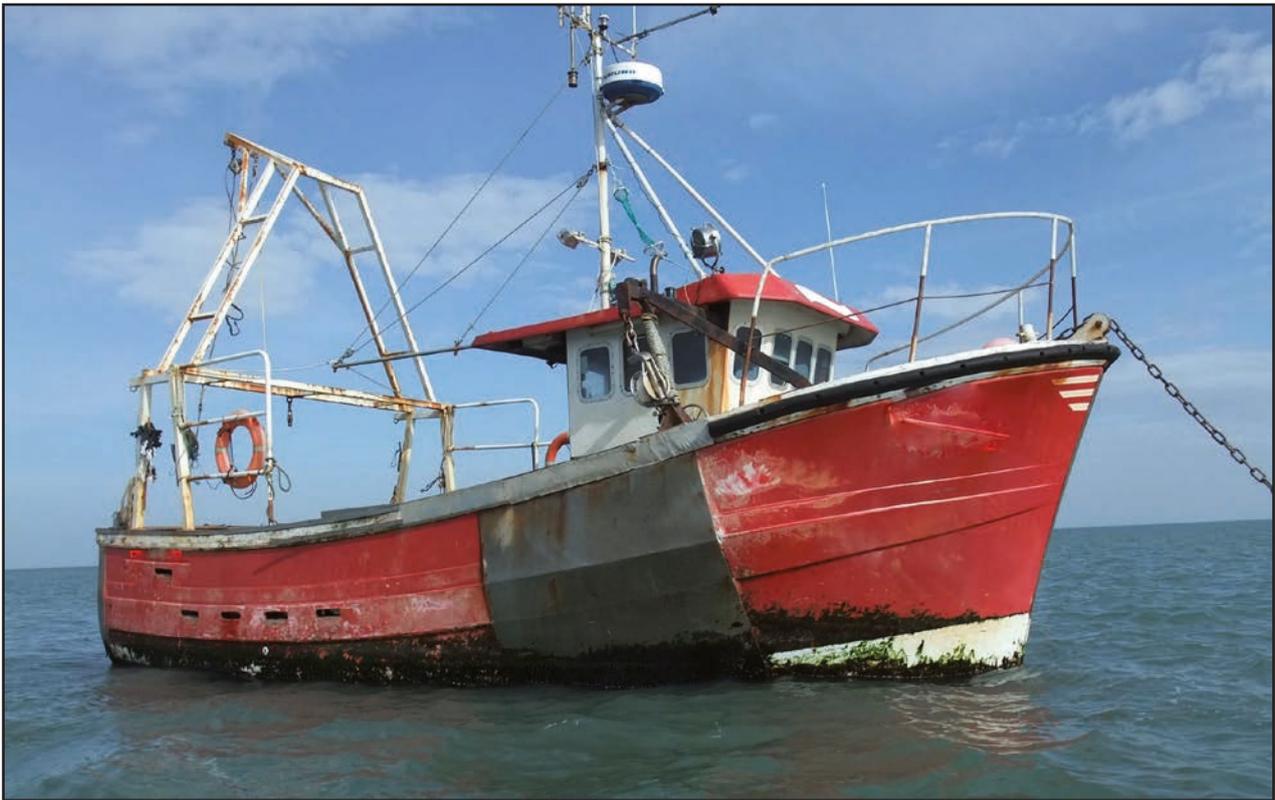
The vessel had been modified to operate as a scallop dredger from its original design as a whelk potter. These changes had resulted in a complex system for shooting and hauling the gear that was not suitable for single-handed operation (Figure 2). The winch installed was in a poor condition and was not fitted with any safety cut-off devices. As the skipper was

Figure 1: Single-handed scallop dredger

1. Single-handed operation of small fishing vessels is a well-documented hazard and all too frequently is highlighted in MAIB reports when something goes wrong. Safe systems of work need to be put in place following careful assessment of risks.
2. Emergency stops, safety cut-off and guards around machinery reduce the risk of an accident occurring. These should be fitted where possible and appropriate.
3. Working near unguarded rotating or moving equipment is hazardous. Ill-fitting or incorrectly worn clothing can introduce an extremely dangerous snagging hazard. Check for loose straps, tie cords and jewellery.
4. Maintenance forms a crucial part of any vessel's safety management, and can ensure costly breakdowns are rare. Incorrect or insufficient maintenance can lead to the premature failure or incorrect operation of machinery and equipment at safety-critical times.

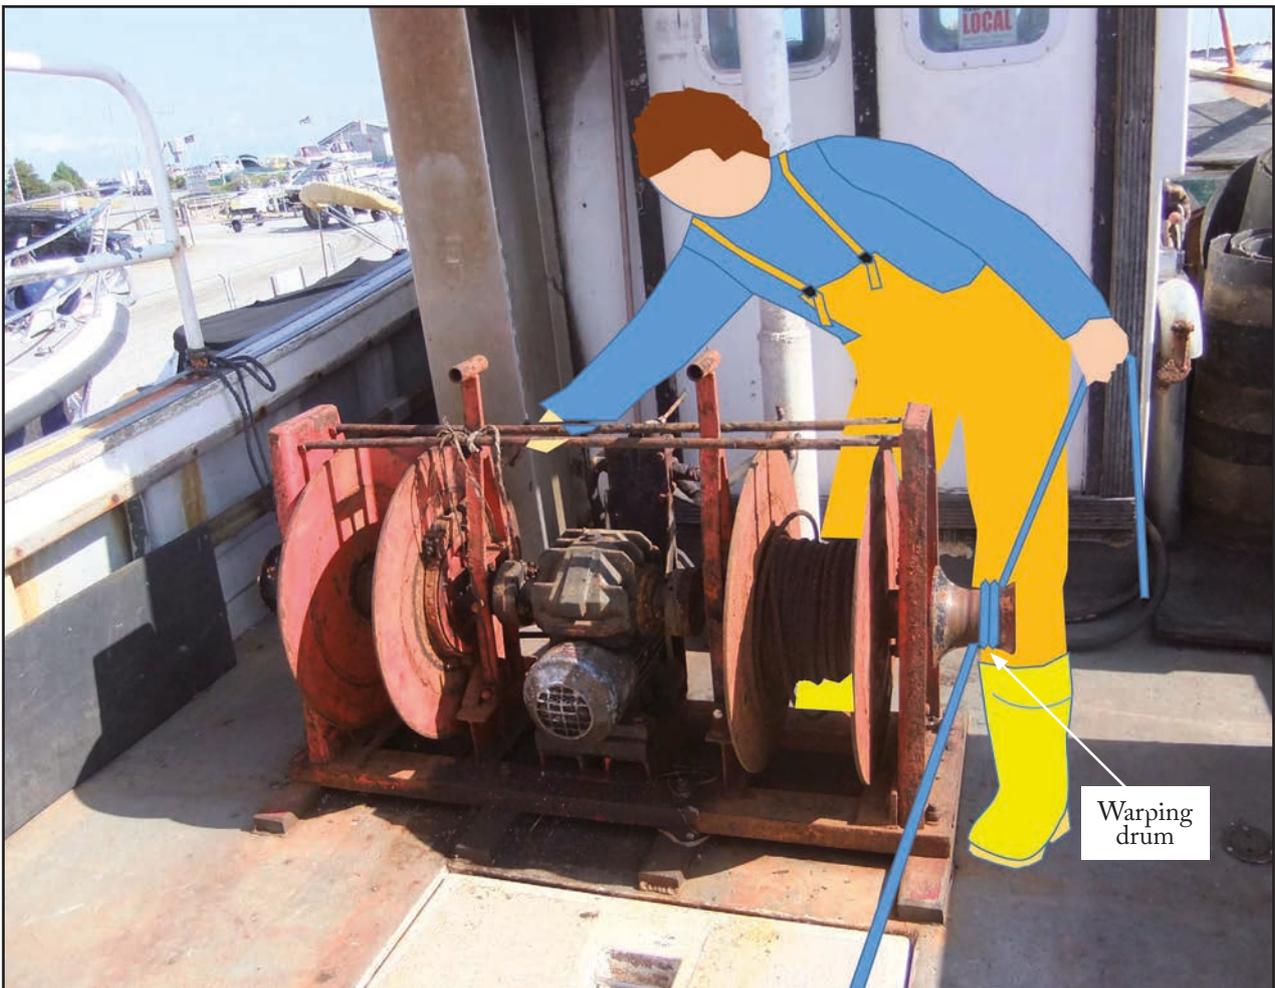
Figure 2: Simplified illustration of the skipper operating the vessel's winch while recovering his dredging gear on board

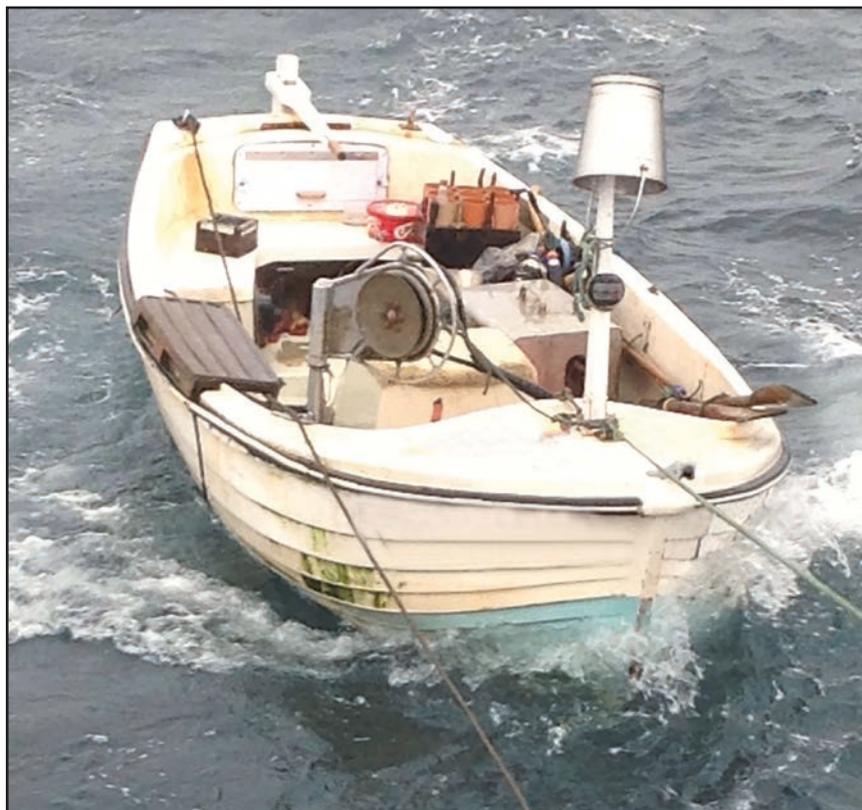
Figure 1: Picture of vessel under tow after recovery

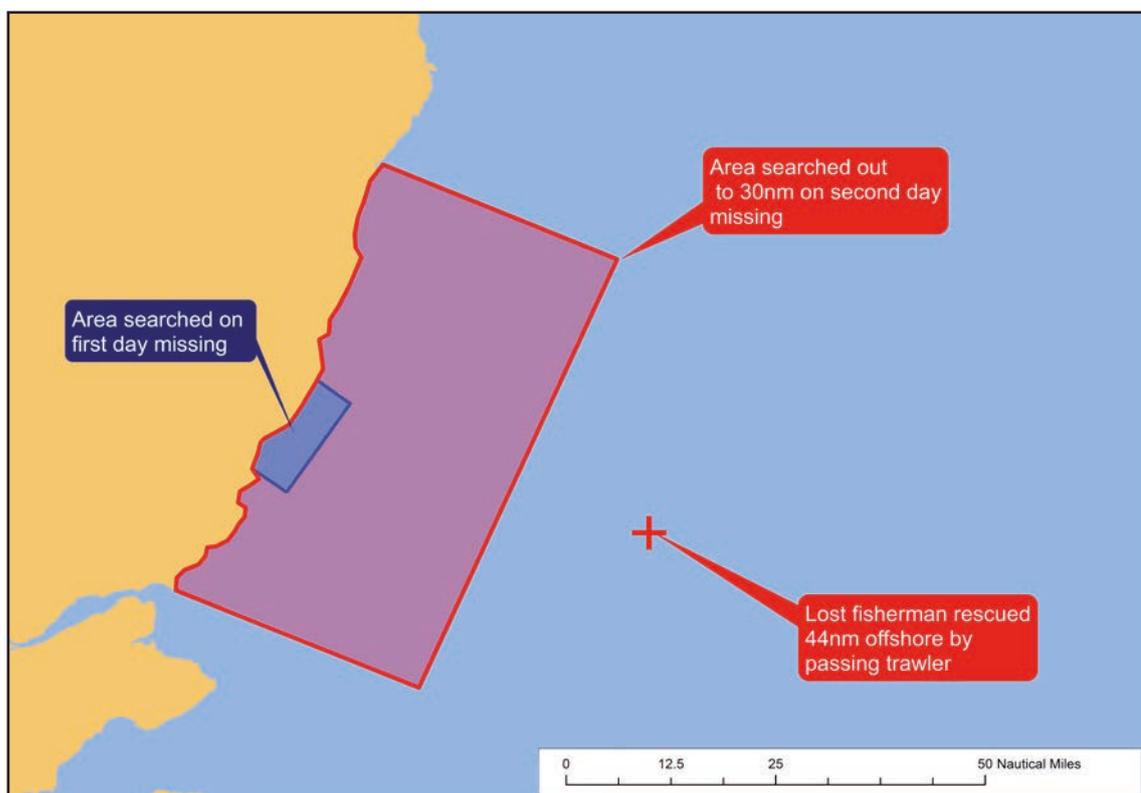
Later that morning, the skipper's wife raised the alarm when the boat was overdue. This triggered an extensive search using lifeboats, helicopters, other vessels in the area and coastguard rescue teams ashore. The search extended up to 30 miles offshore (Figure 2); however, after 2 days nothing had been found and the men were assumed to have been lost at sea.

The fishermen were cold, hungry and exhausted. With the weather conditions deteriorating, they were almost resigned to their fate when they sighted a deep-sea trawler approaching. Having gained the attention of its watchkeeper, the lost crew were rescued from their boat and transferred ashore to be reunited with their family. The rescue took place 44 miles offshore (Figure 2).

Figure 2: Area searched for missing small fishing vessel and position where it was found after over 2 days at sea
