**Lessons from Marine
Accident Reports
1/2016**

SAFETY DIGEST
Lessons from Marine Accidents
No 1/2016

April 2016

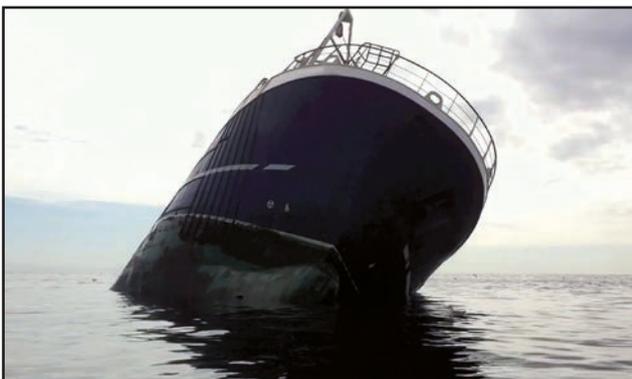
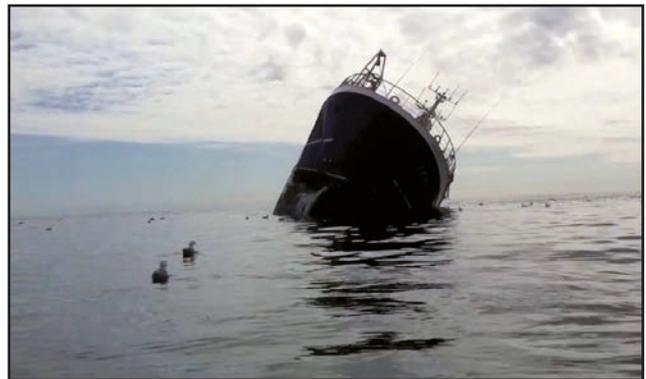
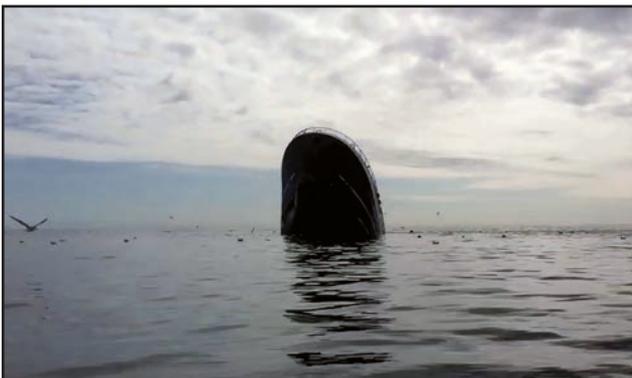
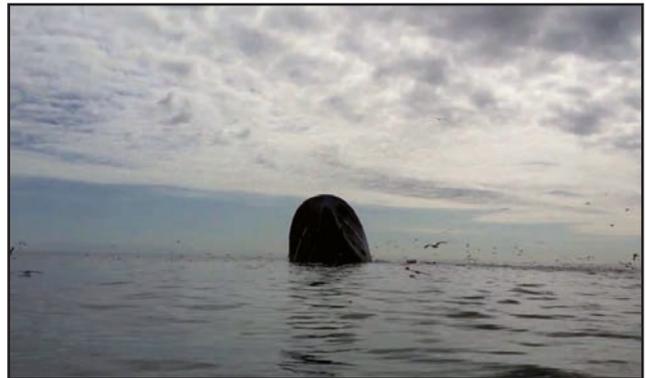
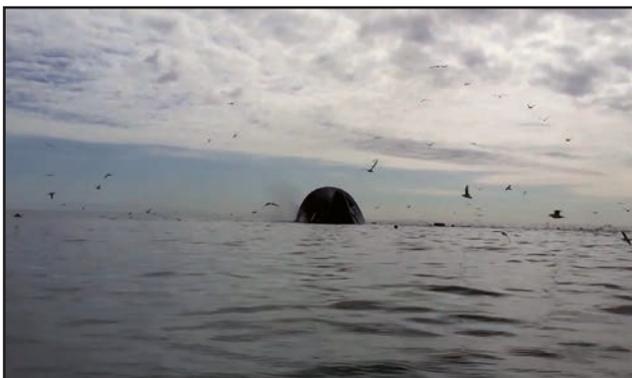
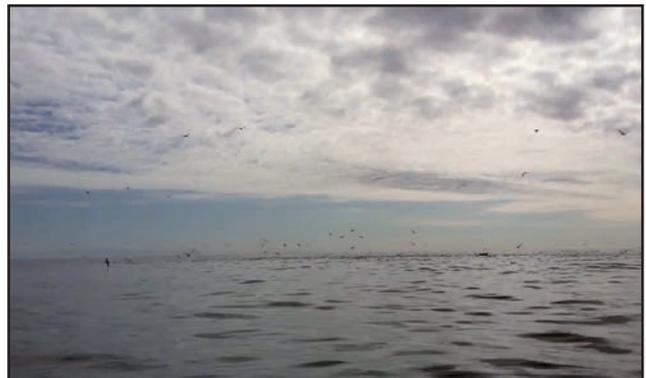
Figure 1: Sequence showing fishing vessel sinking

4. The rate of water ingress and the speed at which the vessel sank suggests the failure of a main engine sea water cooling pipe. Analysis of maintenance records showed that this pipework had not been inspected or renewed for many years. Sea inlet pipework should be thoroughly checked during planned maintenance periods.

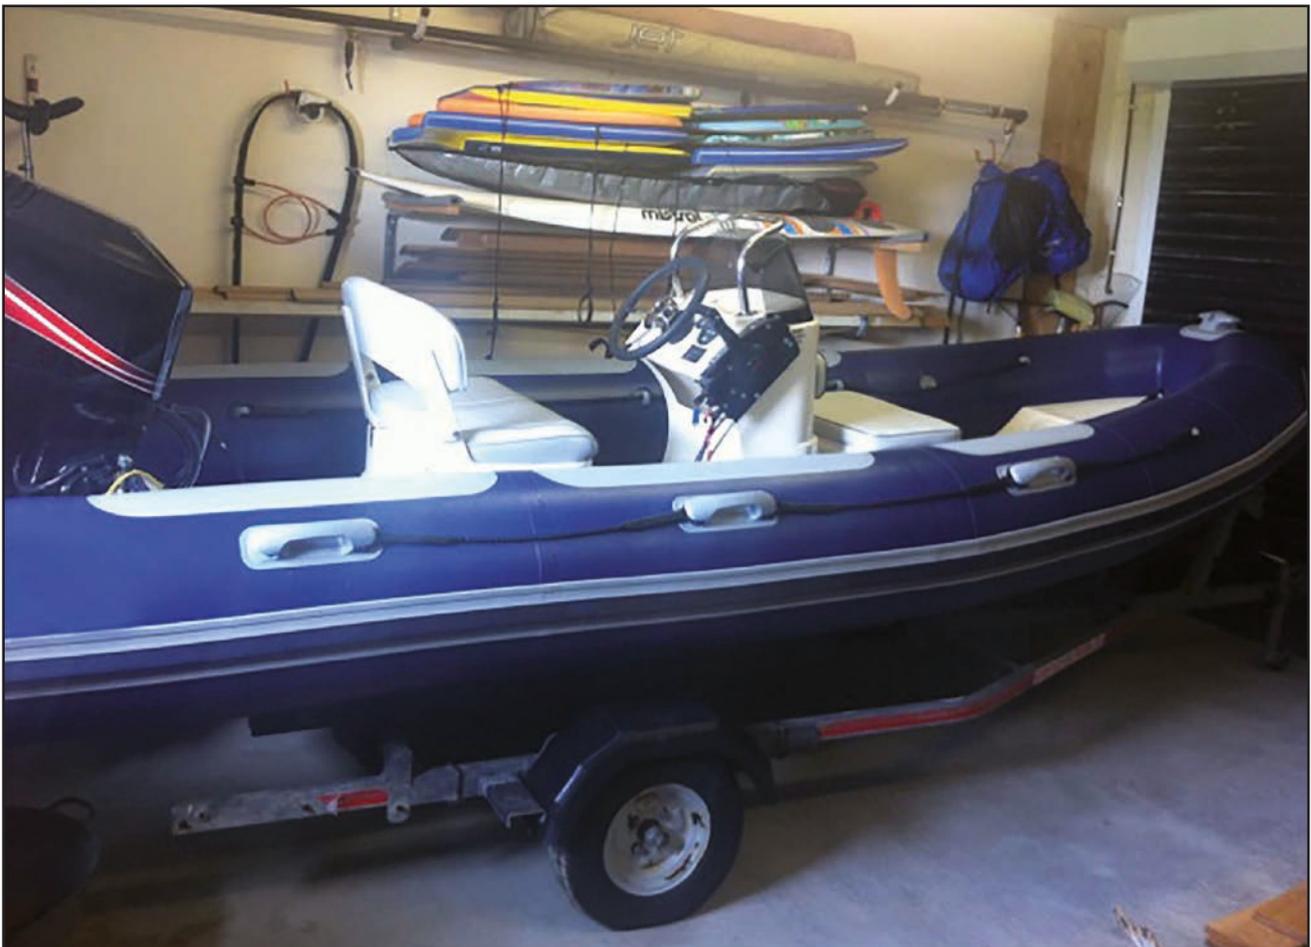
Figure 1: The 5 metre RIB

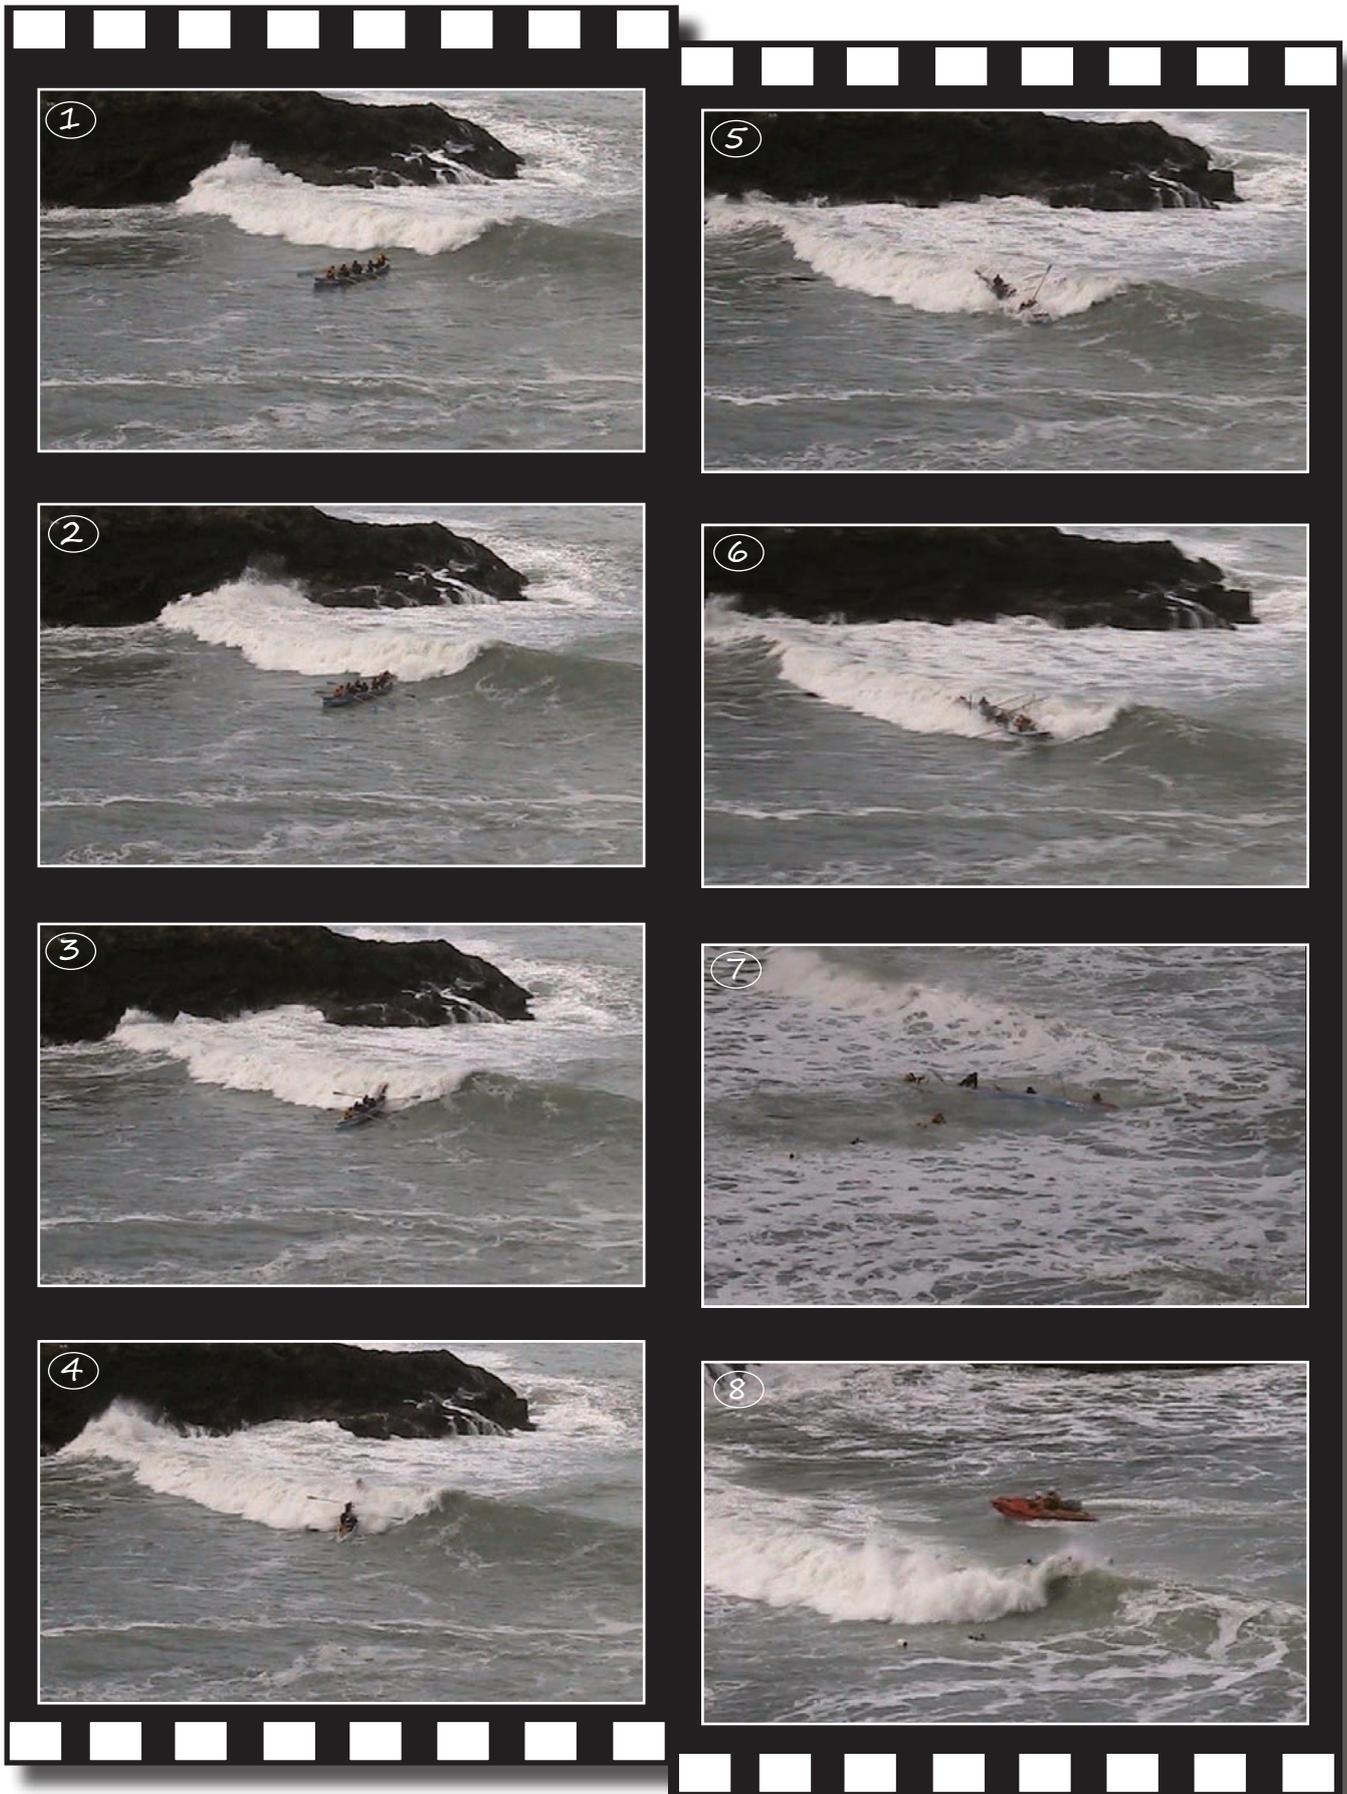
Most of the inflatable lifejackets supplied by the lifeboat did their job by inflating and supporting their wearers. One lifejacket however did not automatically inflate and the weight of the wearer's waterlogged all-in-one suit quickly sapped his energy as he attempted to stay afloat while successive waves broke over him. Fortunately he was able to grab an oar and gain some support from that.

Figures 1-8: Series of images showing the gig being caught by the swell and broaching

1. It was known that a ground swell regularly developed at the mouth of this harbour 1 hour either side of low water. There was, therefore, a risk of making a harbour entry in marginal conditions, or having a long cold wait. With hindsight, it is easy to see that a better decision would have been to delay the training until conditions were more favourable.

2. Having decided to proceed with the training session the gig's crew knew they could face a long wait at sea if the ground swell developed. They should therefore have taken appropriate extra clothing in case this occurred. While the all-in-one woollen suits supplied by the RNLI are good at retaining warmth, they are intended to be worn under dry suits; their fleece like construction acts like a sponge in water and, as was shown in this case, when waterlogged their weight can quickly sap the energy of an unsupported swimmer.

3. Many rowers choose not to wear PFDs as they perceive them to restrict their rowing. Given the conditions on the day it would have been sensible, as a minimum, to have stowed lifejackets on board. They could then have been donned before starting any potentially hazardous activity, such as attempting to enter harbour through a heavy swell.

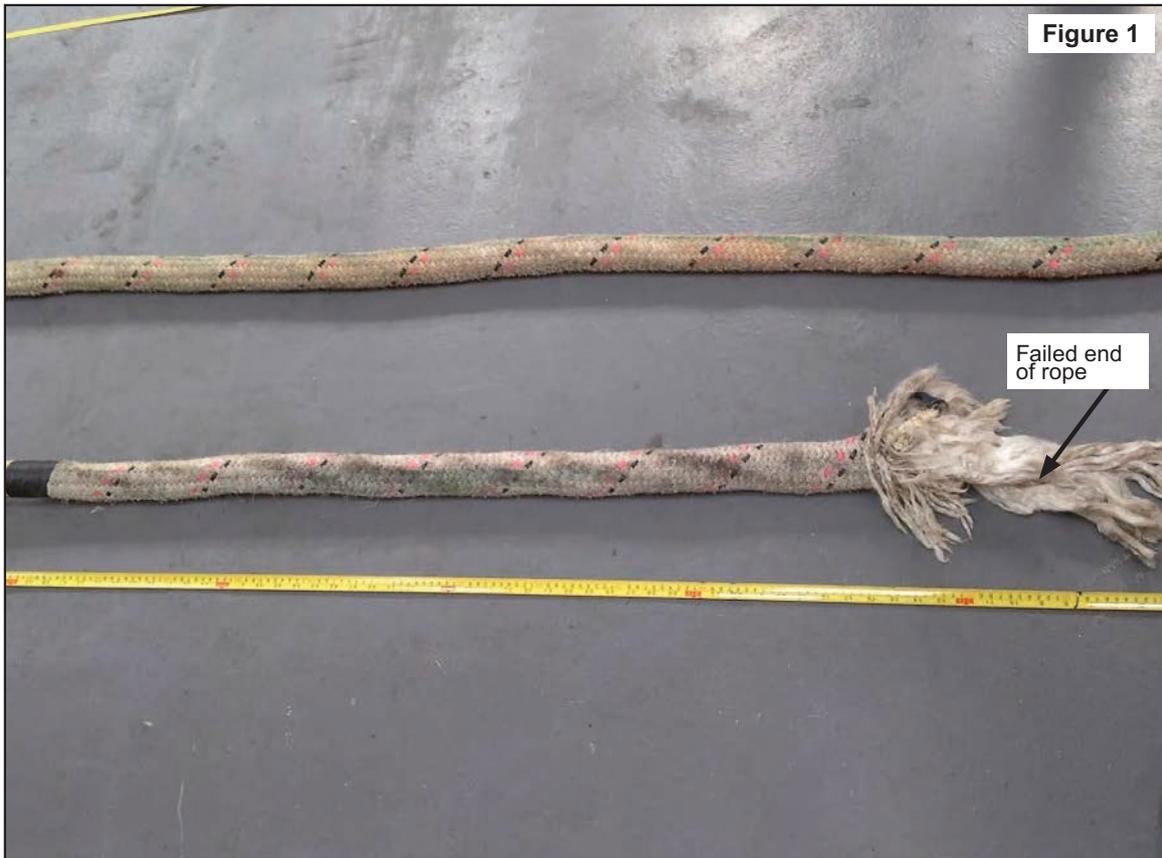
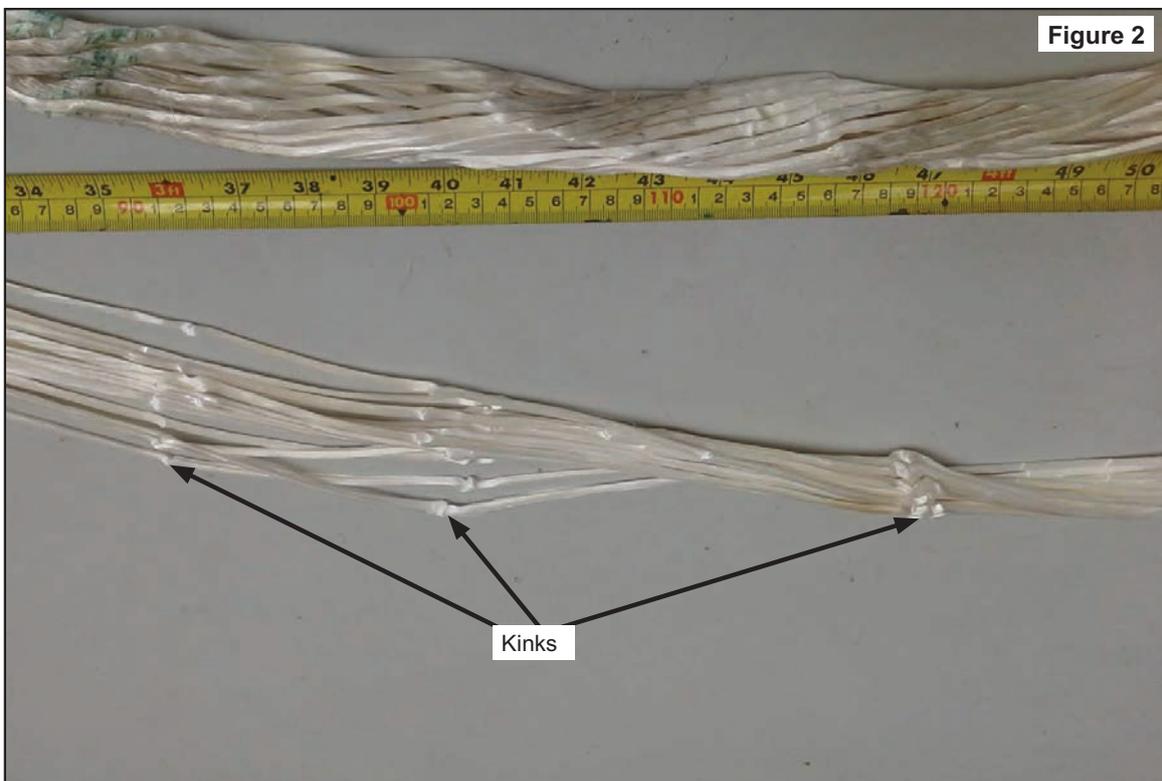
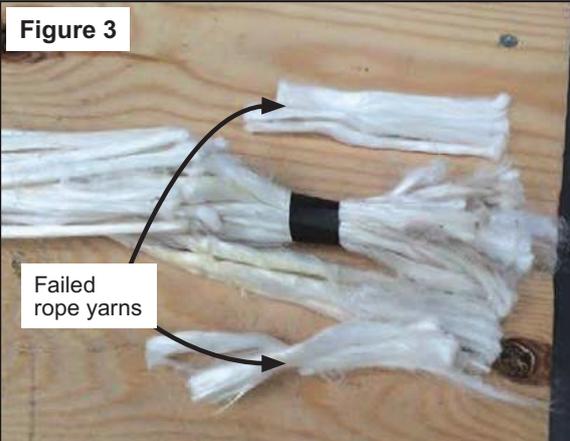
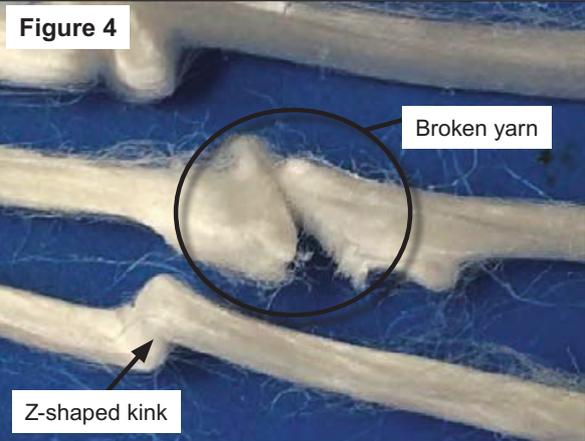
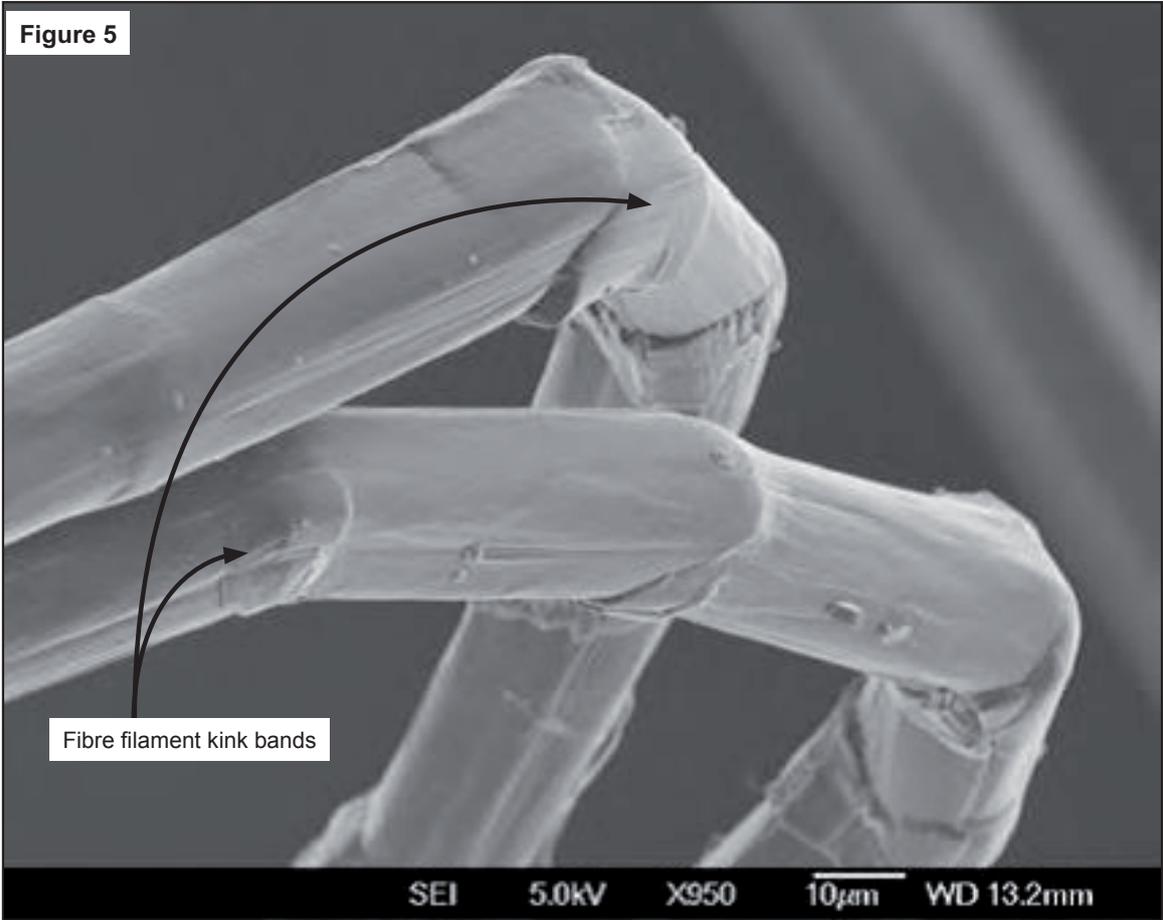
Following the identification of the kinking and failed rope yarns, a number of additional sections of the rope were inspected. Further rope yarn failures and damage to the rope yarns at filament level were seen (**Figure 5**). The damage identified was consistent with axial compression fatigue.

Operating ropes around tight bend radii can exacerbate axial compression fatigue and also cause internal abrasion damage. In this case, the failed mooring rope had been run from its winch drum to the LNG terminal hook via a deck roller bollard and a ship's side roller fairlead. The diameters of the rollers for both the deck bollard and deck fairlead were less than the minimum recommended by the rope manufacturer for its 44mm HMPE jacketed ropes.

Close-fitting jackets prevent operators from visually inspecting these types of rope for core and yarn fatigue damage, and there are currently no non-destructive tests available to assess the level of fatigue degradation in fibre filaments in ropes. If it had been possible to visually inspect the load-bearing core of *Zarga's* rope, the rope yarn kinks and the broken rope yarns would have been identified.

The HMPE rope failed at well below its certificated minimum breaking load and well before its anticipated lifetime prediction. This was the latest in a series of mooring line failures that had occurred on board large LNG carriers at, mainly, exposed berths over several years. The investigation into the causes and circumstances of the rope failure is ongoing and will be discussed in the full investigation report, along with other safety issues identified during the investigation.

- Confirm or otherwise that the rope is suitable for its intended use and envisaged operating conditions including, specifically, that it is compatible with the vessel's deck fittings, and,
- Ensure that an appropriate regime exists to monitor the condition of the ropes in use so as to maintain a high level of confidence that they can be replaced before they become materially weakened or degraded.
