Report on the investigation of the grounding
of the cruise ship
Hamburg
in the Sound of Mull, Scotland

11 May 2015

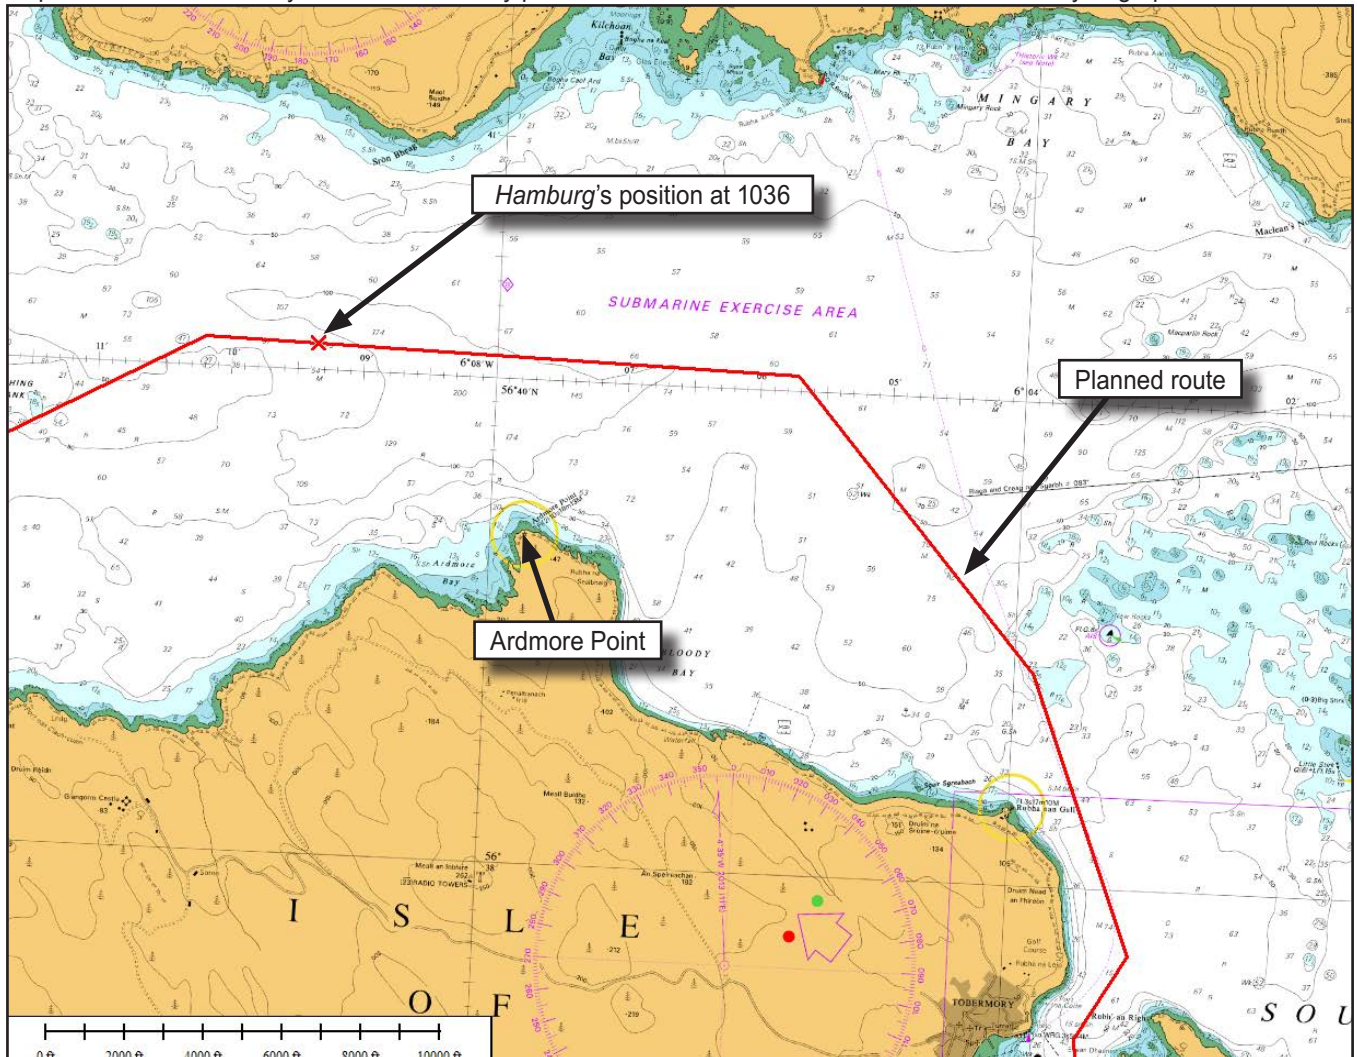
Figure 3: Extract of chart BA 2392 showing *Hamburg*'s position at 1036

At 1036 *Hamburg* approached Ardmore Point (**Figure 3**). The master decided that *Hamburg* would continue towards Tobermory and then drift in the northern part of the Sound of Mull. He advised the OOW of his intentions but did not amend the passage plan.

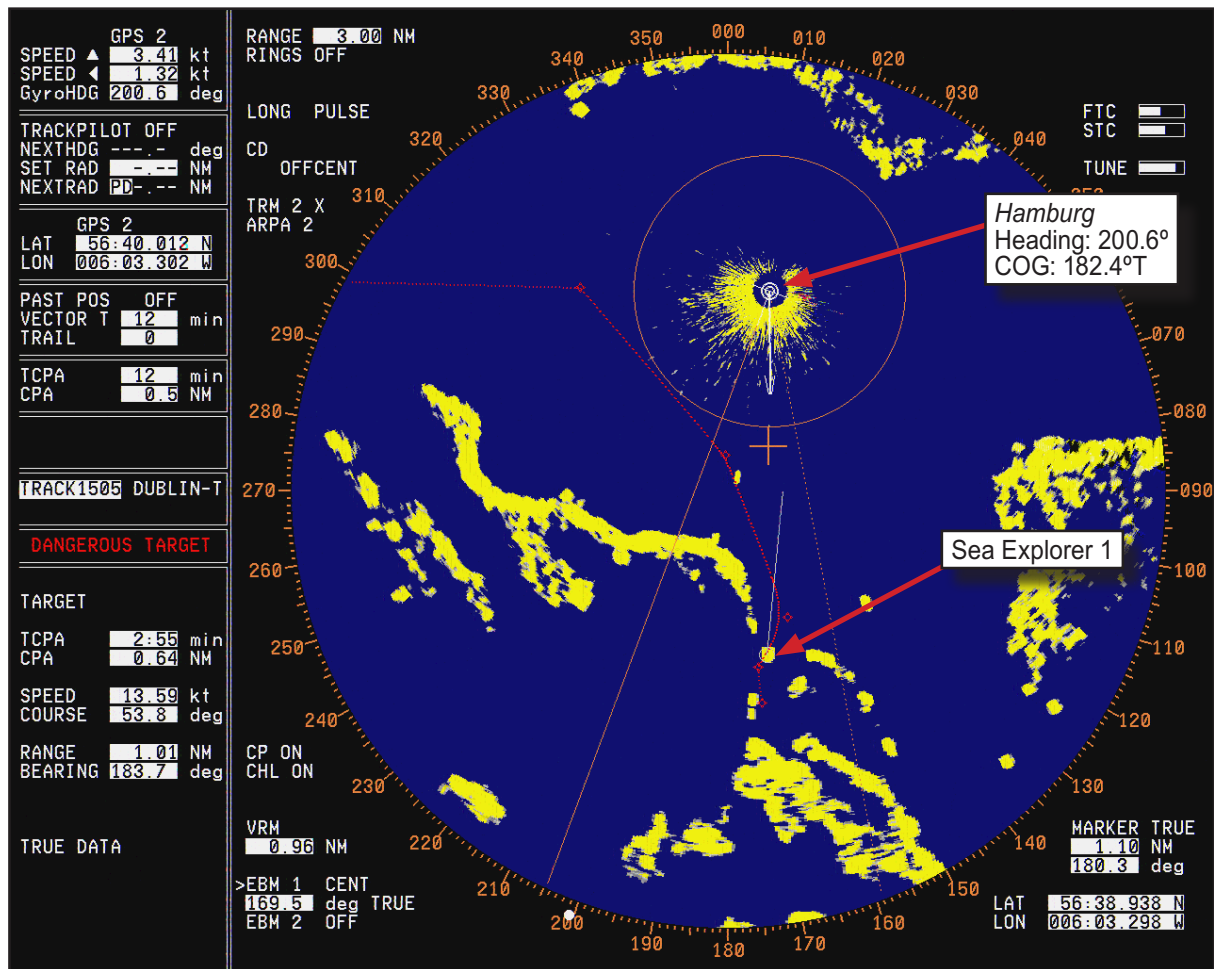
Figure 4: Radar display showing the positions of *Hamburg* and *Sea Explorer 1* at 1318

By 1318 *Sea Explorer I* had cleared Tobermory Bay and was on a northerly heading through the Sound of Mull. *Hamburg* was on a heading of 200.6° with a COG of 182.4° and a SOG of 3.41kts (**Figure 4**). *Hamburg's* master then ordered the AB to steer 195°. By 1320 the master had set the engine control to 'half ahead' and *Hamburg* was steady on 195° with a COG of 181° and a SOG of 3.72kts.

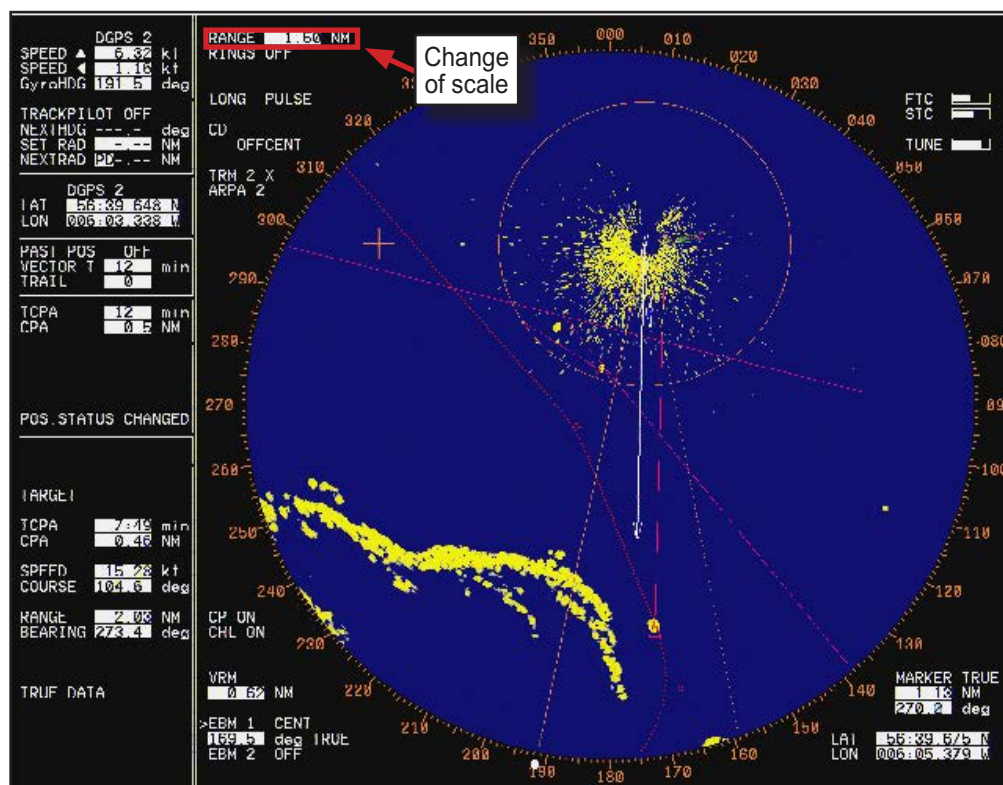
Figure 6: Radar display showing Hamburg's position at 1322:55

At 1321 both the OOW and the cadet plotted *Hamburg's* position on the chart (**Figure 5**). The cadet saw that his plotted position was some distance away from the OOW's position but closer to the New Rocks shoal. Without consulting the OOW, the cadet assumed his own position was incorrect and removed it from the chart using an eraser. At 1322:55 the OOW reduced the starboard radar display to the 1.5nm setting (**Figure 6**).

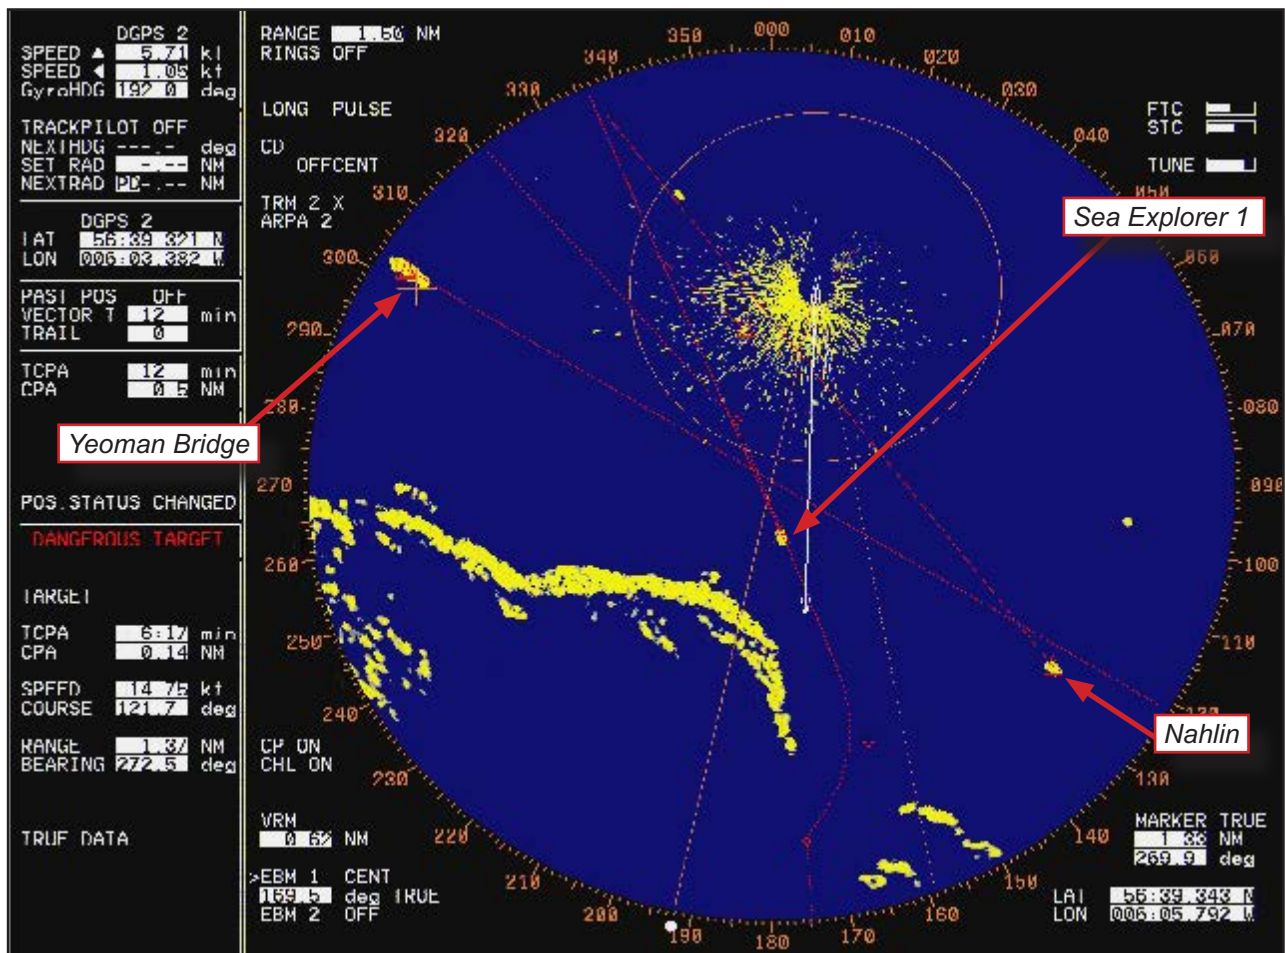
Figure 7: Radar display showing positions of Hamburg, Sea Explorer 1, Nahlin and Yeoman Bridge

Shortly afterwards, at 1324, motor yacht *Nahlin* was on a north-westerly course and approaching the New Rocks buoy from the south-east. At the same time the bulk carrier *Yeoman Bridge* was approaching the New Rocks buoy from the north-west (**Figure 7**). Simultaneously, officers on board both *Nahlin* and *Yeoman Bridge* called *Hamburg* on VHF radio channel 16 and *Hamburg*'s OOW replied. A transcript of the resulting VHF conversation is at **Table 1** below.

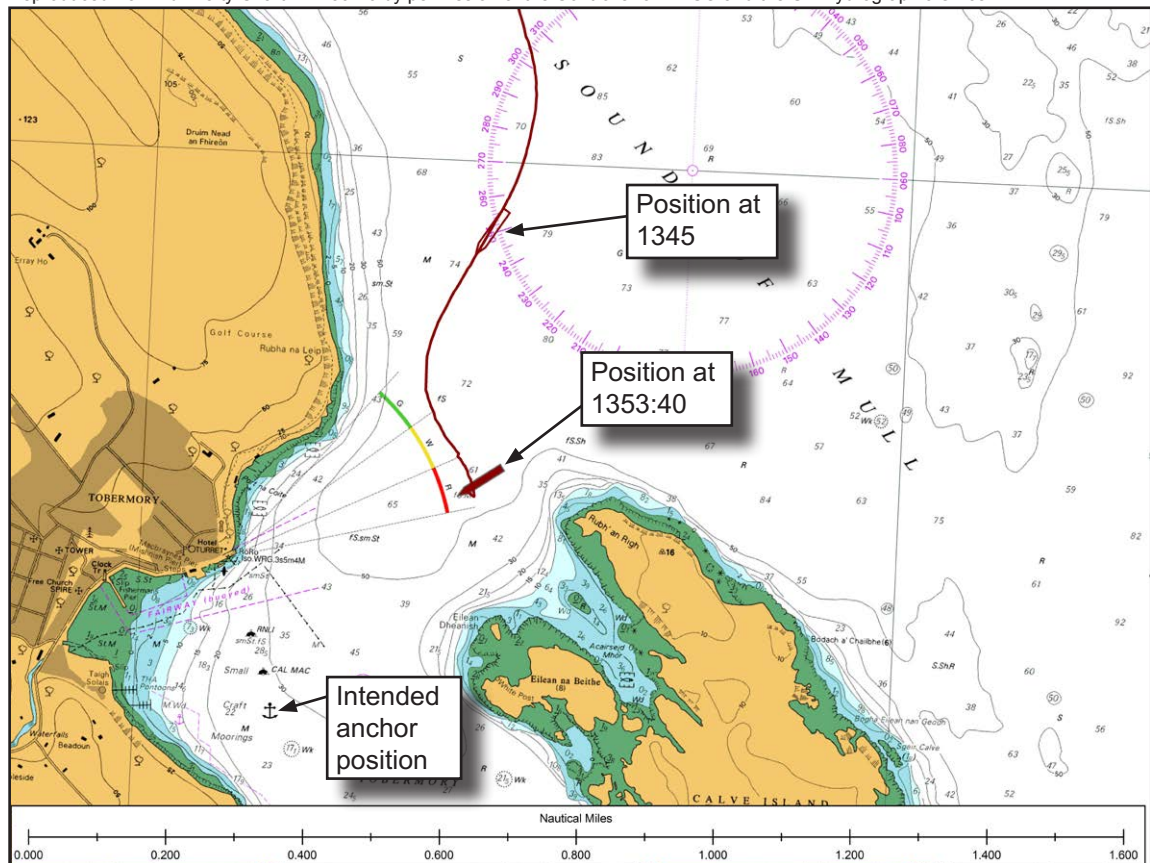
Figure 9: Extract of chart BA 2392 showing *Hamburg's* position and track between 1345 and 1353:40

At 1345:37 *Hamburg* was at the entrance to Tobermory Bay (**Figure 9**) heading 209.5° with a SOG of 4.5kts. The wind continued from a south-westerly direction but its strength had decreased slightly in the sheltered bay. The master saw that there were many small boats on moorings in the bay and, unwilling to continue into the congested area, he decided to anchor in the bay entrance rather than in the planned position at the THA designated anchorage to the south-west. The master continued to reduce *Hamburg*'s speed in preparation for anchoring.

By 1351:29 *Hamburg*'s master had ordered the starboard anchor to be let go to 5 shackles⁶ on deck⁷. The cruise ship was on a heading of 223.9° and the charted depth of water was 61m. As the anchor was deployed, *Hamburg* was slowly moved astern using its engine and assisted by the wind. The cruise ship travelled in an easterly direction across the bay entrance and, at 1353:40, the OOW advised the master that there was a shallow patch of water on the vessel's port side (**Figure 9**).

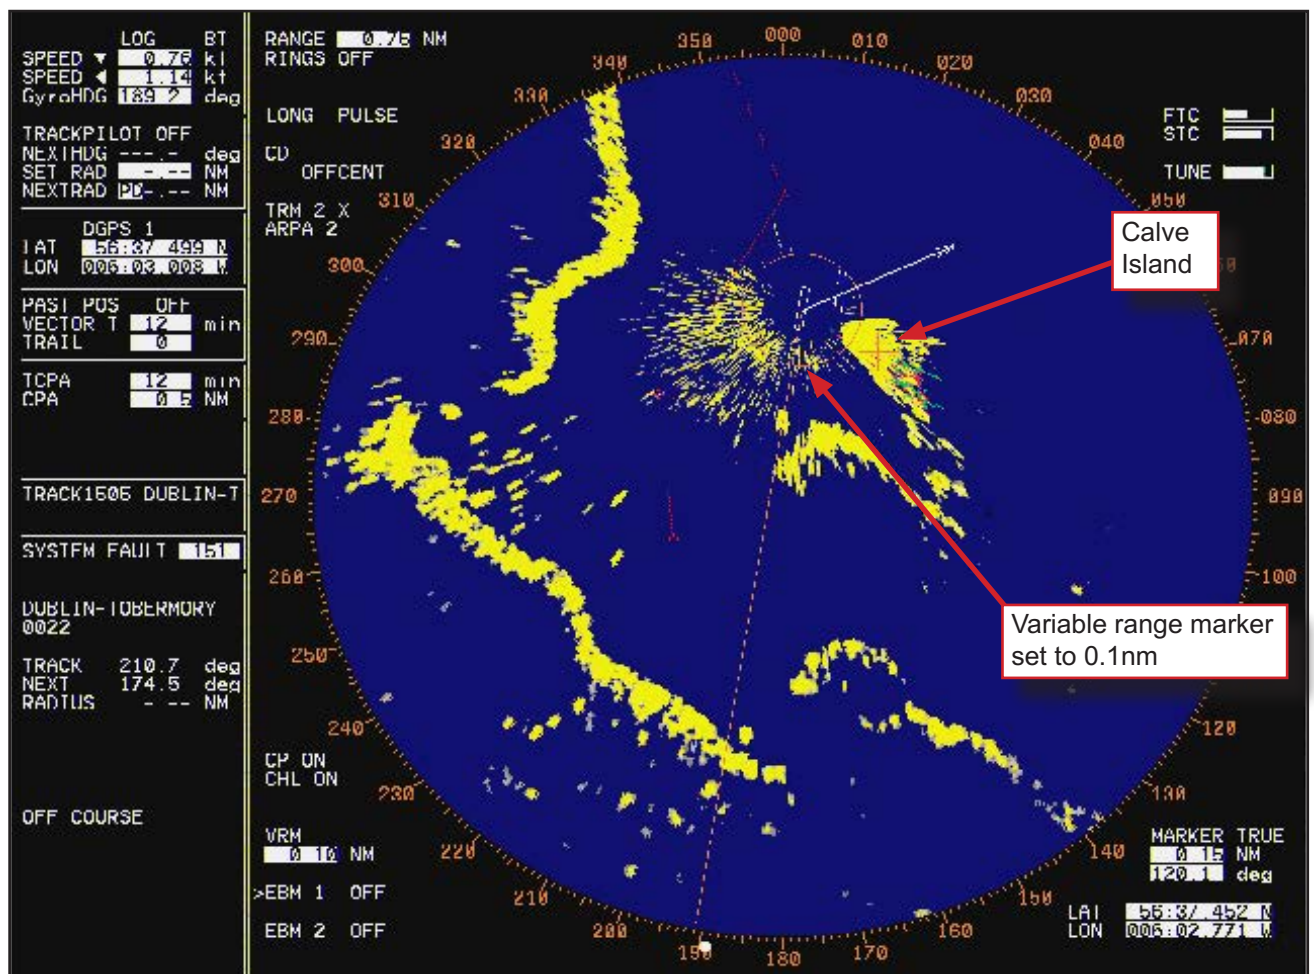
Figure 10: Radar display showing *Hamburg* passing within 1 cable of Calve Island

By 1401, *Hamburg* had 5 shackles of anchor cable deployed. The OOW set the variable range marker on the starboard radar display to 0.15nm to monitor the vessel's position and, at 1405, he informed the master that *Hamburg* was moving astern towards Calve Island⁸ at a SOG of approximately 0.5kt. The master decided to abort the anchoring operation and ordered the recovery of the anchor. The master, intending to move *Hamburg* backwards out of the bay before turning the vessel to the north, increased its astern power and turned the vessel to clear the island. The cruise ship moved astern out of Tobermory as its anchor was being recovered, passing less than 0.1nm off Calve Island (**Figure 10**). The anchor was reported as home⁹ at 1422.
