MARINE ACCIDENT
INVESTIGATION BRANCH

SAFETY DIGEST

**Lessons from Marine
Accident Reports
2/2016**

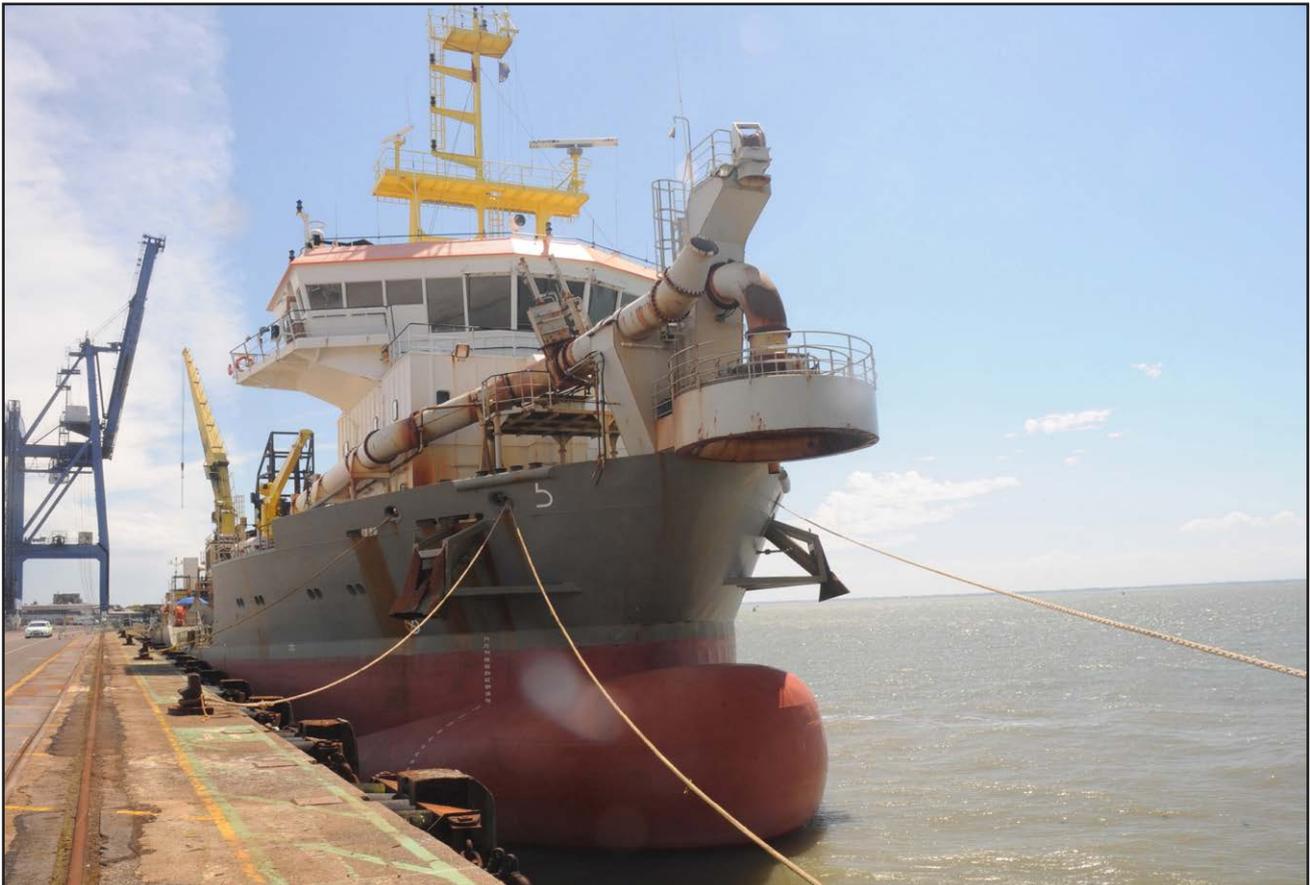
Figure 1: The dredger

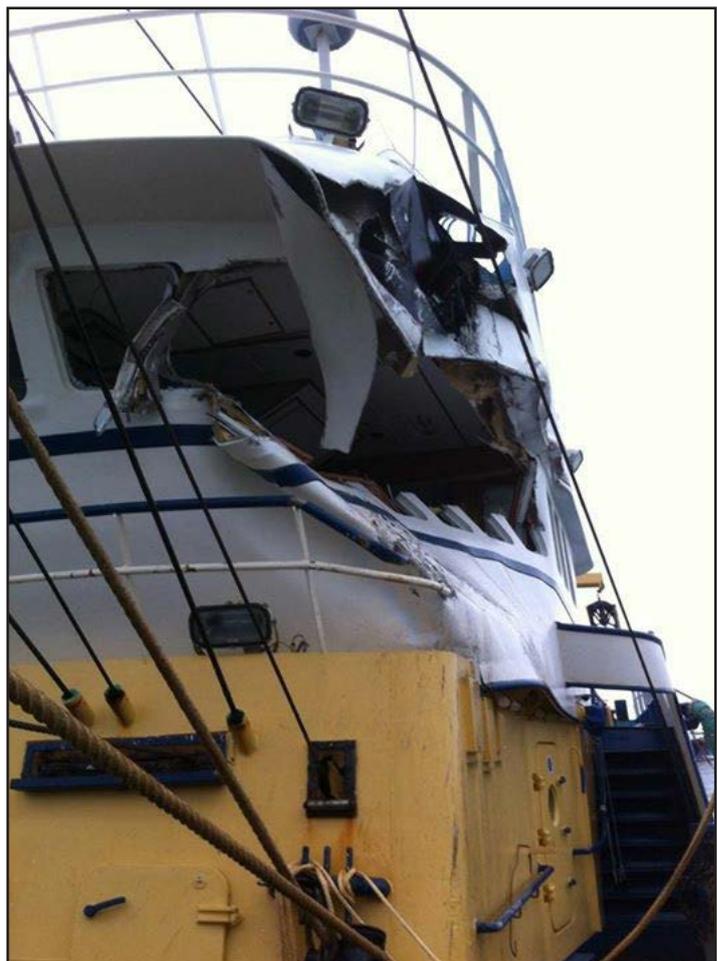
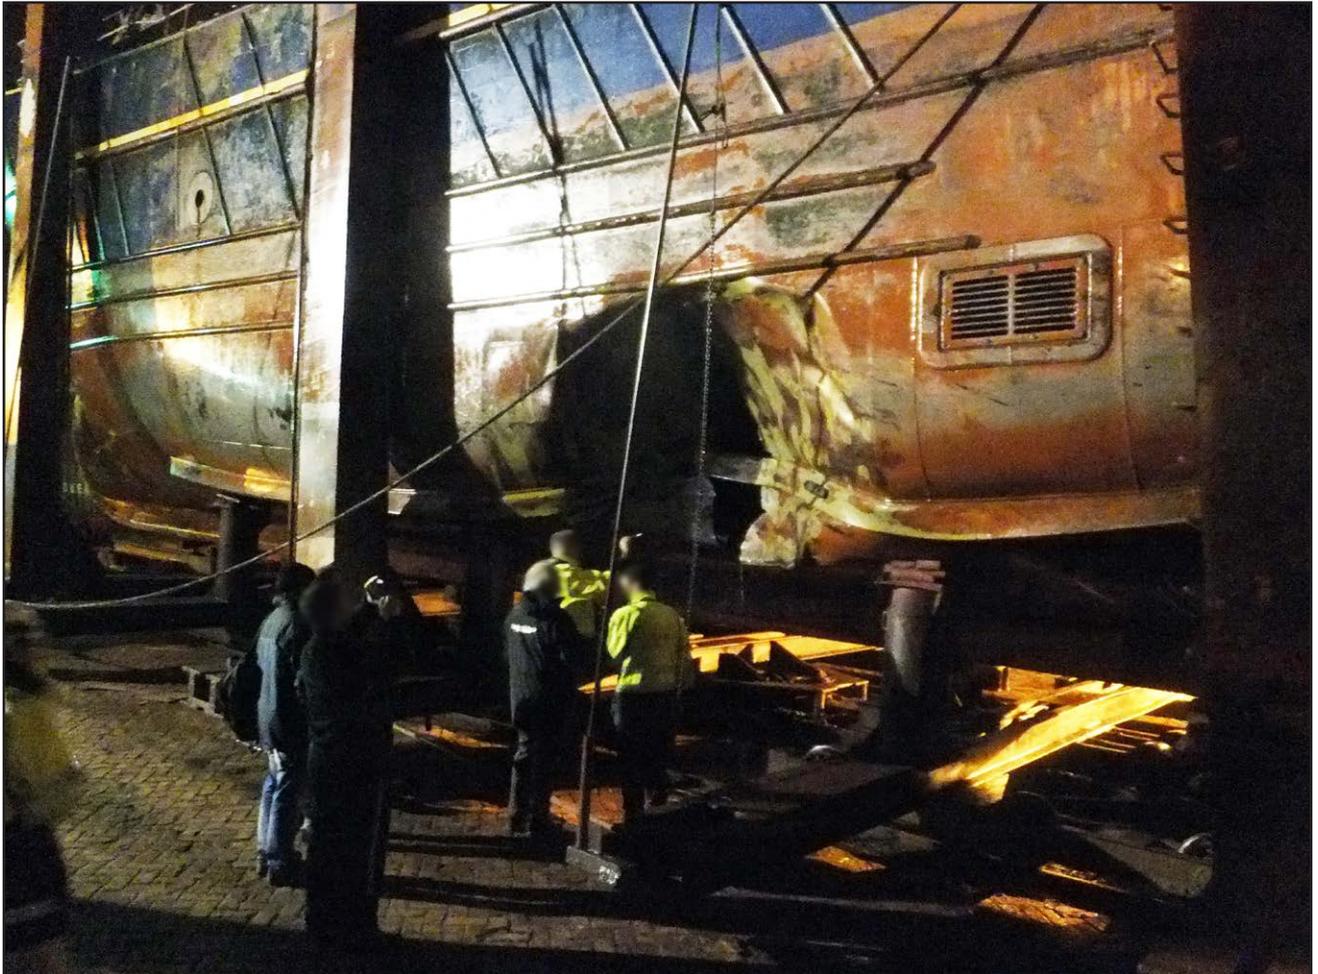
The tanker's bow collided with the fishing vessel's port side, causing extensive damage below the waterline in way of a wing fuel tank between the fish hold and the engine room (see figures). There were no injuries, but the crew of the fishing vessel were very fortunate. Had the damage been either side of the fuel tank, the resulting flooding of either the fish room or the engine room would probably have caused the fishing vessel to quickly founder.

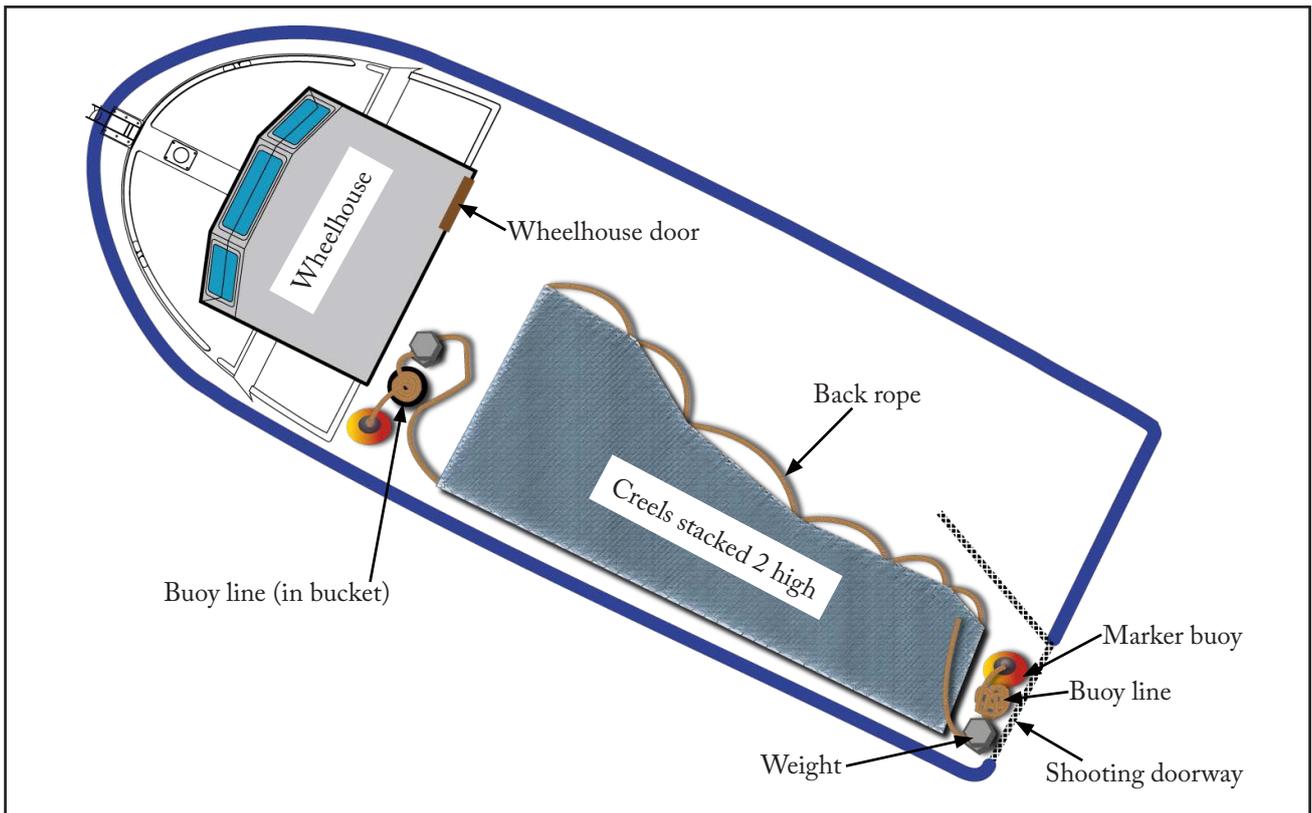
Figure 1: Single fleet storage of creels on deck of fishing vessel

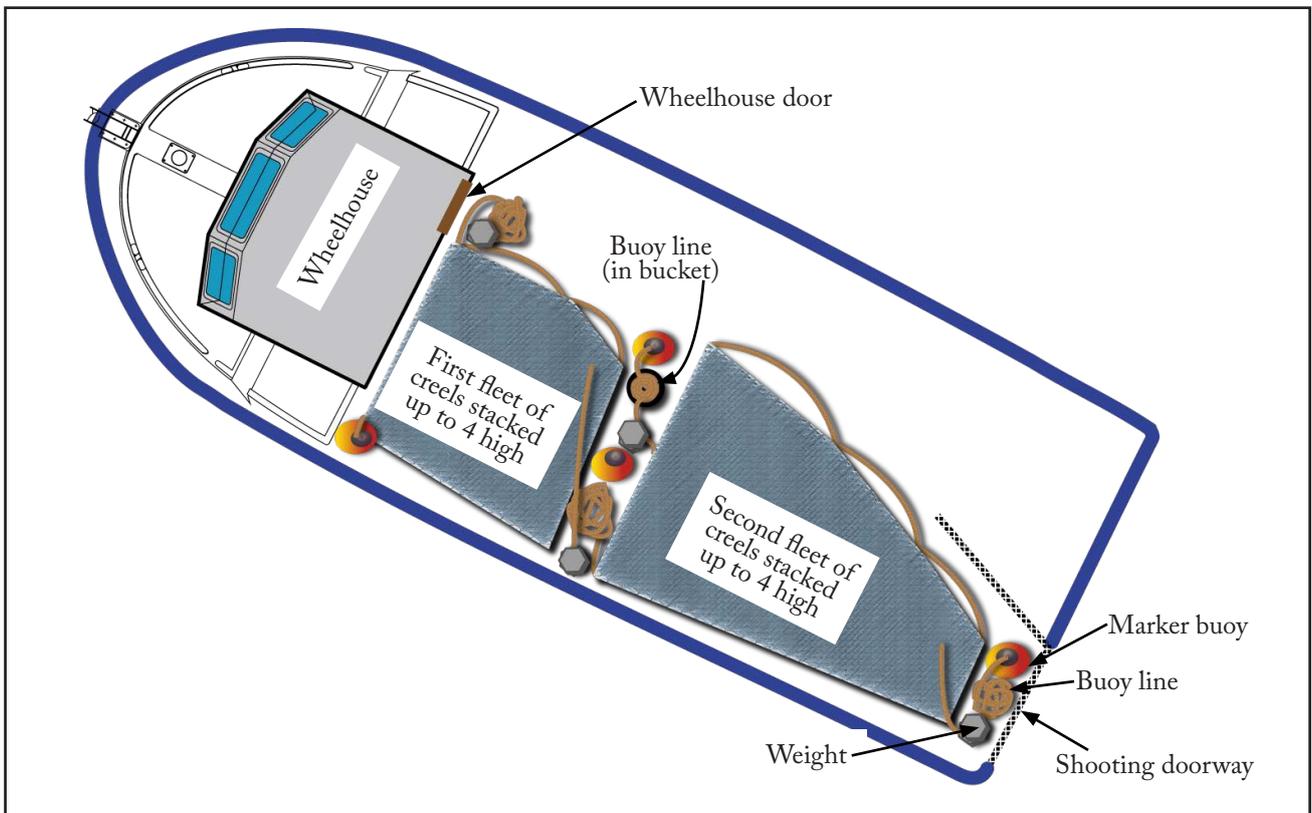
Figure 2: Storage of two fleets of creels on deck of fishing vessel (as on the day of the accident)

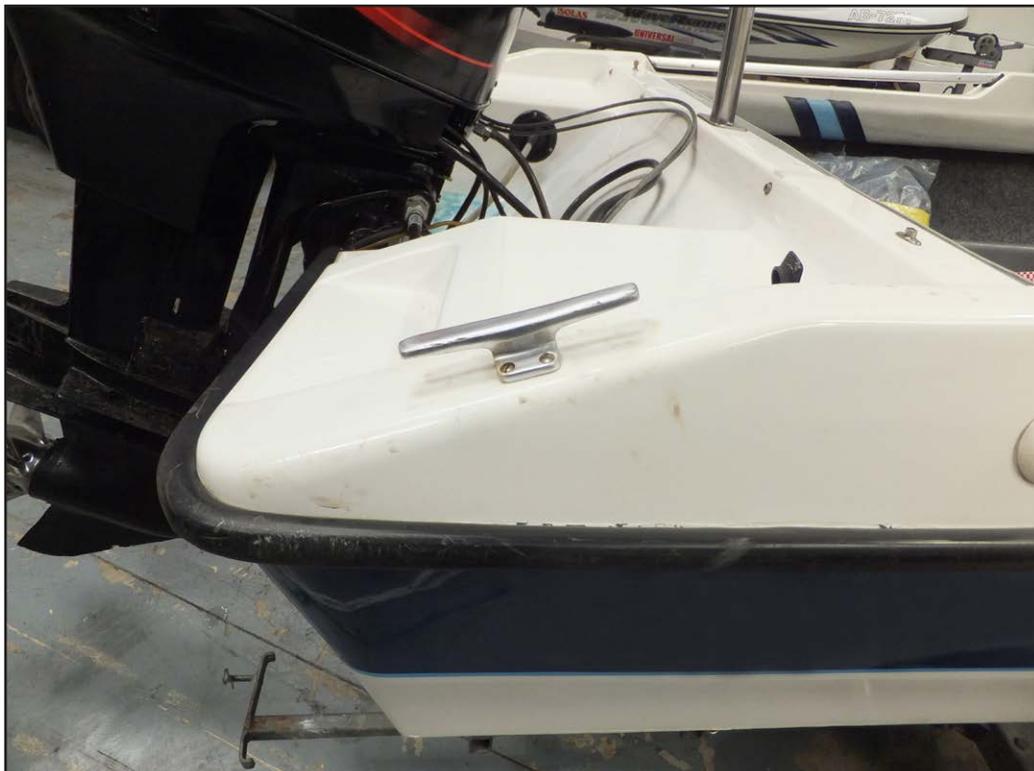
1. One of the straps of the buoyancy aid worn by the casualty was found to have become caught on an aft mooring cleat of the speedboat (see figure). The buoyancy aid was too big for the child and this increased the risk of it becoming snagged. Buoyancy aids and lifejackets are important items of safety equipment, but they must be a close fit to ensure that they are able to function correctly and minimise an opportunity to become caught.

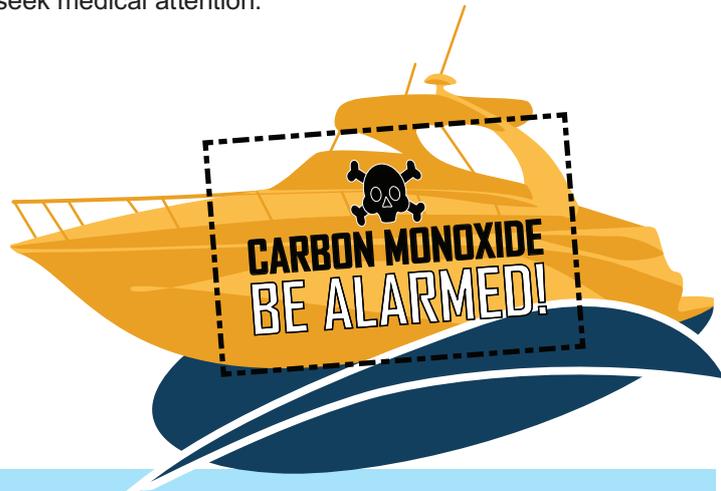
The motor cruiser's 5.7 litre petrol-driven inboard engine had been left running at 3000rpm while it was moored alongside, probably to charge the batteries. A slight wind blowing from the stern caused exhaust gas emitting from below the aft transom to enter the canopy covering the aft deck (**Figure 1**) from where it spread down into the accommodation area forward. During in-situ tests with the engine running the concentration of carbon monoxide from the wet exhaust (**Figure 2**), reached high levels in the accommodation in less than 3 minutes. The accommodation area was not ventilated and the couple and their dog were overcome. No carbon monoxide alarms were fitted.

2. The use of canopies can potentially increase the risk of poisoning, even when a boat is making way. Although external engine exhaust outlets discharge exhaust fumes into the open, the wind, aerodynamic effects and the proximity of nearby structures frequently result in the fumes entering the boat. Ensure that all spaces, including those under a canopy or an awning are always well ventilated. Never ignore the smell of exhaust fumes in any enclosed space.

3. Carbon monoxide is a silent killer. Its symptoms can be similar to colds, flu or hangovers; headaches, dizziness, nausea, vomiting, tiredness, confusion, stomach pain and shortness of breath are warning signs of its presence. If carbon monoxide poisoning is suspected, stop the source, get to the open air and seek medical attention.
