Final report MO-2013-203: DEV *Aratere*, fracture of starboard propeller shaft,
resulting in loss of starboard propeller, Cook Strait, 5 November 2013

Marine inquiry MO-2013-203
DEV *Aratere*,
fracture of starboard propeller shaft
resulting in loss of starboard propeller,
Cook Strait,
5 November 2013

Approved for publication: November 2016

Transport Accident Investigation Commission

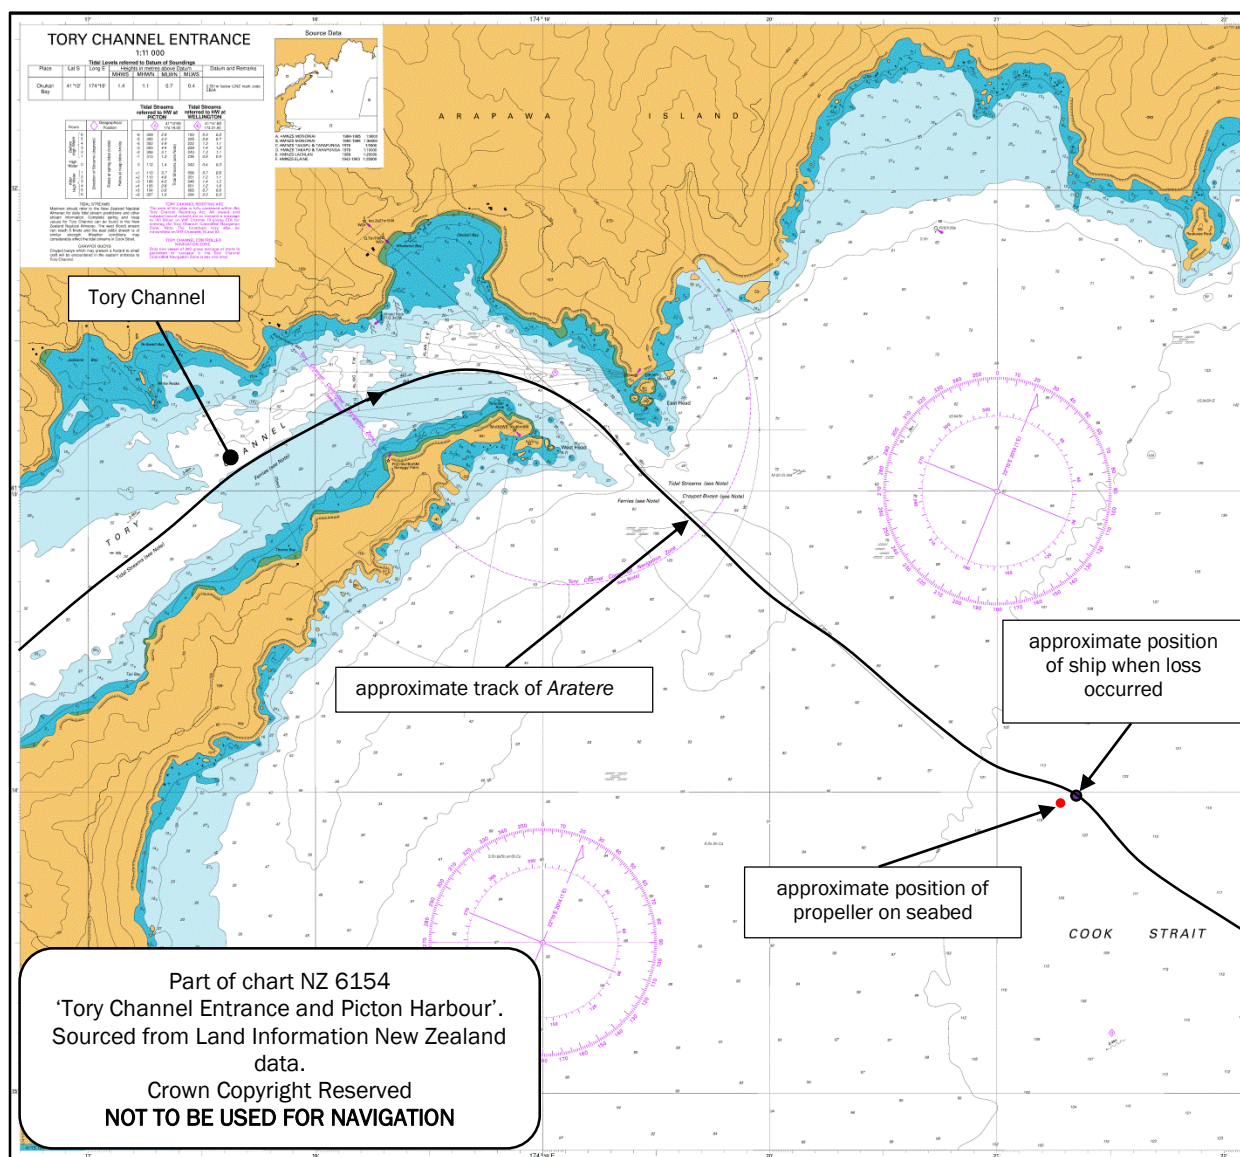
Figure 2
Tory Channel entrance with position of loss

- 3.1.14. A specialist company engaged by KiwiRail found the propeller and shaft stub on the seabed on 23 November 2013, and recovered them on 10 December 2013. The propeller was recovered close to where the *Aratere*'s crew had heard the double bang. (See Figure 2.)
- 3.1.15. The propeller was taken to the Commission's technical facility in Wellington.

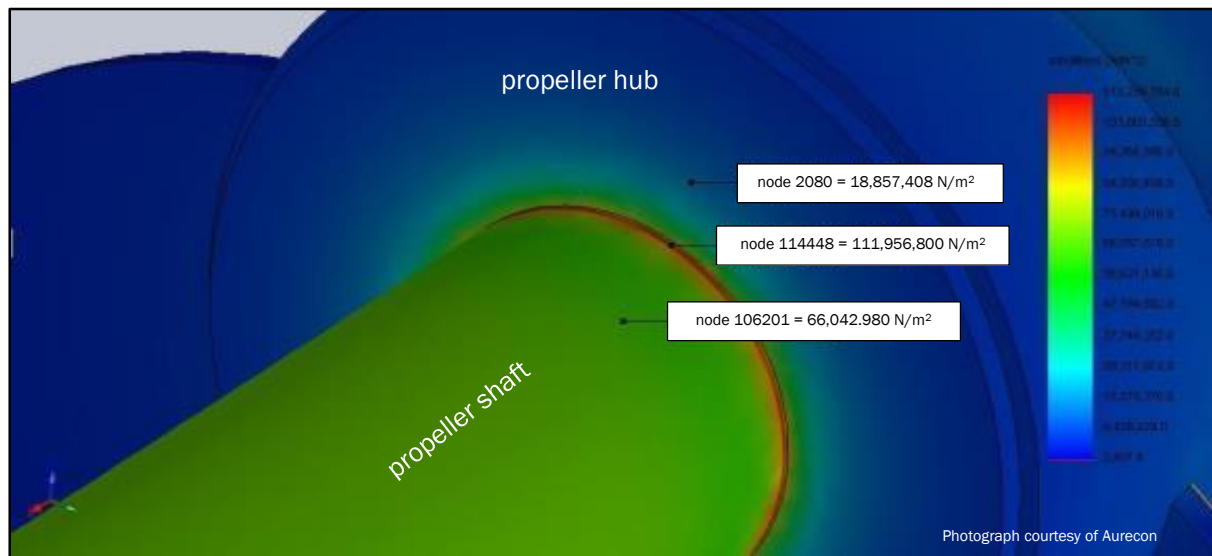
Figure 5
Image showing example of stress concentration
where a propeller is clamped onto a shaft

4.5.4. Some of the stresses on a propeller shaft are unavoidable due to the method of construction. An example is the clamping stress of the propeller onto the shaft itself, which is a form of stress concentration. In Figure 5 the red represents a higher level of stress concentration where the front end of the propeller boss clamps onto the propeller shaft. Unavoidable stresses exist in most propeller and shaft assemblies, but would normally be well below the crack initiation limit.⁶ A propeller shaft is designed to withstand these foreseen stresses.

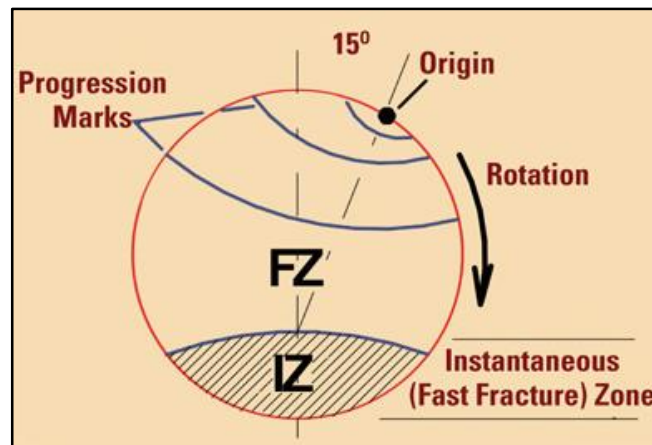
Figure 6
Illustration of typical bending fatigue failure in a rotating shaft

- 5.1.1. Various experts⁸ concluded that the type of fracture that occurred on the *Aratere's* starboard propeller shaft was a fatigue fracture, typical of that resulting from uniaxial bending forces acting on a rotating shaft. Shaft failures resulting from bending fatigue display a unique fracture surface not seen in other types of shaft fatigue failure. Figure 6 is a drawing of a typical plane bending fatigue failure in a rotating shaft. The drawing shows how a crack starts at the origin and slowly propagates (grows) across the fatigue zone. When the crack reaches the boundary of the instantaneous zone, its growth rate increases significantly. (Sachs, 2012)
- 5.1.2. The drawing in Figure 6 shows remarkable similarities to the photograph of the shaft fracture face of the *Aratere's* propeller shaft, shown in Figure 7.

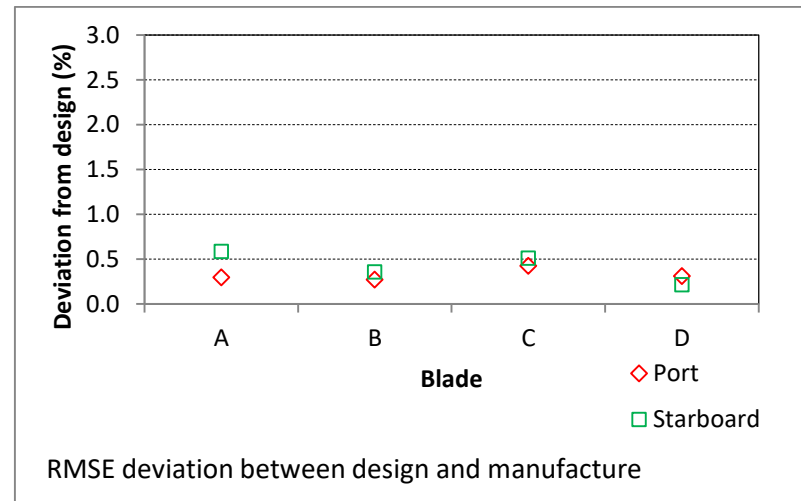
Root mean square error of port and starboard propeller pitches as manufactured when compared to designed pitch

The Y axis in Figure 1 shows, as an absolute percentage, how much the ‘as manufactured’ propeller blade pitch deviates from design. For example: the average pitch of blade A on the port side propeller deviates from design by about 0.3%, whereas blade A of the starboard propeller deviates from design about 0.6%. The percentage was calculated using the Root Mean Square Error method described below.

Figure 1 shows that generally the port and starboard propellers deviated from design by about the same amount, although it remains to be seen whether or not this magnitude of deviation from design is significant.
