## MARINE SAFETY INVESTIGATION REPORT

**Safety investigation into the mooring equipment failure and  
subsequent fatality of a Shipyard worker  
on board the Cyprus registered ro-ro passenger**

***GALAXY***

MARINE SAFETY INVESTIGATION REPORT NO. 02/2017

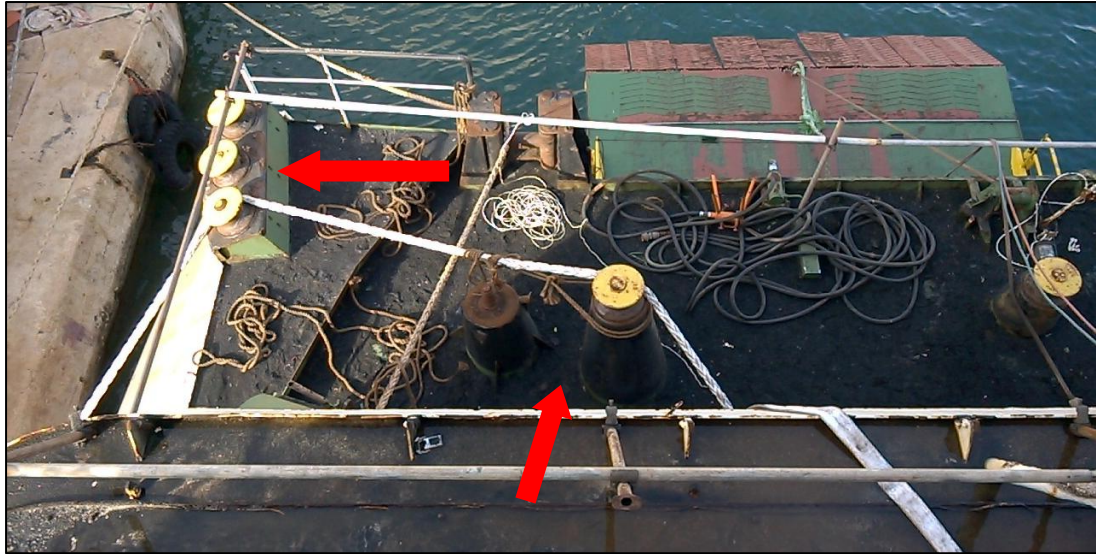
Winch controls were fitted at each ship side and adjacent to each winch, providing the operator with a good view of the lines being handled ashore from the respective side. The design was such that the mooring lines could be led ashore through a chock of three open button-rollers at each quarter and on each side of the stern ramp. In turn, they led onto the mooring winches around two pedestal fairleads; one pedestal fairlead serving the rope on the single-drum winch and another pedestal fairlead (approximately 0.40 m higher than the other) serving the warping drum end (Figure 3).

**Figure 3: Open button-roller chock and pedestal fairleads on the aft mooring deck**

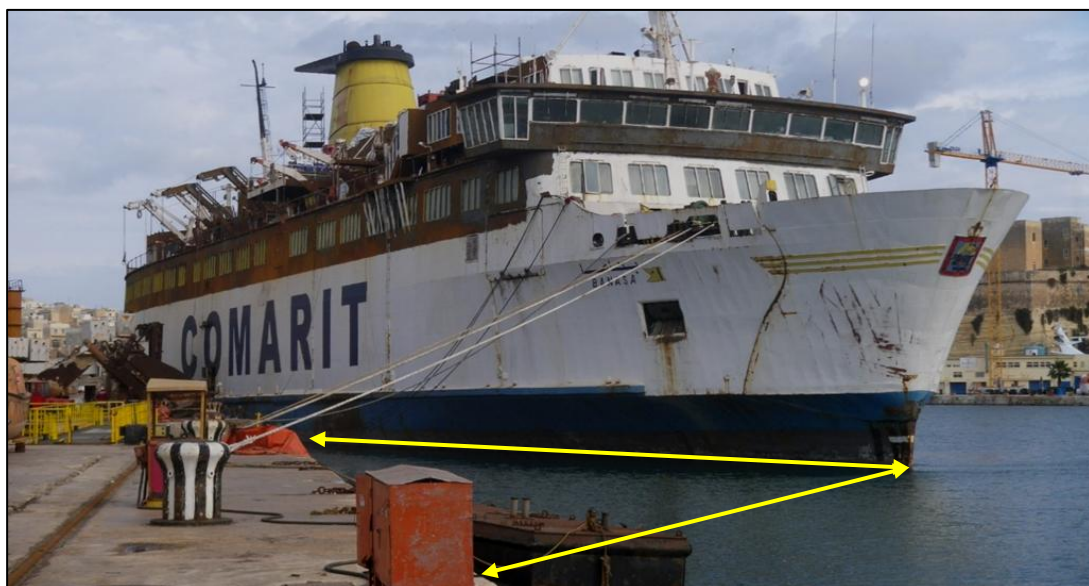
**Figure 6: Overhang distance at the forward part of the vessel**

The vessel was assigned a berthing position with a considerable part of it (almost half of her length) overhanging. The overhang resulted from the fact that the berth changed direction away from the ship, from about amidships towards the bow by about 25° (Figure 6). This meant that *Galaxy* was not lying fully alongside and when taking into consideration that the forward-most Yokohama fender against which the vessel was leaning, was positioned approximately adjacent the letter "O" of the name 'COMARIT' painted on the shipside, it meant that the forward half of the ship was overhanging the allocated berth.

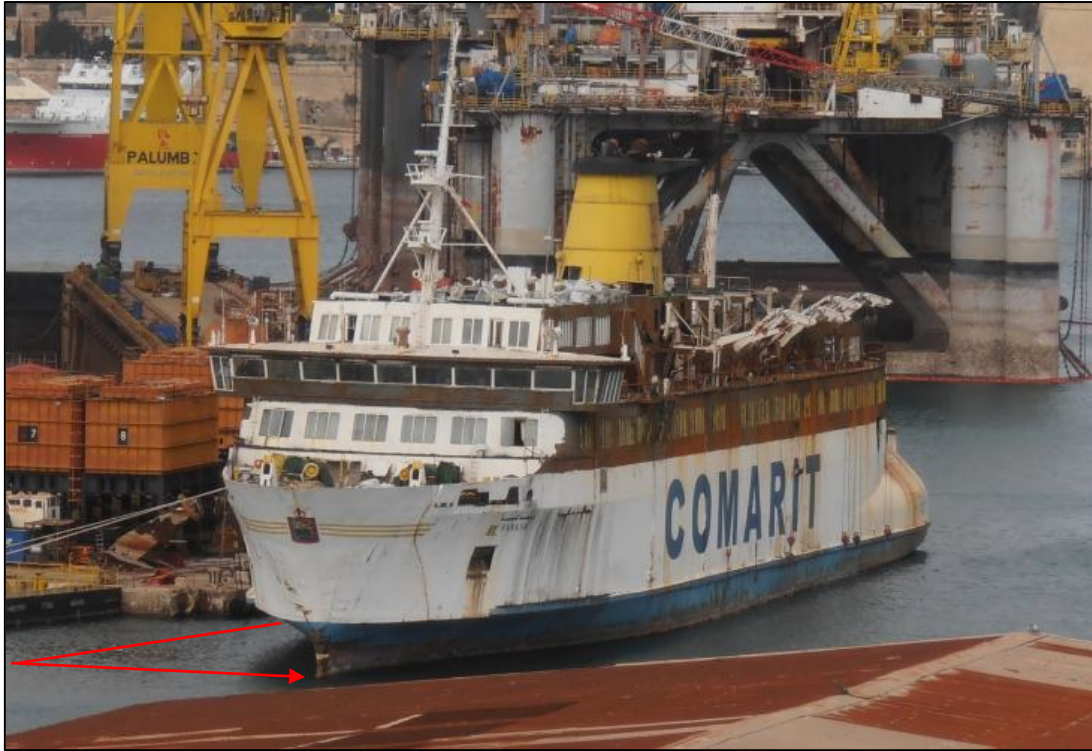
**Figure 7: Overhang distance at the forward part of the vessel from a different angle**

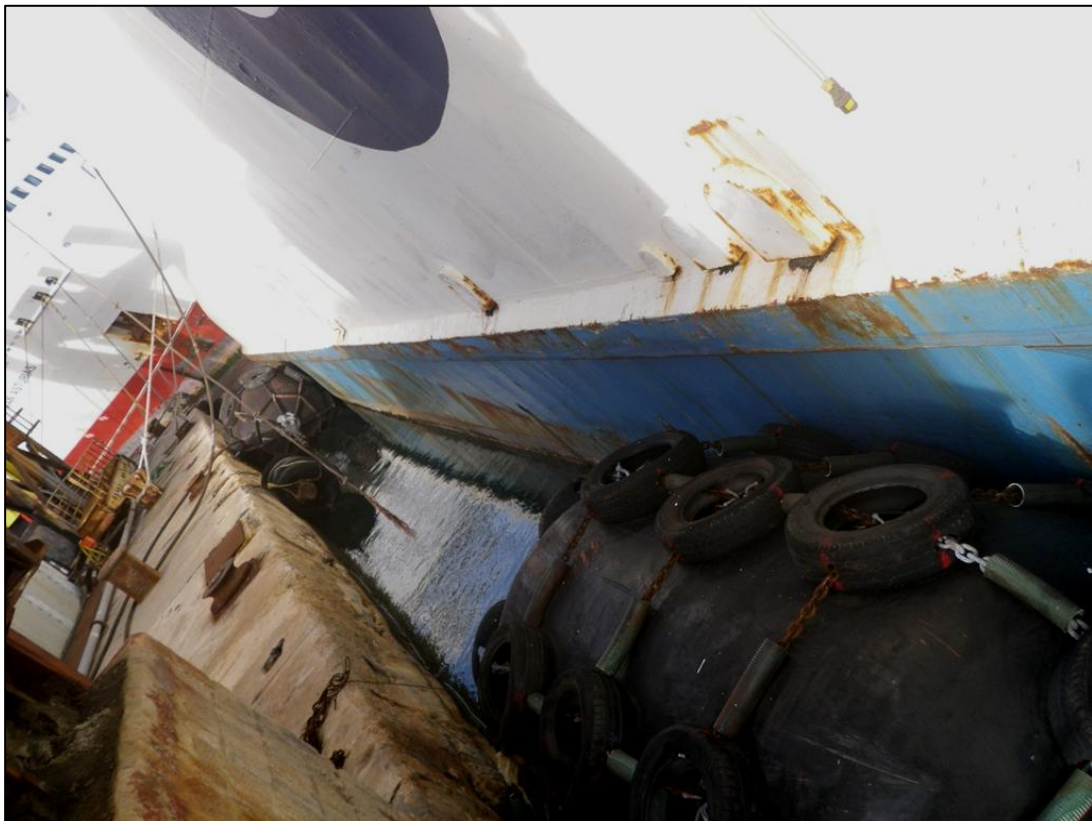
**Figure 8: Yokohama fenders between the jetty and the vessel**
